**Early Childhood
Education Center
at Maddox**
700 W. Mansfield Ave.

Facility Performance Scorecard

Maddox Early Childhood Education Center

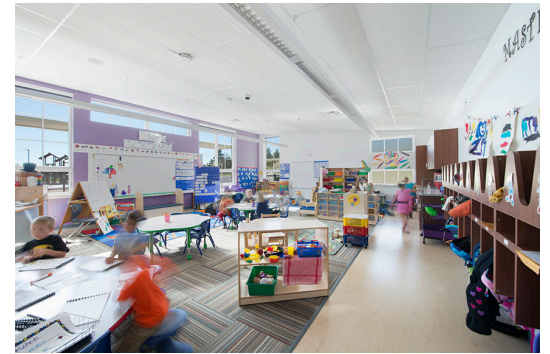
Structure: Some areas of flooring are in need of replacement. Roof sections all in excess of 15 years old and some minor leaks. No noted foundation issues. No exterior wall issues. Single pane, low-efficiency windows.

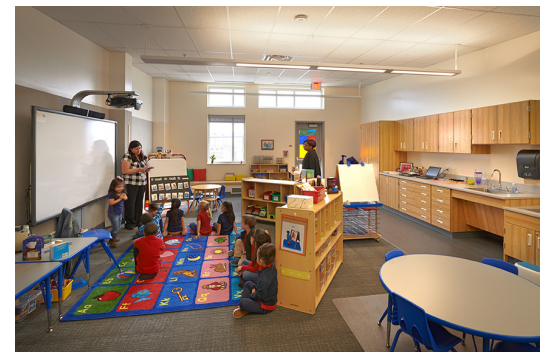
Safety Devices: The fire alarm system is over 15 years old and does not meet current fire code. It is subject to frequent trouble signals. No fire sprinkler system in the building. Building is equipped with a functioning alarm system containing door contacts and motion sensors. Building entry requires buzz-in intercom with security camera. Intercom system is aging and should be relocated for current building use.
