January 24, 2020

Re: Indoor Environmental Assessment  
Fairfield Ludlowe High School, Fairfield, Connecticut

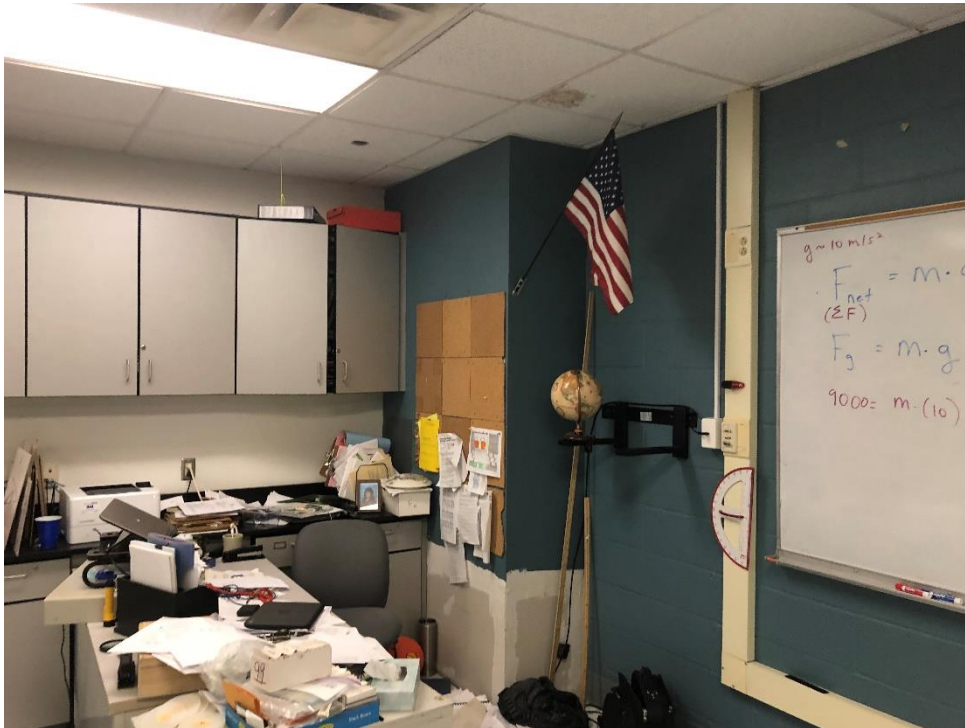
Photo Number: 1

- In the Physics Room, Room 153, one stained ceiling tile was visible, and a repaired gypsum board wall was visible near the teachers' desk. Photograph 1 in Attachment A documents this condition. The tile and wall did not contain elevated moisture. The source of the stained tile was not readily apparent. Also, the metal decking was heavily rusted and rust flakes were visible on the suspended ceiling. Photographs 2 and 3 in Attachment A document this condition.

Description: Stained ceiling and repairs to gypsum board wall

- In the Physics Room, Room 153, the water stained ceiling tile should be replaced and the rust that has fallen from the ceiling deck should be cleaned in a manner that minimizes generation of airborne dust such as using a high efficiency particulate air (HEPA) vacuum. Identify and repair the source of rust on the ceiling deck.

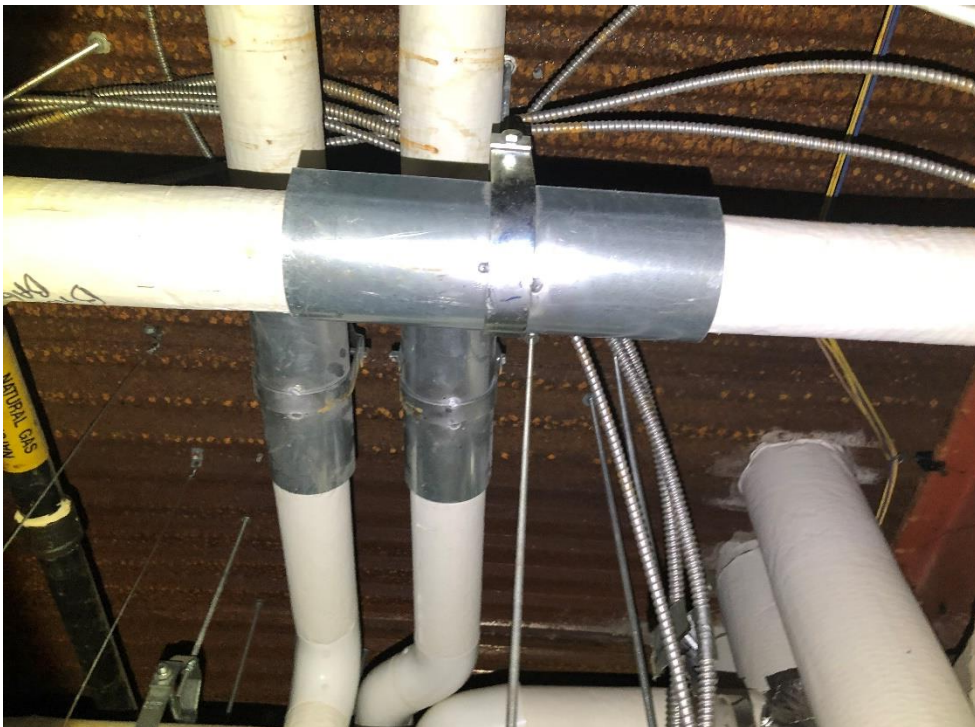
Photo Number: 2

Description: Rust on ceiling deck

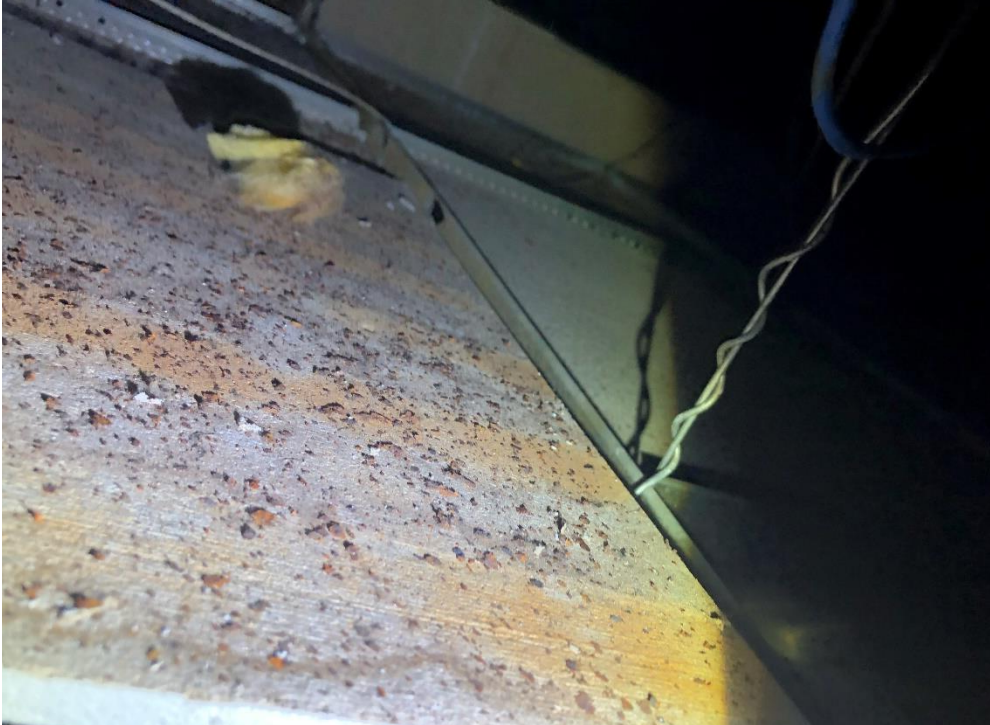
Photo Number: 3

Description: Rust particulate on ceiling tiles

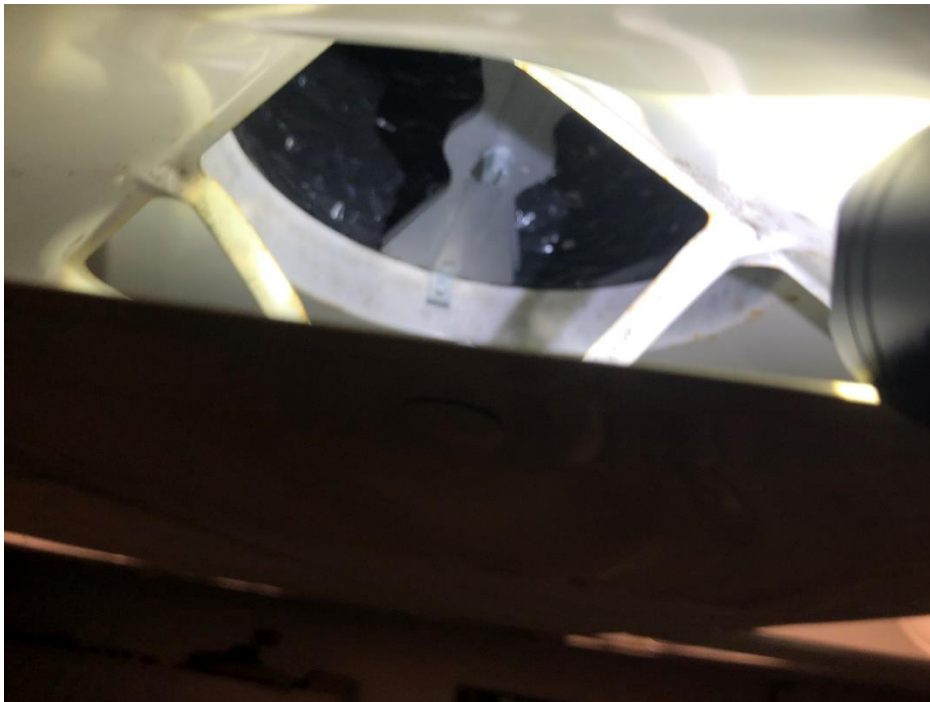
Photo Number: 4

- In the Physics Room, Room 153, dust was observed on the supply air diffuser fins. Photograph 4 in Attachment A documents this condition. A surface sample for mold content determination was collected from the air diffuser fins in this room and the results indicate that the surface sample collected from this supply air diffuser contains mold growth. The laboratory analytical report detailing these results is included in Attachment B.

Description: Particulate on supply air diffuser fins

- Wipe clean the supply air diffuser fins in Room 153 and continue to monitor for debris build up on supply air vents.
- In Classroom 262, the water stained ceiling tiles should be replaced. Identify and repair the source of the water staining.

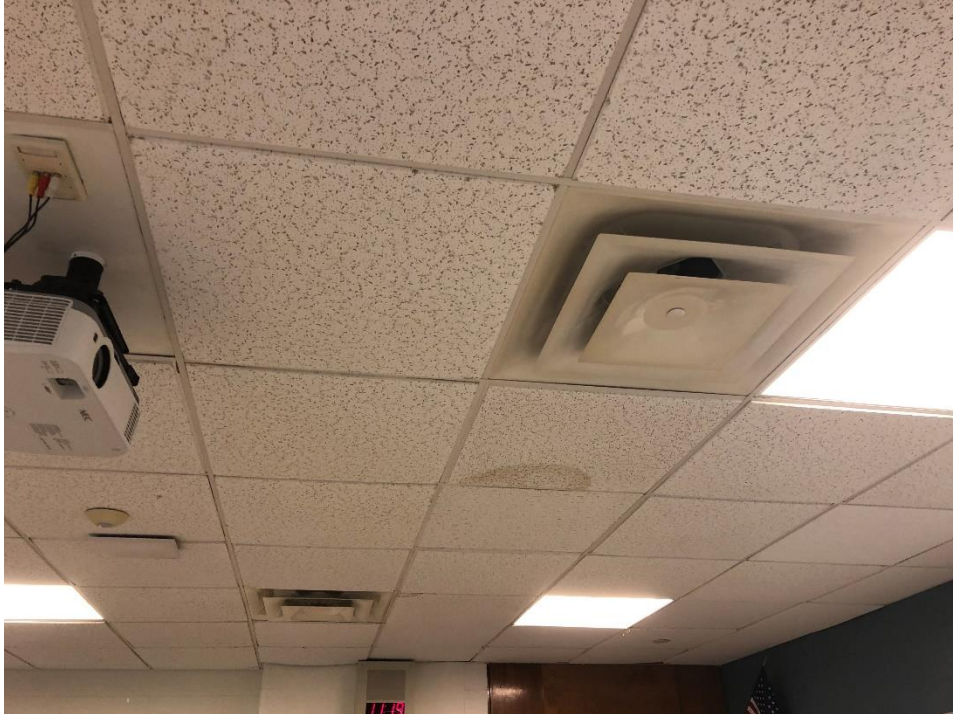
Photo Number: 5

- In Classroom 262, three spots of apparent water staining were observed on the ceiling tiles. Photograph 5 in Attachment A documents this condition. One ceiling tile stain in the center of the room appeared to be caused by a leaking pipe, while the cause of the other spots was not immediately obvious.

Description: Stained ceiling tile

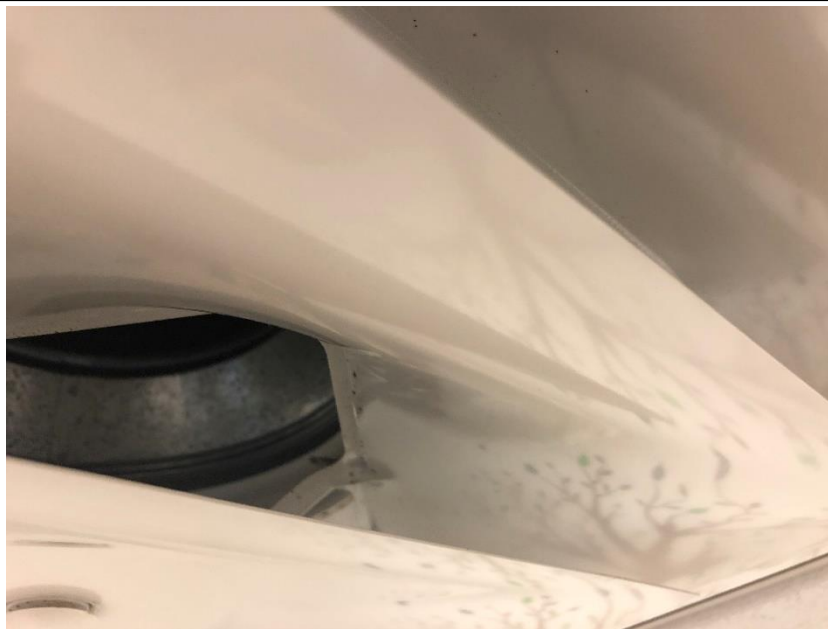
Photo Number: 6

- In the Conference Room 266E, particulate was observed on the supply air diffuser fins. Photograph 6 in Attachment A documents this condition. A surface sample for mold content determination was collected from the air diffuser fins in this room and the results indicate that the surface sample collected from this supply air diffuser contains mold growth. The laboratory analytical report detailing these results is included in Attachment B.

Description: Particulate on supply air diffuser fins

- Wipe clean the supply air diffuser fins in Conference Room 266E and continue to monitor for debris build up on supply air vents.
- In the Conference Room 266E, identify the source of the leaves, debris and suspect fur that was observed above the suspended ceiling and clean this debris in a manner that minimizes generation of airborne dust such as using a high efficiency particulate air (HEPA) vacuum.

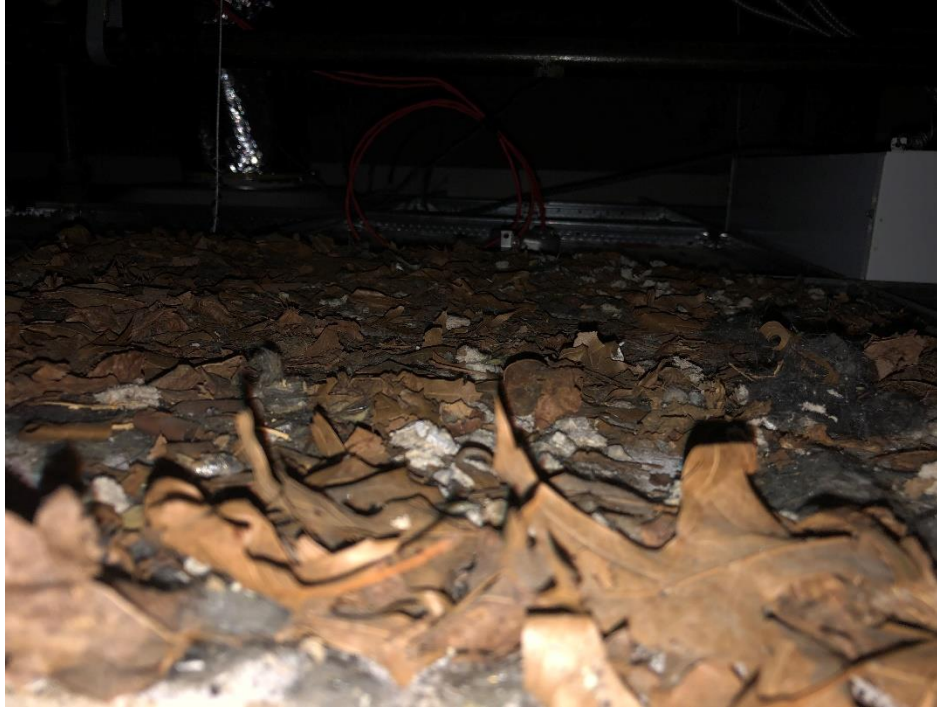
Photo Number: 7

- In Room 266E, above the suspended ceiling tiles, leaves and debris were settled on the tiles. Suspected animal fur was also visibly mixed in with the leaves. Photograph 7 in Attachment A documents this condition.

Description: Leaves, debris, and suspected fur above the suspended ceiling

- Review the school's rodent control procedures and ensure procedures are being implemented throughout the school.
- In Room 269 identify and repair any roof leaks that could allow water to penetrate into the room.
