**space needs study
town administration offices
town of suffield**

**suffield
ct**

tos-2456

december 9, 2005

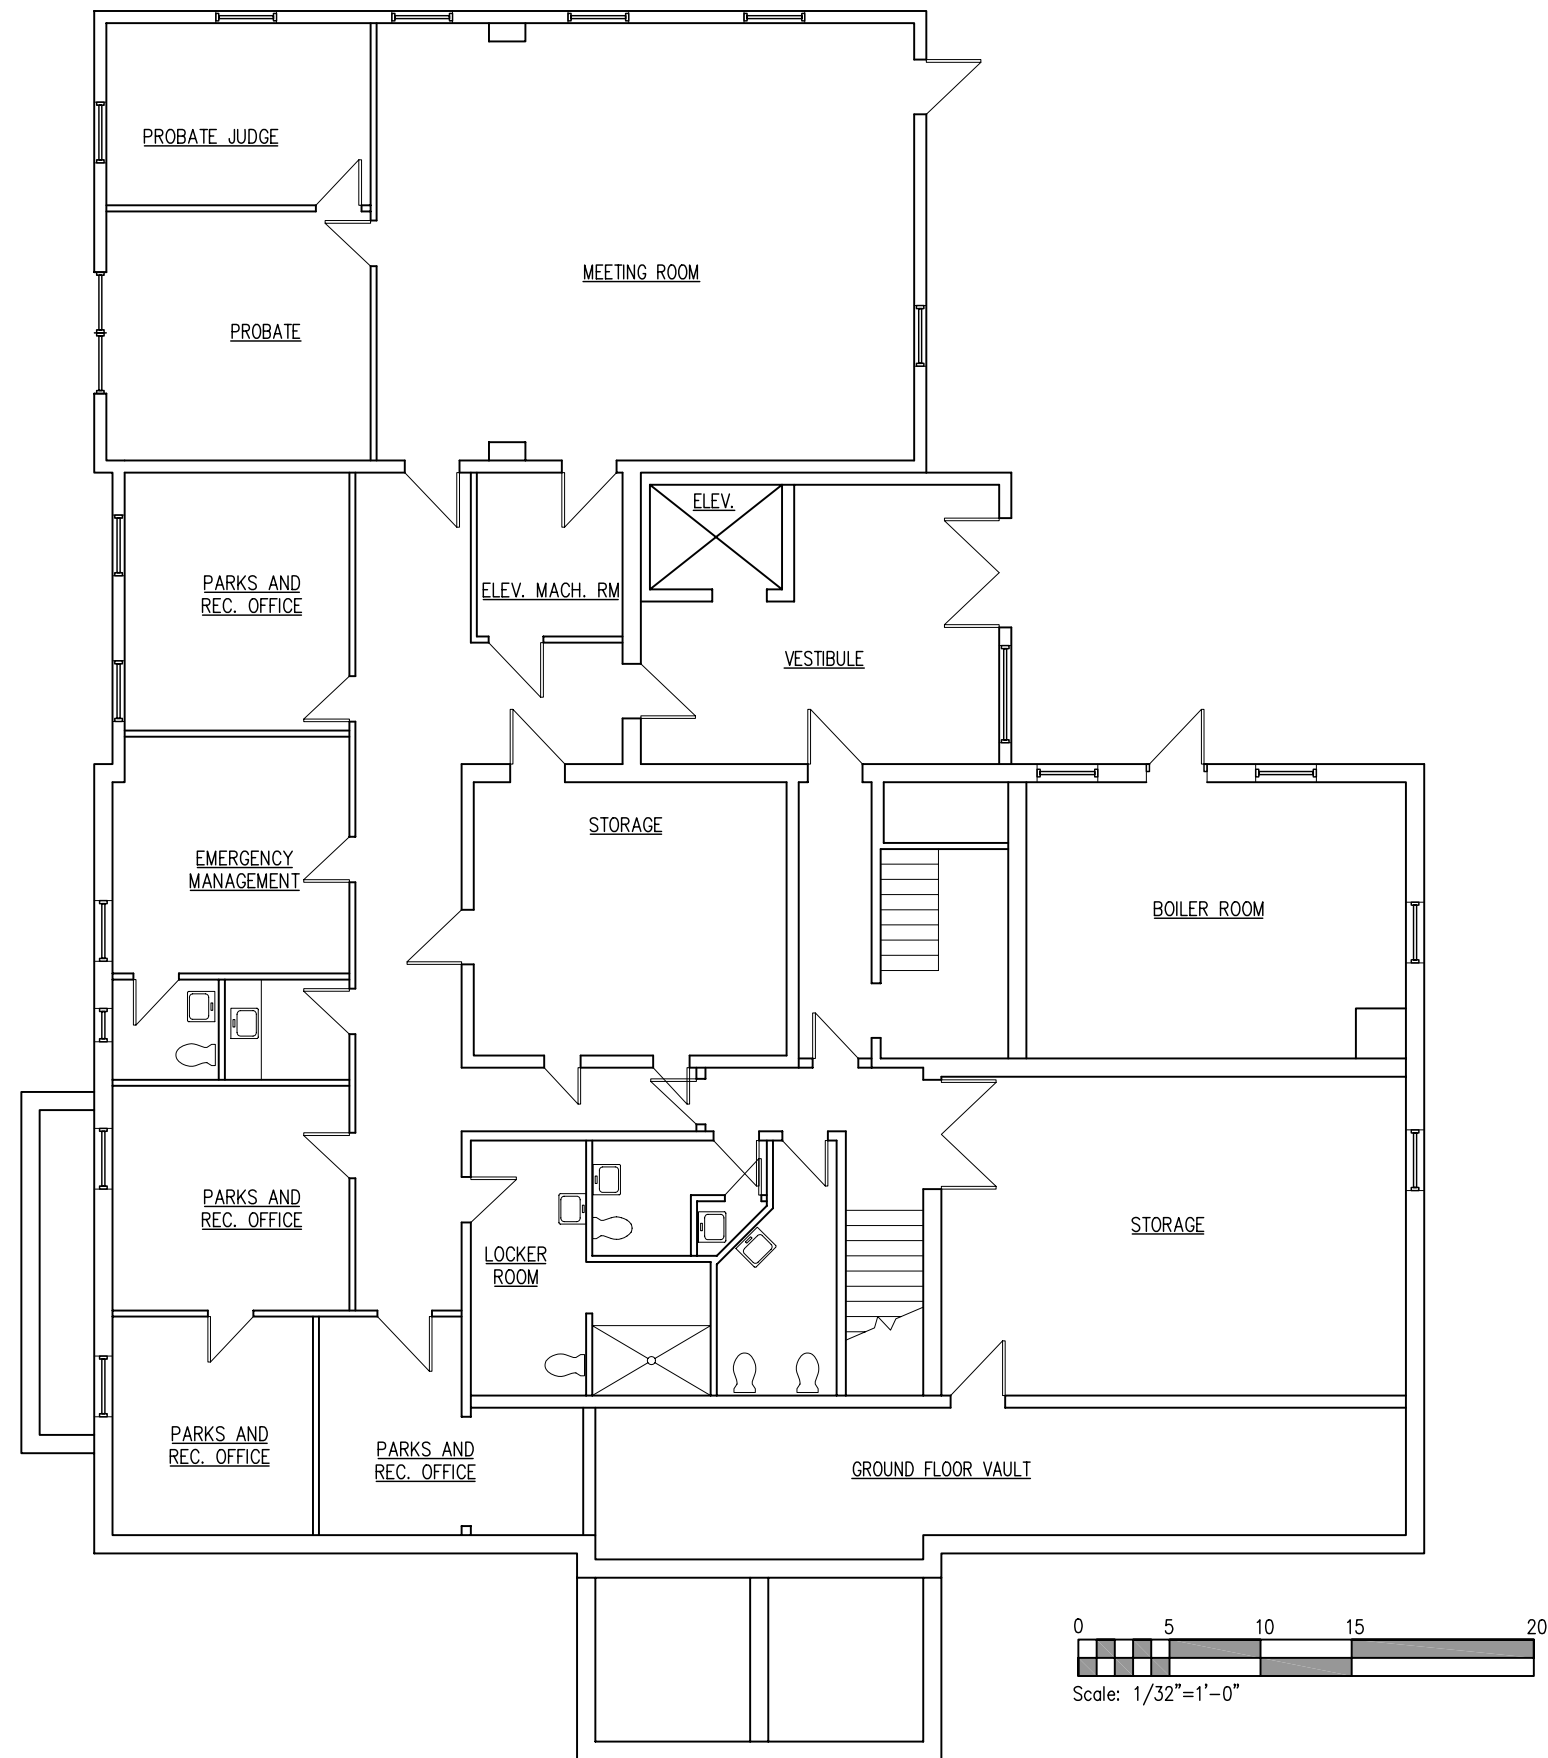
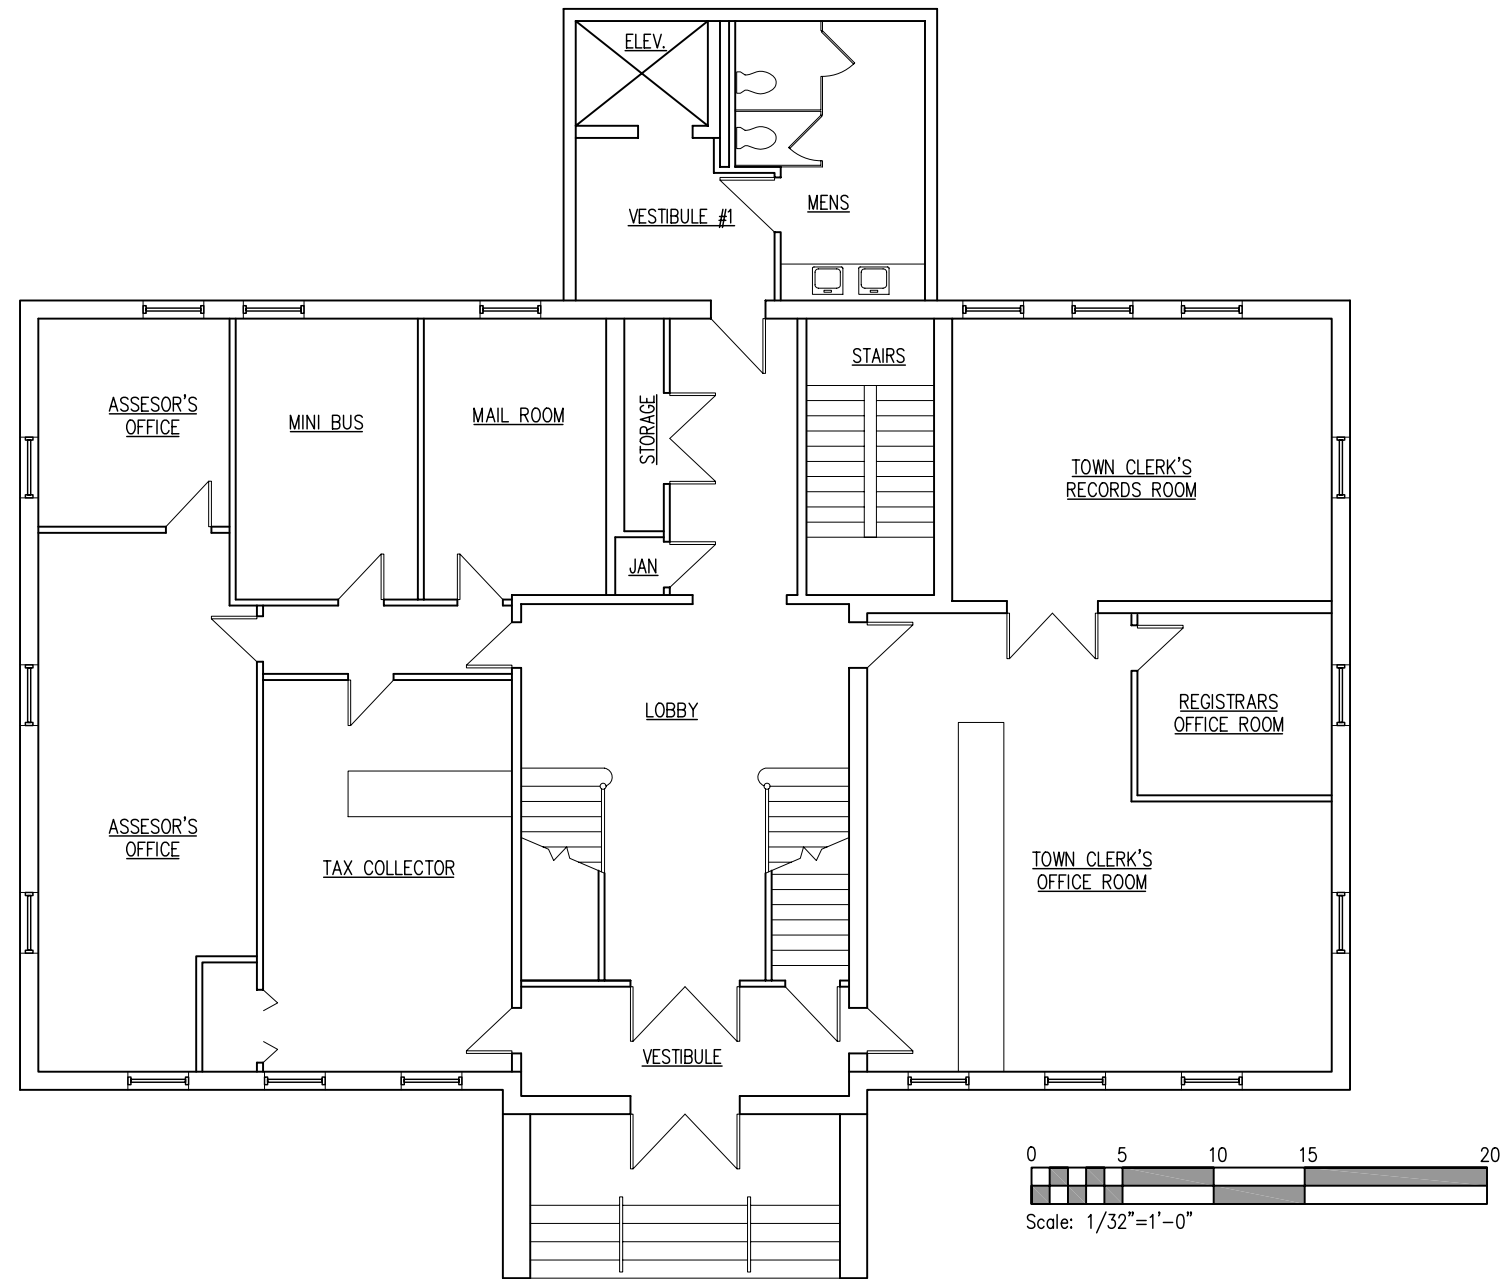
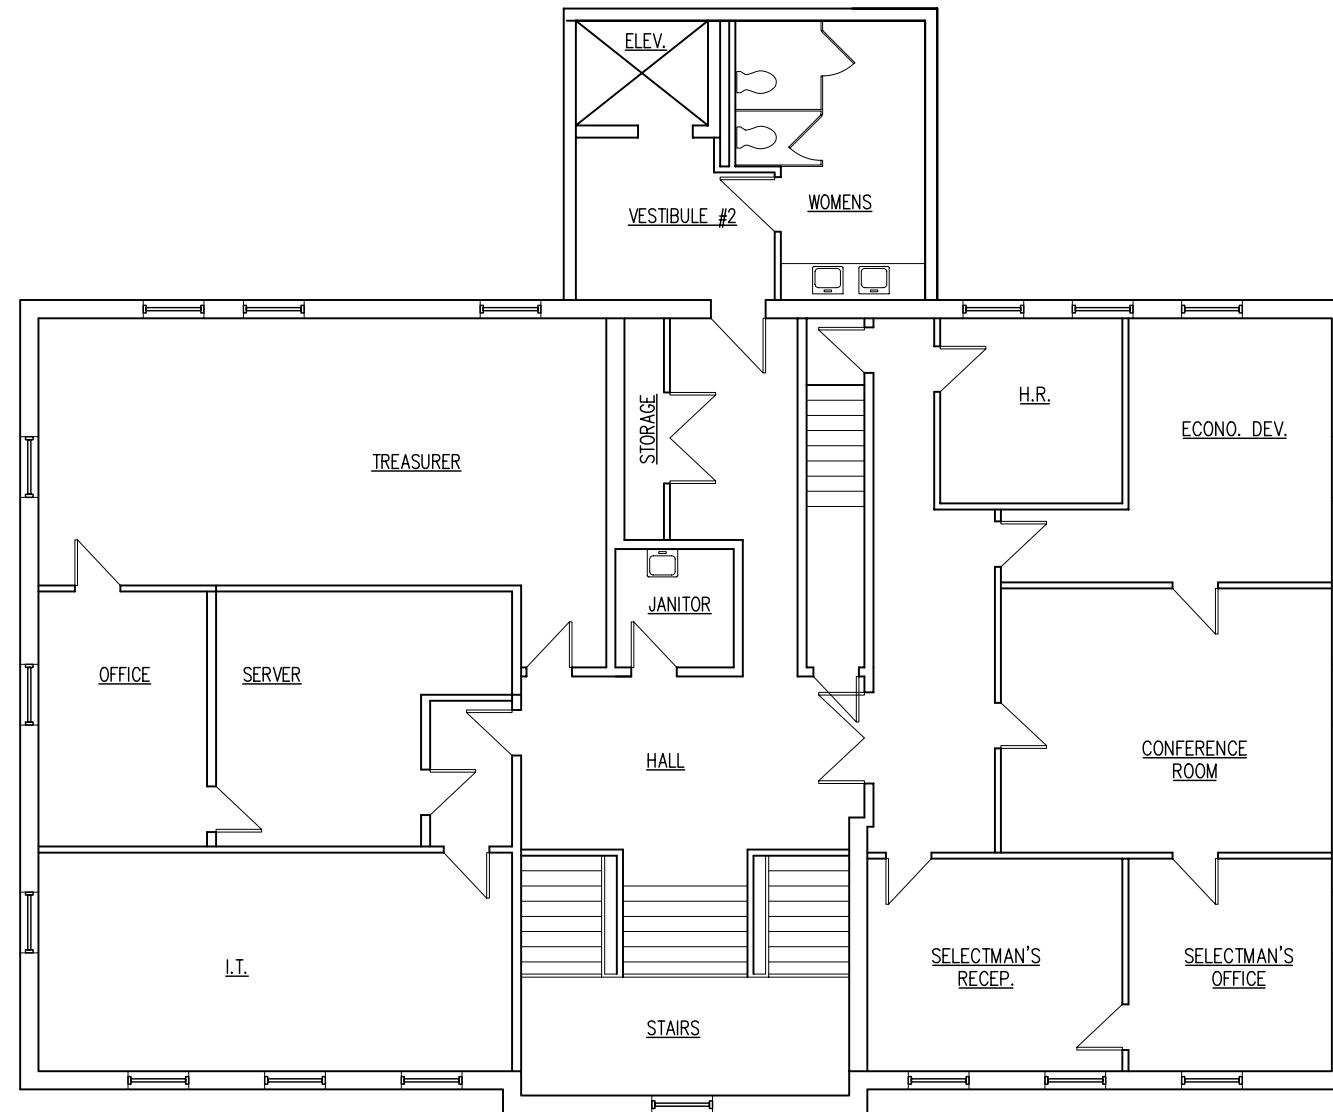
Site - A drainage problem was noted at the foundation at the retaining wall on the east side of the building. An additional drainage concern was noted at the front of the building to the left of the entrance stairs. Both of these areas should be regraded to direct water away from the building structure.

Entries – The main entrance exterior stair is well worn. The concrete is spalling, creating a potentially hazardous condition. The railings are not compliant.

Overall the interior of the building is in good condition. No significant architectural deferred maintenance issues were noted with the exception of the mold noticed in the entry vestibule and on the lower level. This mold appears to be the result of uninsulated chilled water lines (piping that feeds building cooling system) condensing and then dripping water onto various surfaces such as ceiling tiles and gypsum wallboard. In a continuous wet state, these surfaces have grown mold.

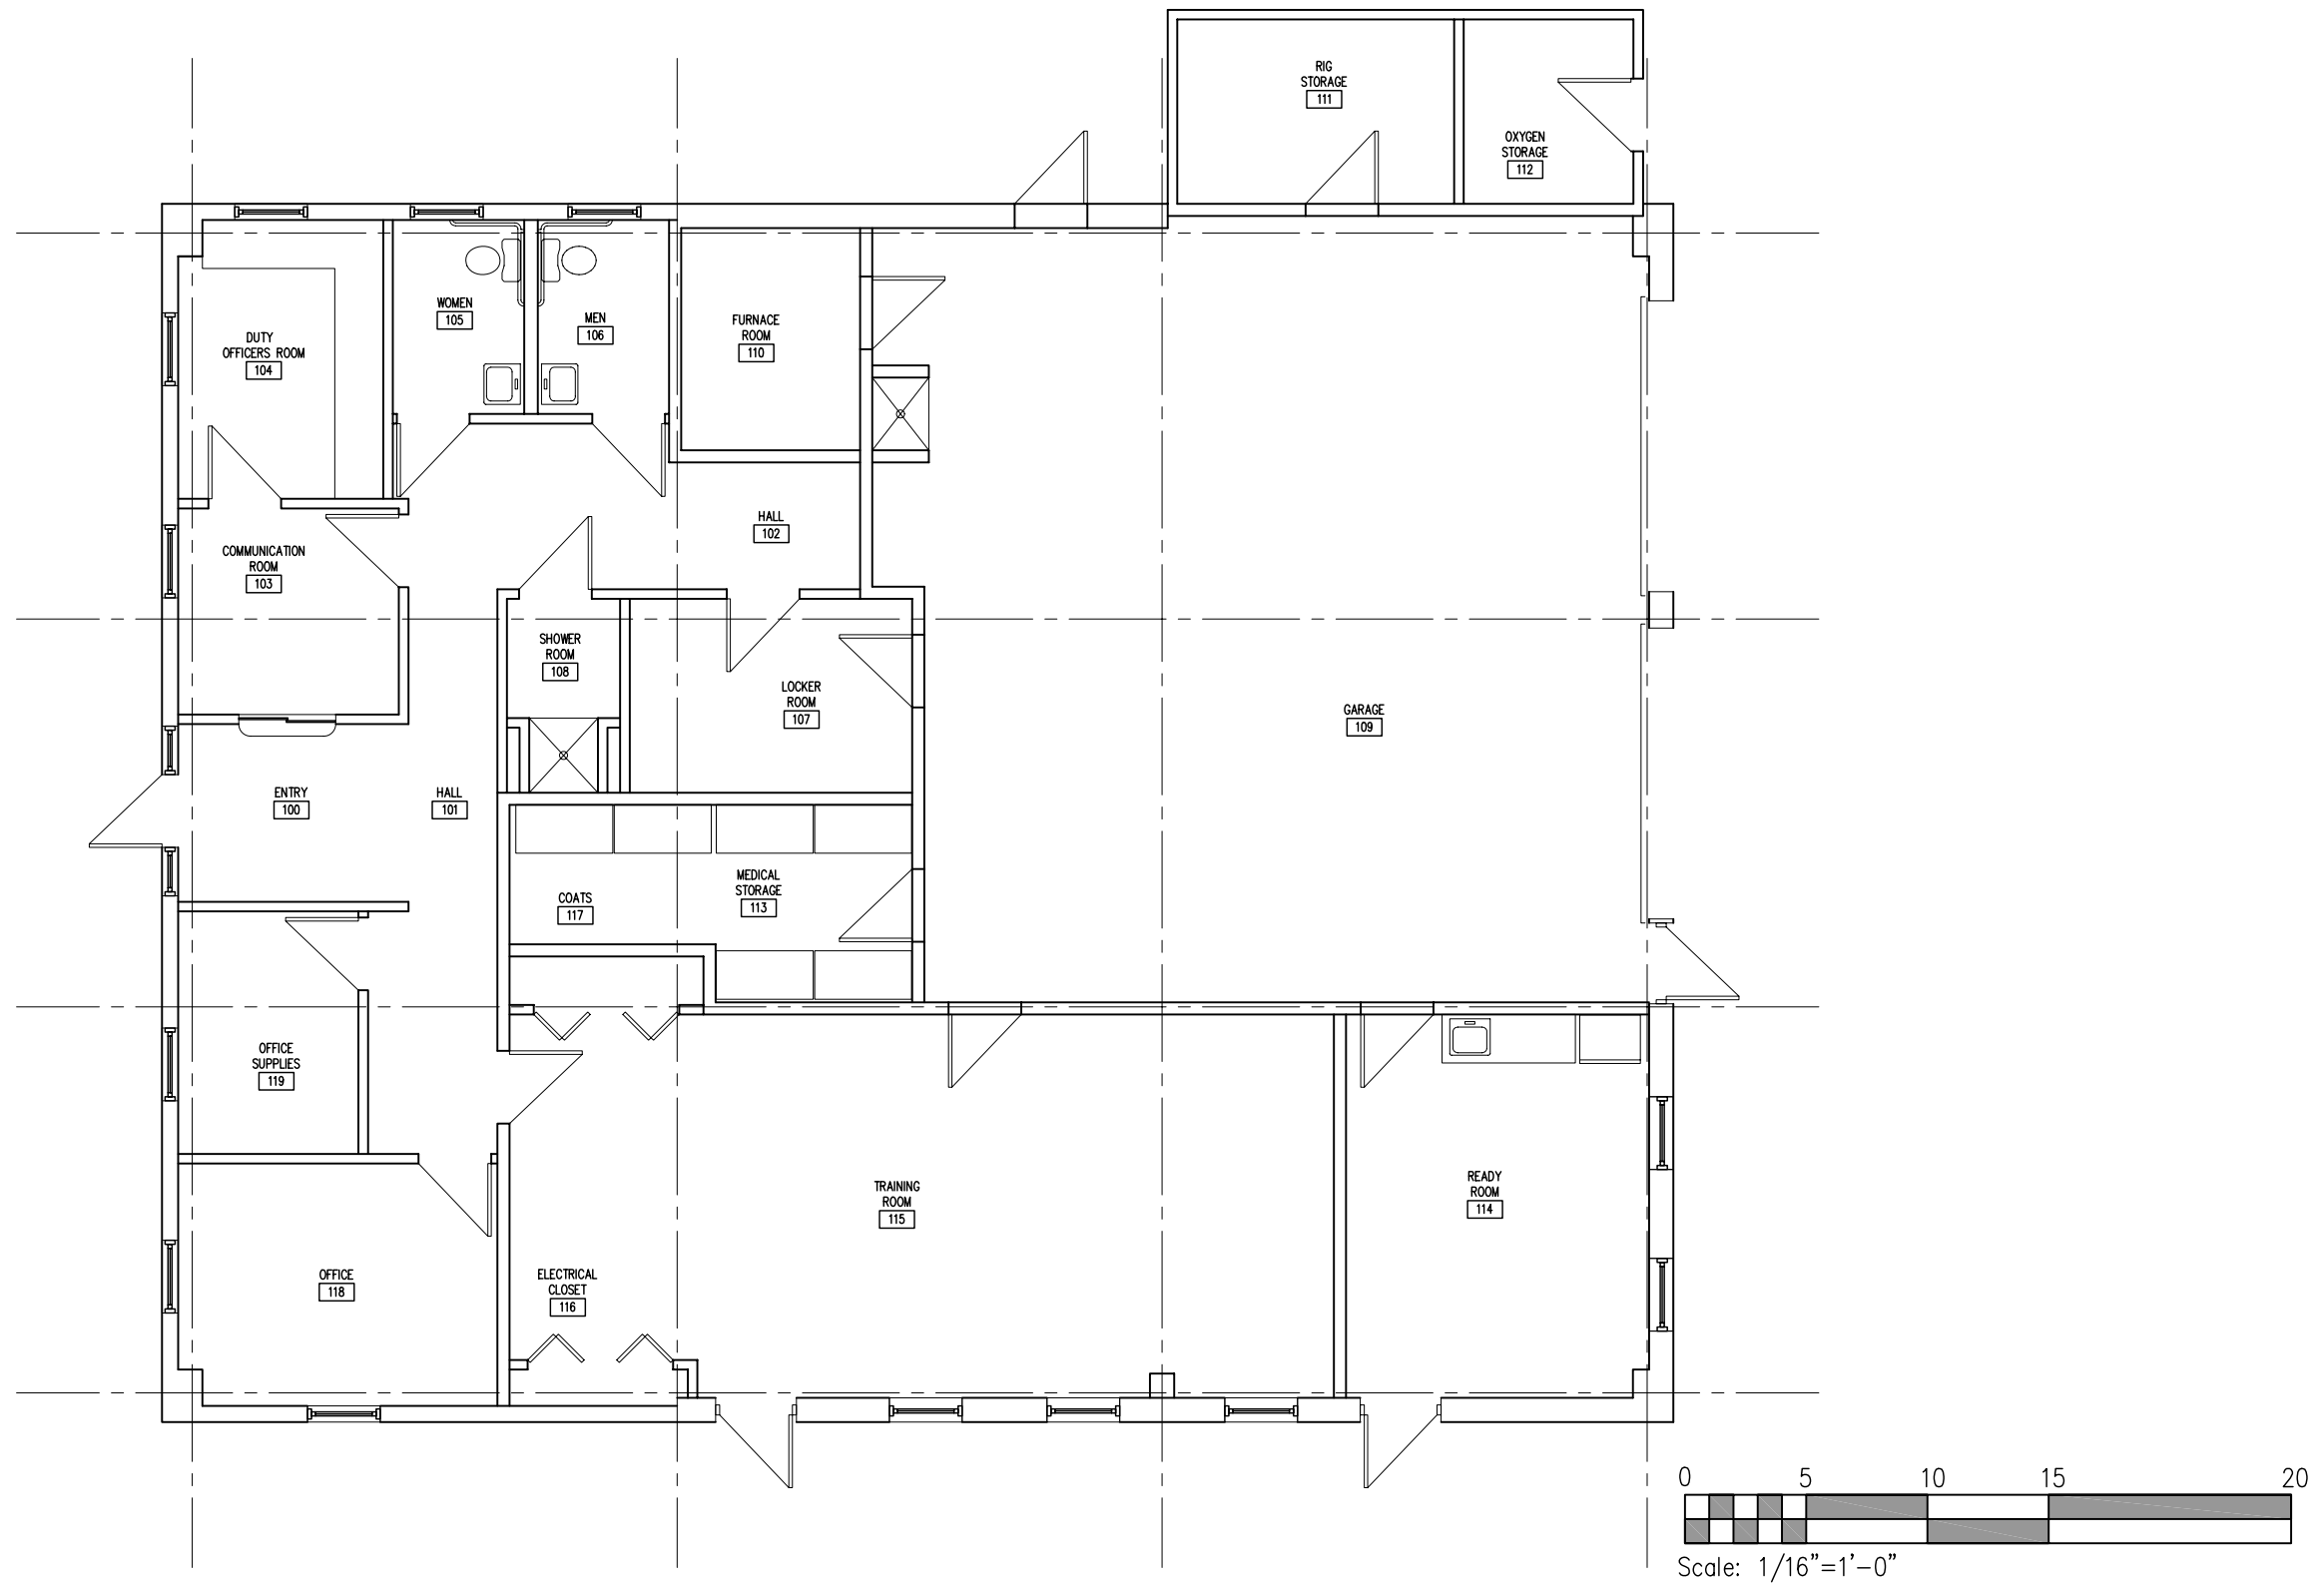
building evaluation – ambulance building

Site - A drainage problem was noted along the east side of the building (between the storage addition and the front of the building.) The area appeared that water would pond in this location in a lowered area created by an incomplete electrical/communication installation (w\the excavated trench was not backfilled.) This area should be backfilled and regraded to direct water away from the building structure.

Concrete – There is some minor spalling of the top of foundation wall at the garage door openings.

Portions of the roof vapor barrier in the garage are cracked/damaged.

It is recommended to add battery powered remote dual heads outside of all egress exit doors to illuminate the area immediately around the exit to become compliant.

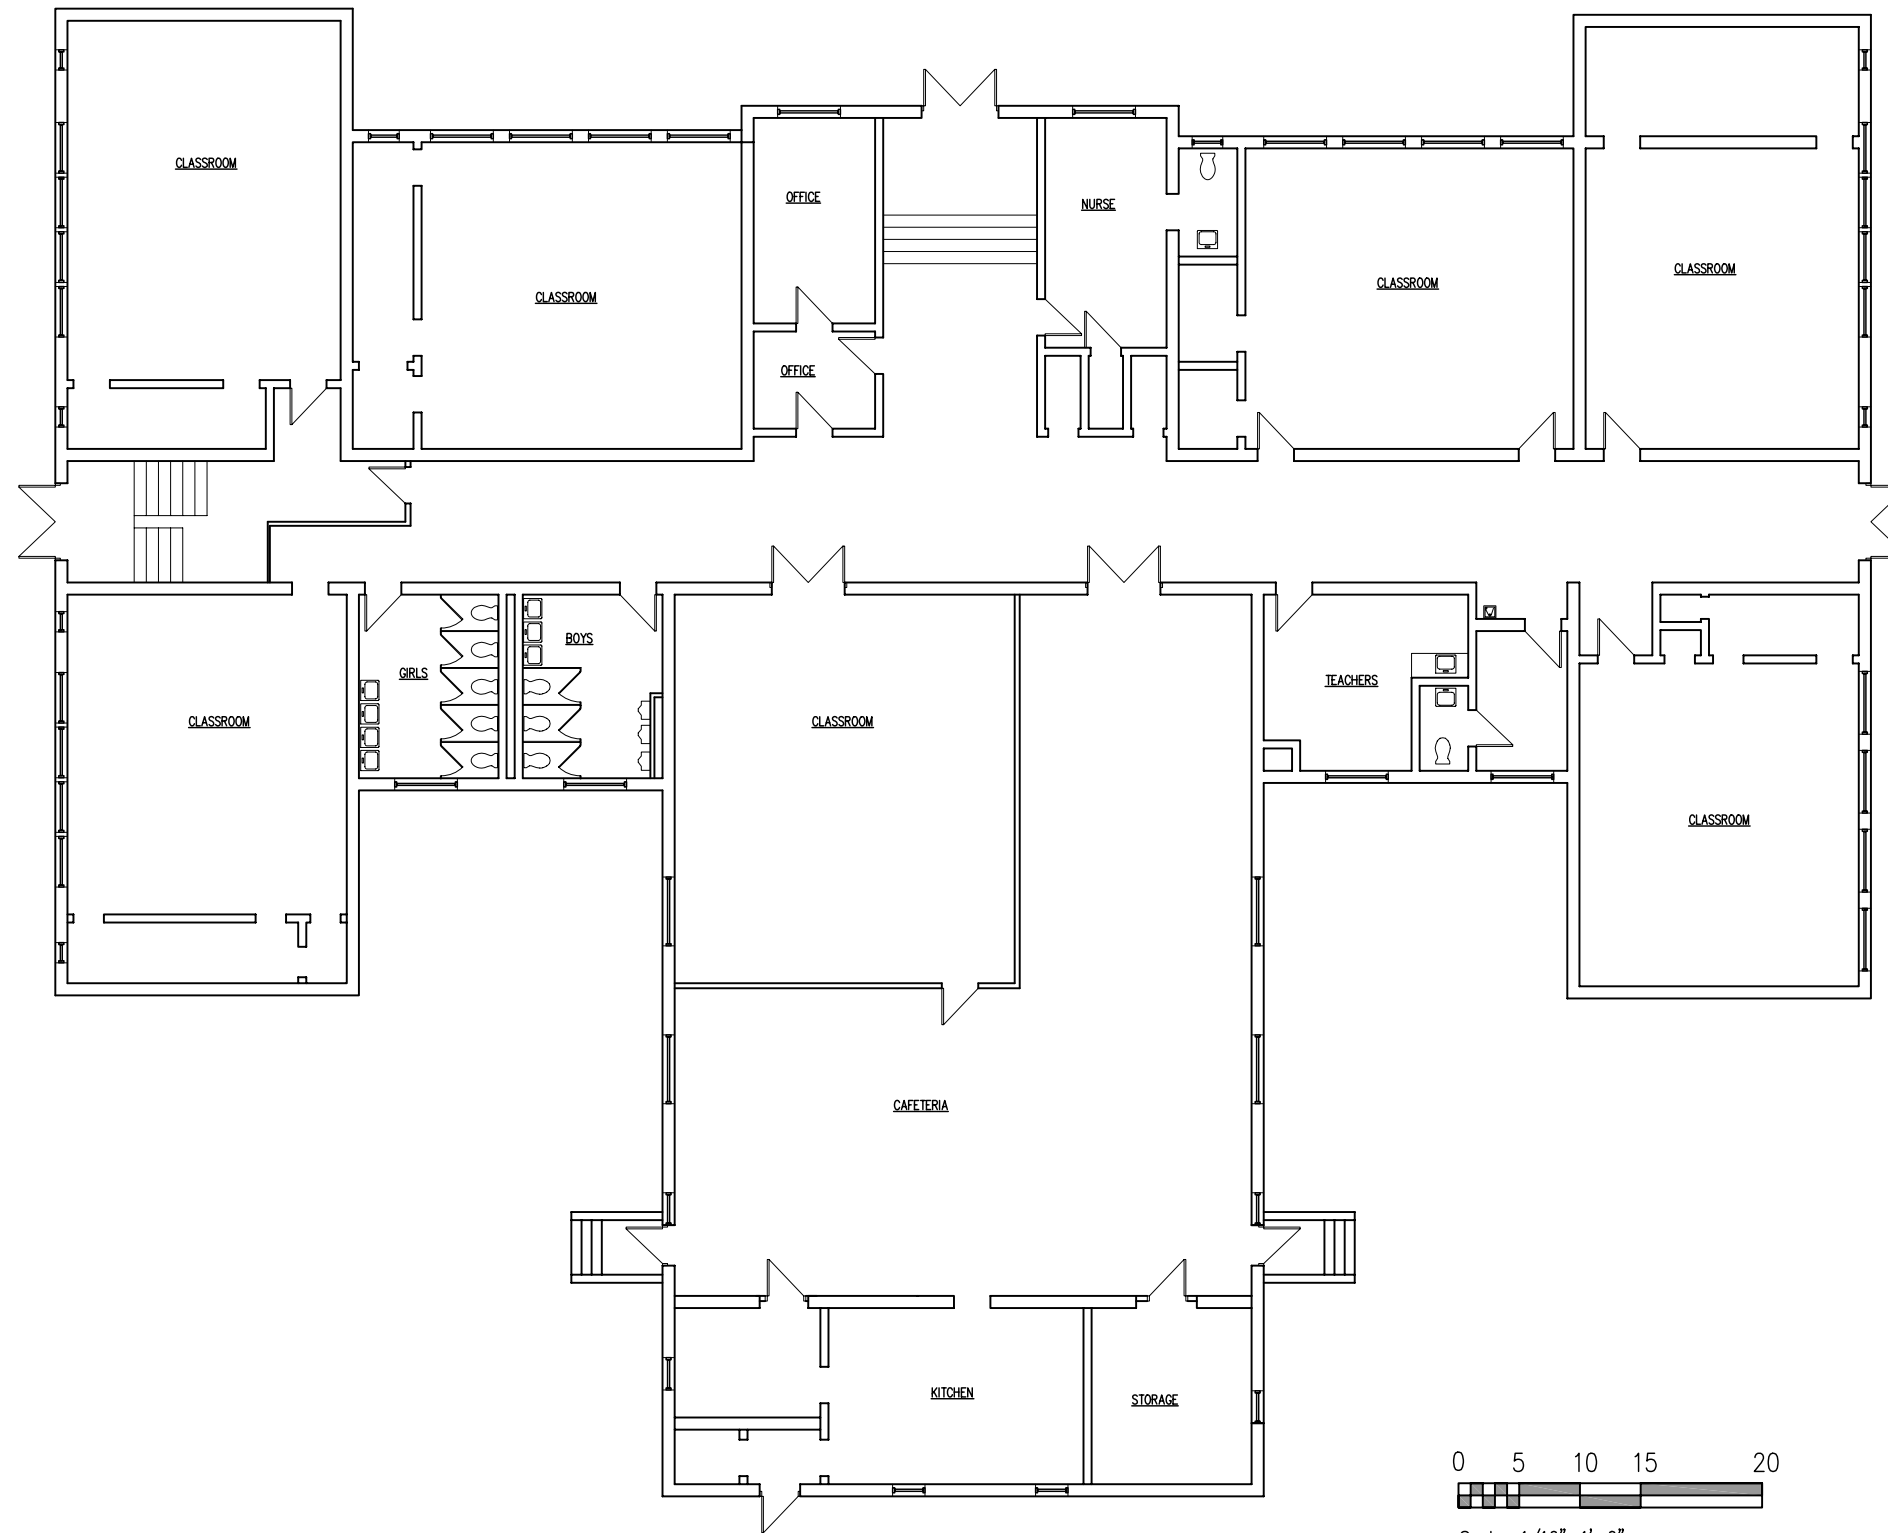
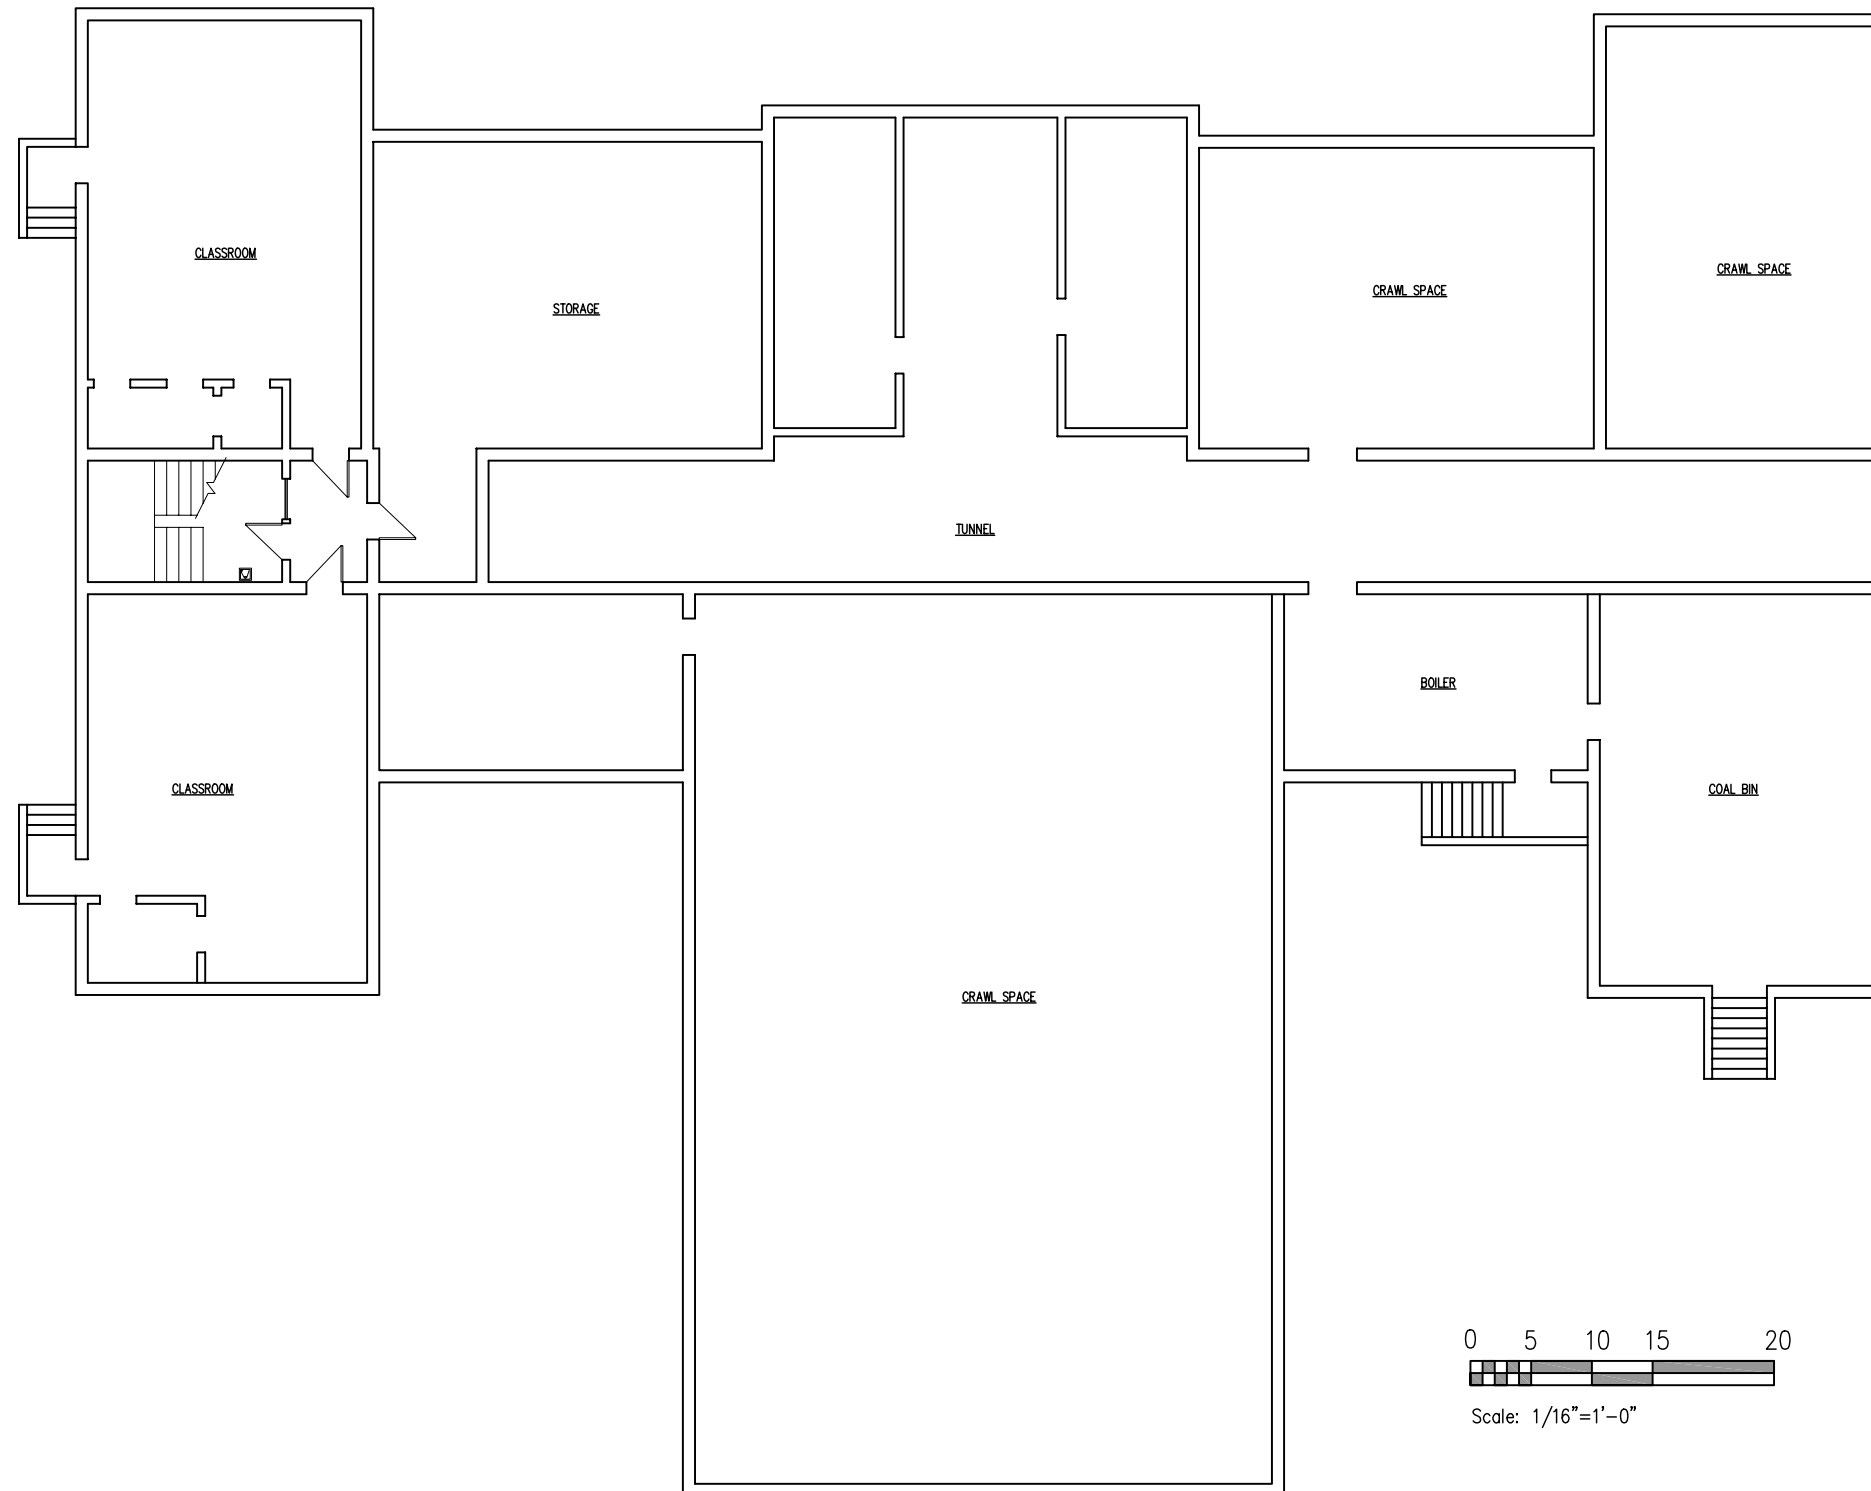
building evaluation – bridge street school

Site - Water was noted in the basement areas. The finished grade around the building should be regraded to direct water away from building foundation. Additionally it was noted that the existing drainage systems around the building have failed and should be repaired. The storm drain from the back of the building is directed to the property line and needs to be cleaned at the outlet. Other storm drain pipes should be investigated as to the discharge location and repaired or cleaned as required. The size of the drainage pipes connecting to roof rain water leaders should be evaluated. In several cases the rain water leaders are larger than the piping they are supposed to be connected to. This is leading to water being dumped directly on the ground adjacent to the building.

There are several low-slope roofs. On the interior of the building there appear to be leaks below all of these areas. These portions of the roof should be removed and replaced with proper flashing.

Windows – The original windows are primarily wood double-hung units with single glazing. They are in various states of repair. All are in need of reglazing and repainting. There is some broken glass in these windows.

Entries – The railings are not compliant at any of the entries. The concrete stoop at the east door off the Cafeteria is spalling. The concrete stoop at the west door off the Cafeteria has sunk leaving a riser of about 9-1/2" at the door.
