March 2, 2020

Cardno
6720 SW Macadam Avenue, Suite 200
Portland, OR 97219

Report of Pavement Engineering Services
Chehalem Elementary School Pavement Improvements
15555 SW Davis Road
Beaverton, Oregon
GeoDesign Project: BeavSchool-61-01

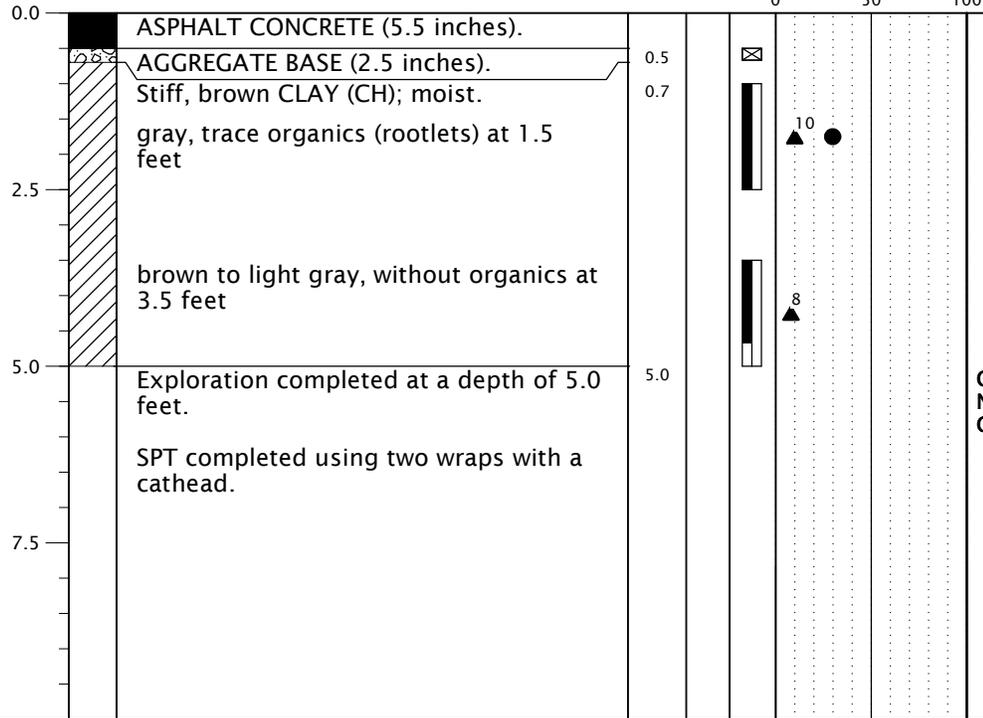
C-3

CORE DETAILS:
No patch observed.
Cored on severe fatigue crack.

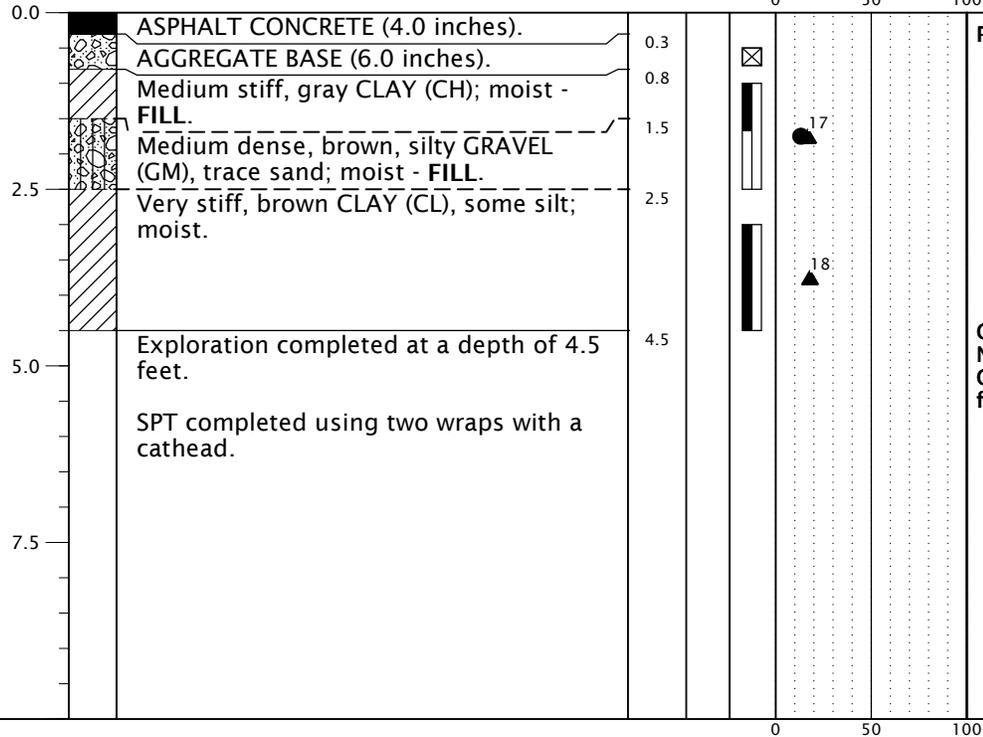
C-4

Pavement fabric at 2.0 inches.

CORE DETAILS:
No patch observed.
Cored on moderate to severe fatigue crack.

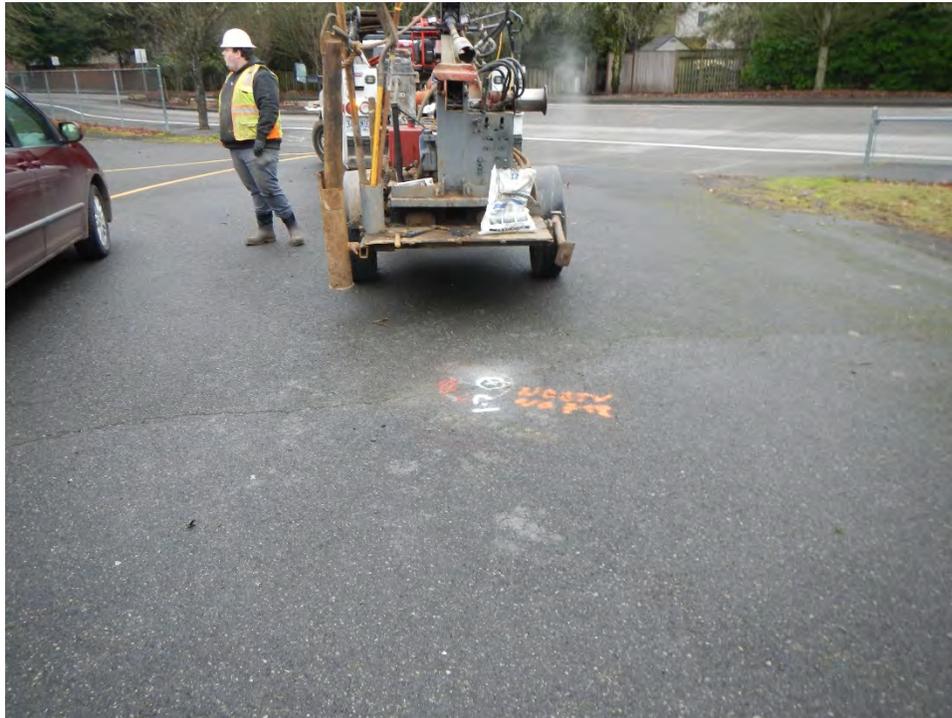
CORE LOCATION C-1.

Core Number	Cracking Zone (inches)	Stripping Zone (inches)	Other Distress (inches)
C-1	0 to 6.5	None	Moderate fatigue, minor raveling, fabric at 2.0
C-2	0 to 6.8	None	Moderate fatigue, fabric at 2.0
C-3	0 to 5.5	Yes, 1.8 to 2.3	Severe fatigue
C-4	0 to 4.0	None	Moderate to severe fatigue, fabric at 2.0
