BEAVERTON SCHOOL DISTRICT COOPER MOUNTAIN ELEMENTARY SCHOOL

SEISMIC EVALUATION AND CONCEPTUAL SEISMIC STRENGTHENING SCHEME

NOVEMBER 14, 2018

KPFF PROJECT No. 10021800754

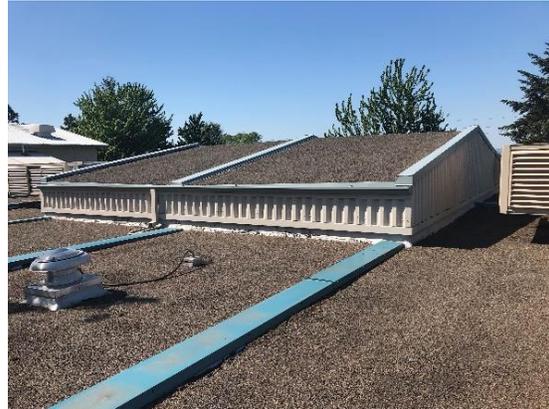
Figure 10: "Pop-up" at Building Part C1

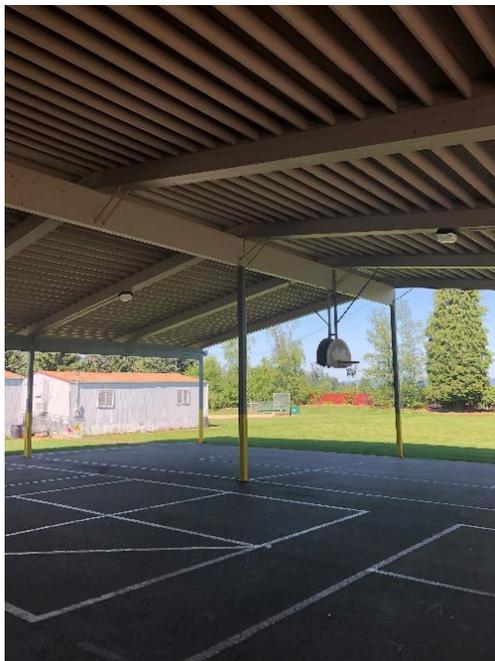
Figure 11: Roof framing at covered play area of Building Part C2

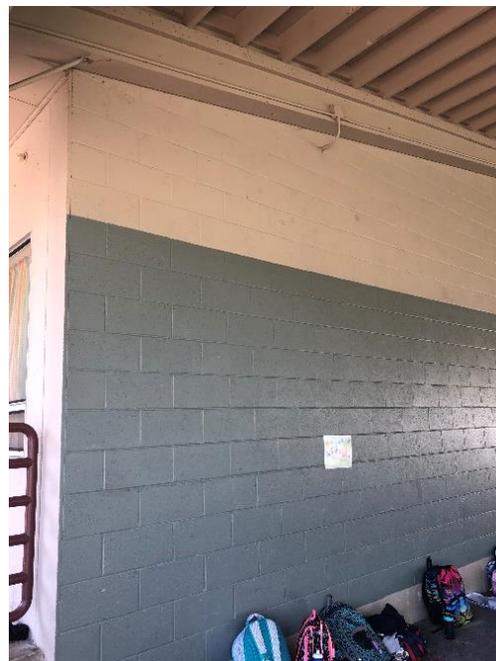
Figure 12: CMU wall at covered play area of Building Part C2

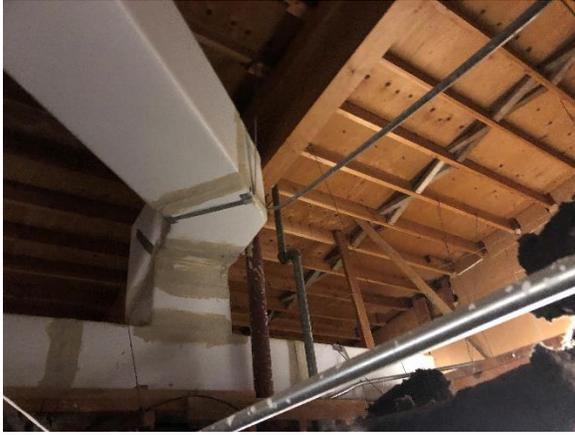
Figure 13: Unblocked plywood roof diaphragm

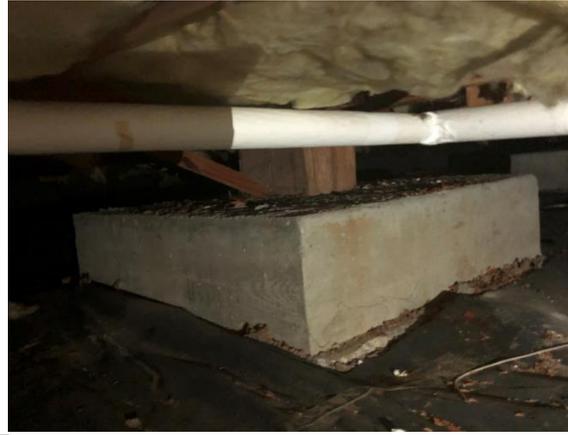
- In Building Part A1, there is not a continuous load path from the roof to the foundation at the walls along the edge of the classroom wings. This non-conformance item has been addressed by item “E” in the strengthening plan.

Figure 14: Absence of blocking for load path transfer

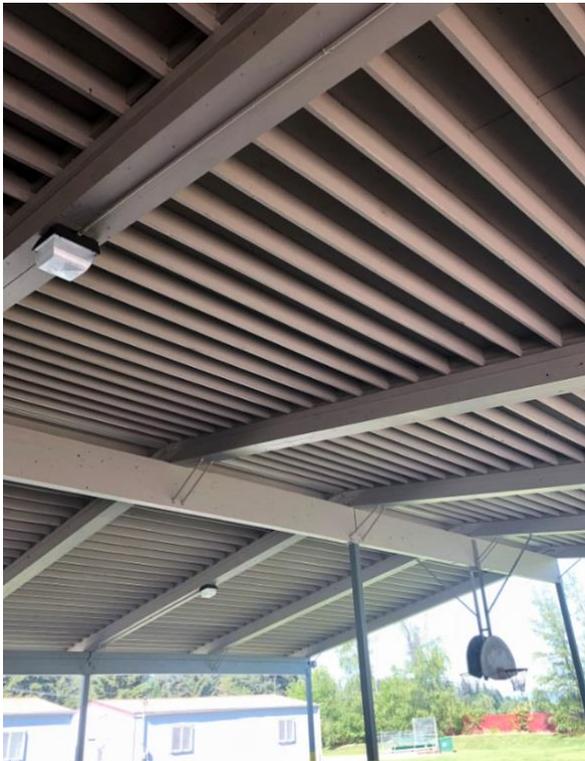
- Wood Posts – This criterion requires that there is a positive connection of wood posts to the foundation.
 - It is unclear how Building Part B1, the 1954 Cafeteria building, is framed and how and what material the posts that support the roof framing are and how they are connected to the foundation. It is assumed that this building part is compliant with this requirement.

Figure 14: Lack of positive connection of wood posts to the foundation

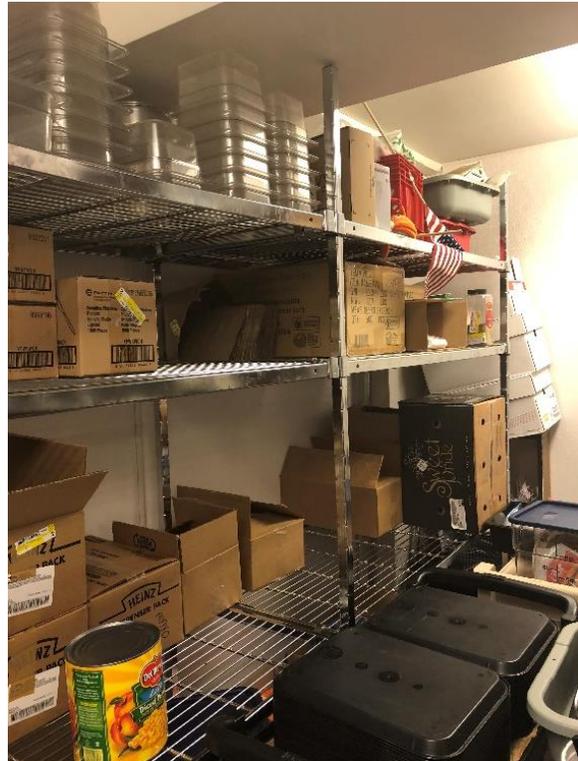
Figure 16: Tall and narrow contents in the kitchen
