SOLICITATION ADDENDUM NO. 4
ITB 19-0054
Errol Hassell Restrooms Remodel

LIMITED HAZARDOUS MATERIALS SURVEY REPORT

**Errol Hassell Elementary School
(Restrooms)
1800 SW Bany Road
Beaverton, Oregon 97007**

Report Date: December 13, 2019

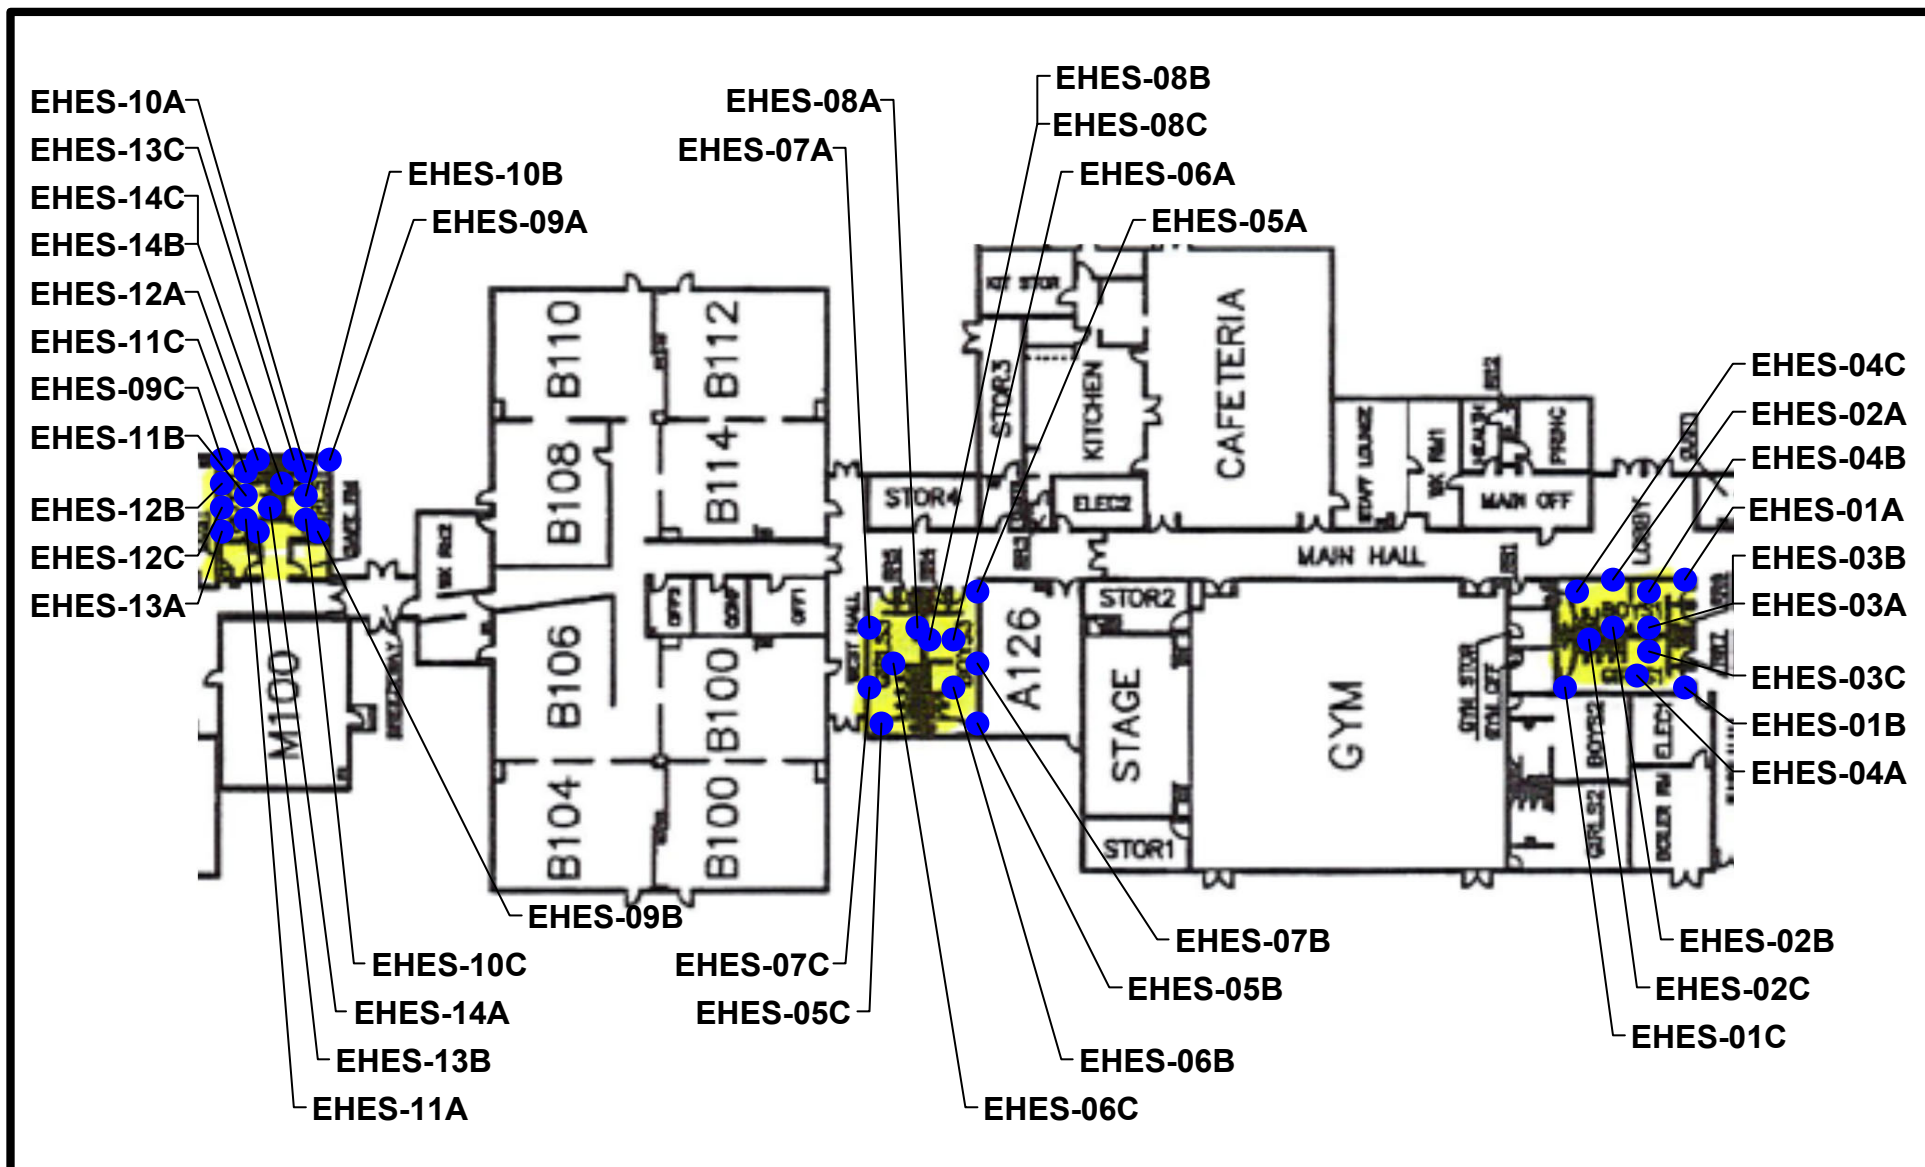
LEGEND	LIMITED HAZARDOUS MATERIALS SURVEY REPORT (ACM SAMPLE LOCATION MAP) BEAVERTON SCHOOL DISTRICT ERROL HASSELL ELEMENTARY SCHOOL 18100 SW BANY ROAD BEAVERTON, OREGON 97007

— Non-Asbestos Sample Location	TRC Project No.: 369880		Figure: 1	
	Drawn by: JS	Reviewed by: RAL	Date: 12/13/19

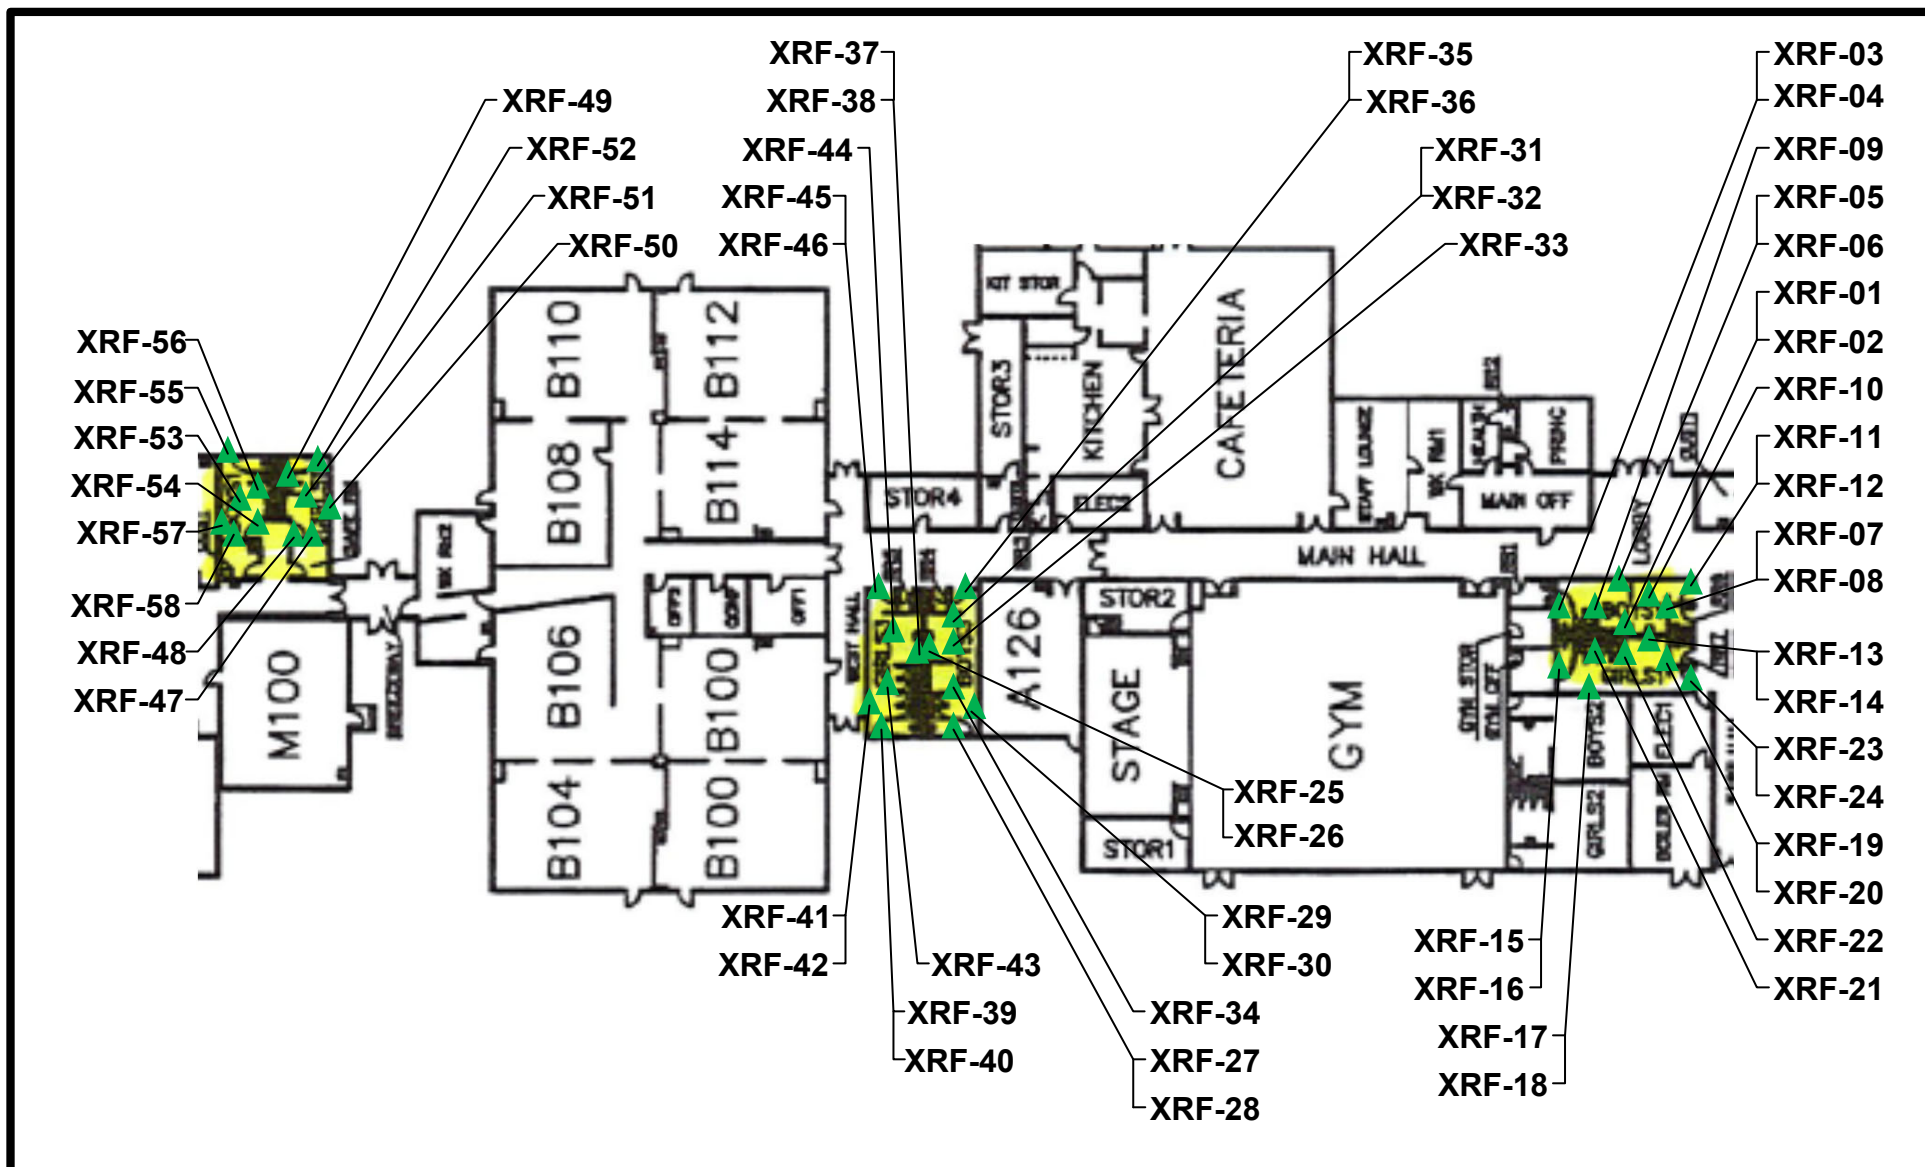
LEGEND		LIMITED HAZARDOUS MATERIALS SURVEY REPORT (XRF SAMPLE LOCATION MAP) BEAVERTON SCHOOL DISTRICT ERROL HASSELL ELEMENTARY SCHOOL 18100 SW BANY ROAD BEAVERTON, OREGON 97007

4105 SE International Way, Suite 505 Milwaukie, Oregon 97222 Phone: (503) 387-3251 Fax: (503) 908-1318
▲ — Paint Sample Location				
TRC Project No.: 369880		Figure: 2		
Drawn by: JS	Reviewed by: RAL	Date: 12/13/19

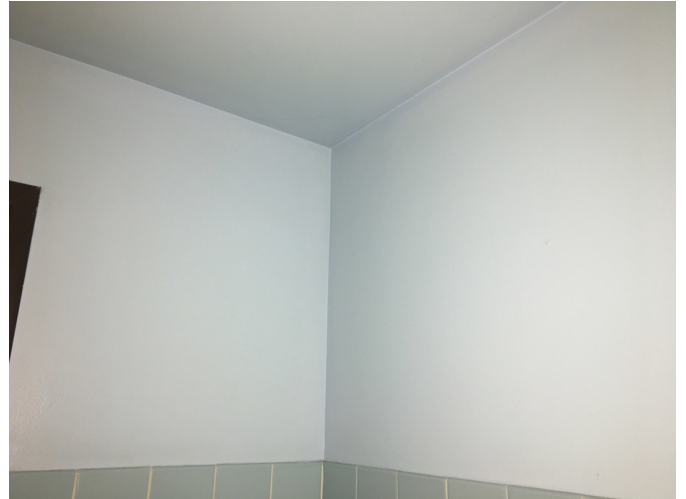
Sample Numbers	EHES-01A, EHES-01B, & EHES-01C
Material Description	Wallboard Gypsum with Joint Compound Brown
Accessible Material	Accessible
Reason Inaccessible	N/A
Asbestos Detected	Negative
Asbestos Type	No Asbestos Detected
Homogeneous Area	Restrooms 1
Total Approximate Quantity	N/A
Condition	Good
Material Type	N/A
NESHAP Category	N/A
Notes	Not Applicable

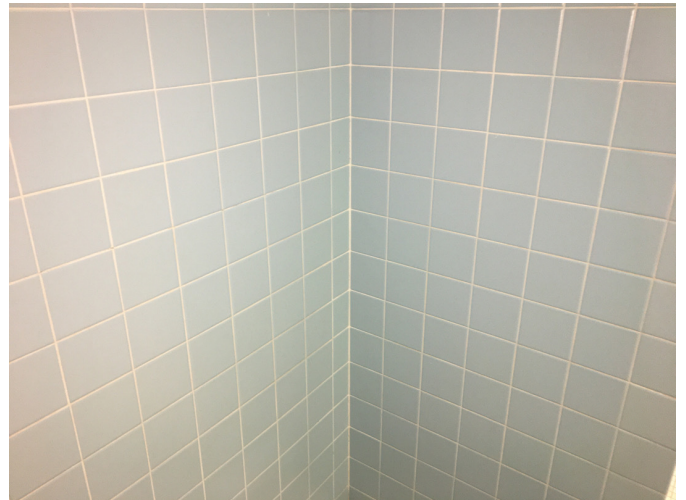
Sample Numbers	EHES-02A, EHES-02B, & EHES-02C
Material Description	Ceramic Wall Tile Grout/Glue
Accessible Material	Accessible
Reason Inaccessible	N/A
Asbestos Detected	Negative
Asbestos Type	No Asbestos Detected
Homogeneous Area	Restrooms 1
Total Approximate Quantity	N/A
Condition	Good
Material Type	N/A
NESHAP Category	N/A
Notes	Not Applicable

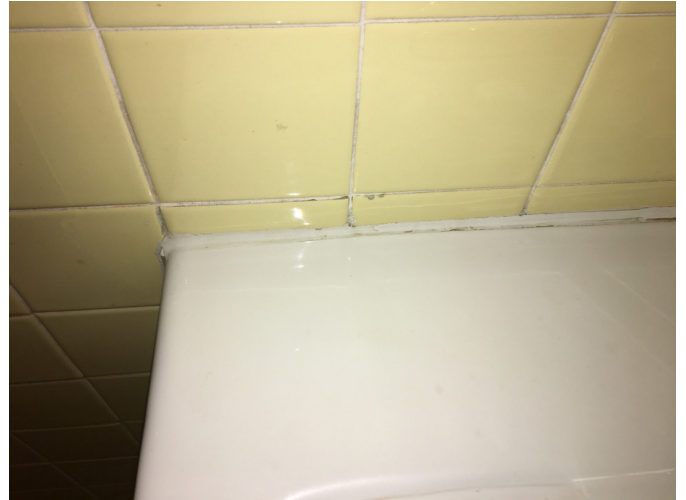
Sample Numbers	EHES-03A, EHES-03B, & EHES-03C
Material Description	Caulking White
Accessible Material	Accessible
Reason Inaccessible	N/A
Asbestos Detected	Negative
Asbestos Type	No Asbestos Detected
Homogeneous Area	Restrooms 1
Total Approximate Quantity	N/A
Condition	Good
Material Type	N/A
NESHAP Category	N/A
Notes	Not Applicable

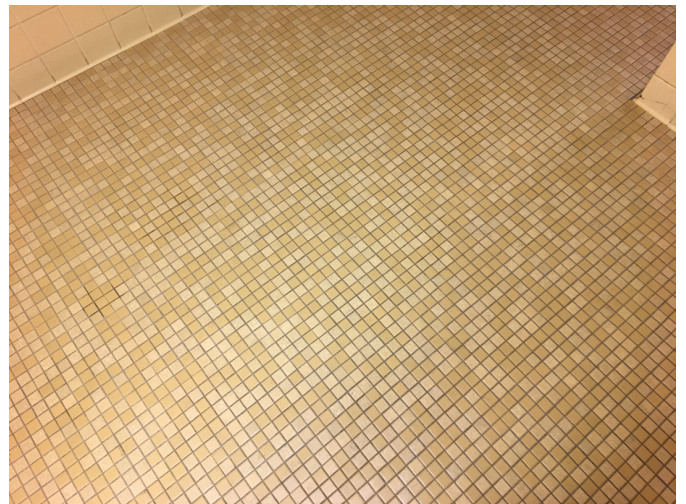
Sample Numbers	EHES-04A, EHES-04B, & EHES-04C
Material Description	Ceramic Floor Tile Grout/Glue
Accessible Material	Accessible
Reason Inaccessible	N/A
Asbestos Detected	Negative
Asbestos Type	No Asbestos Detected
Homogeneous Area	Restrooms 1
Total Approximate Quantity	N/A
Condition	Good
Material Type	N/A
NESHAP Category	N/A
Notes	Not Applicable

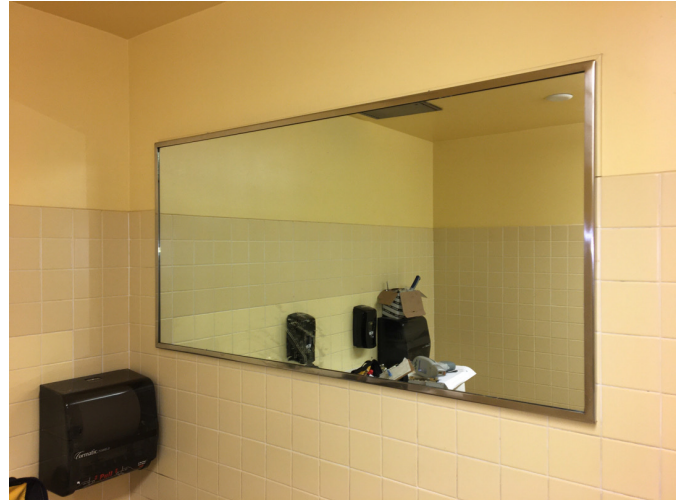
Sample Numbers	N/A
Material Description	Mirror Glue
Accessible Material	Inaccessible
Reason Inaccessible	Discreet Sampling Requested
Asbestos Detected	N/A
Asbestos Type	N/A
Homogeneous Area	Restrooms 1
Total Approximate Quantity	30 SF
Condition	N/A
Material Type	N/A
NESHAP Category	N/A
Notes	Not Applicable

The following materials and areas listed in the table below were not accessible at the time the asbestos survey was conducted and should be treated as asbestos containing materials until sampling activities are allowed to take place:

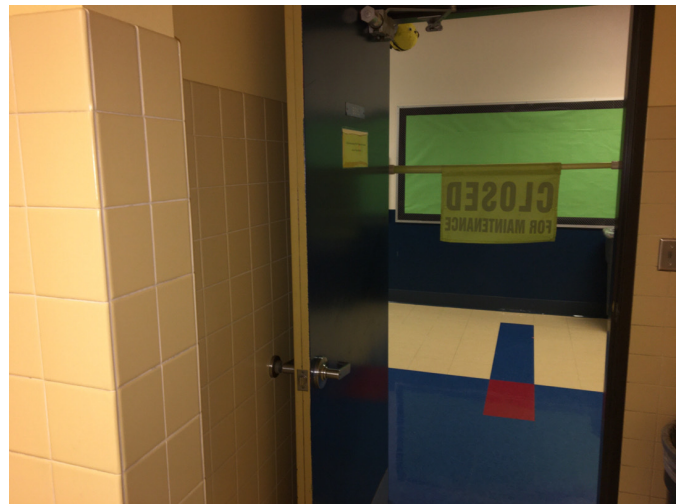
Sample Numbers	N/A
Material Description	Fire Doors
Accessible Material	Inaccessible
Reason Inaccessible	N/A
Asbestos Detected	N/A
Asbestos Type	N/A
Homogeneous Area	Restrooms 1
Total Approximate Quantity	2 Each
Condition	N/A
Material Type	N/A
NESHAP Category	N/A
Notes	Not Applicable

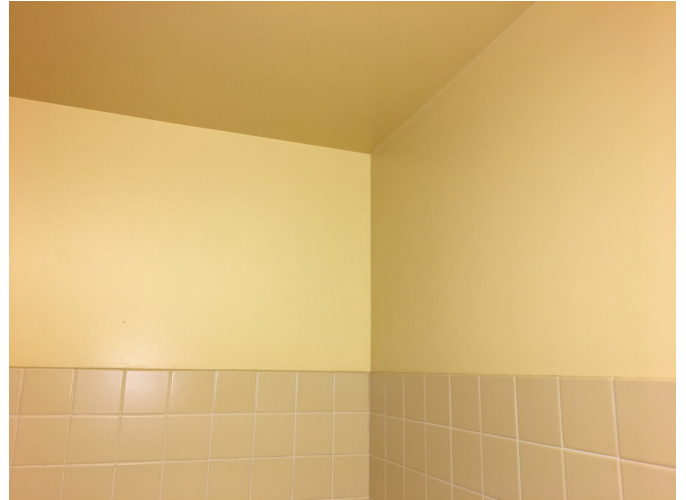
Sample Numbers	EHES-05A, EHES-05B, & EHES-05C
Material Description	Wallboard Gypsum with Joint Compound Brown
Accessible Material	Accessible
Reason Inaccessible	N/A
Asbestos Detected	Negative
Asbestos Type	No Asbestos Detected
Homogeneous Area	Restrooms 3
Total Approximate Quantity	N/A
Condition	Good
Material Type	N/A
NESHAP Category	N/A
Notes	Not Applicable

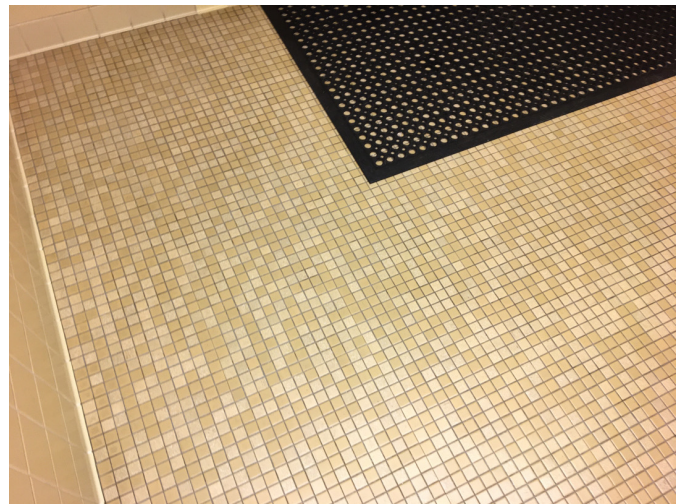
Sample Numbers	EHES-06A, EHES-06B, & EHES-06C
Material Description	Ceramic Floor Tile Grout/Glue
Accessible Material	Accessible
Reason Inaccessible	N/A
Asbestos Detected	Negative
Asbestos Type	No Asbestos Detected
Homogeneous Area	Restrooms 3
Total Approximate Quantity	N/A
Condition	Good
Material Type	N/A
NESHAP Category	N/A
Notes	Not Applicable

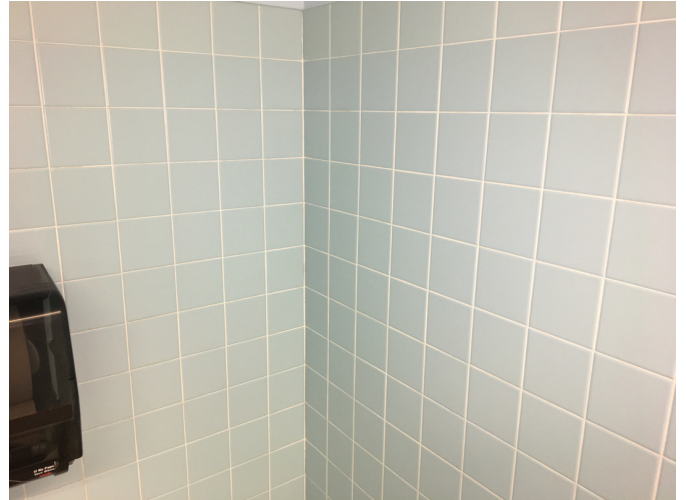
Sample Numbers	EHES-07A, EHES-07B, & EHES-07C
Material Description	Ceramic Wall Tile Grout/Glue
Accessible Material	Accessible
Reason Inaccessible	N/A
Asbestos Detected	Negative
Asbestos Type	No Asbestos Detected
Homogeneous Area	Restrooms 3
Total Approximate Quantity	N/A
Condition	Good
Material Type	N/A
NESHAP Category	N/A
Notes	Not Applicable

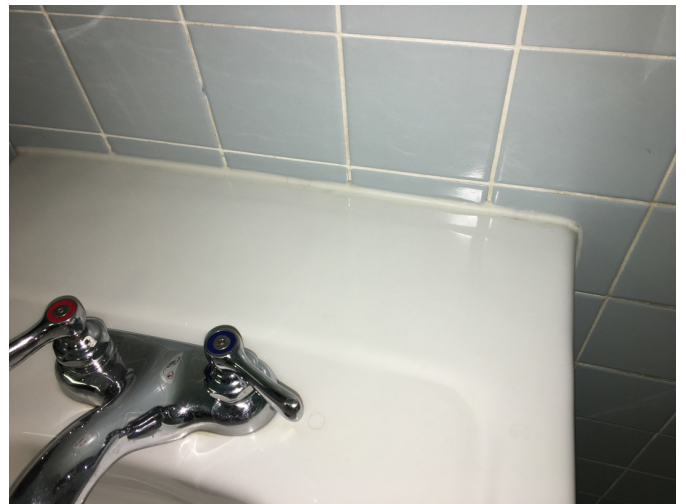
Sample Numbers	EHES-08A, EHES-08B, & EHES-08C
Material Description	Caulking White
Accessible Material	Accessible
Reason Inaccessible	N/A
Asbestos Detected	Negative
Asbestos Type	No Asbestos Detected
Homogeneous Area	Restrooms 3
Total Approximate Quantity	N/A
Condition	Good
Material Type	N/A
NESHAP Category	N/A
Notes	Not Applicable

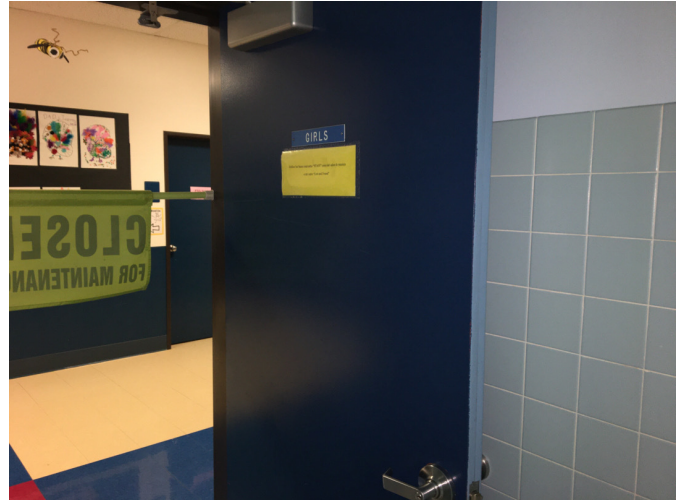
Sample Numbers	N/A
Material Description	Fire Doors
Accessible Material	Inaccessible
Reason Inaccessible	Discreet Sampling Requested
Asbestos Detected	N/A
Asbestos Type	N/A
Homogeneous Area	Restrooms 3
Total Approximate Quantity	2 Each
Condition	N/A
Material Type	N/A
NESHAP Category	N/A
Notes	Not Applicable

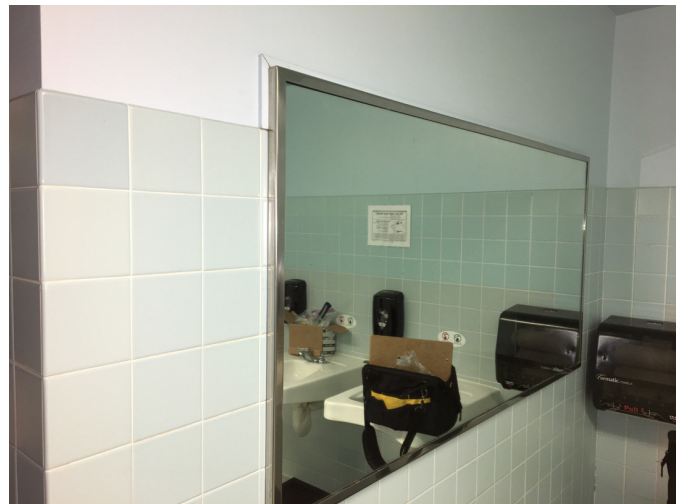
Sample Numbers	N/A
Material Description	Mirror Glue
Accessible Material	Inaccessible
Reason Inaccessible	Discreet Sampling Requested
Asbestos Detected	N/A
Asbestos Type	N/A
Homogeneous Area	Restrooms 3
Total Approximate Quantity	30 SF
Condition	N/A
Material Type	N/A
NESHAP Category	N/A
Notes	Not Applicable

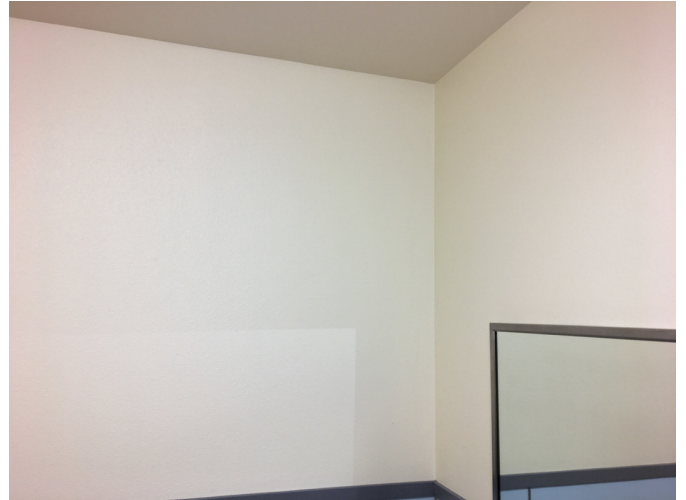
Sample Numbers	EHES-09A, EHES-09B, & EHES-09C
Material Description	Wallboard Gypsum with Joint Compound Gray
Accessible Material	Accessible
Reason Inaccessible	N/A
Asbestos Detected	Negative
Asbestos Type	No Asbestos Detected
Homogeneous Area	Modular Restrooms
Total Approximate Quantity	N/A
Condition	Good
Material Type	N/A
NESHAP Category	N/A
Notes	Not Applicable

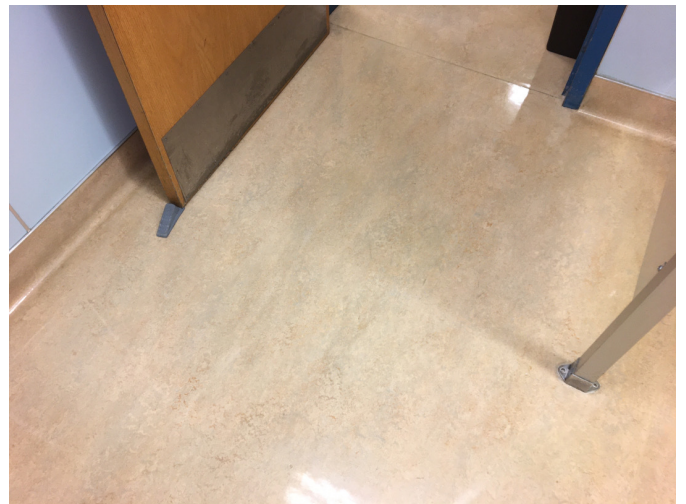
Sample Numbers	EHES-10A, EHES-10B, & EHES-10C
Material Description	Sheet Vinyl Flooring (Marble Pattern)
Accessible Material	Accessible
Reason Inaccessible	N/A
Asbestos Detected	Negative
Asbestos Type	No Asbestos Detected
Homogeneous Area	Modular Restrooms (Girls)
Total Approximate Quantity	N/A
Condition	Good
Material Type	N/A
NESHAP Category	N/A
Notes	Not Applicable

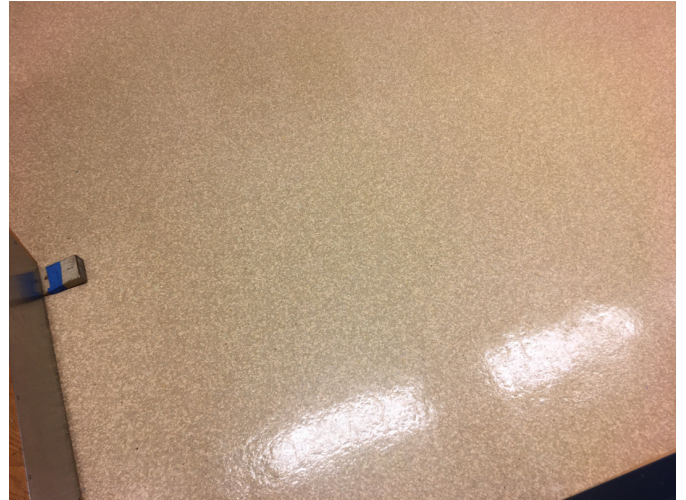
Sample Numbers	EHES-11A, EHES-11B, & EHES-11C
Material Description	Sheet Vinyl Flooring (Stone Pattern)
Accessible Material	Accessible
Reason Inaccessible	N/A
Asbestos Detected	Negative
Asbestos Type	No Asbestos Detected
Homogeneous Area	Modular Restrooms (Boys)
Total Approximate Quantity	N/A
Condition	Good
Material Type	N/A
NESHAP Category	N/A
Notes	Not Applicable

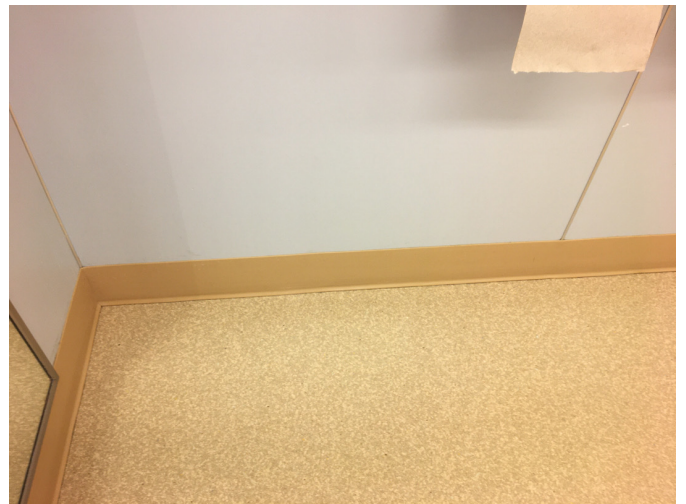
Sample Numbers	EHES-12A, EHES-12B, & EHES-12C
Material Description	6" Beige Cove Base & Associated Glue
Accessible Material	Accessible
Reason Inaccessible	N/A
Asbestos Detected	Negative
Asbestos Type	No Asbestos Detected
Homogeneous Area	Modular Restrooms (Boys)
Total Approximate Quantity	N/A
Condition	Good
Material Type	N/A
NESHAP Category	N/A
Notes	Not Applicable

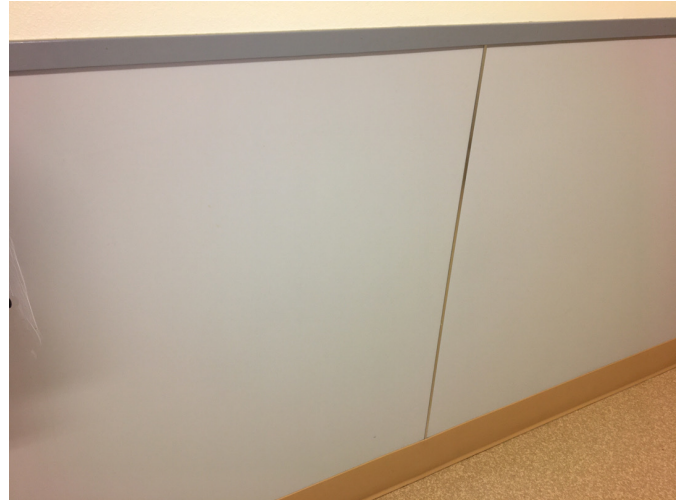
Sample Numbers	EHES-13A, EHES-13B, & EHES-13C
Material Description	RFP Glue
Accessible Material	Accessible
Reason Inaccessible	N/A
Asbestos Detected	Negative
Asbestos Type	No Asbestos Detected
Homogeneous Area	Modular Restrooms
Total Approximate Quantity	N/A
Condition	Good
Material Type	N/A
NESHAP Category	N/A
Notes	Not Applicable

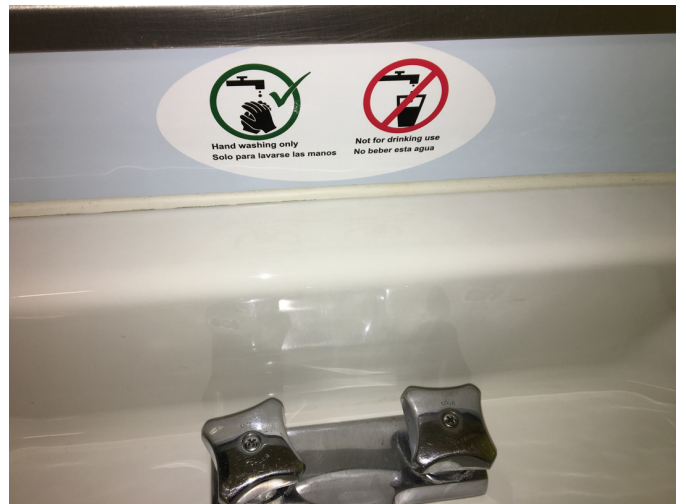
Sample Numbers	EHES-14A, EHES-14B, & EHES-14C
Material Description	Caulking White
Accessible Material	Accessible
Reason Inaccessible	N/A
Asbestos Detected	Negative
Asbestos Type	No Asbestos Detected
Homogeneous Area	Modular Restrooms
Total Approximate Quantity	N/A
Condition	Good
Material Type	N/A
NESHAP Category	N/A
Notes	Not Applicable

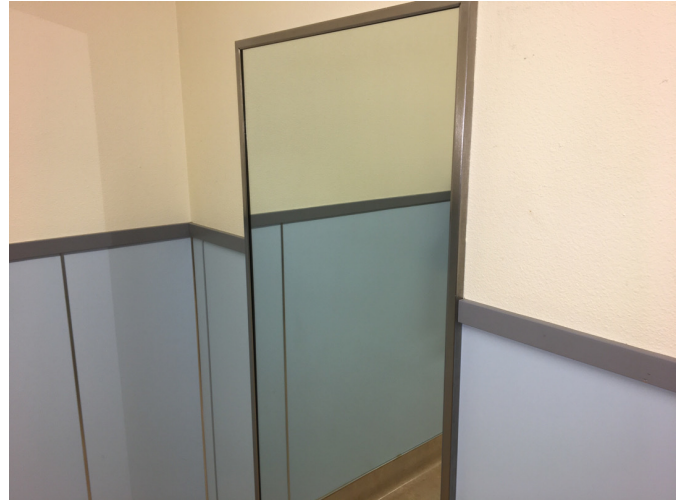
Sample Numbers	N/A
Material Description	Mirror Glue
Accessible Material	Inaccessible
Reason Inaccessible	Discreet Sampling Requested
Asbestos Detected	N/A
Asbestos Type	N/A
Homogeneous Area	Modular Restrooms
Total Approximate Quantity	60 SF
Condition	N/A
Material Type	N/A
NESHAP Category	N/A
Notes	Not Applicable

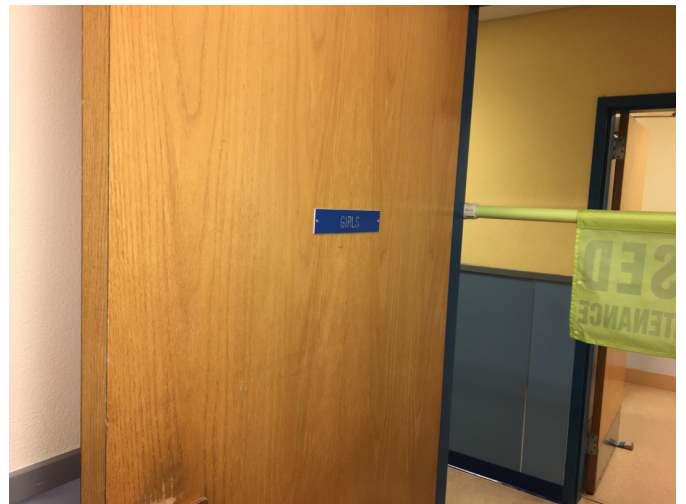
Sample Numbers	N/A
Material Description	Fire Doors
Accessible Material	Inaccessible
Reason Inaccessible	Discreet Sampling Requested
Asbestos Detected	N/A
Asbestos Type	N/A
Homogeneous Area	Modular Restrooms
Total Approximate Quantity	2 Each
Condition	N/A
Material Type	N/A
NESHAP Category	N/A
Notes	Not Applicable
