Askew

2630 Topping

REUSE ASSESSMENT

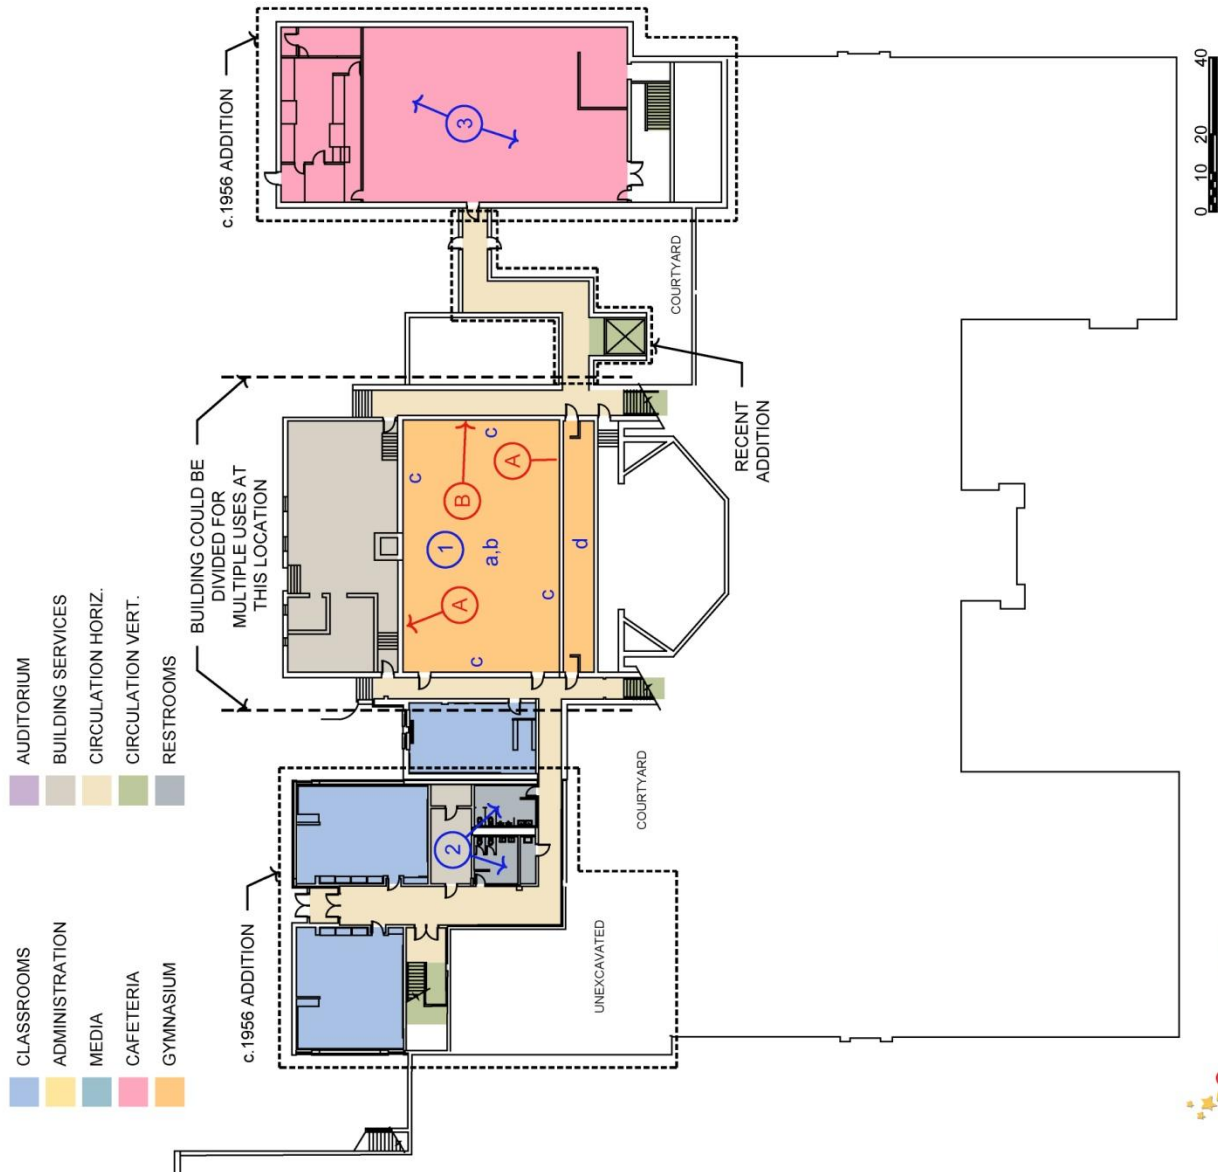
Ground Floor

1. Gymnasium:
 - a. Exposed steel beams
 - b. Wood floors
 - c. Glazed brick/plaster walls
 - d. Concrete bleachers
2. Modern restrooms
3. Cafeteria modern finishes
4. Typical classroom:
 - a. Newer slab door with narrow glazing
 - b. VCT or linoleum flooring
 - c. Plaster walls with wood chair rail, vinyl base
 - d. Acoustical ceiling tile in grid
 - e. Built in cabinets with decorative glazing in doors
5. Tile floor, glazed wall with transoms, ornate plaster molding, arches and columns
6. Library fireplace
7. Typical entrance, tile floor, glazed wall, non-historic doors
8. Auditorium has attached seating, sloped floor, beamed ceiling, raised stage, ornate plaster proscenium arch
9. Wood skylights covered by newer roof, visible from classrooms above lay-in ceiling

- A. Evidence of roof leakage
- B. Water infiltration at wall
- C. Paint peeling
- D. Site retaining walls are rotating outward
- E. Sidewalks in fair condition
- F. Asphalt on west side in poor condition
- G. Asphalt around playground in poor condition and overgrown with vegetation
- H. Site fencing in fair condition
- I. Site metal railings in fair to poor condition

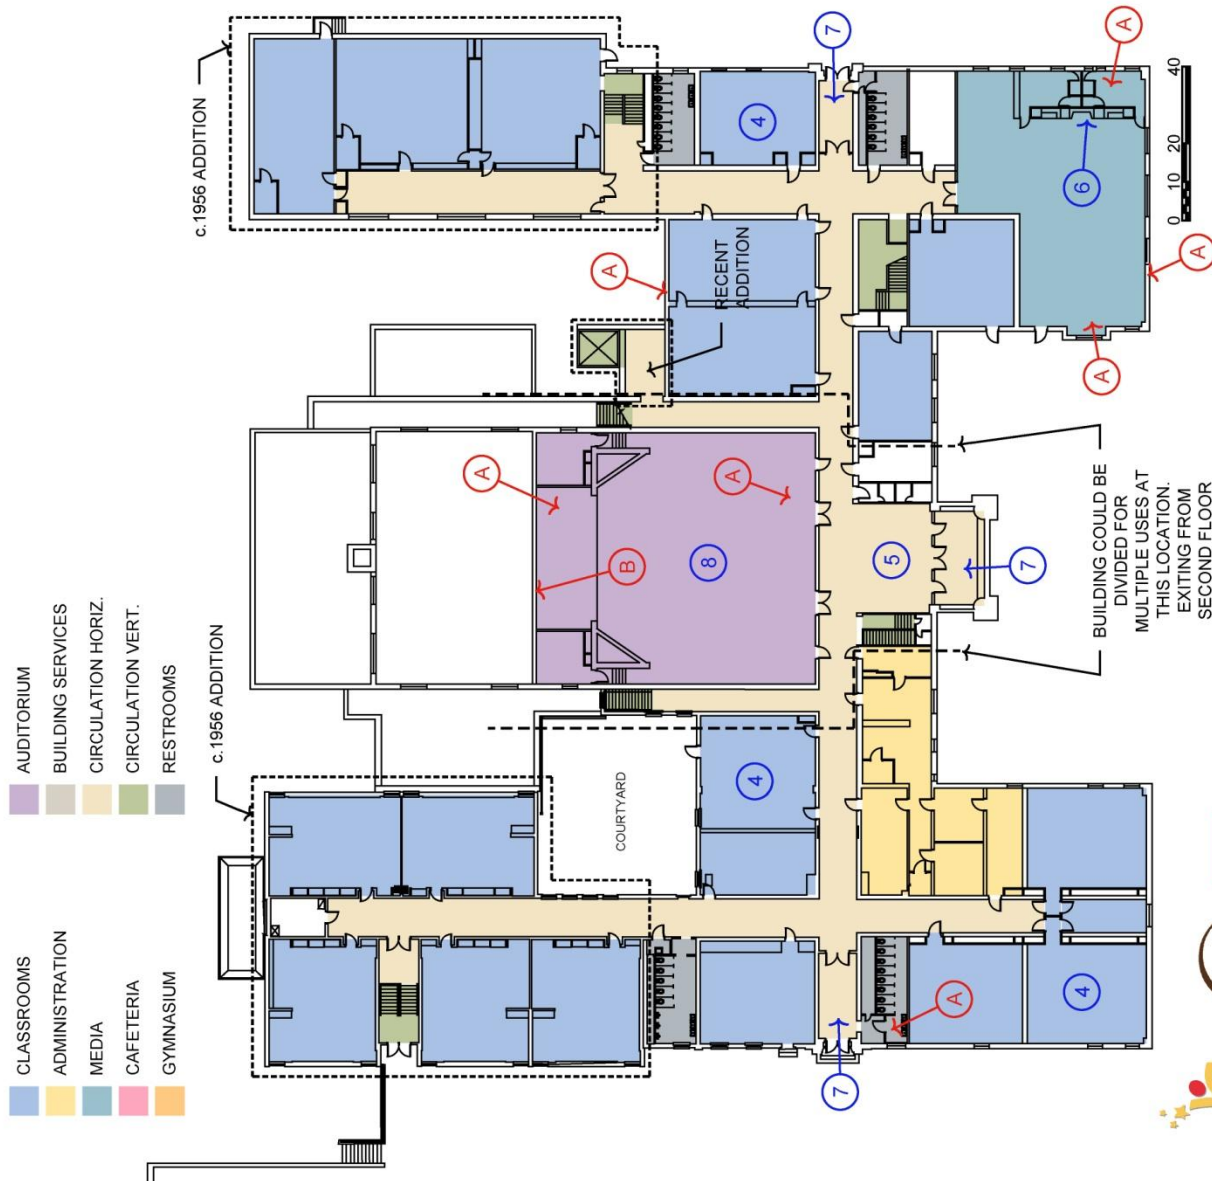
First Floor Plan

1. Gymnasium:
 - a. Exposed steel beams
 - b. Wood floors
 - c. Glazed brick/plaster walls
 - d. Concrete bleachers
2. Modern restrooms
3. Cafeteria modern finishes
4. Typical classroom:
 - a. Newer slab door with narrow glazing
 - b. VCT or linoleum flooring
 - c. Plaster walls with wood chair rail, vinyl base
 - d. Acoustical ceiling tile in grid
 - e. Built in cabinets with decorative glazing in doors
5. Tile floor, glazed wall with transoms, ornate plaster molding, arches and columns
6. Library fireplace
7. Typical entrance, tile floor, glazed wall, non-historic doors
8. Auditorium has attached seating, sloped floor, beamed ceiling, raised stage, ornate plaster proscenium arch
9. Wood skylights covered by newer roof, visible from classrooms above lay-in ceiling

- A. Evidence of roof leakage
- B. Water infiltration at wall
- C. Paint peeling
- D. Site retaining walls are rotating outward
- E. Sidewalks in fair condition
- F. Asphalt on west side in poor condition
- G. Asphalt around playground in poor condition and overgrown with vegetation
- H. Site fencing in fair condition
- I. Site metal railings in fair to poor condition

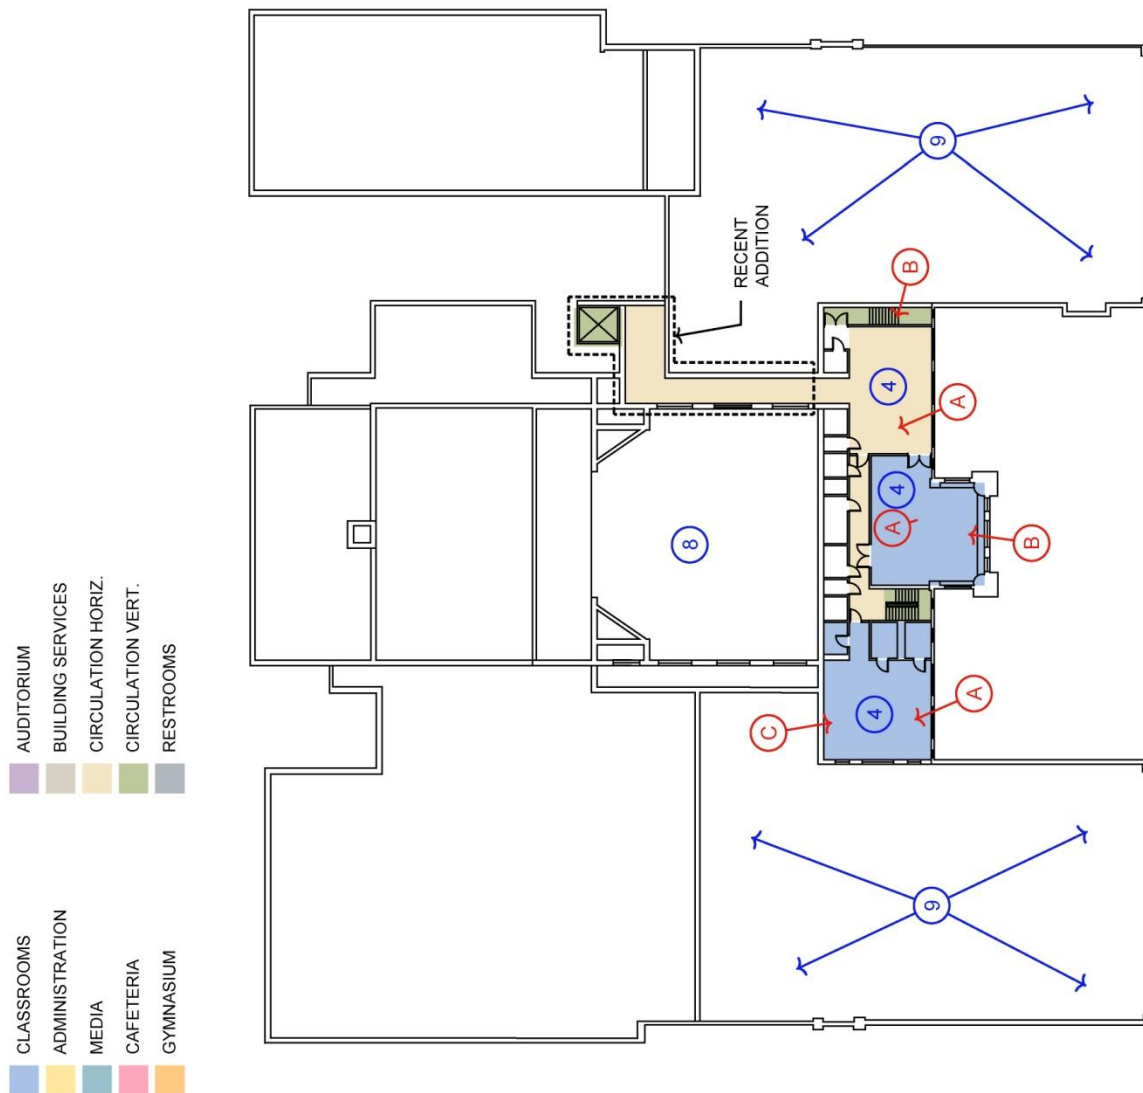
Second Floor Plan

- Original building has stone foundation in good condition, with later additions in concrete in good condition
- Exterior painting generally in good condition

- Exterior terracotta and stone work in good condition
- Building has functioning elevator
- Manual fire alarm system c. 1999
- Play equipment in fair to good condition

- Exterior fencing in fair condition
- Exterior metal railings in poor condition
- Typical classroom size is 750-850 SF. This size of classroom converts well into a single bedroom apartment or combines well into two bedroom apartments
