2411 E. 70th Terrace

REUSE ASSESSMENT

Blenheim - 2

PHOTOGRAPHS

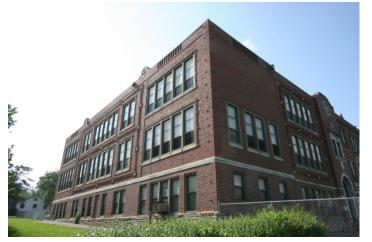
Main entrance

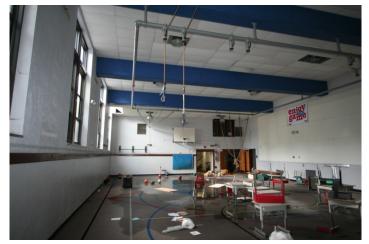
Gymnasium
