Chick

4101 East 53rd Street

REUSE ASSESSMENT

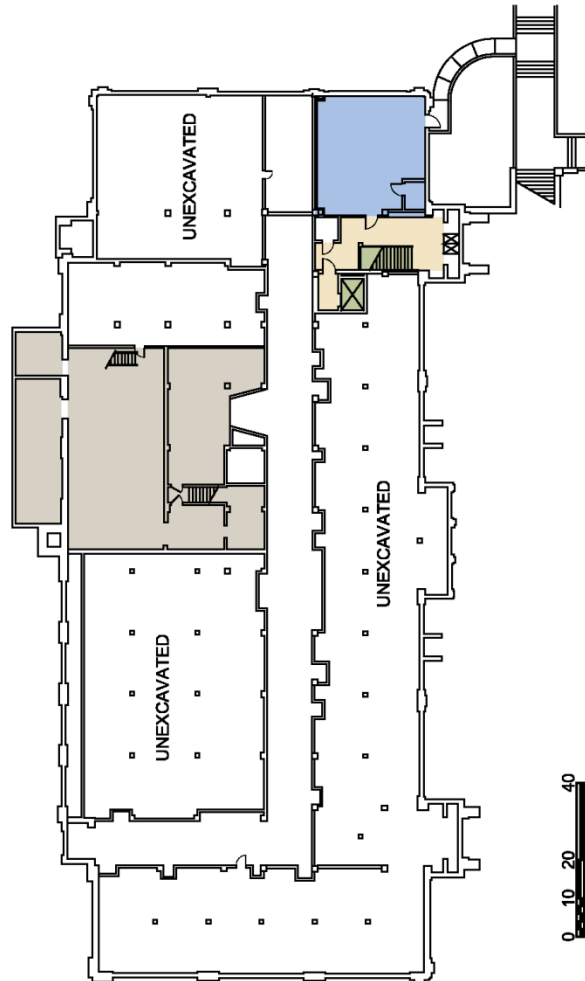
Basement

- A. Water damage
- B. Peeling paint
- C. Mortar parge coating is failing at painted brick above the roof
- D. Broken glass block units
- E. Water infiltration damage at planter and window sill

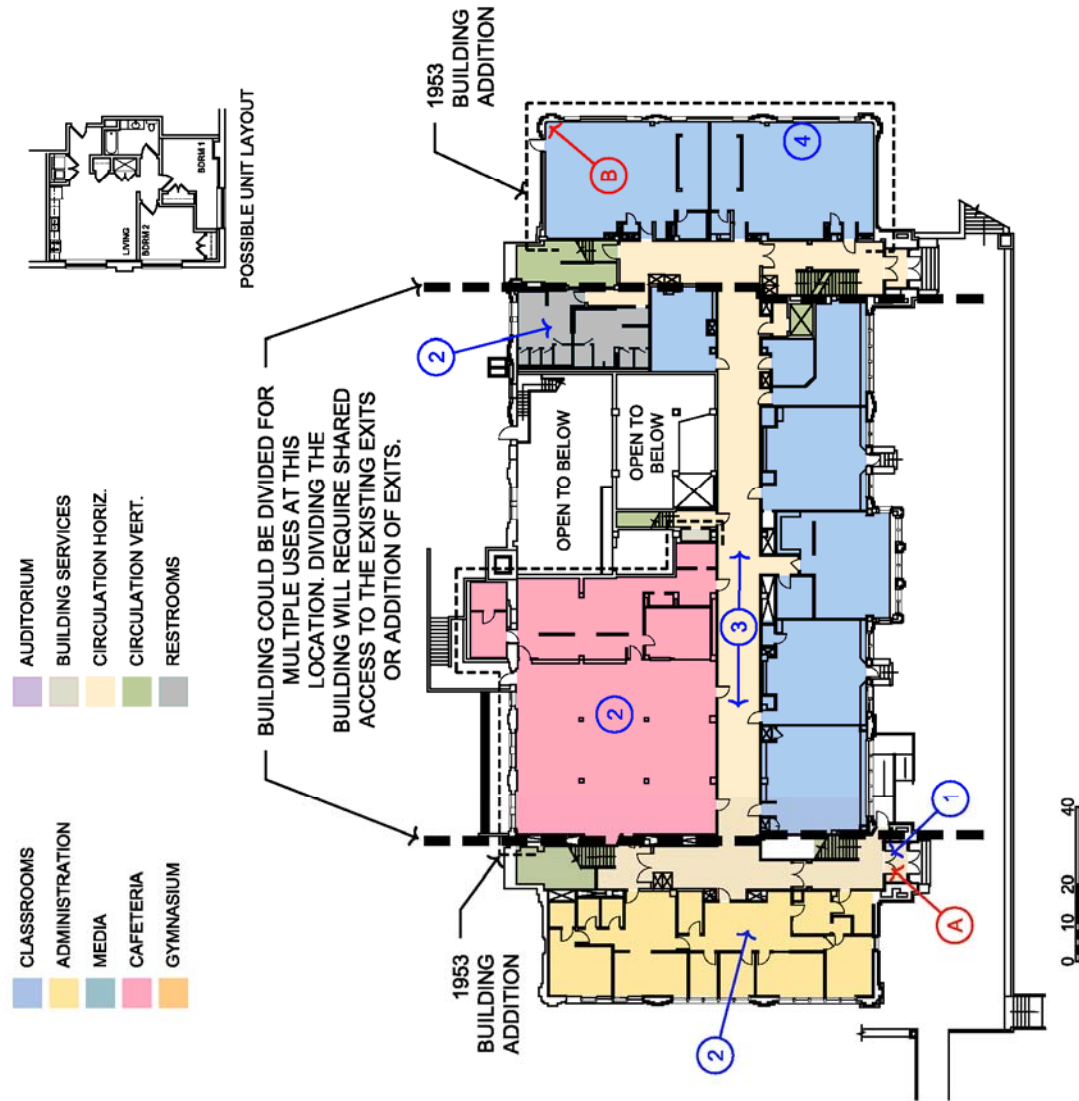
First Floor

- A. Water damage
- B. Peeling paint
- C. Mortar parge coating is failing at painted brick above the roof
- D. Broken glass block units
- E. Water infiltration damage at planter and window sill

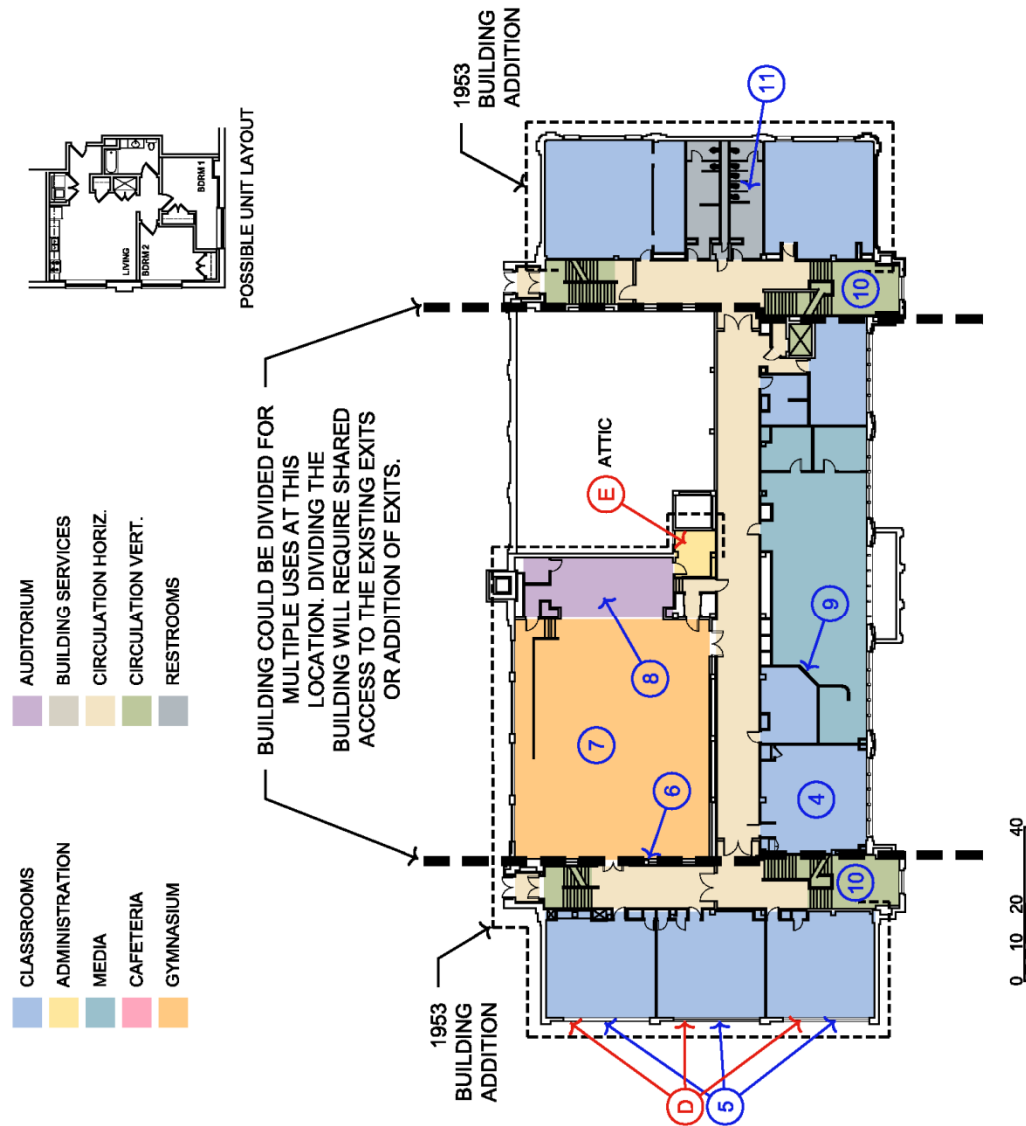
Second Floor

- A. Water damage
- B. Peeling paint
- C. Mortar parge coating is failing at painted brick above the roof
- D. Broken glass block units
- E. Water infiltration damage at planter and window sill

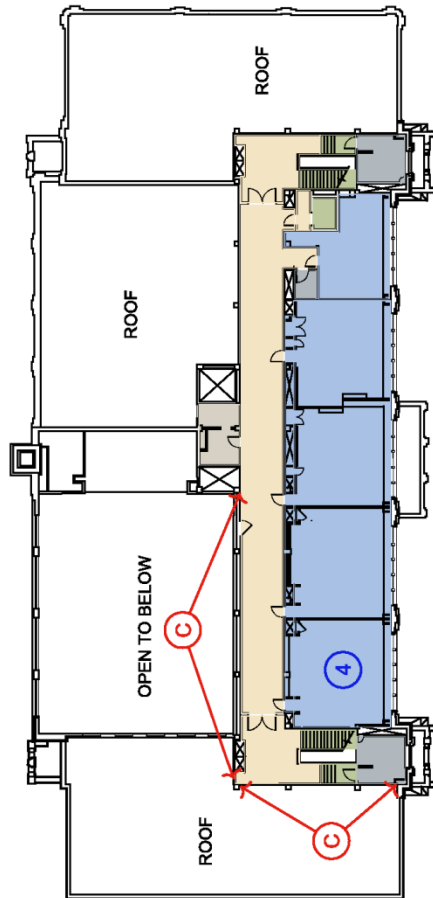
Third Floor

- A. Water damage
- B. Peeling paint
- C. Mortar parge coating is failing at painted brick above the roof
- D. Broken glass block units
- E. Water infiltration damage at planter and window sill

THE SIZE AND LAYOUT OF THIS LEVEL DOES NOT DIVIDE FOR MULTIPLE USERS
