Dunbar

5419 E. 36th Street

REUSE ASSESSMENT

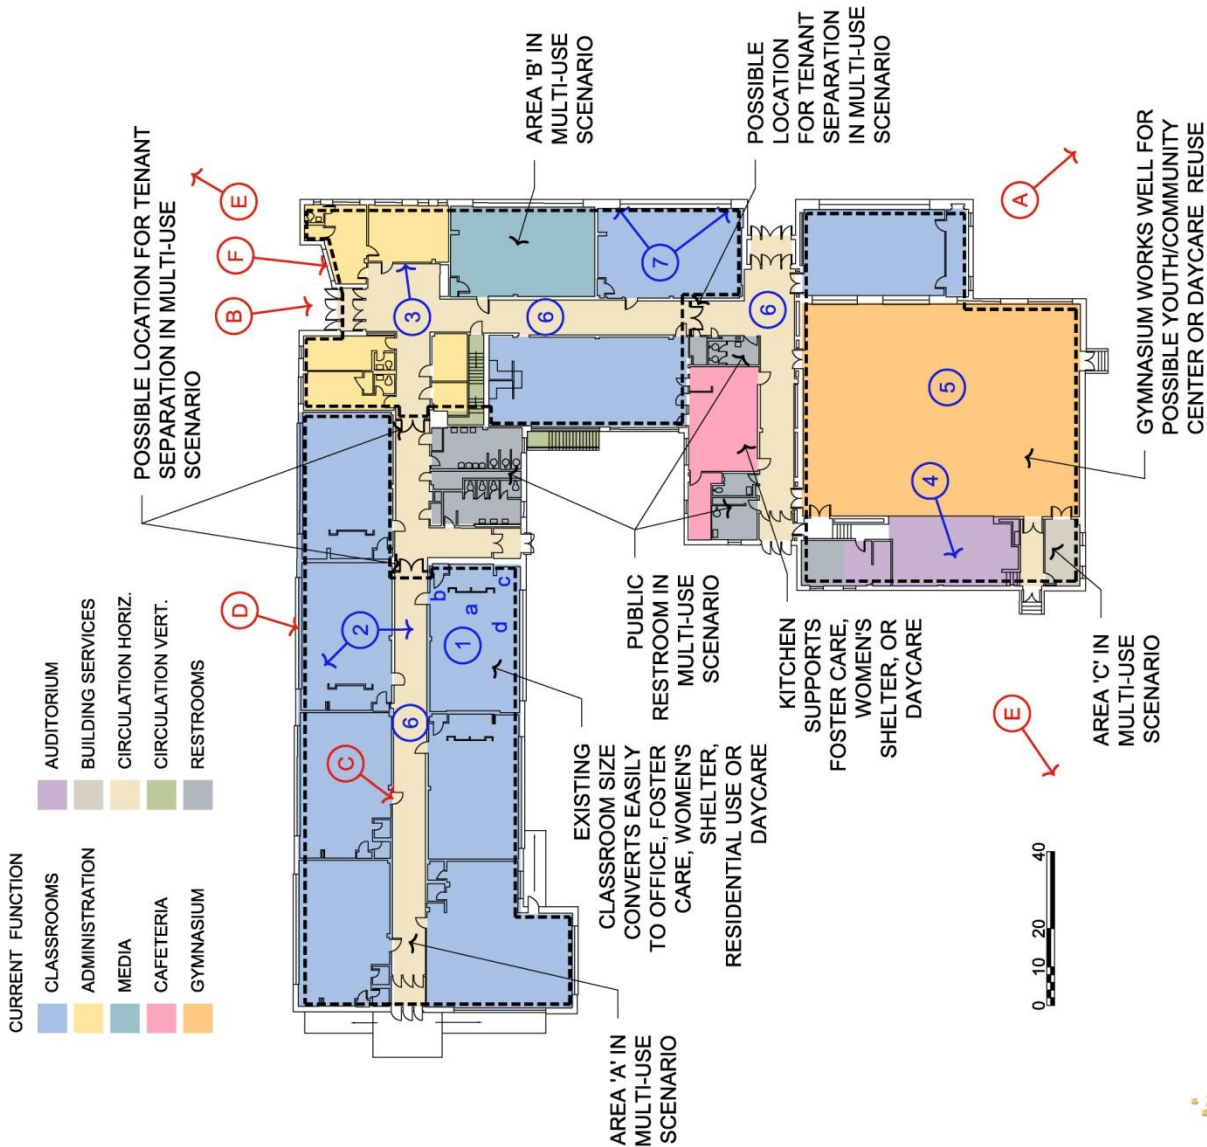
First Floor Plan

- A. Asphalt parking lot in fair condition, typical cracking/settlement, large pot hole at south entrance
- B. Concrete sidewalk settled and cracked at main entrance overall in fair condition
- C. Hollow metal door frames need repainting typical
- D. Cooling appears to be provided by window units typical
- E. Chain link fence on north and southwest corner in poor condition
- F. Glass block damaged
