# Franklin

3400 Highland Avenue

## PHYSICAL BUILDING ASSESSMENT

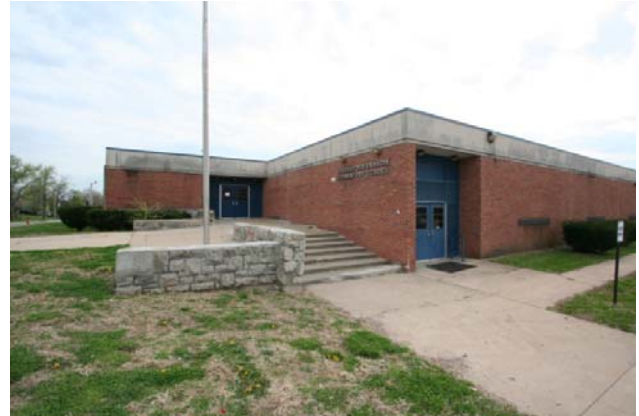
The building is structurally sound. The exterior envelop is in good condition with remaining usable life of the envelop components. Building envelop requires only minor repairs. Interior finishes are in fair condition with typical wear from use. The mechanical and electrical systems appear to be sufficient and in good condition for immediate building use. The exterior site requires repairs of damaged areas, including parking and playground areas and stone retaining walls.
