Graceland

2803 East 51st Street

REUSE ASSESSMENT

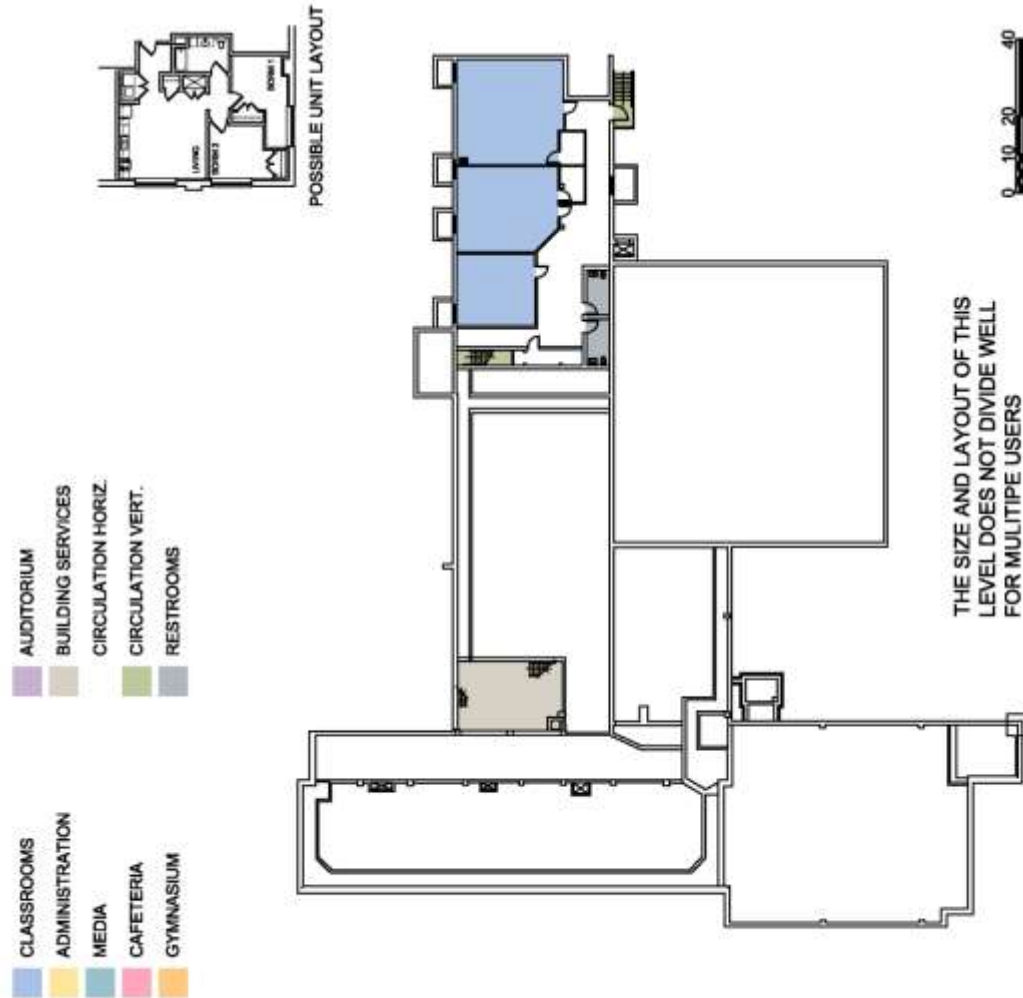
Basement

- A. Brick masonry has fallen off at the parapet
- B. Movement and cracking in brick masonry
- C. Brick faces are spalling on light colored brick
- D. Rusted and damaged window lintels
- E. Cast stone masonry pieces are cracked and spalling
- F. Damaged transom window
- G. Damaged concrete stair
- H. Collapsed ceiling
- I. Peeling paint

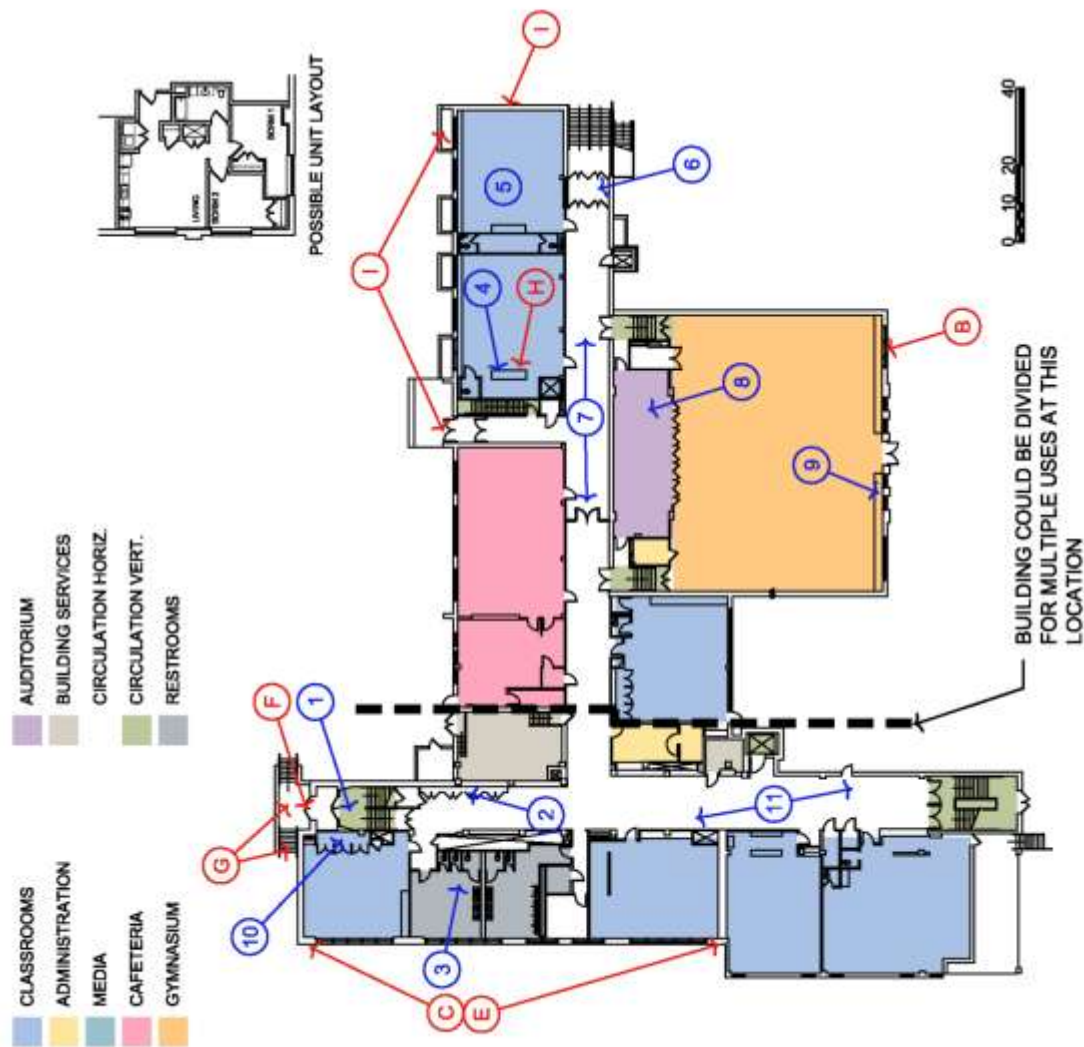
First Floor

- A. Brick masonry has fallen off at the parapet
- B. Movement and cracking in brick masonry
- C. Brick faces are spalling on light colored brick
- D. Rusted and damaged window lintels
- E. Cast stone masonry pieces are cracked and spalling
- F. Damaged transom window
- G. Damaged concrete stair
- H. Collapsed ceiling
- I. Peeling paint

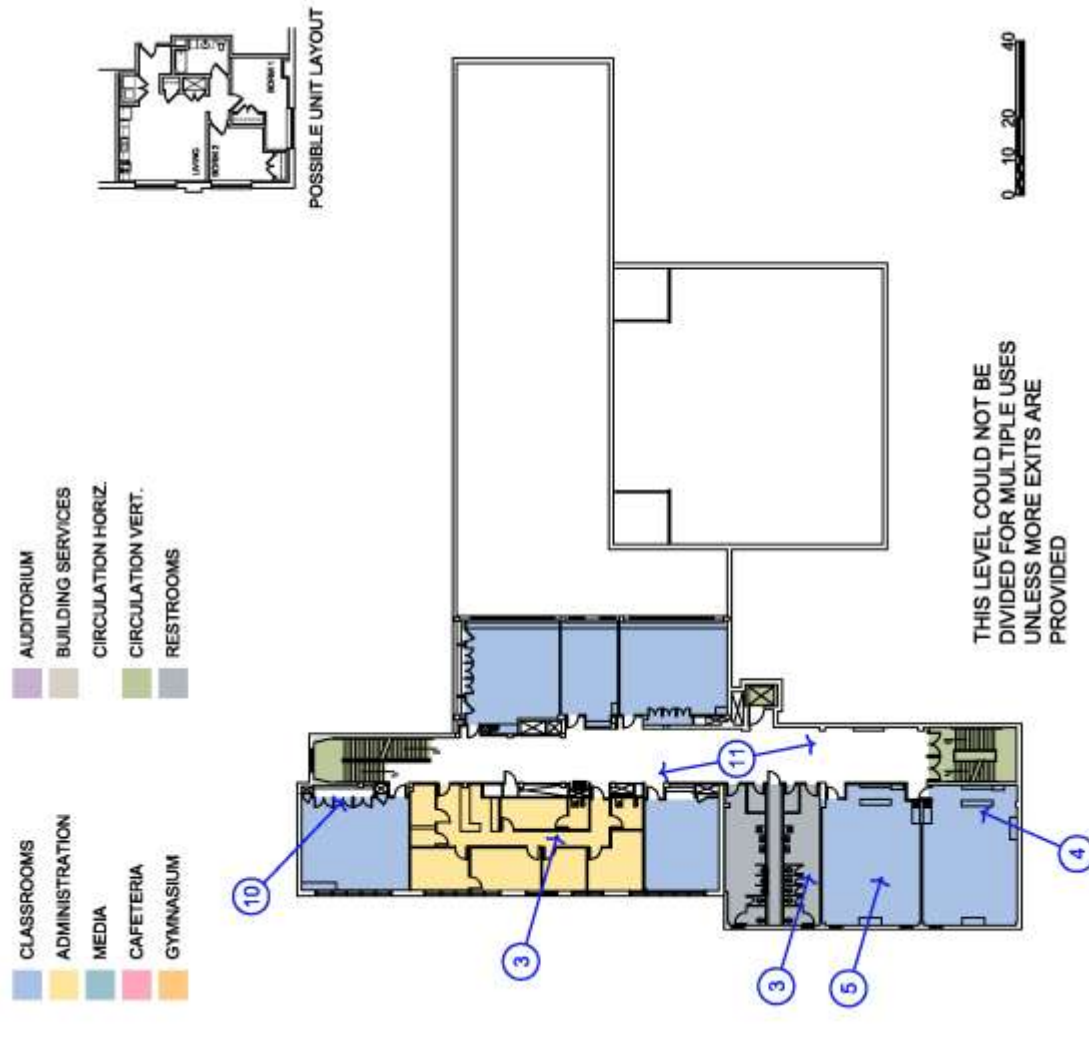
Second Floor

- A. Brick masonry has fallen off at the parapet
- B. Movement and cracking in brick masonry
- C. Brick faces are spalling on light colored brick
- D. Rusted and damaged window lintels
- E. Cast stone masonry pieces are cracked and spalling
- F. Damaged transom window
- G. Damaged concrete stair
- H. Collapsed ceiling
- I. Peeling paint

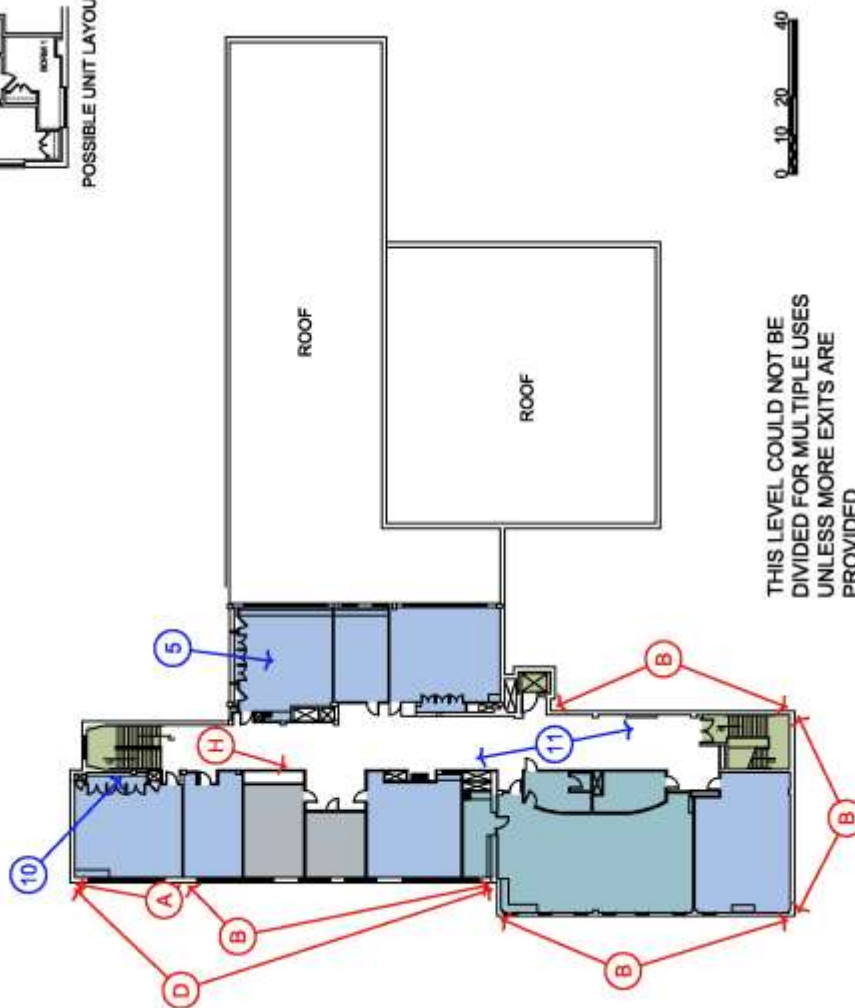
Third Floor

- A. Brick masonry has fallen off at the parapet
- B. Movement and cracking in brick masonry
- C. Brick faces are spalling on light colored brick
- D. Rusted and damaged window lintels
- E. Cast stone masonry pieces are cracked and spalling
- F. Damaged transom window
- G. Damaged concrete stair
- H. Collapsed ceiling
- I. Peeling paint

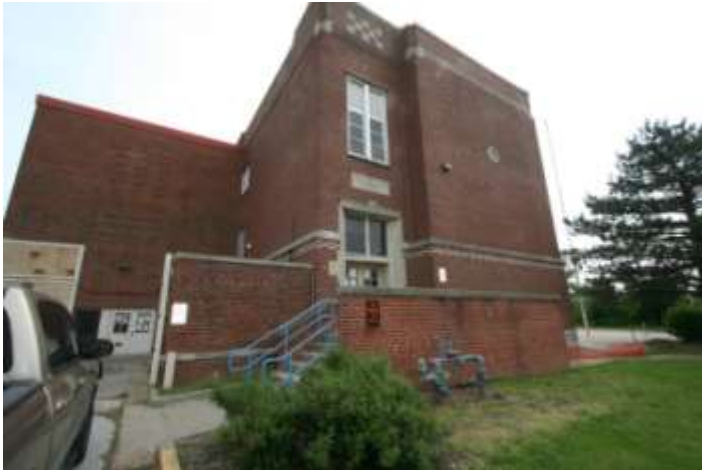
Main entrance (original circa 1926)

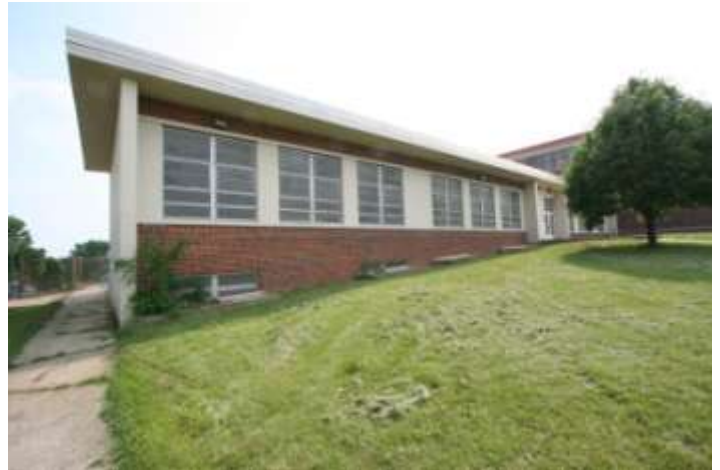
Addition (circa 1954-56)
