Greenwood

3711 E. 27th Street

PHYSICAL BUILDING ASSESSMENT

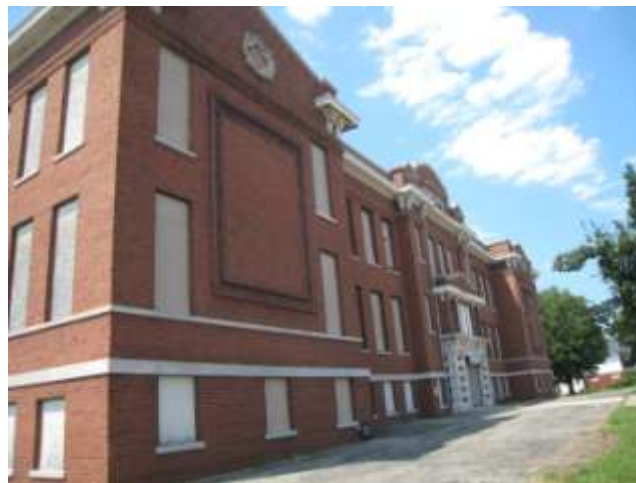
CONDITION RATING: ** 1/2

The building appears to be structurally sound except for possible damage to roof framing around the courtyard. The exterior envelope is in fair condition with areas of the roof noted in poor condition. The building envelope, including masonry and windows, has some remaining usable life, but will require masonry repairs and roof replacement. Interior finishes are in fair to poor condition mainly due to previous water infiltration. The mechanical system is inoperable and the condition of the electrical system is unknown. Damaged areas of the site requiring repair will include parking lot, playground, sidewalks, and stone retaining walls.
