Greenwood

3711 East 27th

REUSE ASSESSMENT

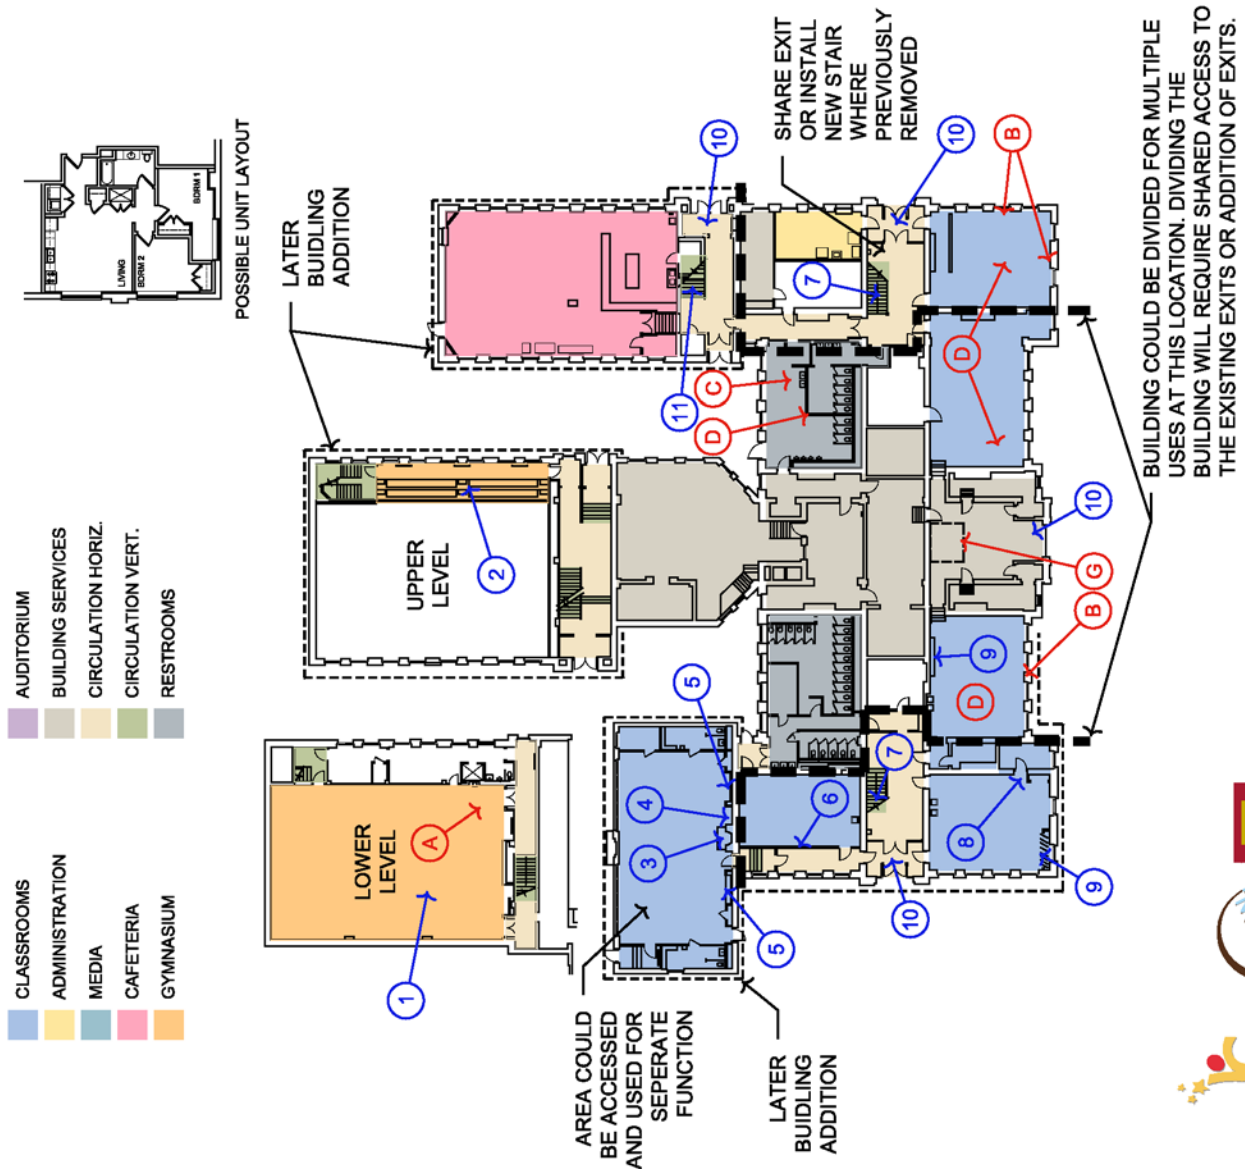
First Floor

- A. Water damage flooring
- B. Water damage at wall
- C. Water damage at ceiling
- D. Mold this area
- E. Decorative metal is deteriorated
- F. Decorative metal gutters are deteriorated and full of plant material and downspouts are disconnected
- G. Stair removed at main entrance
- H. Bird guano in auditorium

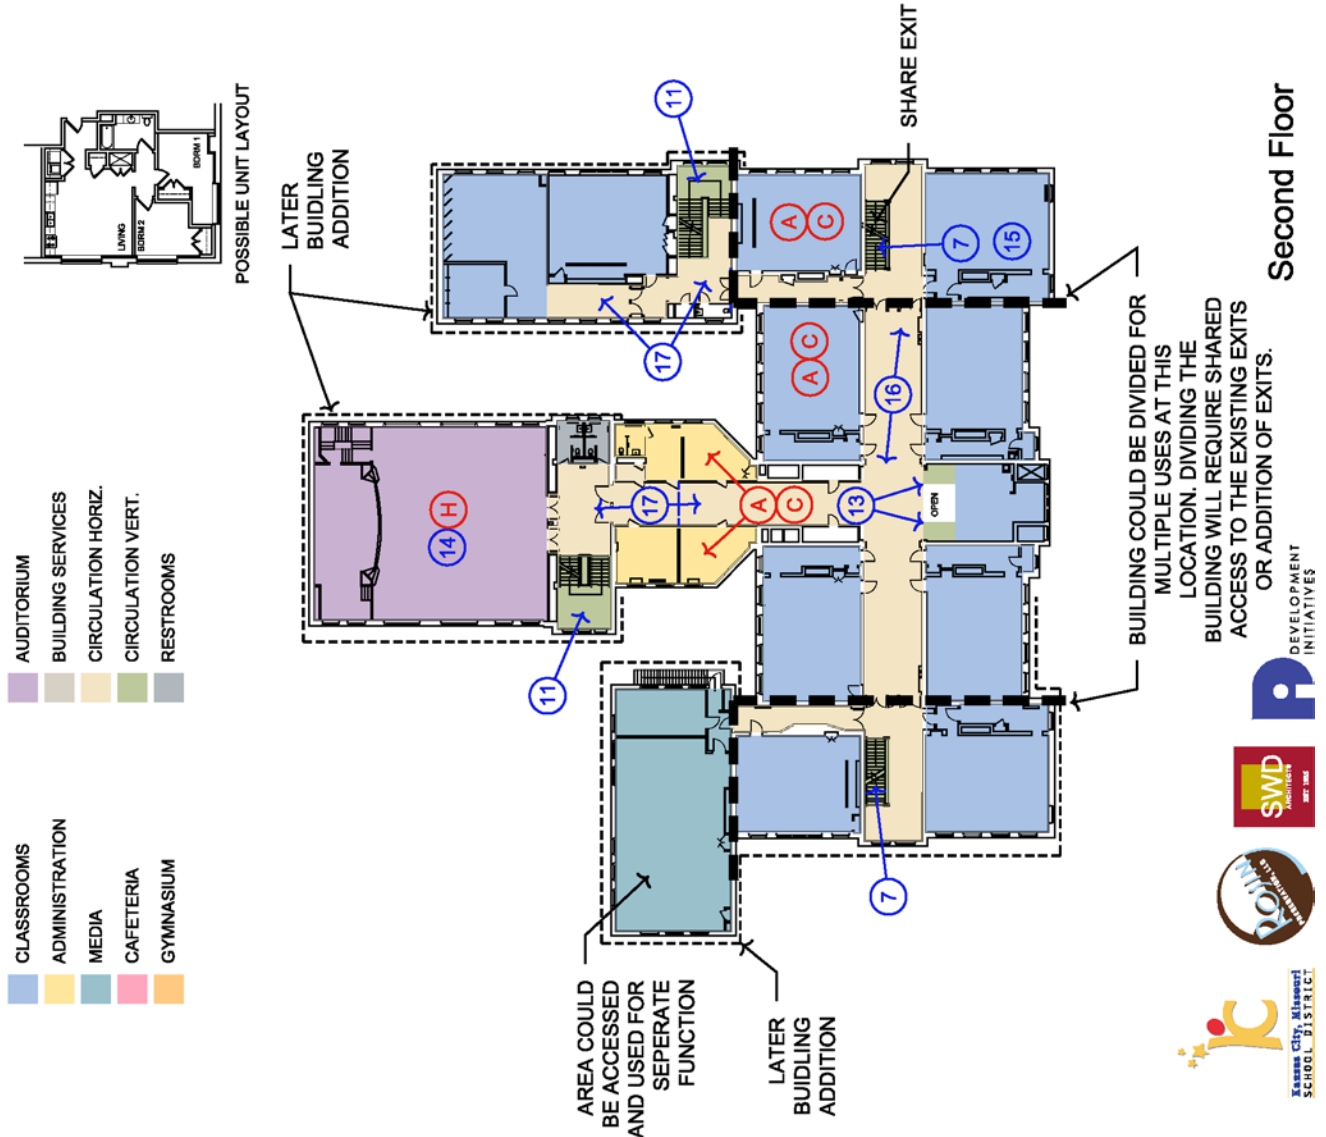
- A. Water damage flooring
- B. Water damage at wall
- C. Water damage at ceiling
- D. Mold this area
- E. Decorative metal is deteriorated
- F. Decorative metal gutters are deteriorated and full of plant material and downspouts are disconnected
- G. Stair removed at main entrance
- H. Bird guano in auditorium

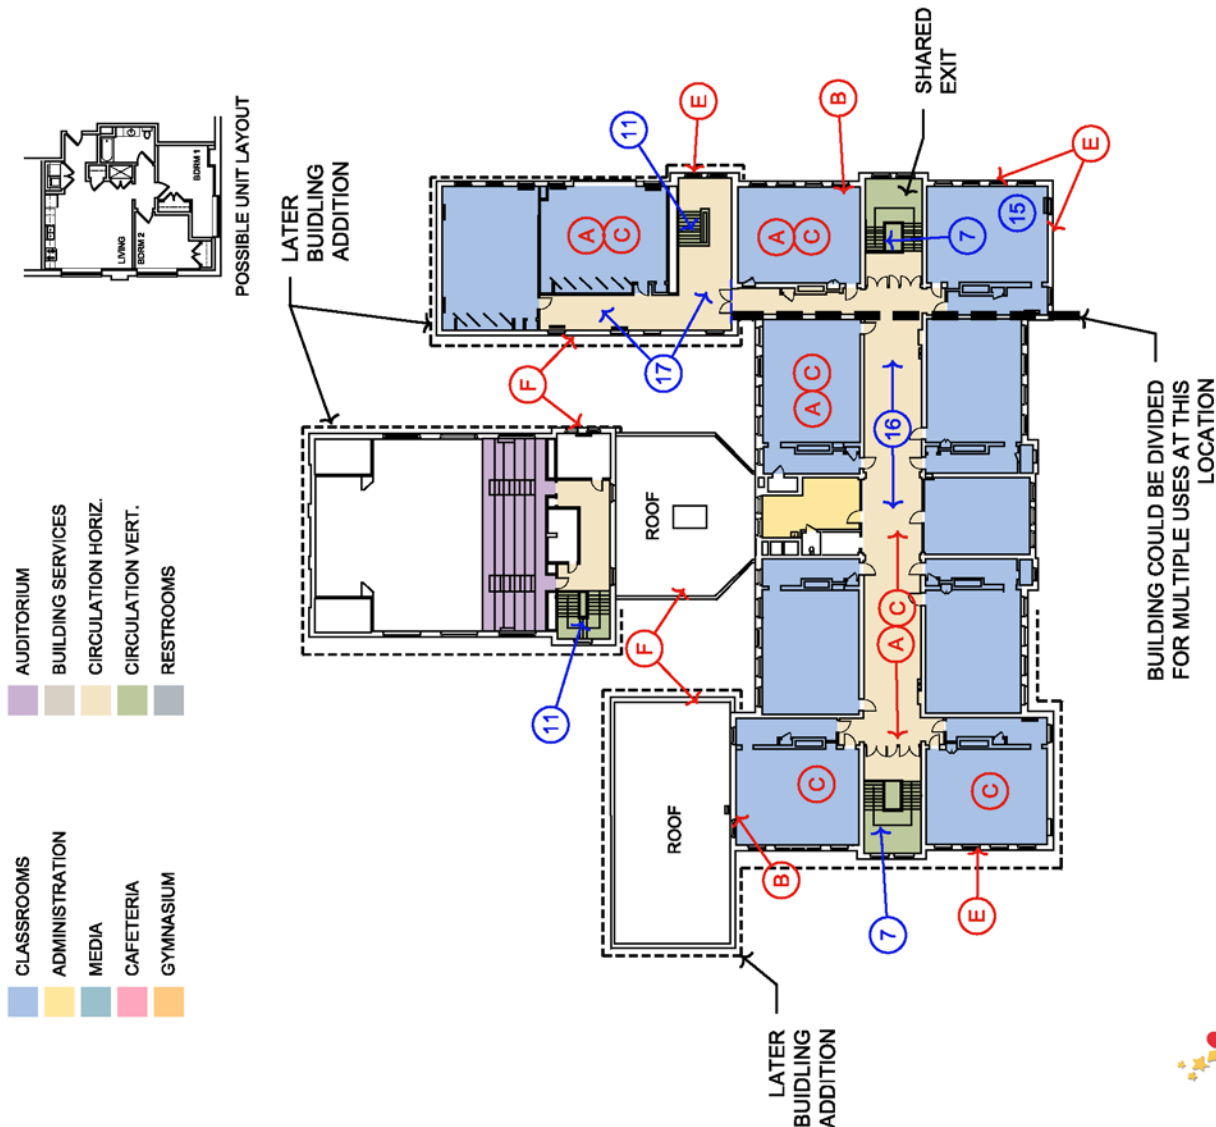
Third Floor

- A. Water damage flooring
- B. Water damage at wall
- C. Water damage at ceiling
- D. Mold this area
- E. Decorative metal is deteriorated and full of plant material and downspouts are disconnected
- F. Stair removed at main entrance
- G. Bird guano in auditorium
