McCoy

1524 White Avenue

Historical Brief

REUSE ASSESSMENT

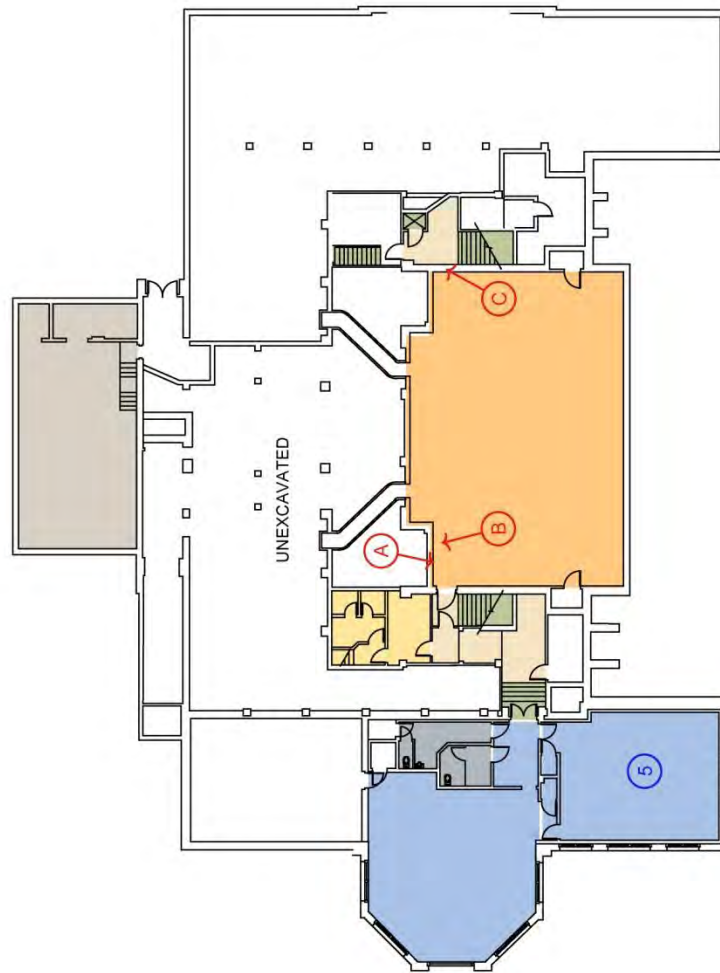
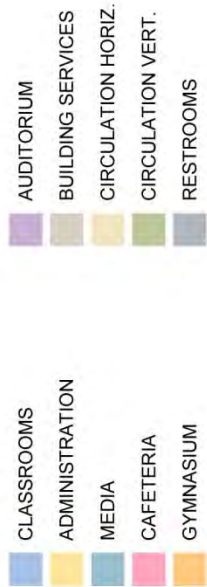
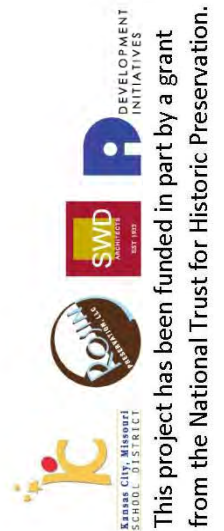
Ground Floor

- A. Efflorescence on brick wall
- B. Wood floor heaved and buckled
- C. Damage threshold
- D. Missing interior wood vestibule doors
- E. Standing water at boiler room floor
- F. Graffiti on entry glazing
- G. Window lintels in poor condition
- H. Stone foundation in good condition
- I. Terracotta in fair to good condition
- J. Window with acrylic plastic glazing has yellowed and fogged opaque
- K. Chain link fence in poor condition
- L. Asphalt in fair-poor condition
- M. Retaining walls on SW corner failed
- N. Damage at east entrance

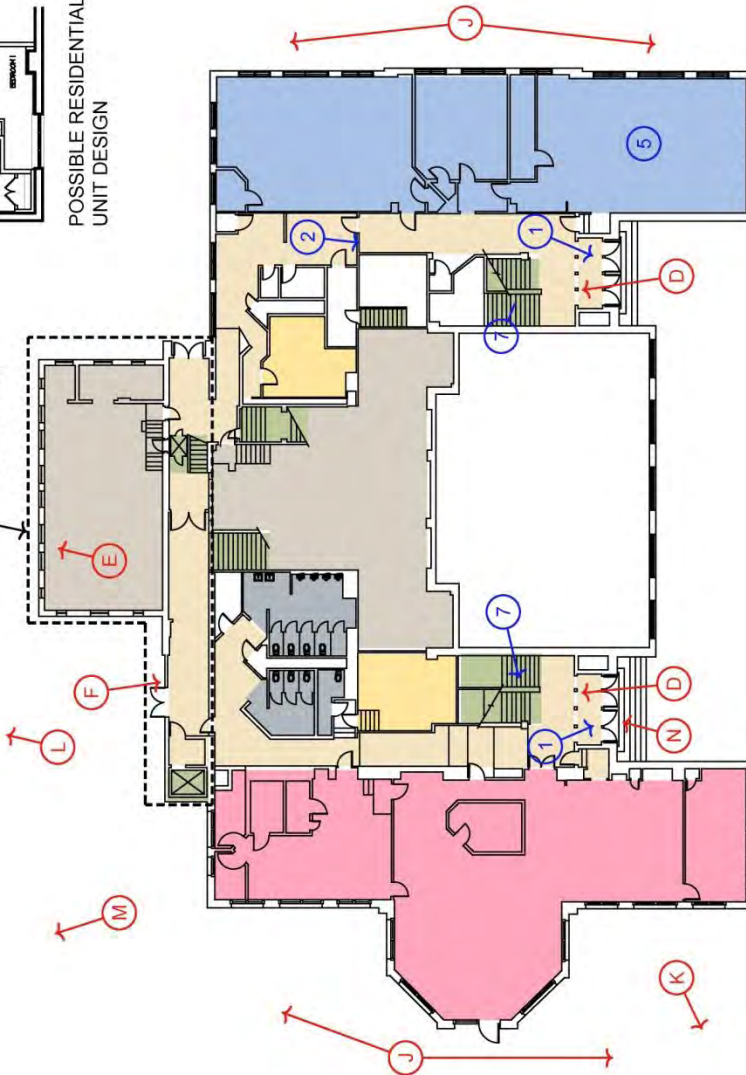
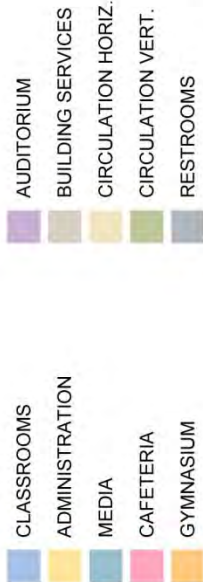
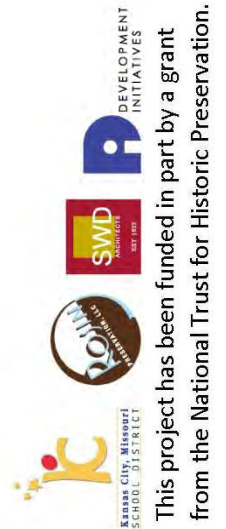
First Floor

- A. Efflorescence on brick wall
- B. Wood floor heaved and buckled
- C. Damage threshold
- D. Missing interior wood vestibule doors
- E. Standing water at boiler room floor
- F. Graffiti on entry glazing
- G. Window lintels in poor condition
- H. Stone foundation in good condition
- I. Terracotta in fair to good condition
- J. Window with acrylic plastic glazing has yellowed and fogged opaque
- K. Chain link fence in poor condition
- L. Asphalt in fair-poor condition
- M. Retaining walls on SW corner failed
- N. Damage at east entrance

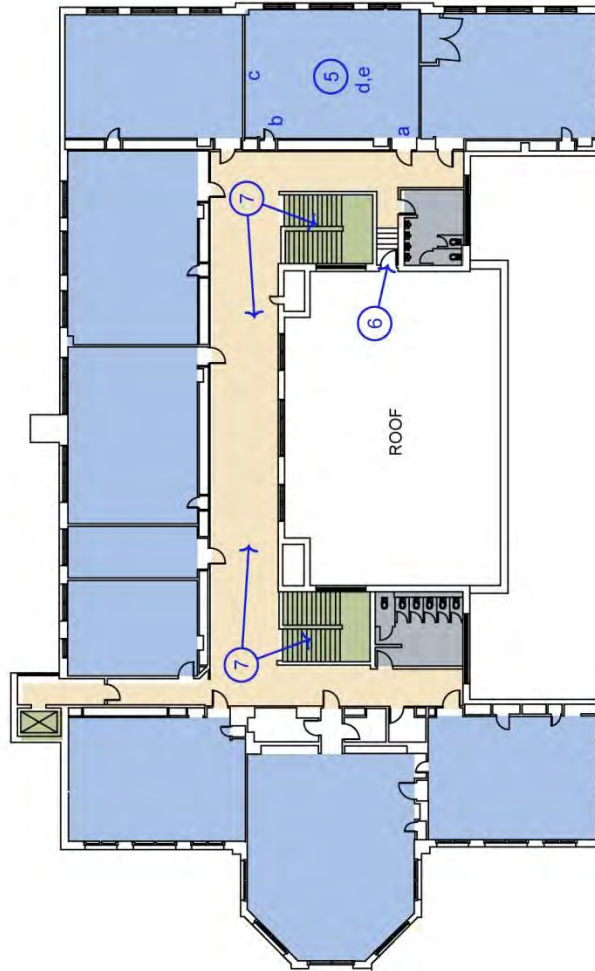
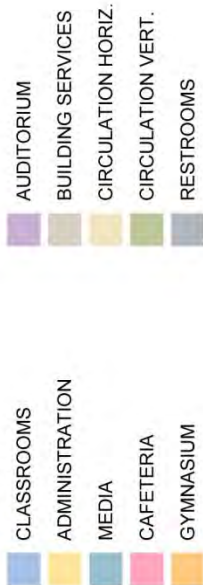
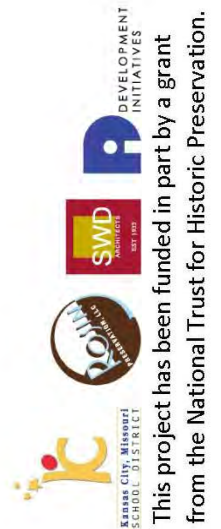
Third Floor

- A. Efflorescence on brick wall
- B. Wood floor heaved and buckled
- C. Damage threshold
- D. Missing interior wood vestibule doors
- E. Standing water at boiler room floor
- F. Graffiti on entry glazing
- G. Window lintels in poor condition
- H. Stone foundation in good condition
- I. Terracotta in fair to good condition
- J. Window with acrylic plastic glazing has yellowed and fogged opaque
- K. Chain link fence in poor condition
- L. Asphalt in fair-poor condition
- M. Retaining walls on SW corner failed
- N. Damage at east entrance
