Meservey

4210 East 45th

REUSE ASSESSMENT

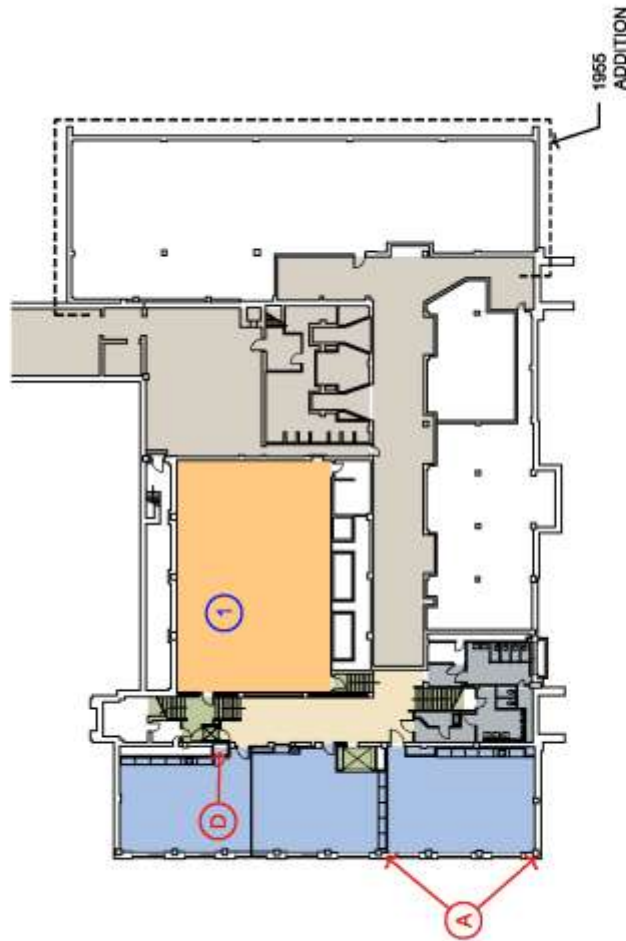
Ground

- A. Water damage at wall
- B. Water damage at floor
- C. Water damage at ceiling
- D. Mold
- E. Movement crack in masonry
- F. Open mortar joint in stone pediment

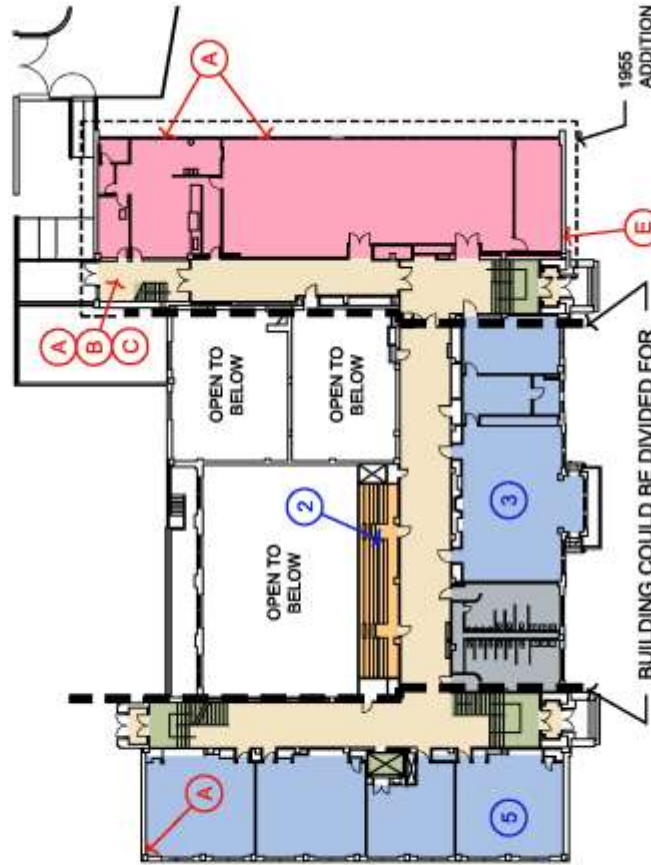
First Floor

- A. Water damage at wall
- B. Water damage at floor
- C. Water damage at ceiling
- D. Mold
- E. Movement crack in masonry
- F. Open mortar joint in stone pediment

BUILDING COULD BE DIVIDED FOR MULTIPLE USES AT THIS LOCATION. DIVIDING THE BUILDING WILL REQUIRE SHARED ACCESS TO THE EXISTING EXITS OR ADDITION OF EXITS.

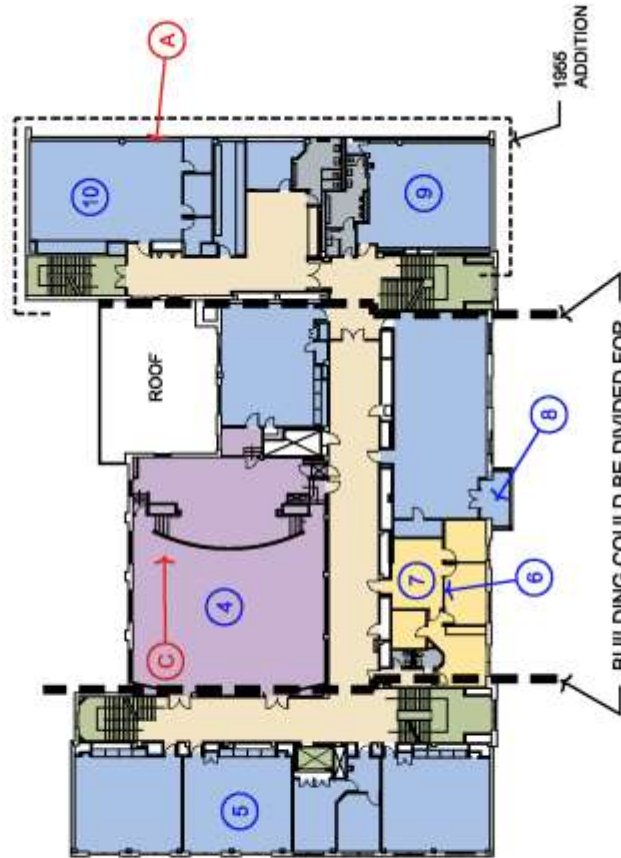
Second Floor

- A. Water damage at wall
- B. Water damage at floor
- C. Water damage at ceiling
- D. Mold
- E. Movement crack in masonry
- F. Open mortar joint in stone pediment

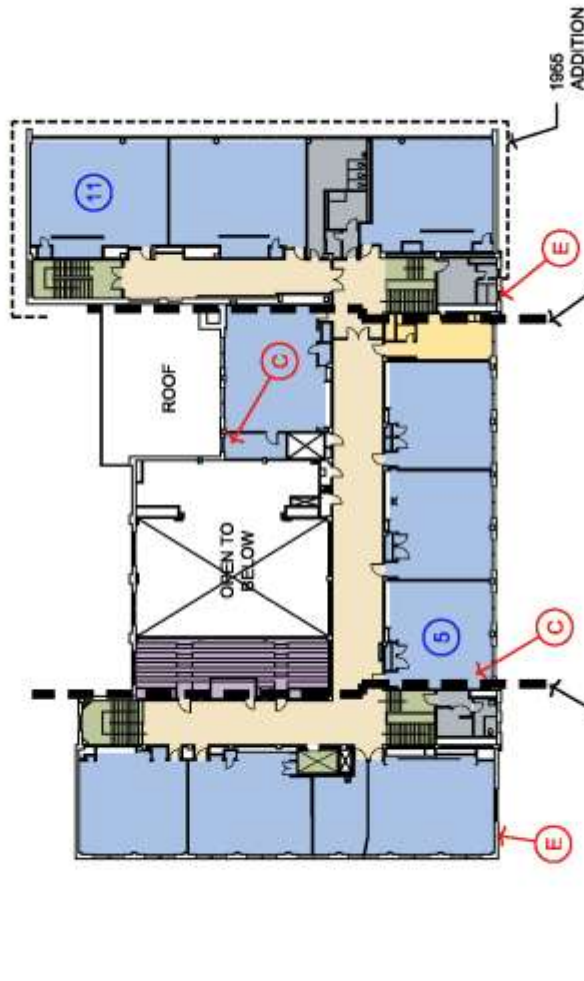
Third Floor

- A. Water damage at wall
- B. Water damage at floor
- C. Water damage at ceiling
- D. Mold
- E. Movement crack in masonry
- F. Open mortar joint in stone pediment
