Pershing

5915 Park

REUSE ASSESSMENT

BUILDING/SITE ASSESSMENT: Building is in good condition. The building size and layout are readily adaptable for multi-family housing (25 +/- units) or a combination of housing + community services/office use. Classroom size converts well into a single bedroom apartment or combines well into two bedroom apartments. Classrooms could also be converted into multi-person office space, although the amount of office space relative to circulation space is not highly efficient. The building's exterior and interior design limit the visibility required for good retail use but could work as an office occupancy or business incubator. There is only partial air conditioning provided by window units, which will limit options under a short-term lease scenario. Any use other than office or education will typically require installation of a fire sprinkler system (a community center may not require this depending on overall square footage and location of exits). The large paved playground on the south side of the building offers opportunities for community use of the grounds (garden, farmer's market, open space, playground, etc.)

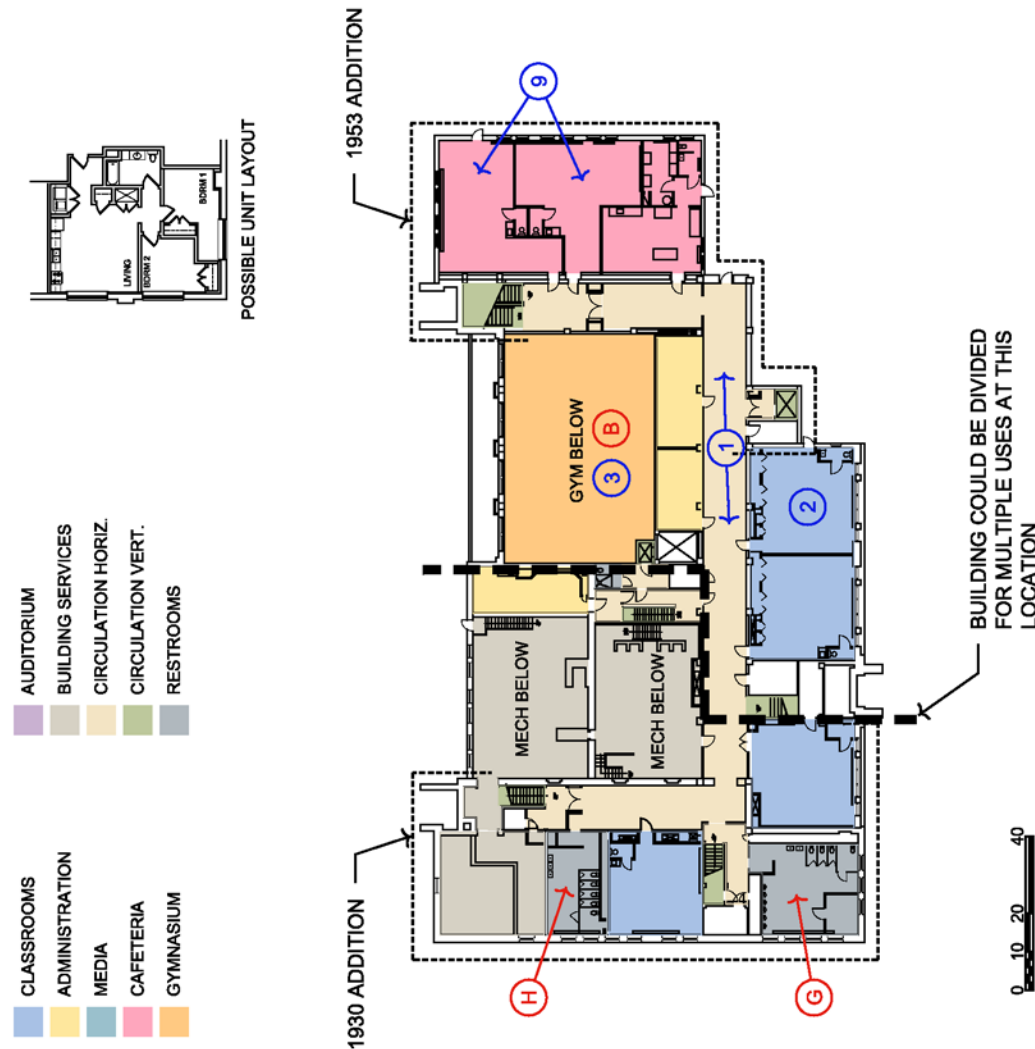
Ground Floor

- CONDITION NOTES**
- A. Brick has fallen off the building in this area
 - B. Floor tile is buckled from past water infiltration
 - C. Ponding water on roof

- D. Missing roof coping in this area
 - E. Some peeling paint in auditorium
 - F. Plaster damage on bottom of stair
 - G. Epoxy flooring is peeling
 - H. Standing water on floor

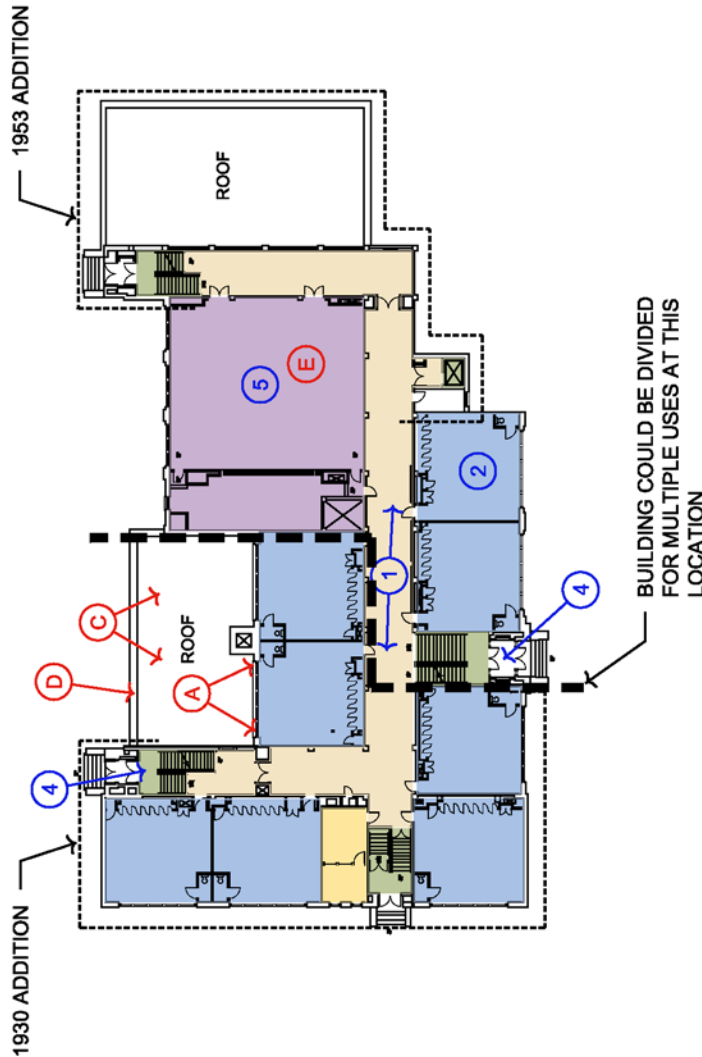
First Floor

- CONDITION NOTES**
- A. Brick has fallen off the building in this area
 - B. Floor tile is buckled from past water infiltration
 - C. Ponding water on roof

- D. Missing roof coping in this area
 - E. Some peeling paint in auditorium
 - F. Plaster damage on bottom of stair
 - G. Epoxy flooring is peeling
 - H. Standing water on floor

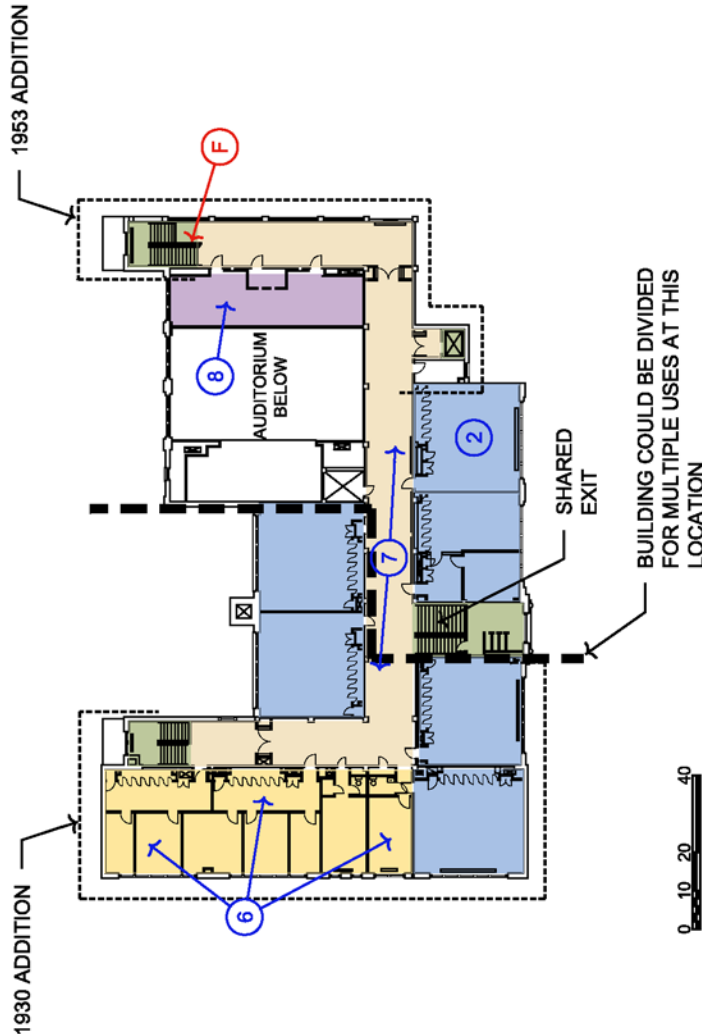
Second Floor

CONDITION NOTES

- A. Brick has fallen off the building in this area
- B. Floor tile is buckled from past water infiltration
- C. Ponding water on roof
- D. Missing roof coping in this area
- E. Some peeling paint in auditorium
- F. Plaster damage on bottom of stair
- G. Epoxy flooring is peeling
- H. Standing water on floor

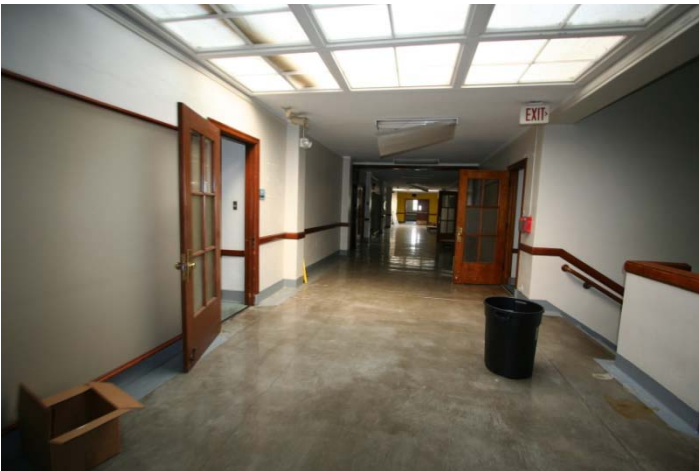
Corridor

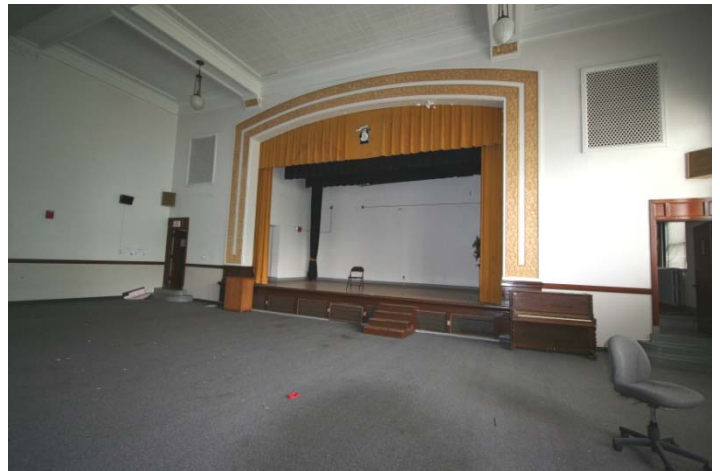
Auditorium

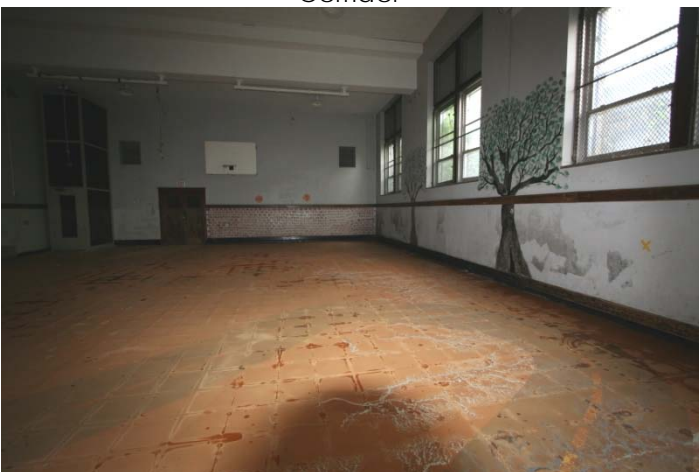
Gymnasium

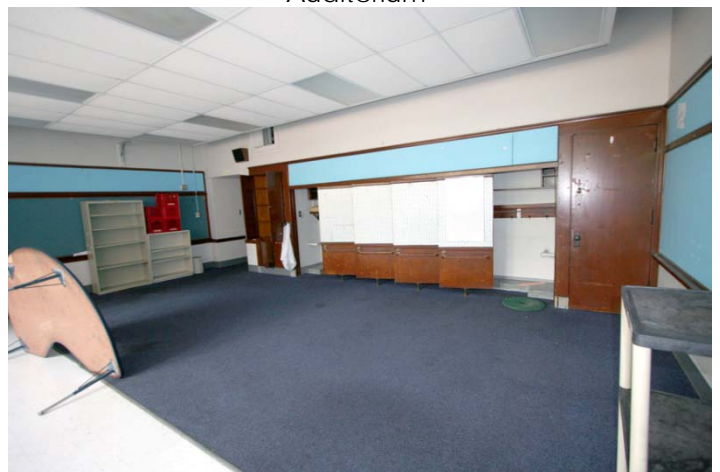
Classroom
