# Pinkerton

6409 Agnes

## REUSE ASSESSMENT

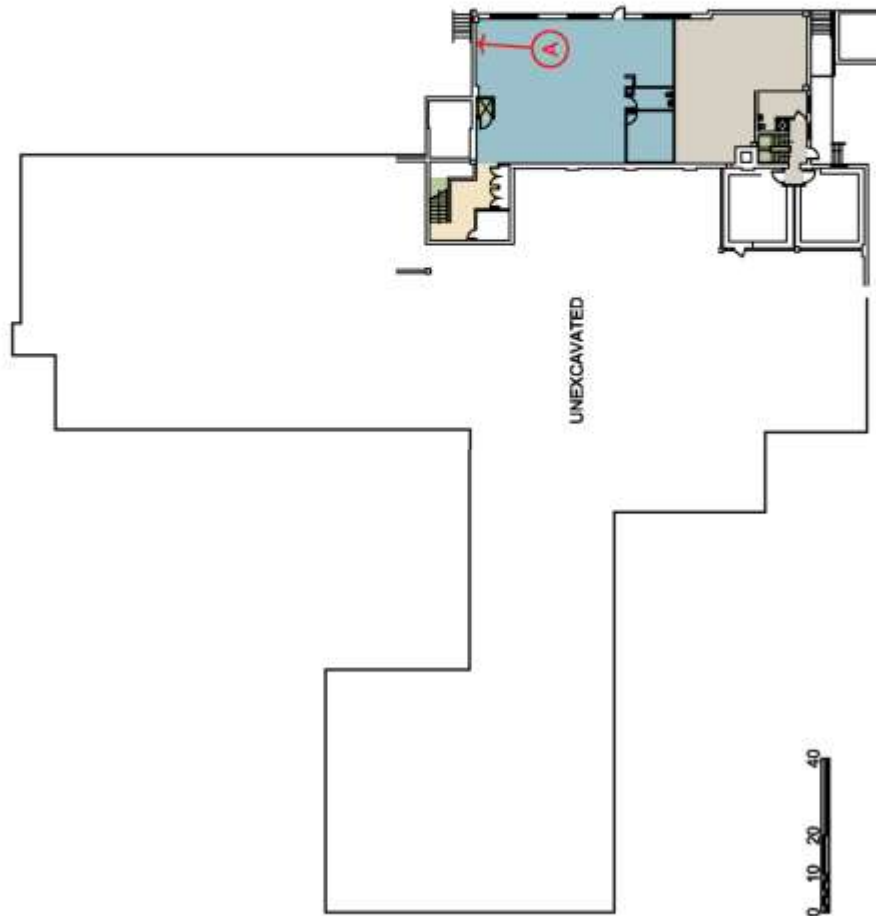
Basement

- A. Paint peeling in this area
- B. Gutter in poor condition
- C. Carpet wrinkled in this area
- D. Spalled concrete at overhang and paint is peeling
- E. Wall settlement in this area
- F. Precast panel corner damaged
- G. Water stains at ceiling in this area
- H. Sink drain clogged
- I. Metal guard and hand rail are in poor condition

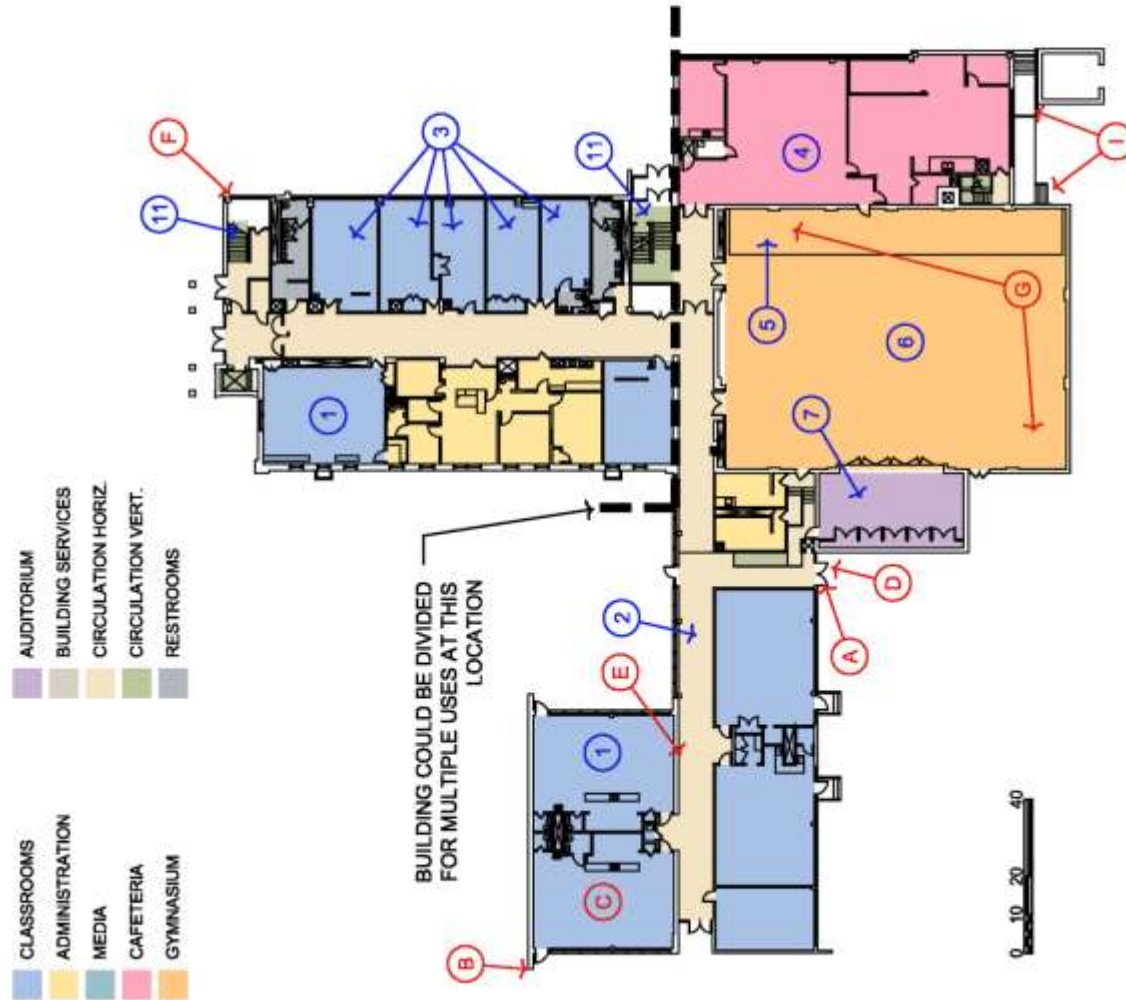
First Floor

- A. Paint peeling in this area
- B. Gutter in poor condition
- C. Carpet wrinkled in this area
- D. Spalled concrete at overhang and paint is peeling
- E. Wall settlement in this area
- F. Precast panel corner damaged
- G. Water stains at ceiling in this area
- H. Sink drain clogged
- I. Metal guard and hand rail are in poor condition

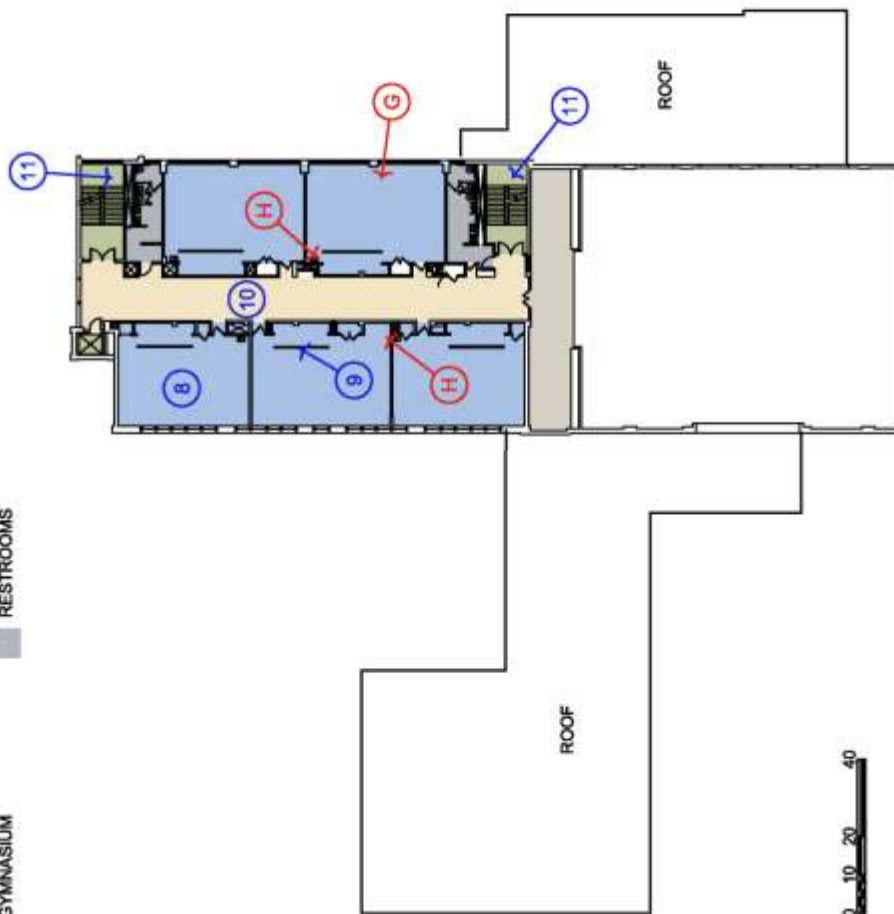
Second Floor

- A. Paint peeling in this area
- B. Gutter in poor condition
- C. Carpet wrinkled in this area
- D. Spalled concrete at overhang and paint is peeling
- E. Wall settlement in this area
- F. Precast panel corner damaged
- G. Water stains at ceiling in this area
- H. Sink drain clogged
- I. Metal guard and hand rail are in poor condition

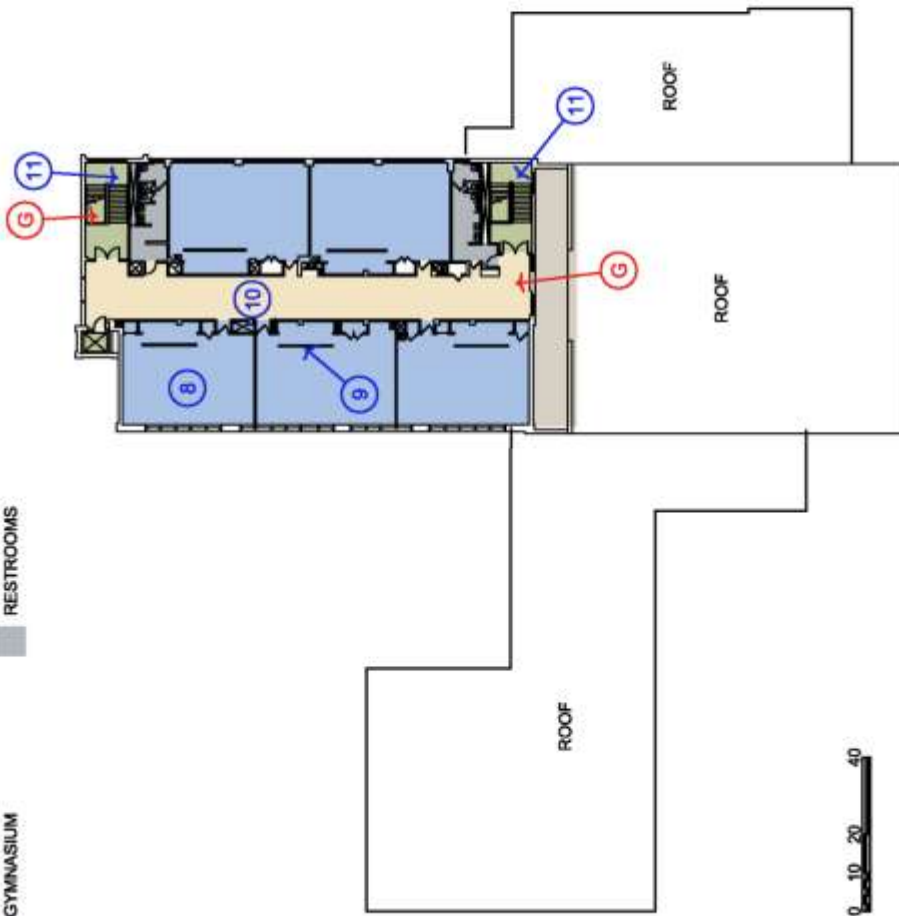
Third Floor

- A. Paint peeling in this area
- B. Gutter in poor condition
- C. Carpet wrinkled in this area
- D. Spalled concrete at overhang and paint is peeling
- E. Wall settlement in this area
- F. Precast panel corner damaged
- G. Water stains at ceiling in this area
- H. Sink drain clogged
- I. Metal guard and hand rail are in poor condition
