March 15, 2010

**PHASE I TARGETED BROWNFIELDS ASSESSMENT
HAZARDOUS MATERIALS SURVEY
REVISION 01**

**RECOVERY-WEST HIGH COMPLEX
1810 AND 1829 MADISON AVENUE, KANSAS CITY, MISSOURI**

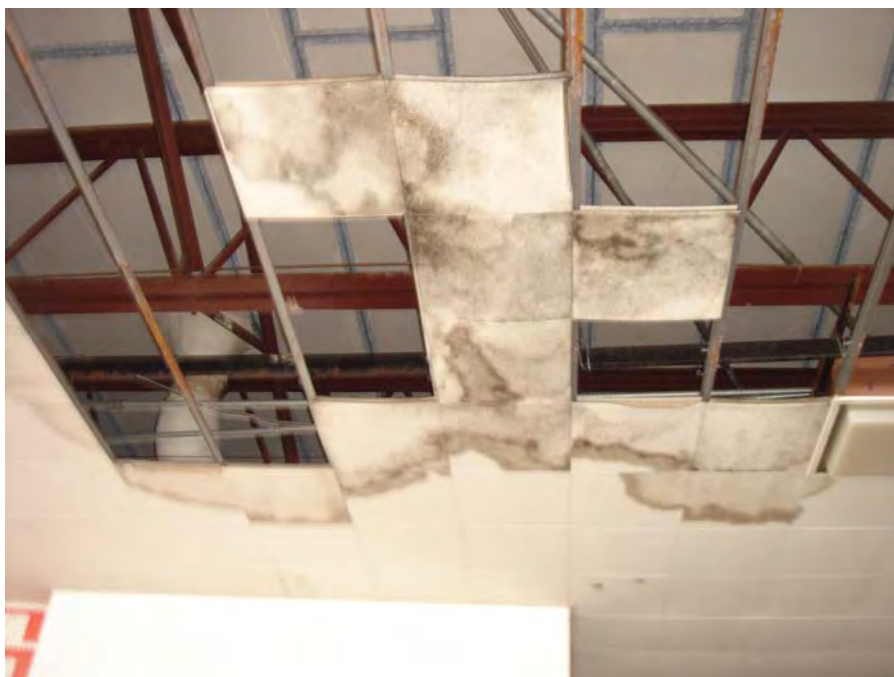
Photo 4: Water damaged ceiling tiles and suspected mold located in a Cafeteria on the third floor of Building A.

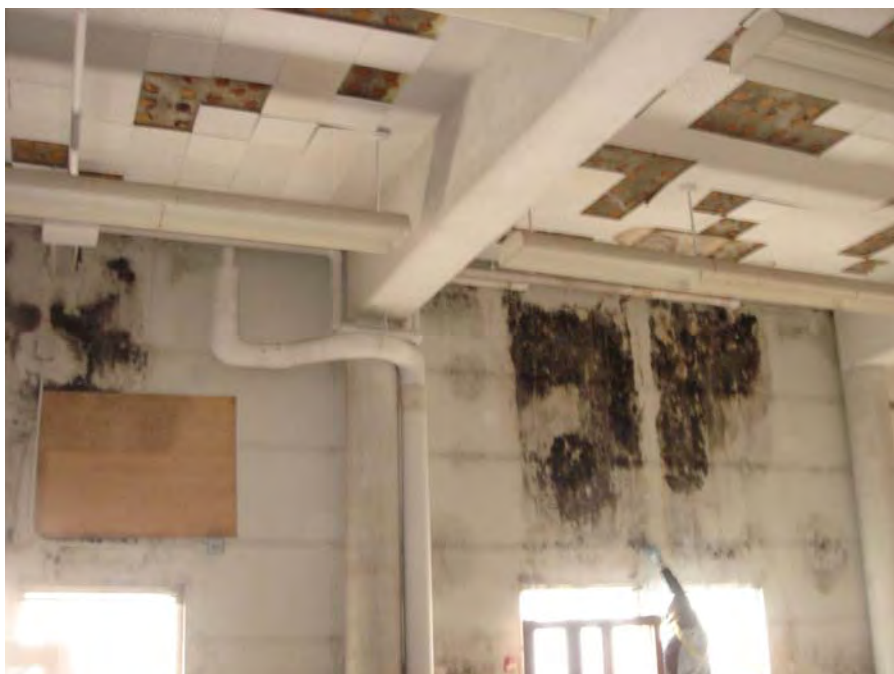
Photo 5: Suspected mold growth on the south wall of the south classroom on the second floor in Building A where samples MD-A-2-SR-1 and MD-A-2-SR-1DUP were taken.

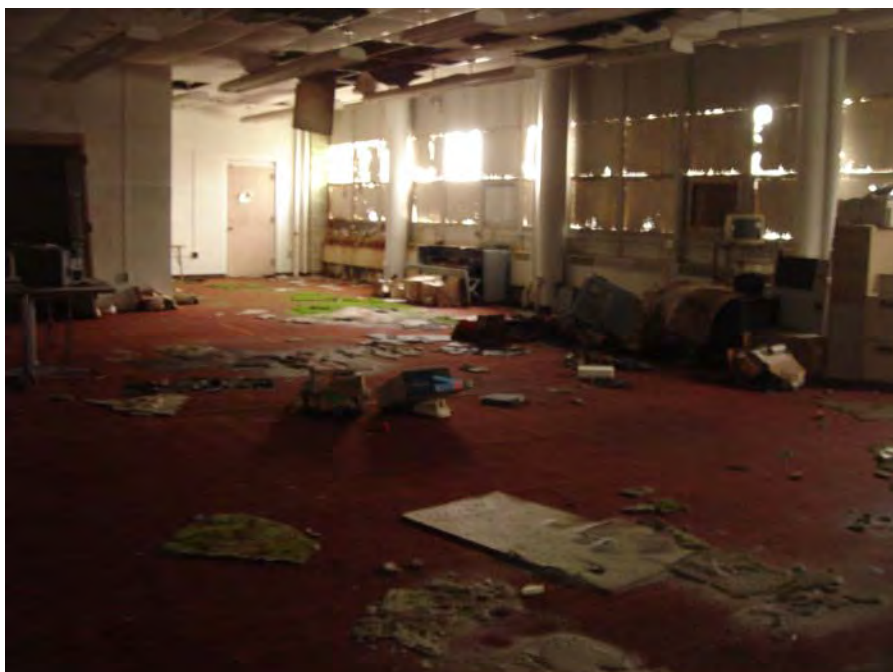
Photo 7: Suspected mold growth and water damage in the west classroom on the second floor of Building A.

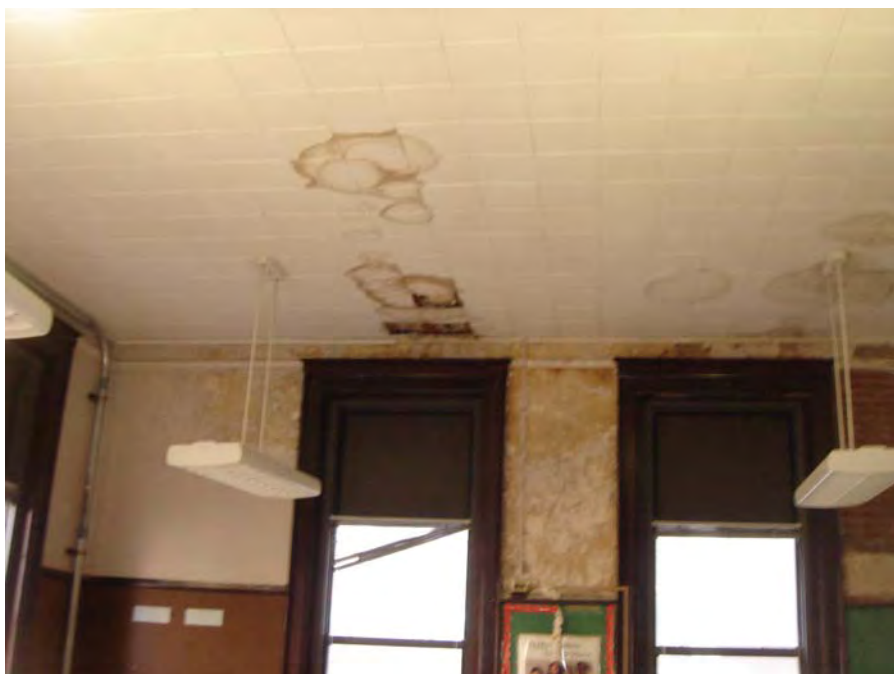
Photo 12: Water damaged ceiling in the auditorium on the ground floor in Building B.

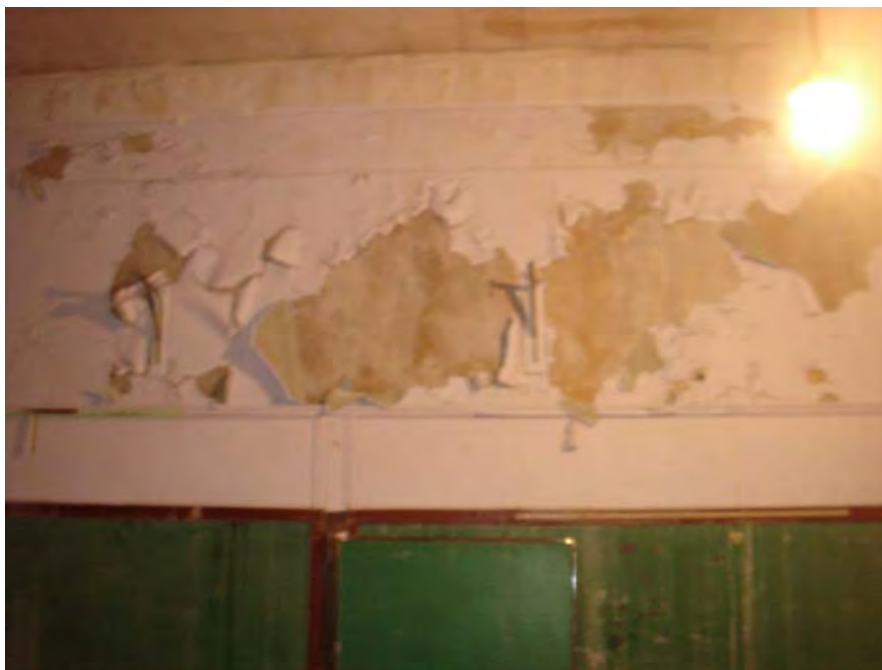
Photo 20: Suspected mold growth on the walls of a stairwell of Building D on the first floor where sample No. MD-D-1-SW-1 was taken.

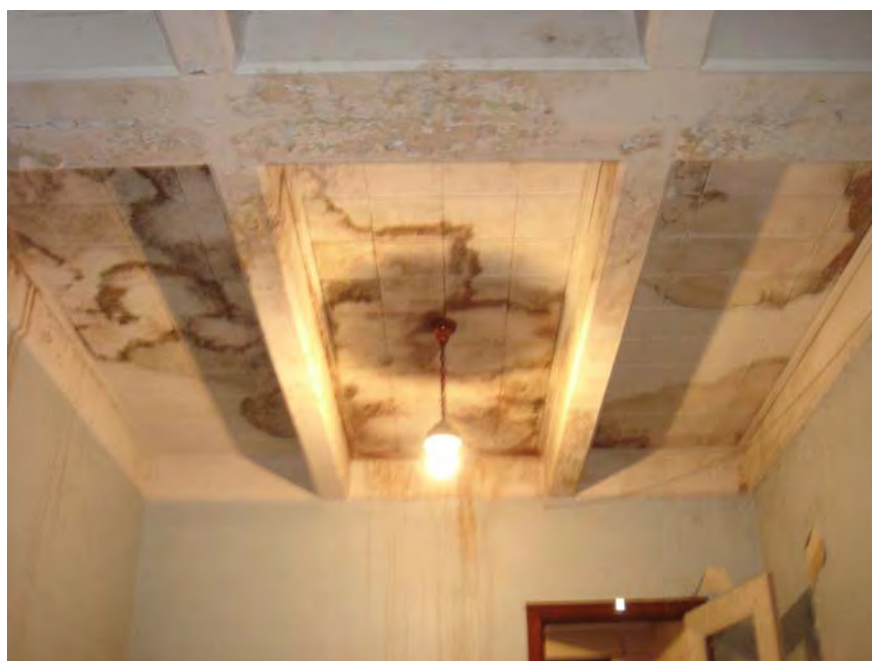
Photo 21: Water damage on the walls and ceiling in Room 8 on the north side of the building in Building D.
