Thacher

5008 Independence Avenue

Historical Brief

REUSE ASSESSMENT

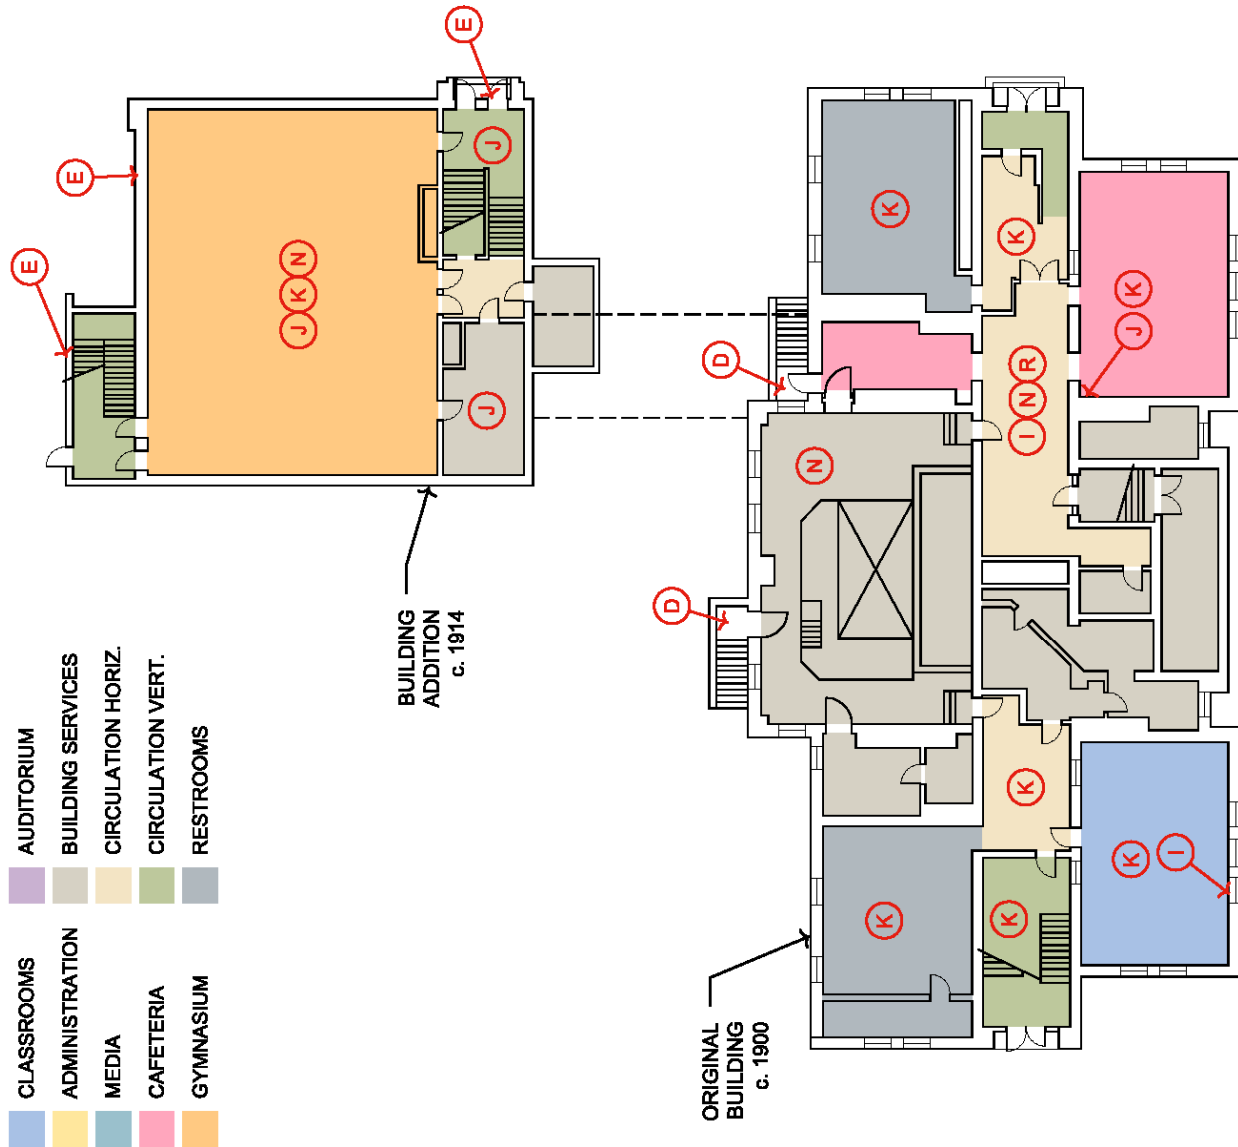
1. Typical classroom has linoleum floor, plaster walls, acoustical grid ceiling, painted wood trim
2. Wide corridor with wood floor
3. Office
4. Typical coatroom has fluted wood jambs and beadboard wainscot
5. Metal pan stair
6. Floor return air grille
7. Concrete floor
8. All partitions and finishes destroyed by fire
9. Steep inclined ramp to addition
10. Historic wood overhead doors

- A. Roof collapsed due to fire damage
- B. Most windows are missing or damaged at this level due to fire damage
- C. Window glass broken
- D. Stairwell full of trash and debris
- E. Graffiti and/or vandalism
- F. Open masonry joints at parapet
- G. Missing down spout
- H. Organic growth on stone detailing
- I. Ceiling treatments appear stained by water and are falling down
- J. Mold present in this area
- K. Paint peeling from wall
- L. Wood floor broken/buckled
- M. Stair full of fire debris
- N. Water damage
- O. Smoke stained ceiling and walls
- P. Stone step cracked and settled
- Q. Metal cornice missing/damaged
- R. Corridor full of debris

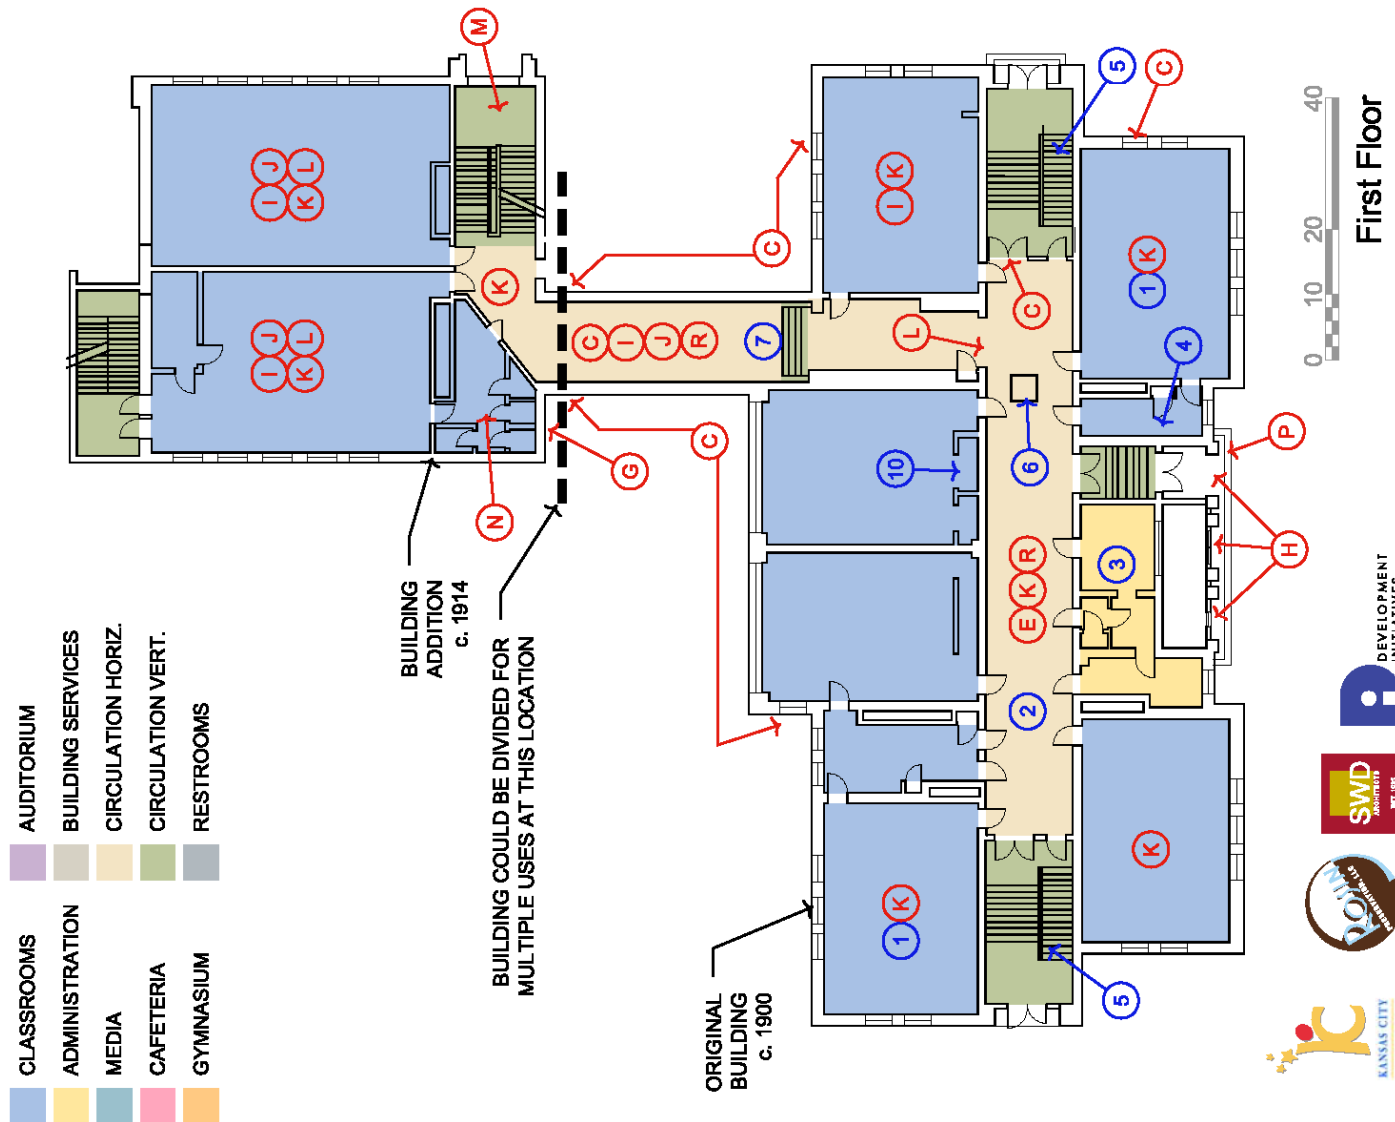
1. Typical classroom has linoleum floor, plaster walls, acoustical grid ceiling, painted wood trim
2. Wide corridor with wood floor
3. Office
4. Typical coathroom has fluted wood jambs and beadboard wainscot
5. Metal pan stair
6. Floor return air grille
7. Concrete floor
8. All partitions and finishes destroyed by fire
9. Steep inclined ramp to addition
10. Historic wood overhead doors

- A. Roof collapsed due to fire damage
- B. Most windows are missing or damaged at this level due to fire damage
- C. Window glass broken
- D. Stairwell full of trash and debris
- E. Graffiti and/or vandalism
- F. Open masonry joints at parapet
- G. Missing down spout
- H. Organic growth on stone detailing
- I. Ceiling treatments appear stained by water and are falling down
- J. Mold present in this area
- K. Paint peeling from wall
- L. Wood floor broken/buckled
- M. Stair full of fire debris
- N. Water damage
- O. Smoke stained ceiling and walls
- P. Stone step cracked and settled
- Q. Metal cornice missing/damaged
- R. Corridor full of debris

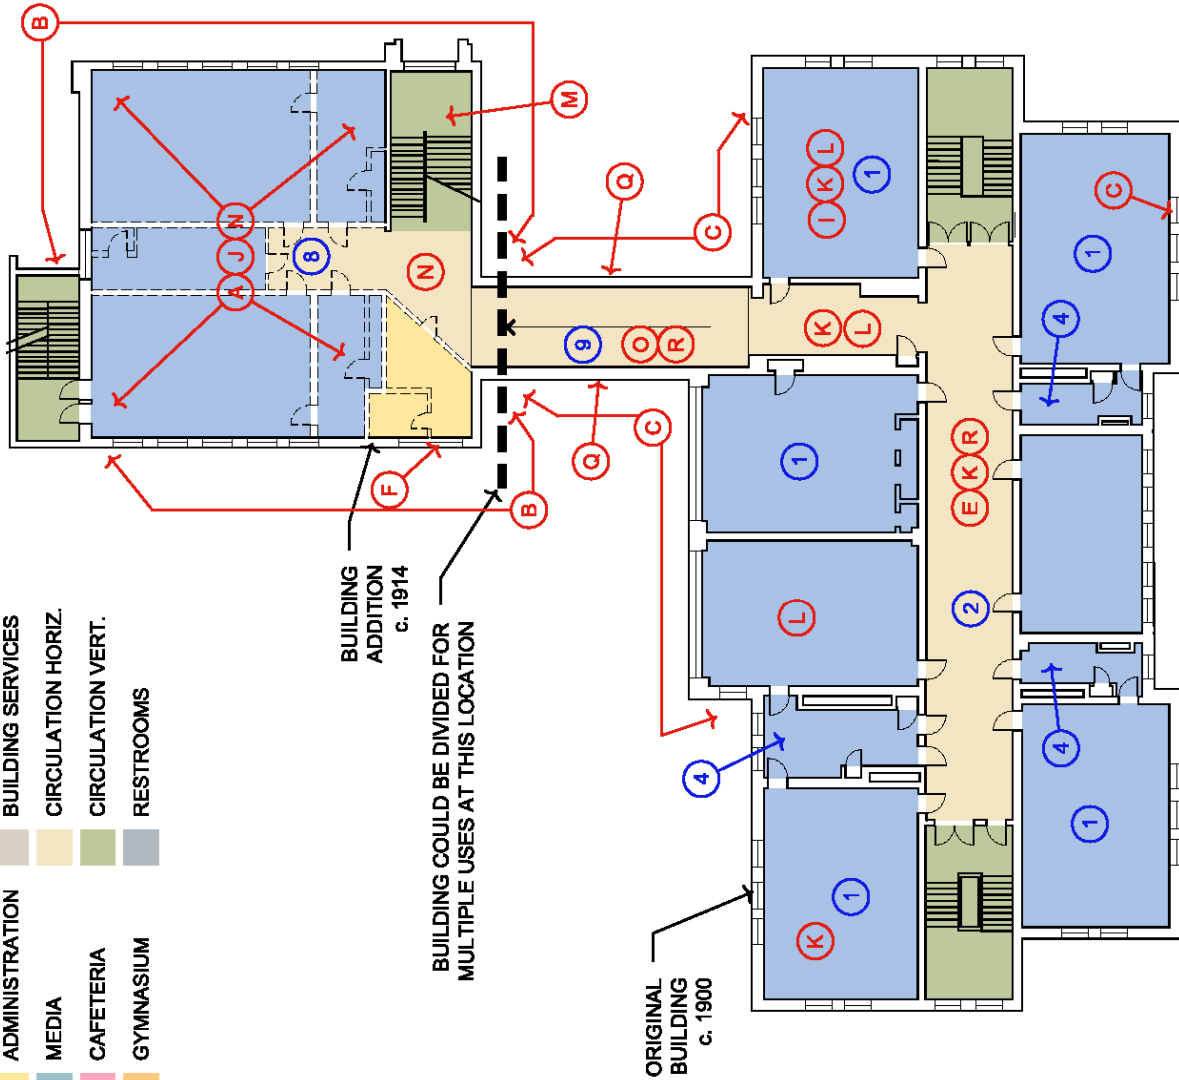
1. Typical classroom has linoleum floor, plaster walls, acoustical grid ceiling, painted wood trim
2. Wide corridor with wood floor
3. Office
4. Typical cootroom has fluted wood jambs and beadboard wainscot
5. Metal pan stair
6. Floor return air grille
7. Concrete floor
8. All partitions and finishes destroyed by fire
9. Steep inclined ramp to addition
10. Historic wood overhead doors

- A. Roof collapsed due to fire damage
- B. Most windows are missing or damaged at this level due to fire damage
- C. Window glass broken
- D. Stairwell full of trash and debris
- E. Graffiti and/or vandalism
- F. Open masonry joints at parapet
- G. Missing down spout
- H. Organic growth on stone detailing
- I. Ceiling treatments appear stained by water and are falling down
- J. Mold present in this area
- K. Paint peeling from wall
- L. Wood floor broken/buckled
- M. Stair full of fire debris
- N. Water damage
- O. Smoke stained ceiling and walls
- P. Stone step cracked and settled
- Q. Metal cornice missing/damaged
- R. Corridor full of debris

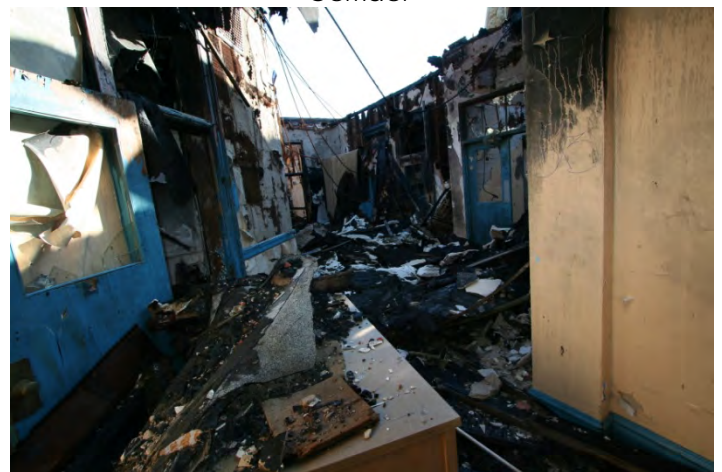
1914 addition fire damage
