# HAZARDOUS MATERIALS SURVEY REPORT

**WESTPORT HIGH SCHOOL  
315 EAST 39<sup>TH</sup> STREET  
KANSAS CITY, MISSOURI**

April 13, 2011

**Family Environmental, Inc.**  
COMPLIANCE SERVICES / SITE CLEARING SERVICES

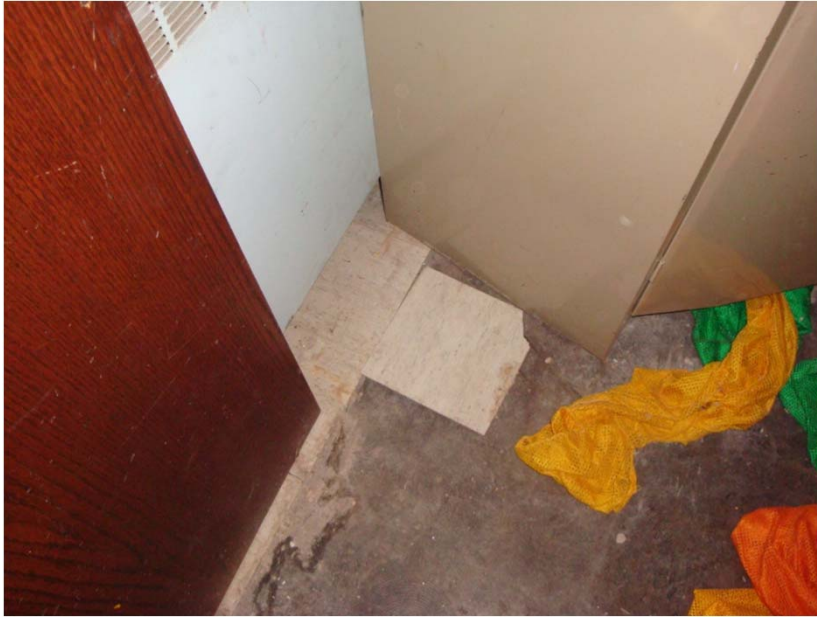
- White 9x9 Floor Tile with Black Mastic is located in the southeast corner of Room G02. The floor tile contains 20% Chrysotile asbestos and the black mastic contains 22% Chrysotile asbestos. Approximately 113 square feet of floor tile and mastic was observed in the same location in this building.

DIRECTION: Southeast	DESCRIPTION	This photograph shows positive White 9x9 Floor Tile with Black Mastic in the SE Corner of Room G02	1
	CLIENT	City of Kansas City Missouri	DATE 02/17/11
	PHOTOGRAPHER	Michael Dustman

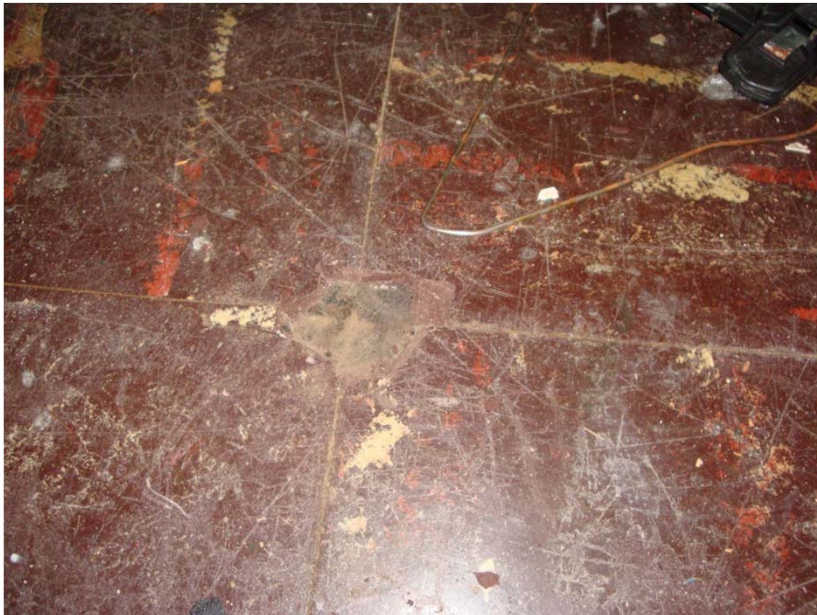
- Brown with Red and White Streaks 9x9 Floor Tile and Black Mastic is located in a closet in Room G19 along the east wall. The floor tile contains 10% Chrysotile asbestos and the mastic contains 22% asbestos. Approximately 90 square feet of floor tile and mastic was observed in the same location in this building.

DIRECTION: East	DESCRIPTION	This photograph shows positive Brown with Red and White Streaks 9x9 Floor Tile and Mastic in a closet in Room G19.	2
	CLIENT	City of Kansas City Missouri	DATE 02/17/11
	PHOTOGRAPHER	Michael Dustman

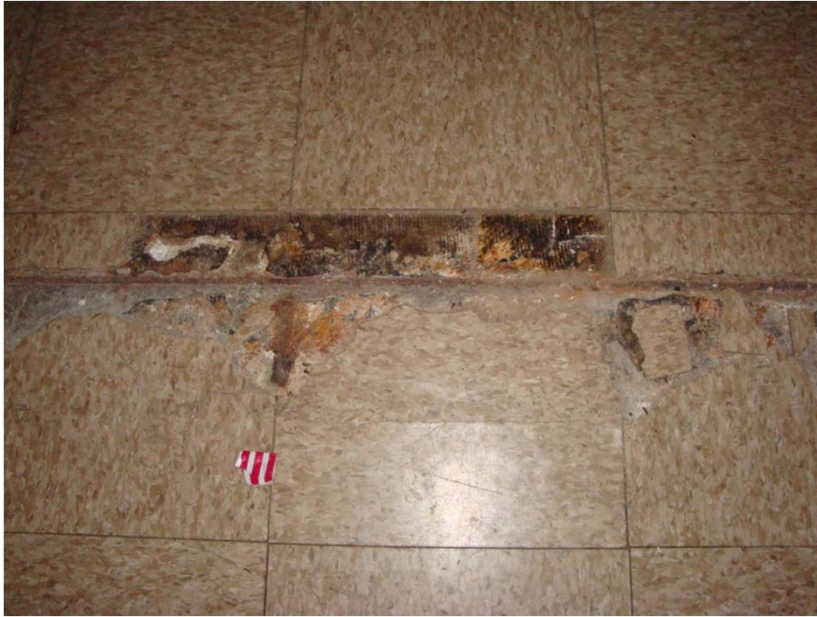
- White and Tan Streaked 12x12 Floor Tile and Mastic is located in Room G21. The floor tile is non-detect for asbestos, but the mastic contains 5% Chrysotile asbestos. Approximately 450 square feet of floor tile and mastic was observed in the same location in this building.

DIRECTION: East	DESCRIPTION	This photograph shows positive White and Tan streaked 12x12 Floor Tile and Mastic. In Room G21.	3
	CLIENT	City of Kansas City Missouri	DATE
	PHOTOGRAPHER	Michael Dustman	02/17/11

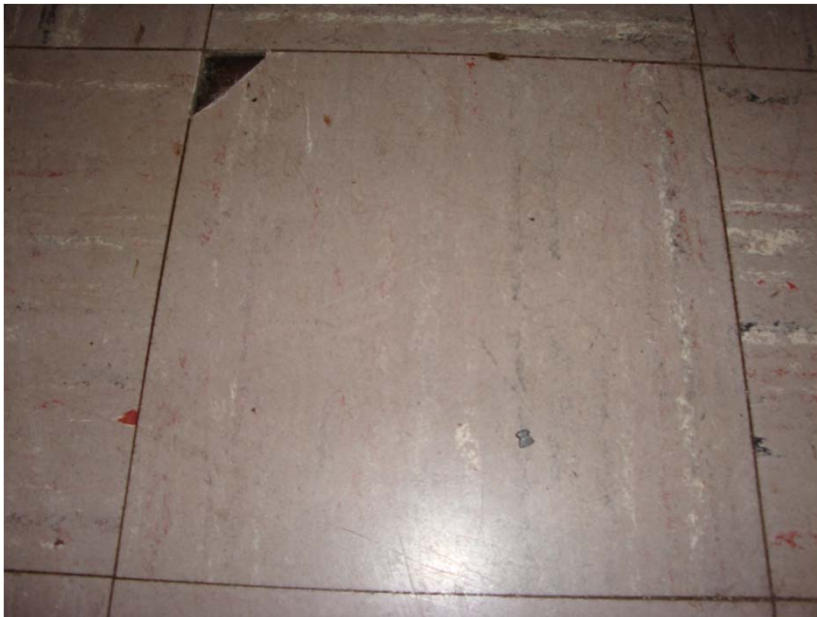
- Tan with White, Red and Black Streaks 9x9 Floor Tile and Mastic is located in Room G21. The floor tile contains 2% Chrysotile asbestos and the mastic contains 22% asbestos. Approximately 450 square feet of floor tile and mastic was observed in the same location in this building.

DIRECTION: East	DESCRIPTION	This photograph shows positive Tan with White, Red and Black Streaks 9x9 Floor Tile and Mastic in Room G21.	4
	CLIENT	City of Kansas City Missouri	DATE
	PHOTOGRAPHER	Michael Dustman	02/17/11

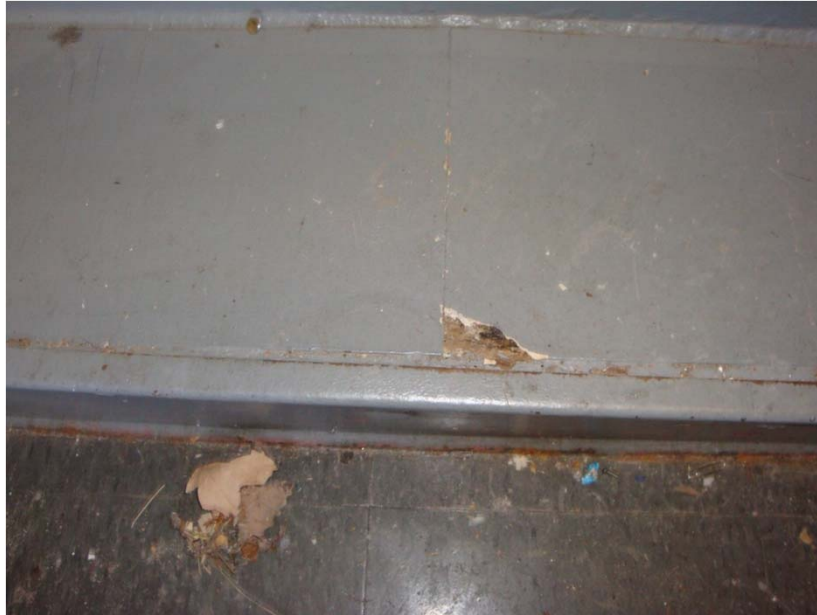
- Grey Painted 12x12 Floor Tile and Mastic is located in the southeast stairwell of the original 1908 constructed portion of this building. The floor tile contains 20% Chrysotile asbestos and the mastic contains 22% Chrysotile asbestos. Approximately 100 square feet of floor tile and mastic were observed in the same location in this building.

DIRECTION: West	DESCRIPTION	This photograph shows positive Grey Painted 12x12 Floor Tile and Mastic in the SE Stairwell.	5
	CLIENT	City of Kansas City Missouri	DATE
	PHOTOGRAPHER	Michael Dustman	02/17/11

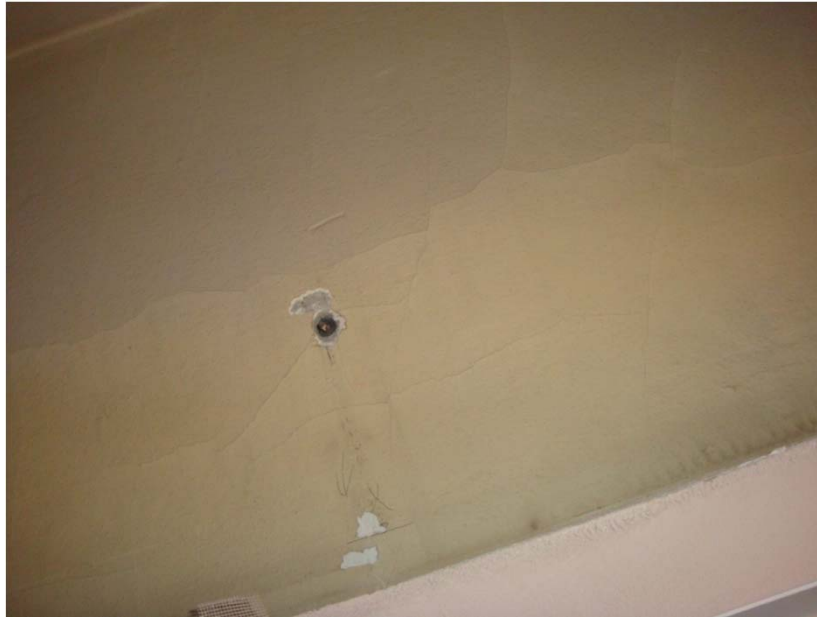
DIRECTION: East	DESCRIPTION	This photograph shows positive tan paint on the east wall above the drop ceiling in Room G30, sample #34.	1
	CLIENT	City of Kansas City, Missouri	DATE 02/22/11
	PHOTOGRAPHER	Michael Dustman

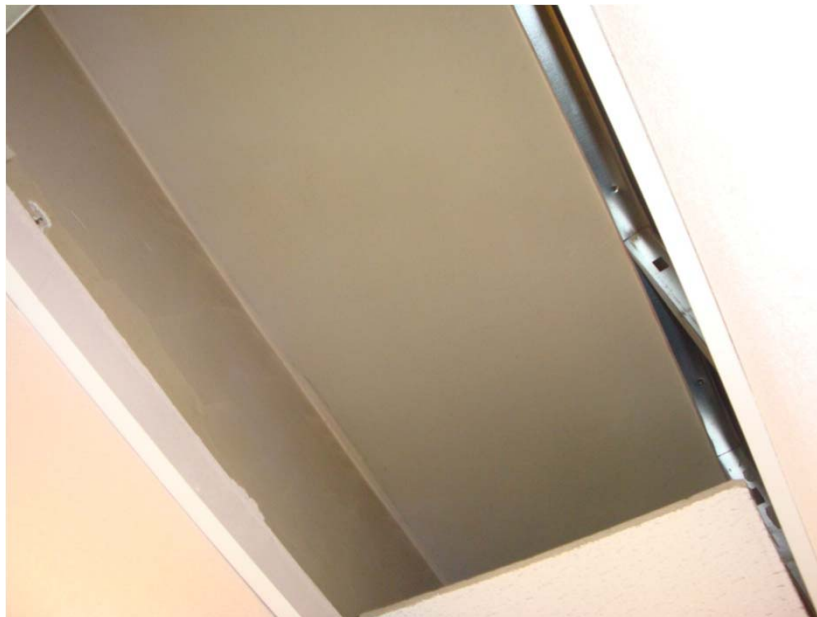
DIRECTION: Southeast	DESCRIPTION	This photograph shows positive tan paint on the east wall above the drop ceiling in Room G30, sample #35.	2
	CLIENT	City of Kansas City, Missouri	DATE 02/22/11
	PHOTOGRAPHER	Michael Dustman

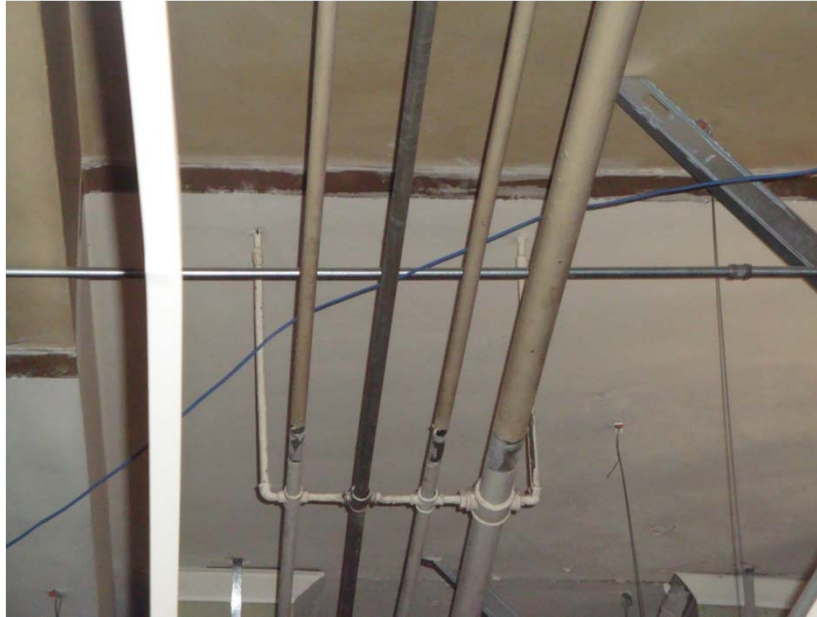
DIRECTION: North	DESCRIPTION	This photograph shows positive tan painted piping above the drop ceiling in Room G31, sample #37 and sample #41.	3
	CLIENT	City of Kansas City, Missouri	DATE
	PHOTOGRAPHER	Michael Dustman	02/22/11

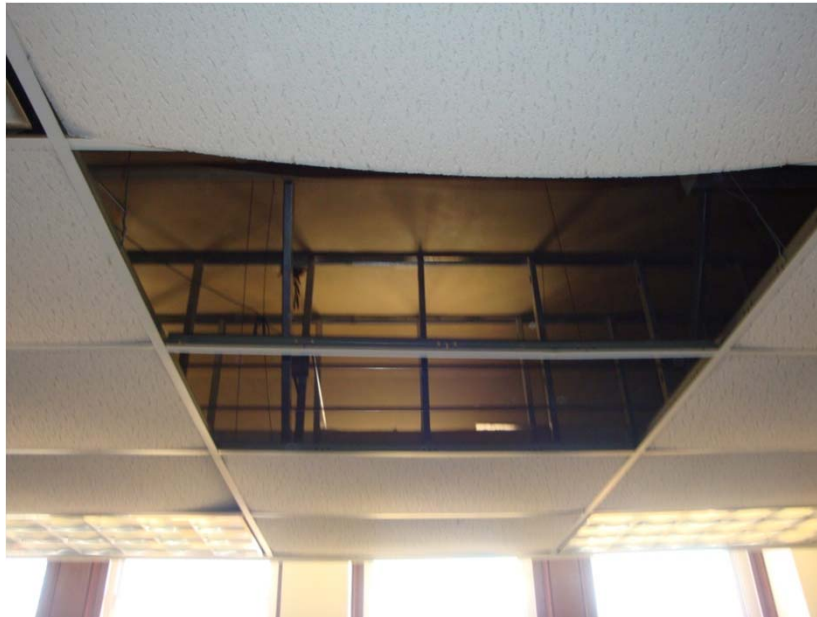
DIRECTION: East	DESCRIPTION	This photograph shows positive tan painted piping above the drop ceiling in Room G31, sample #378 and sample #39.	4
	CLIENT	City of Kansas City, Missouri	DATE
	PHOTOGRAPHER	Michael Dustman	02/22/11

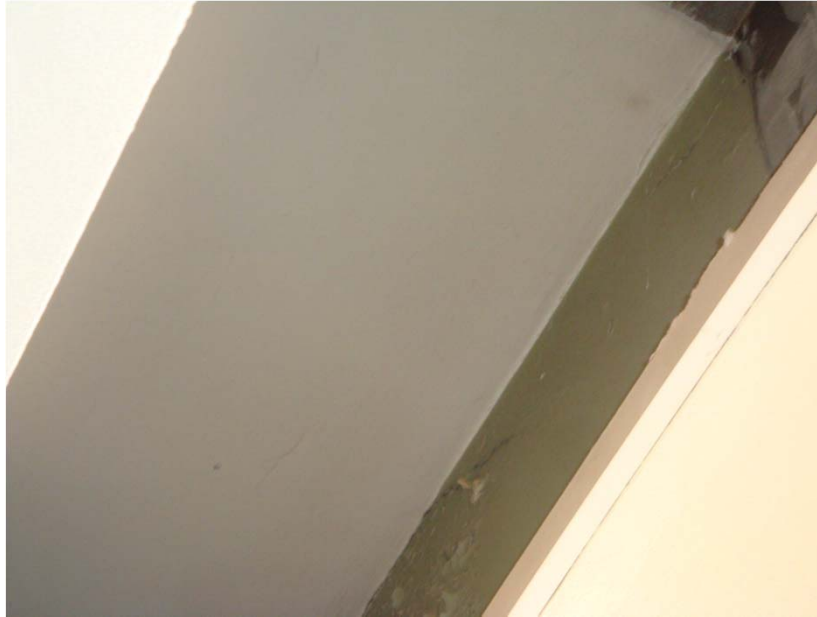
DIRECTION: Northeast	DESCRIPTION	This photograph shows positive green painted east wall above the drop ceiling in Room G31, sample #40.	5
	CLIENT	City of Kansas City, Missouri	DATE 02/22/11
	PHOTOGRAPHER	Michael Dustman

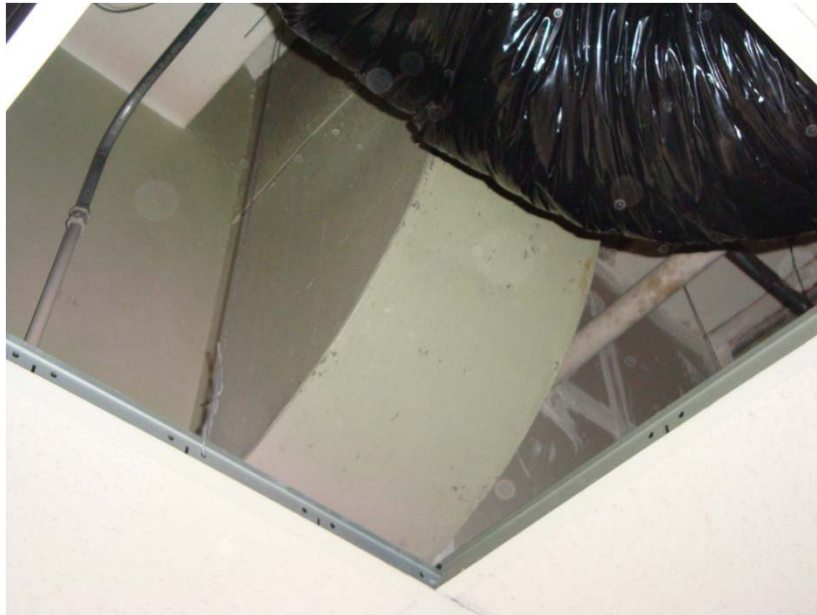
DIRECTION: North	DESCRIPTION	This photograph shows positive green painted duct work in Room G31, sample #42.	6
	CLIENT	City of Kansas City, Missouri	DATE 02/22/11
	PHOTOGRAPHER	Michael Dustman

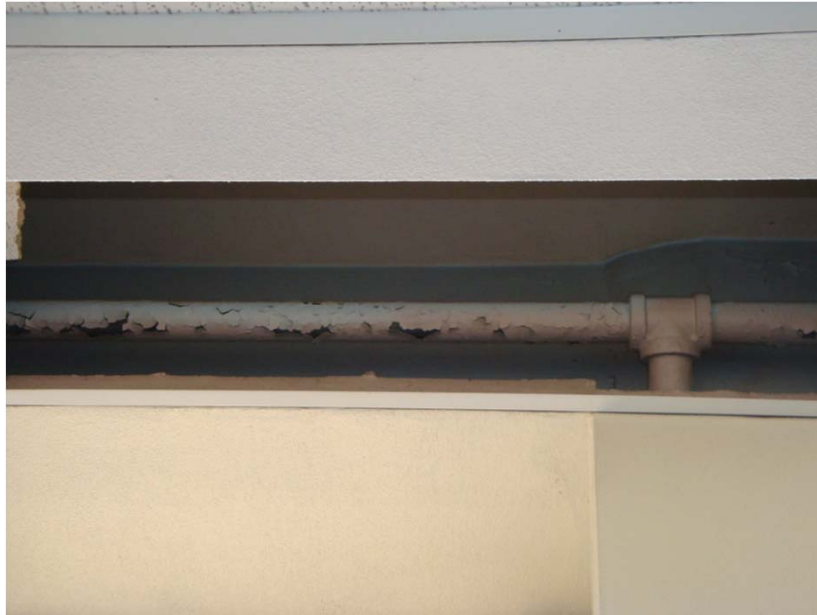
DIRECTION: East	DESCRIPTION	This photograph shows positive robin egg blue and white paint above the drop ceiling in Room G32, sample #44, #45 and #46.	7
	CLIENT	City of Kansas City, Missouri	DATE
	PHOTOGRAPHER	Michael Dustman	02/22/11

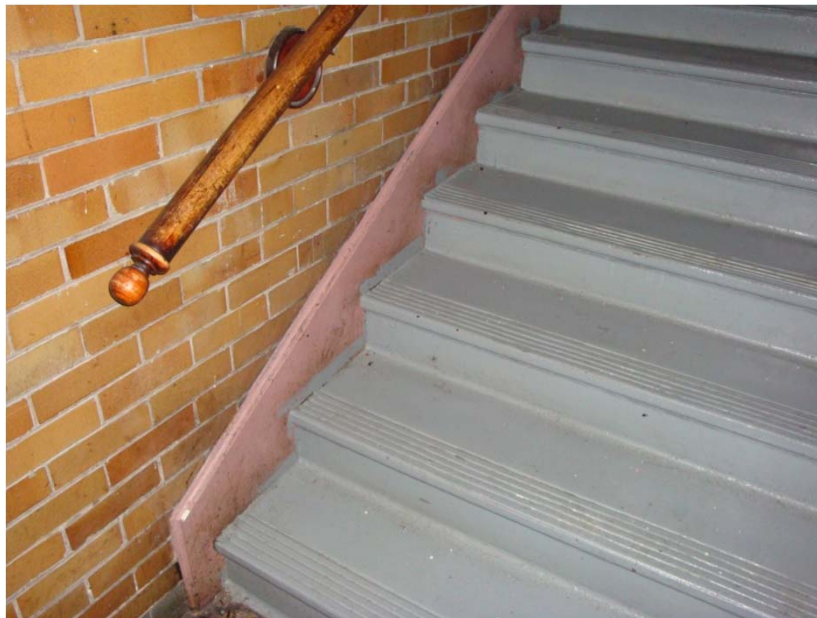
DIRECTION: Northeast	DESCRIPTION	This photograph shows positive pink and grey paint on the east stairs, sample #48 and #49.	8
	CLIENT	City of Kansas City, Missouri	DATE
	PHOTOGRAPHER	Michael Dustman	02/22/11

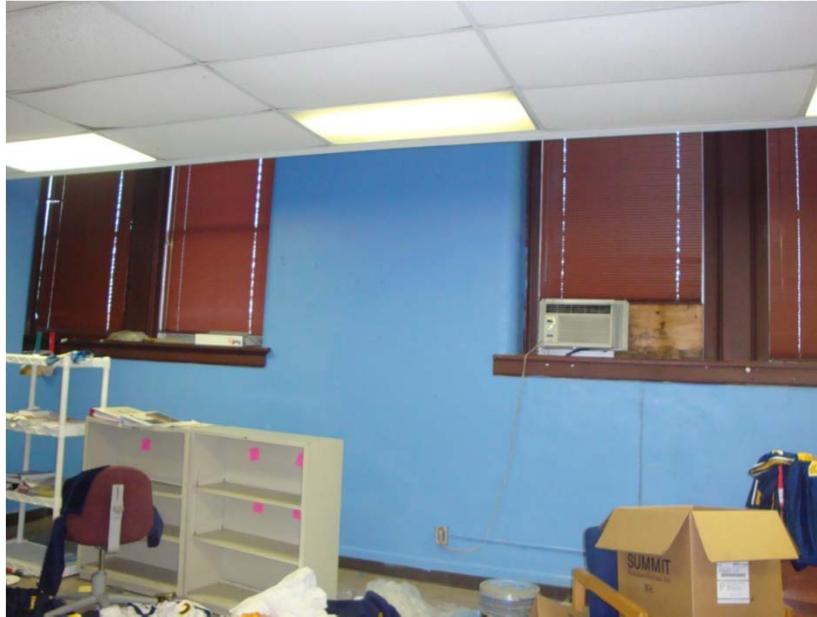
DIRECTION: East	DESCRIPTION	This photograph shows positive blue paint on the east wall in Room G05, sample #51	9
	CLIENT	City of Kansas City, Missouri	DATE
	PHOTOGRAPHER	Michael Dustman	02/22/11

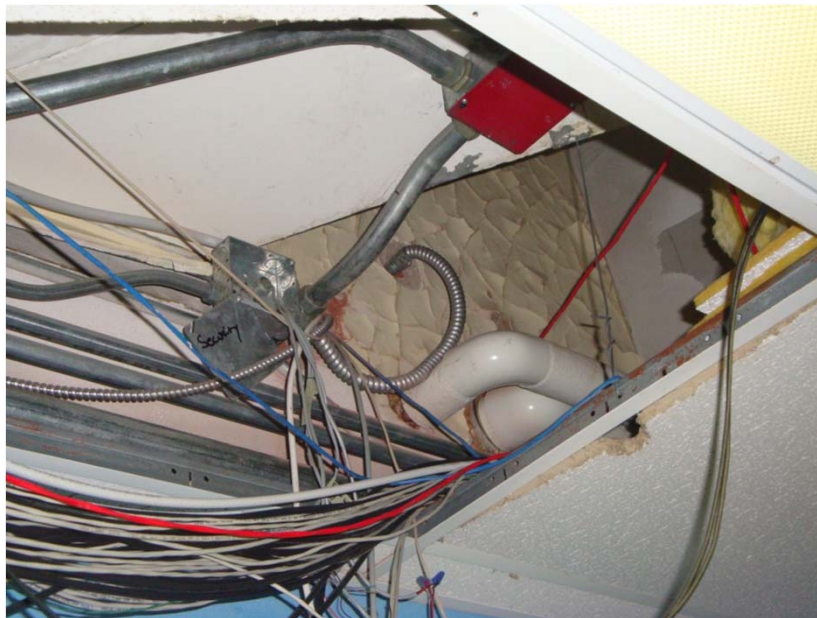
DIRECTION: Northwest	DESCRIPTION	This photograph shows positive white paint above the drop ceiling on the west wall in Room G05, sample #55.	10
	CLIENT	City of Kansas City, Missouri	DATE
	PHOTOGRAPHER	Michael Dustman	02/22/11

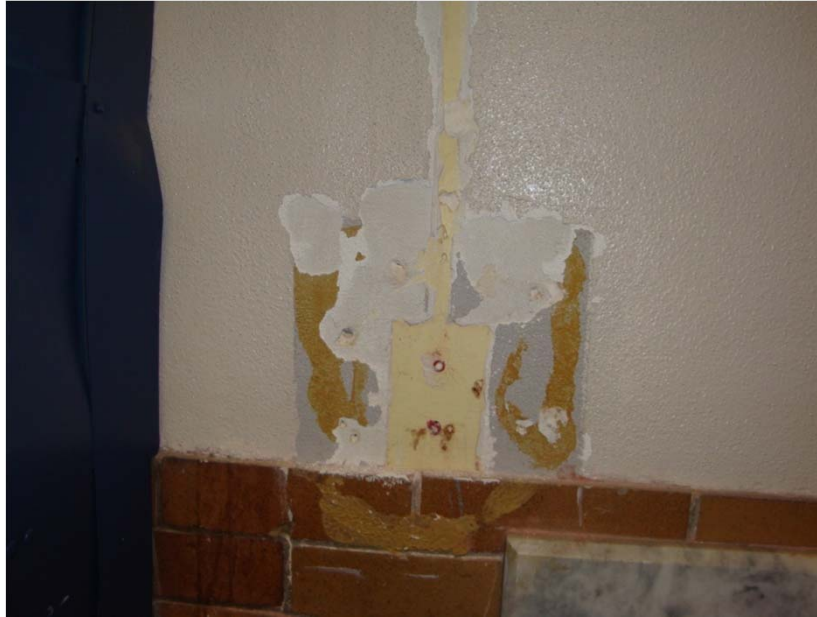
DIRECTION: East	DESCRIPTION	This photograph shows positive yellow paint where a wall receptacle once was, sample #56.	11
	CLIENT	City of Kansas City, Missouri	DATE
	PHOTOGRAPHER	Michael Dustman	02/22/11

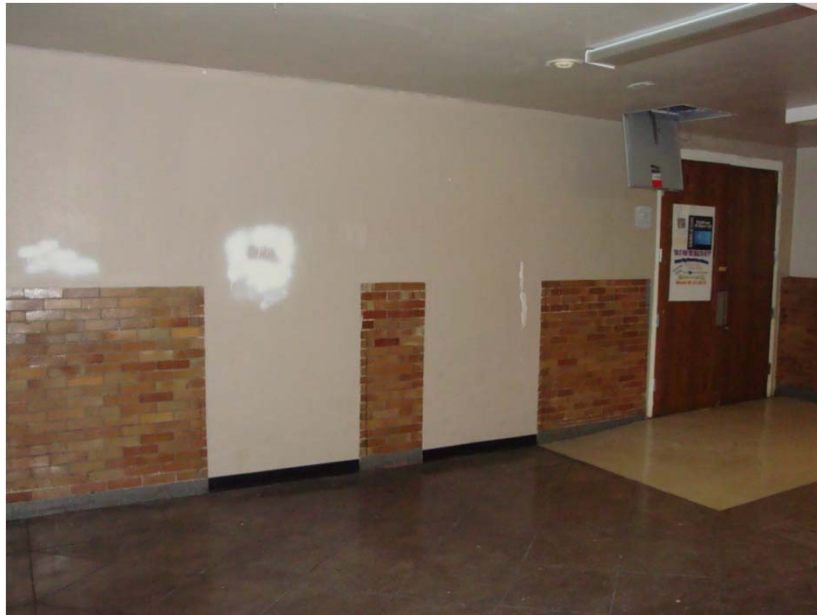
DIRECTION: Northeast	DESCRIPTION	This photograph shows positive tan paint on the north wall by Room G06 Entrance, sample #57.	12
	CLIENT	City of Kansas City, Missouri	DATE
	PHOTOGRAPHER	Michael Dustman	02/22/11

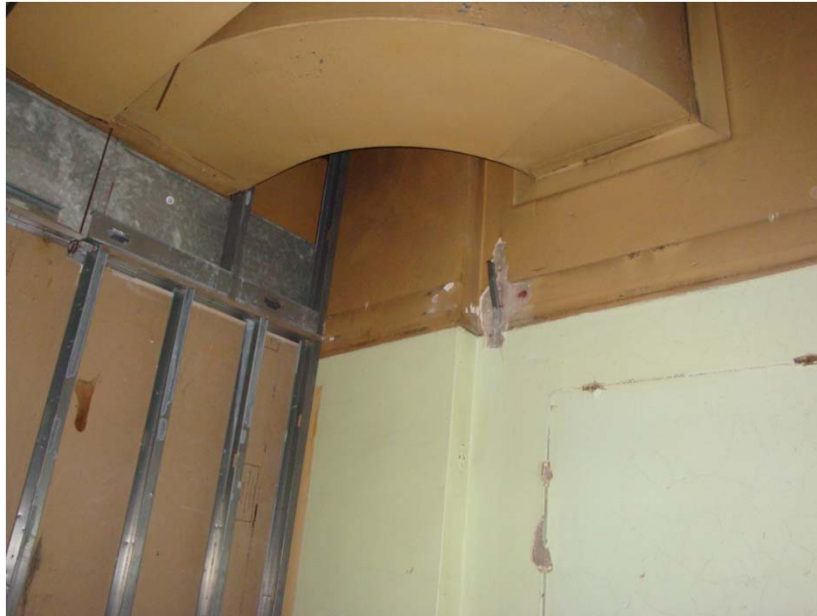
DIRECTION: North	DESCRIPTION	This photograph shows positive yellow and brown paint in the SW closet in Room G06, Sample #58 and #59.	13
	CLIENT	City of Kansas City, Missouri	DATE
	PHOTOGRAPHER	Michael Dustman	02/22/11

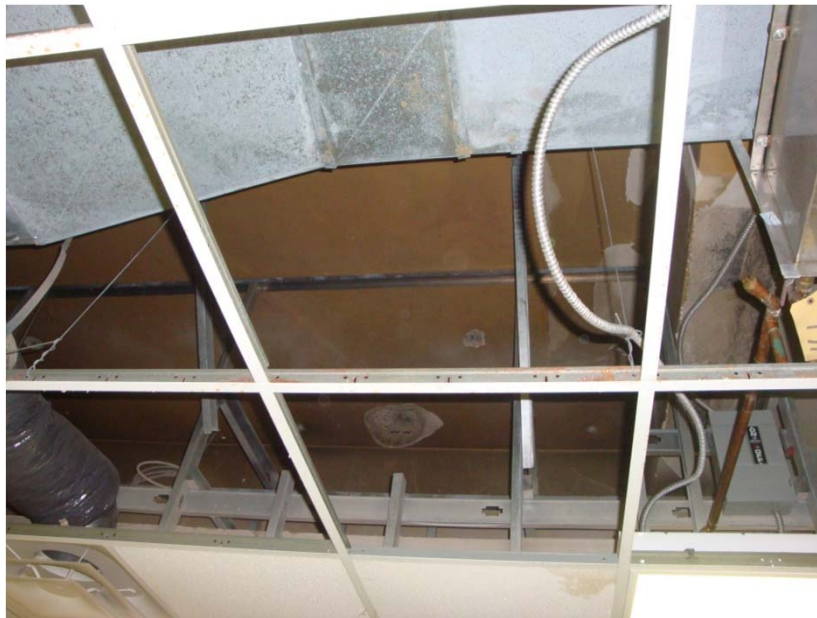
DIRECTION: West	DESCRIPTION	This photograph shows positive tan paint above the drop ceiling in the hallway, sample #64.	14
	CLIENT	City of Kansas City, Missouri	DATE
	PHOTOGRAPHER	Michael Dustman	02/22/11

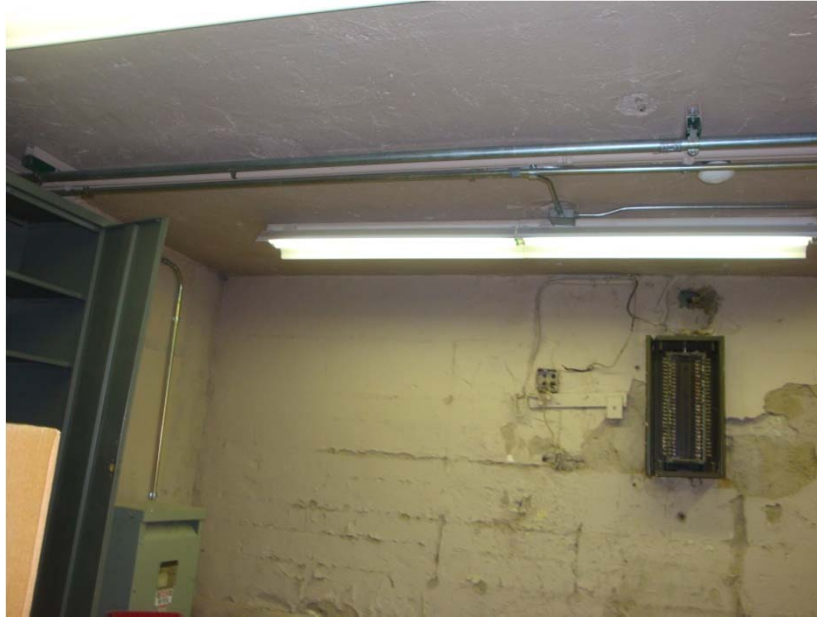
DIRECTION: North	DESCRIPTION	This photograph shows positive light pink paint on a storage room ceiling and north wall in Room G11, sample #65 and #66.	15
	CLIENT	City of Kansas City, Missouri	DATE
	PHOTOGRAPHER	Michael Dustman	02/22/11

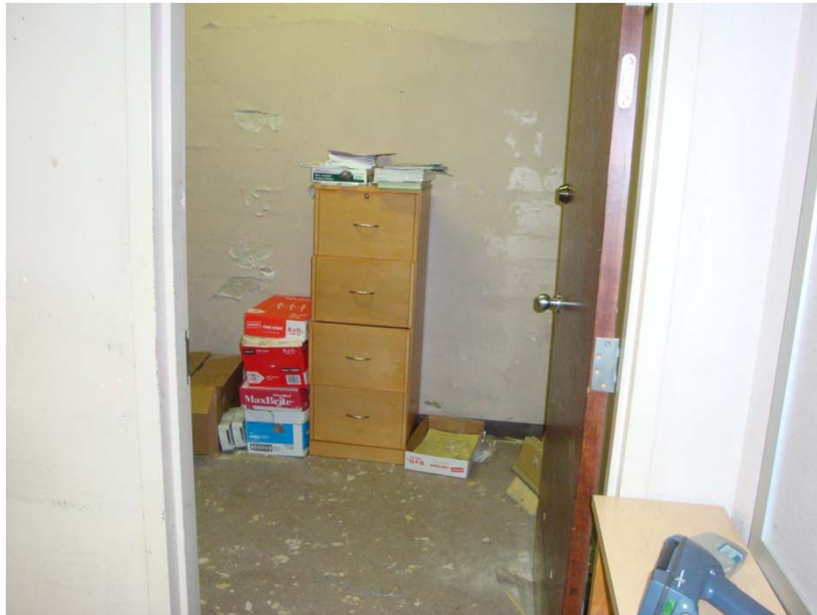
DIRECTION: North	DESCRIPTION	This photograph shows positive tan paint on the north storage room wall in Room G12, sample #67.	16
	CLIENT	City of Kansas City, Missouri	DATE
	PHOTOGRAPHER	Michael Dustman	02/22/11

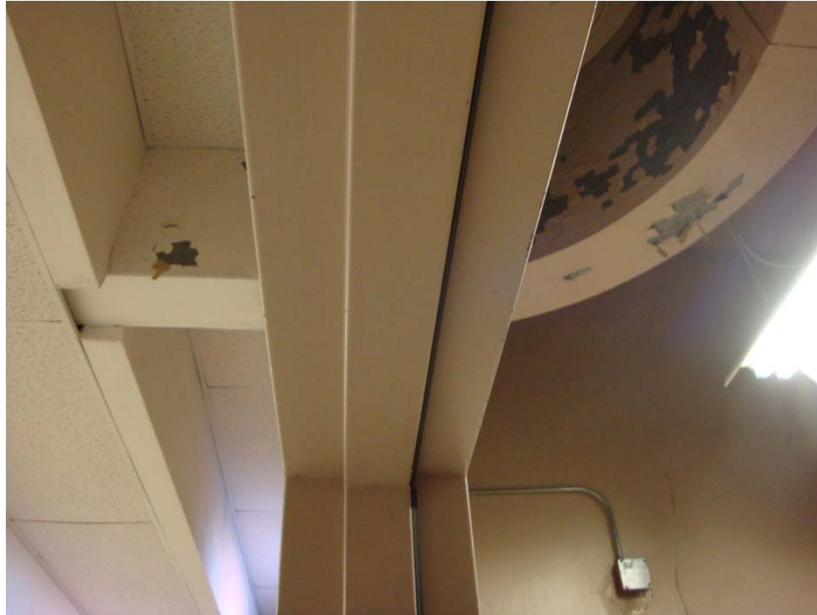
DIRECTION: West	DESCRIPTION	This photograph shows positive white paint on duct work in Room G12, sample #68.	17
	CLIENT	City of Kansas City, Missouri	DATE
	PHOTOGRAPHER	Michael Dustman	02/22/11

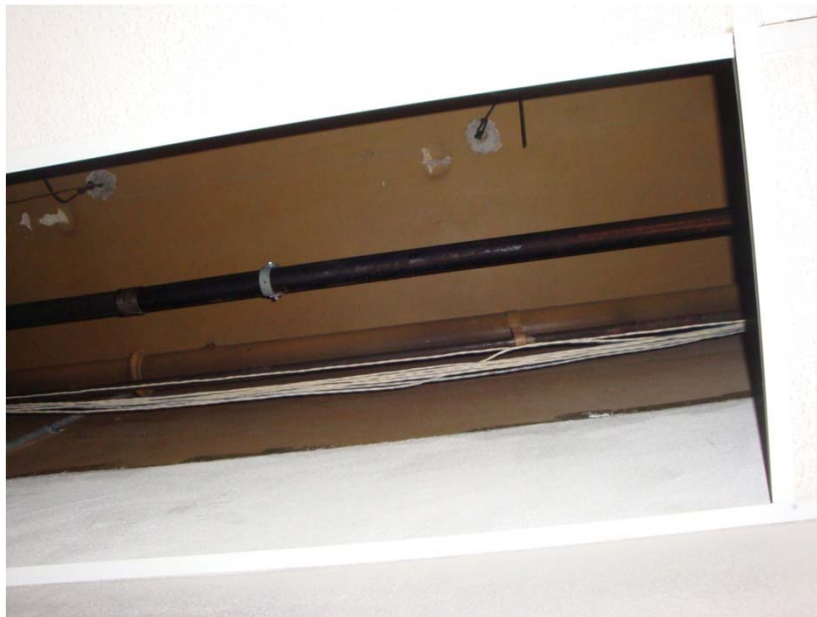
DIRECTION: South	DESCRIPTION	This photograph shows positive tan paint on the south wall above the drop ceiling in Room G13, sample #69 and #70.	18
	CLIENT	City of Kansas City, Missouri	DATE
	PHOTOGRAPHER	Michael Dustman	02/22/11

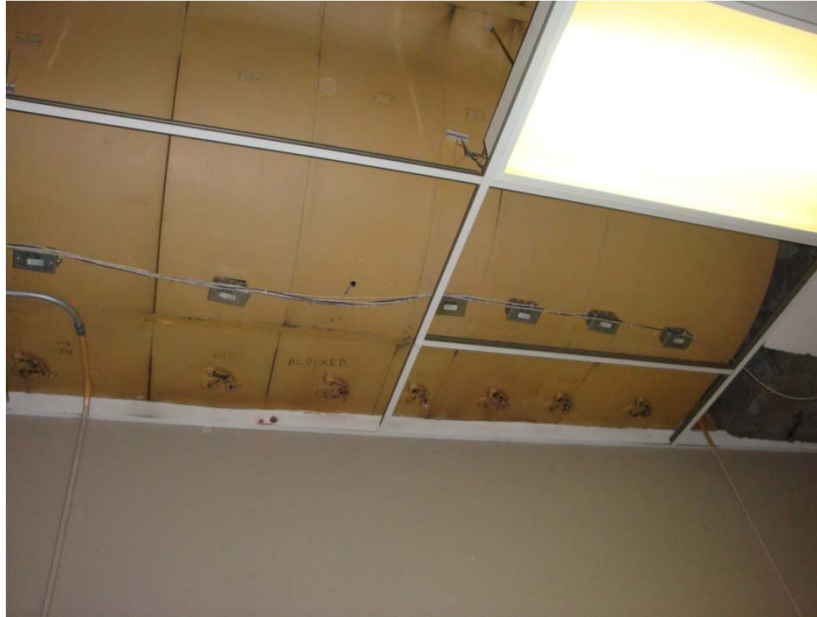
DIRECTION: South	DESCRIPTION	This photograph shows positive tan paint on an air duct above the drop ceiling in Room G14, sample #71.	19
	CLIENT	City of Kansas City, Missouri	DATE
	PHOTOGRAPHER	Michael Dustman	02/22/11

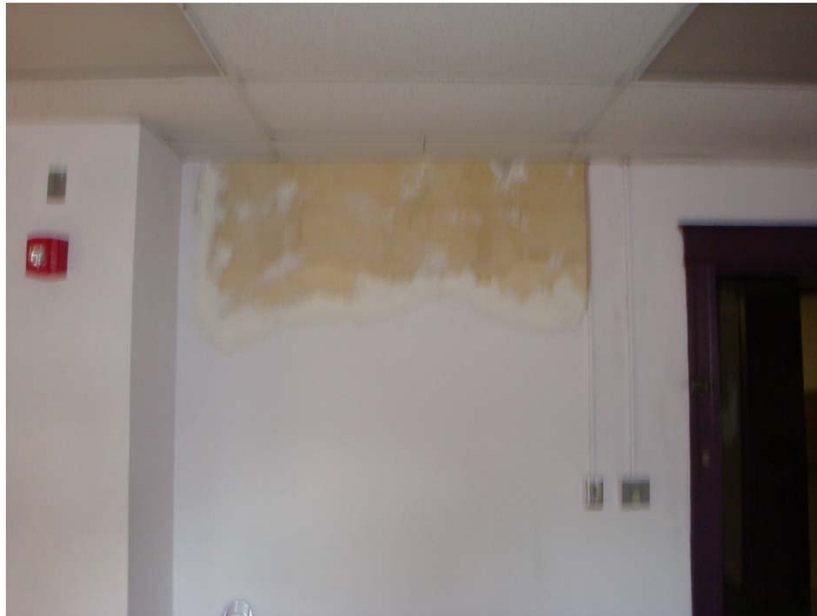
DIRECTION: East	DESCRIPTION	This photograph shows positive tan paint on the east wall in Room G17, sample #73.	20
	CLIENT	City of Kansas City, Missouri	DATE
	PHOTOGRAPHER	Michael Dustman	02/22/11

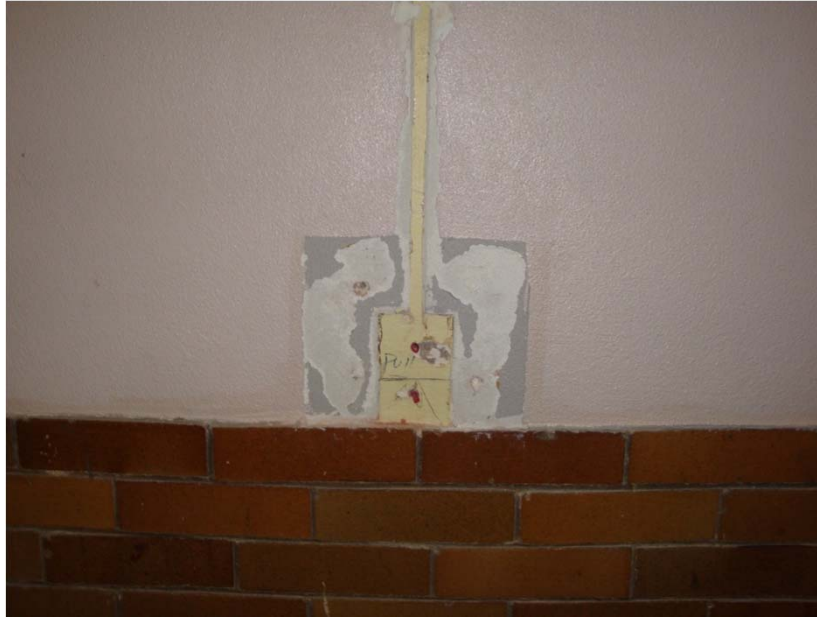
DIRECTION: West	DESCRIPTION	This photograph shows positive yellow paint where a wall receptacle once was, sample #74.	21
	CLIENT	City of Kansas City, Missouri	DATE
	PHOTOGRAPHER	Michael Dustman	02/22/11

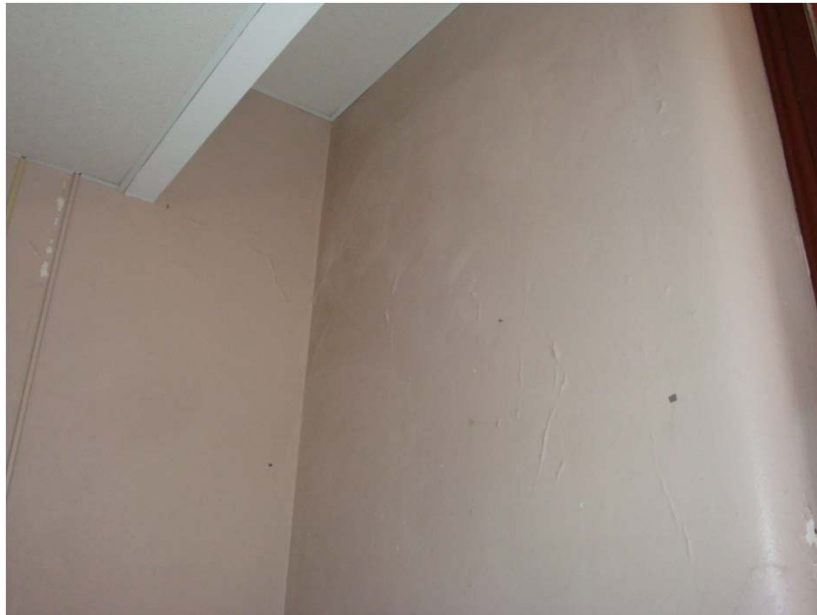
DIRECTION: Southwest	DESCRIPTION	This photograph shows positive light pink paint on the west wall of Room G18, sample #75.	22
	CLIENT	City of Kansas City, Missouri	DATE
	PHOTOGRAPHER	Michael Dustman	02/22/11

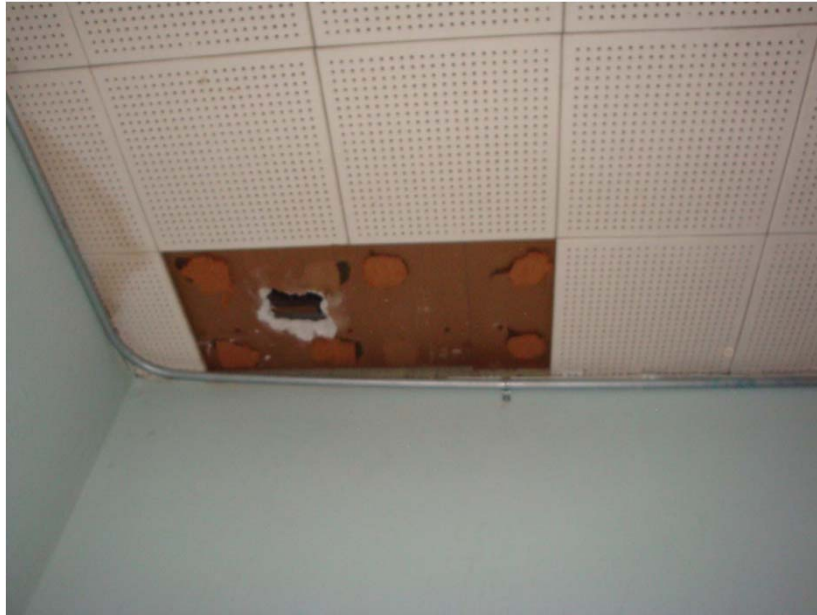
DIRECTION: North	DESCRIPTION	This photograph shows positive light green paint on the north wall of Room G19, sample #76.	23
	CLIENT	City of Kansas City, Missouri	DATE 02/22/11
	PHOTOGRAPHER	Michael Dustman

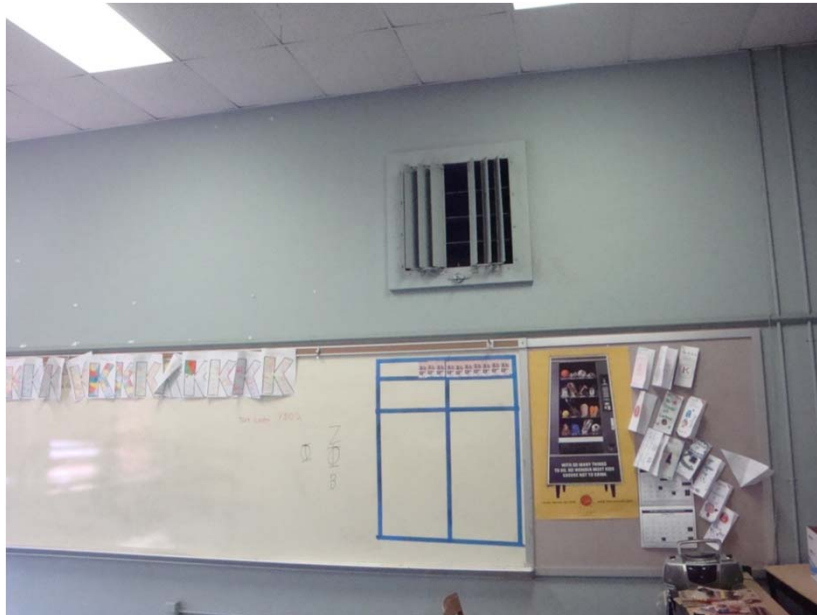
DIRECTION: North	DESCRIPTION	This photograph shows positive green paint on a air duct louver on the north wall in Room 121, sample #78.	24
	CLIENT	City of Kansas City, Missouri	DATE 02/22/11
	PHOTOGRAPHER	Michael Dustman

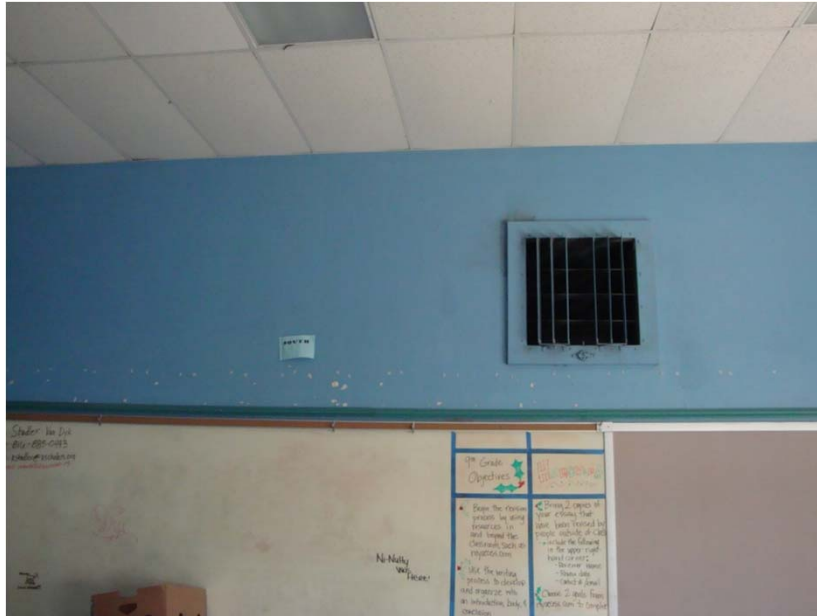
DIRECTION: South	DESCRIPTION	This photograph shows positive blue paint on an air duct louver on the south wall of Room 120, sample #79.	26
	CLIENT	City of Kansas City, Missouri	DATE
	PHOTOGRAPHER	Michael Dustman	02/22/11
