# REUSE STRATEGY AND ACTION PLAN

## WILLARD SCHOOL SITE

5015 Garfield Avenue, Kansas City, Missouri 64130

## PHYSICAL BUILDING ASSESSMENT

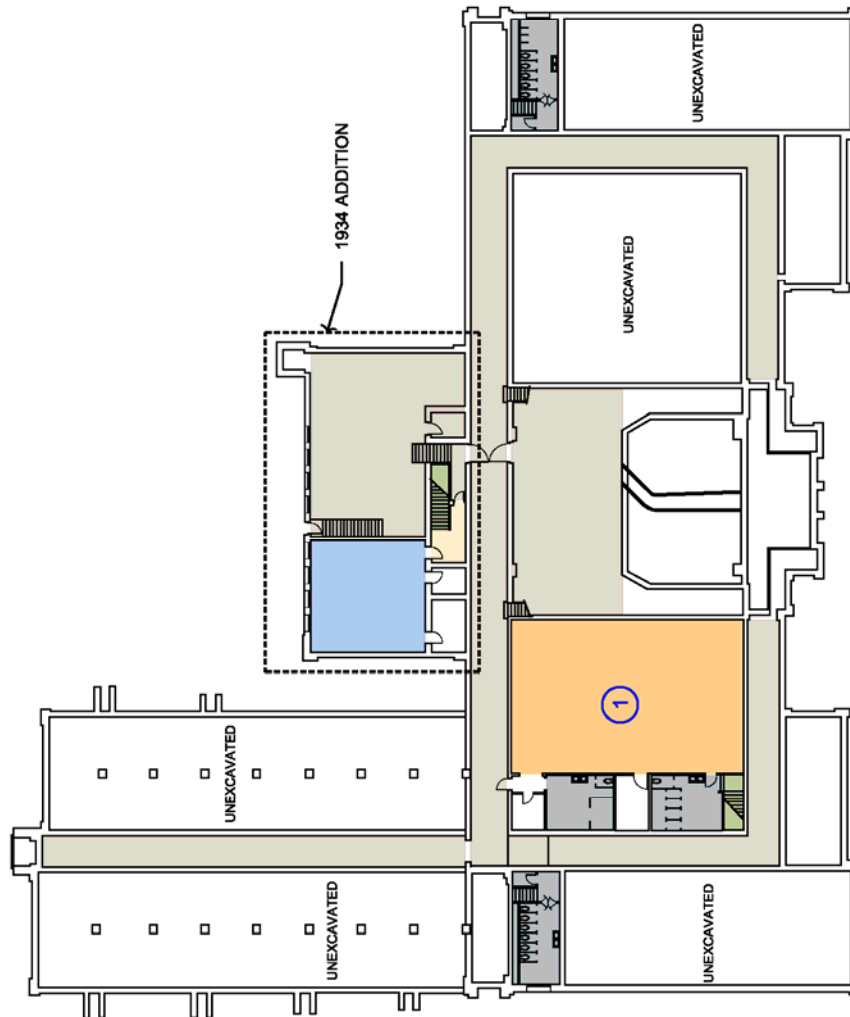
Basement

- A. Building exterior requires masonry repointing typical
- B. Concrete stairs are damaged
- C. Retaining wall is rotating and damaged
- D. Hole in roof at this location

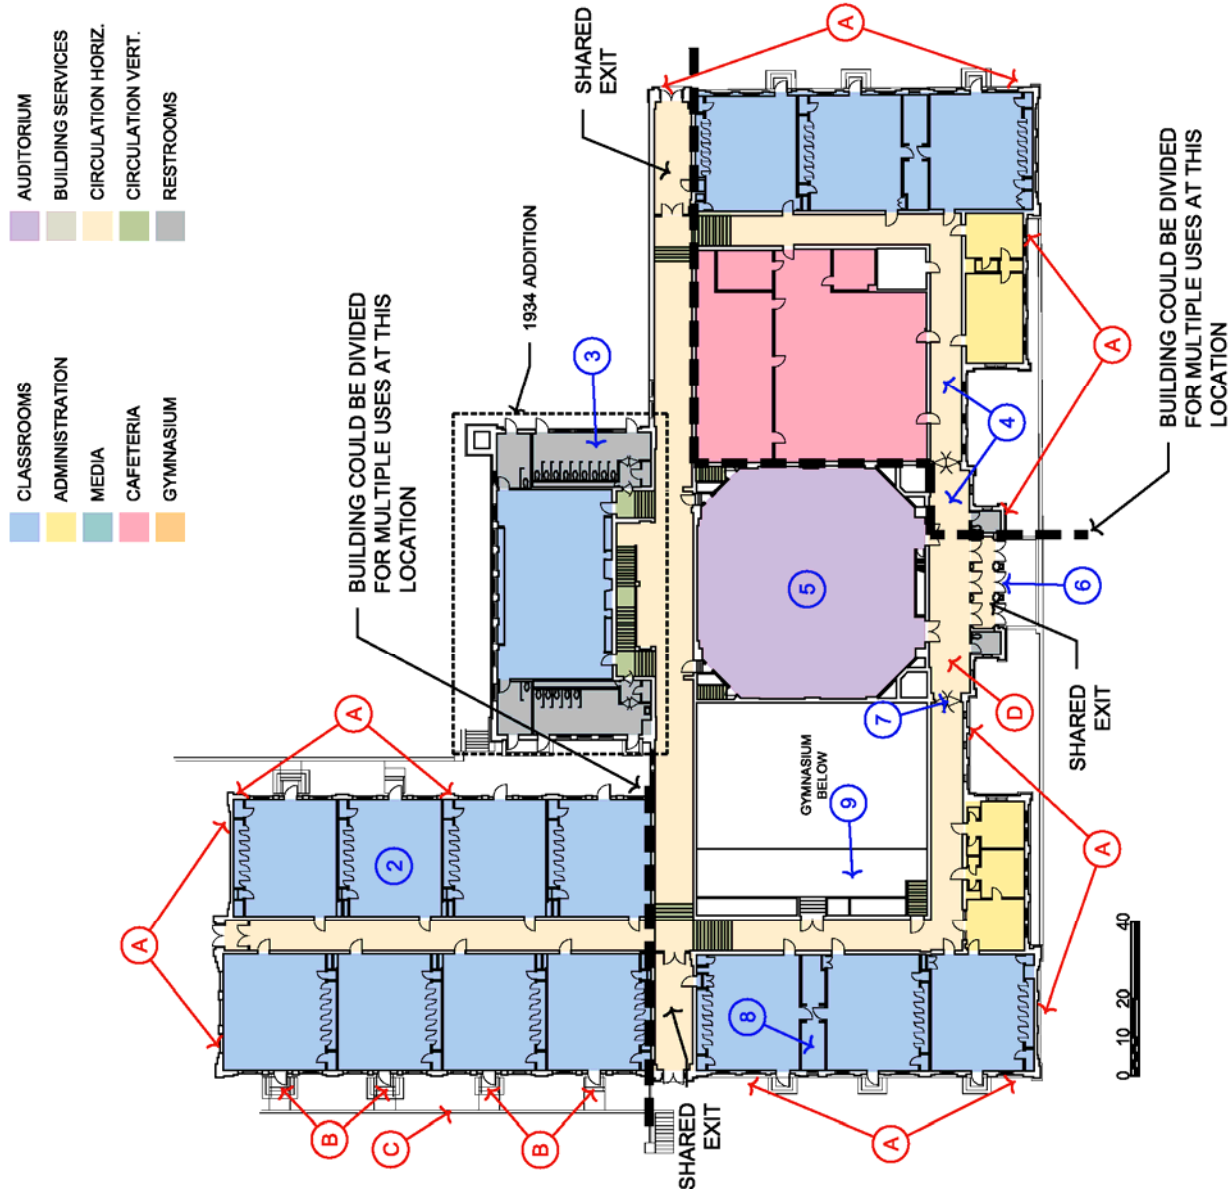
First Floor

- A. Building exterior requires masonry repointing typical
- B. Concrete stairs are damaged
- C. Retaining wall is rotating and damaged
- D. Hole in roof at this location

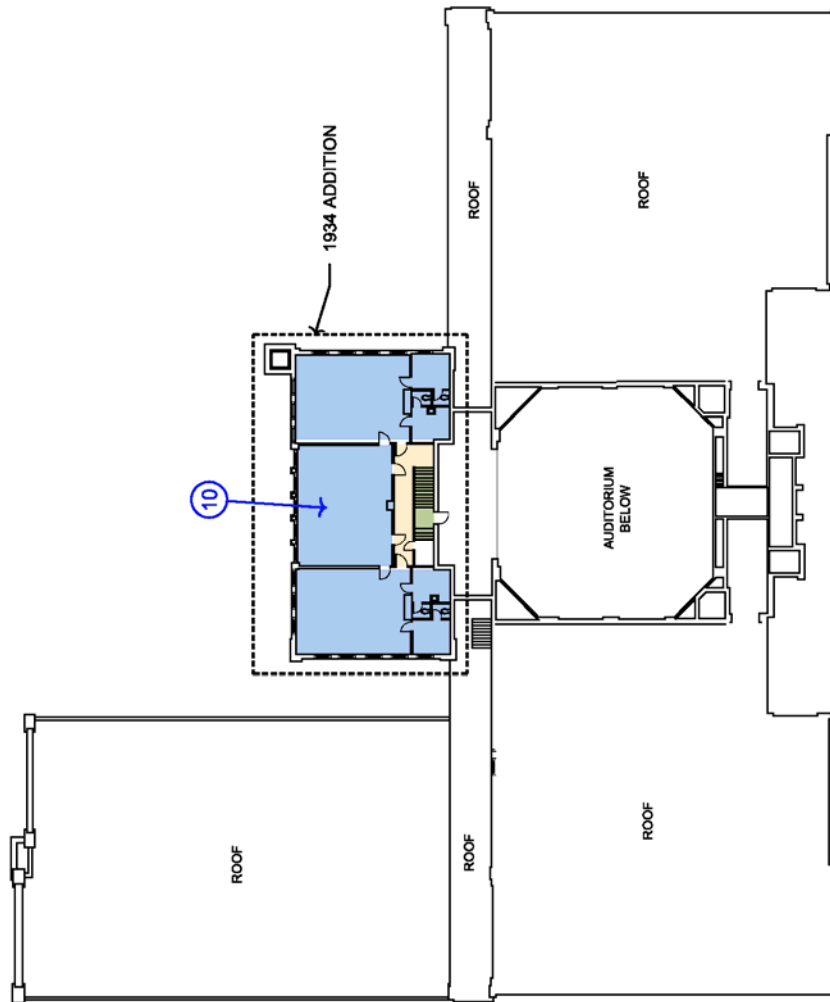
Second Floor

- A. Building exterior requires masonry repointing typical
- B. Concrete stairs are damaged
- C. Retaining wall is rotating and damaged
- D. Hole in roof at this location

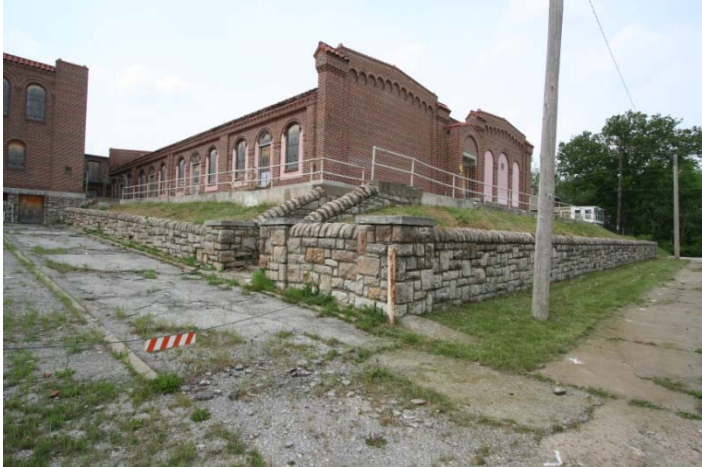
- Exterior Wall Construction: Red brick with cut and cast stone, stucco and tile accents. Masonry is generally in fair condition with multiple areas requiring repointing and brick replacement.

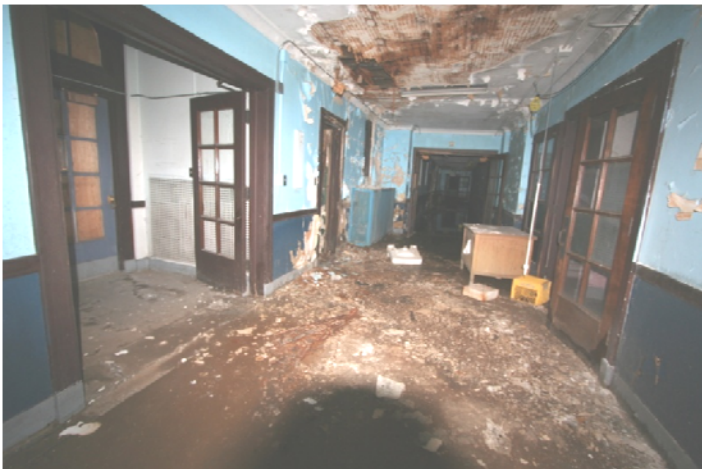
Corridor

- Corridors: Polished concrete floors with an integral concrete base, wood chair rail, and plaster ceilings with picture rail molding and sky lights. Paired multi-light wood doors create deep vestibules at entrances. Materials are generally in fair to poor condition. Plaster is failing where water damaged.
