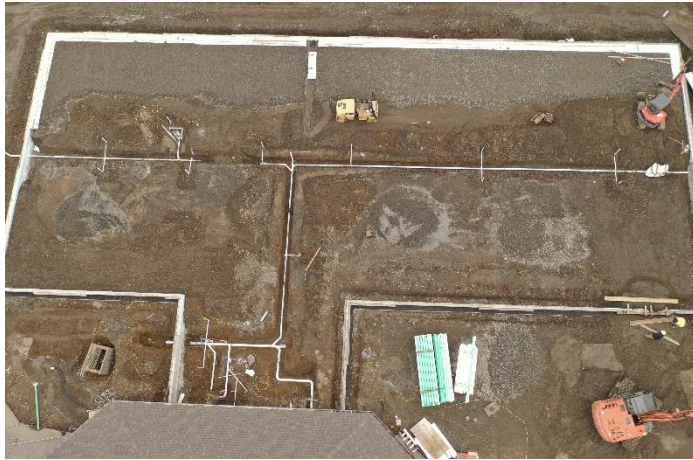
Under slab plumbing was completed, inspected and tested last week.

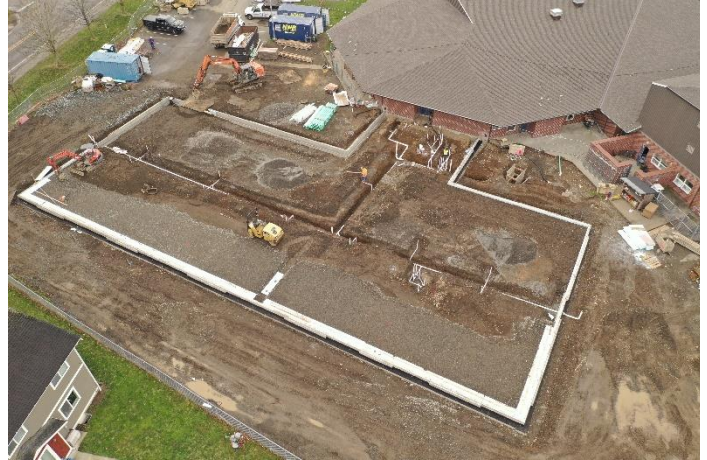
Drain rock is being placed on the east side of the new classroom addition.

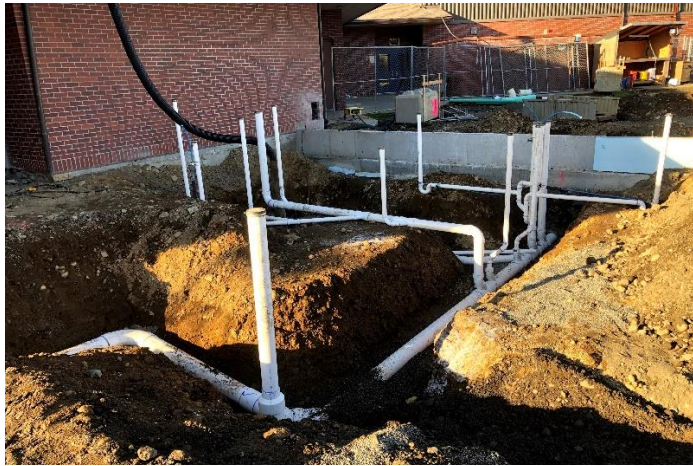
A close up view of the plumbing under the main bathrooms.

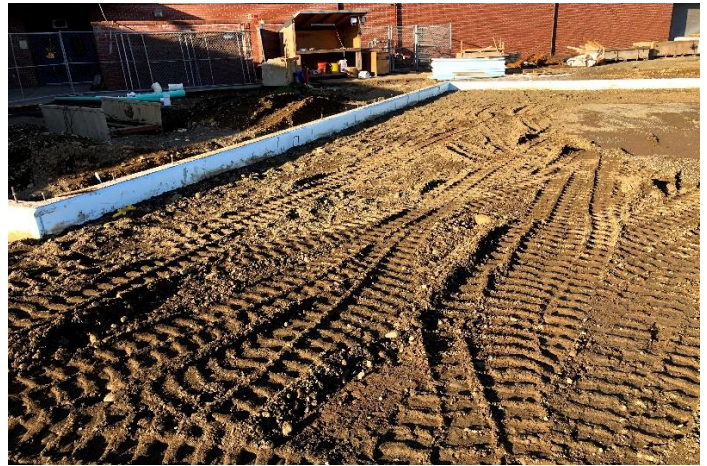
Backfill placement and grading is progressing.

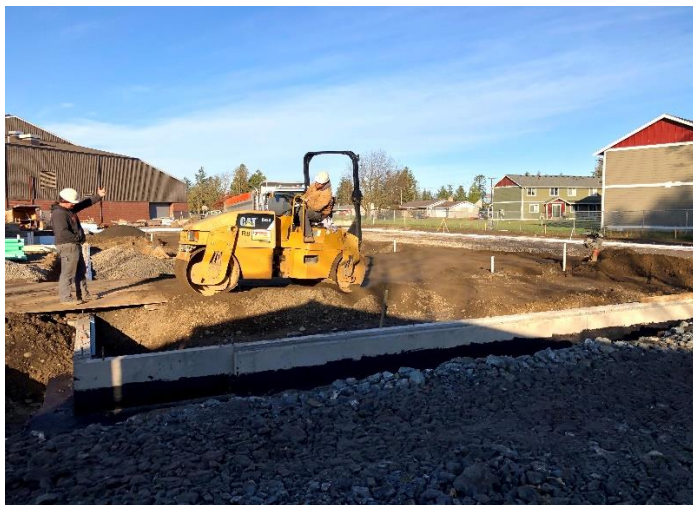
Compaction are underway within the classroom area.

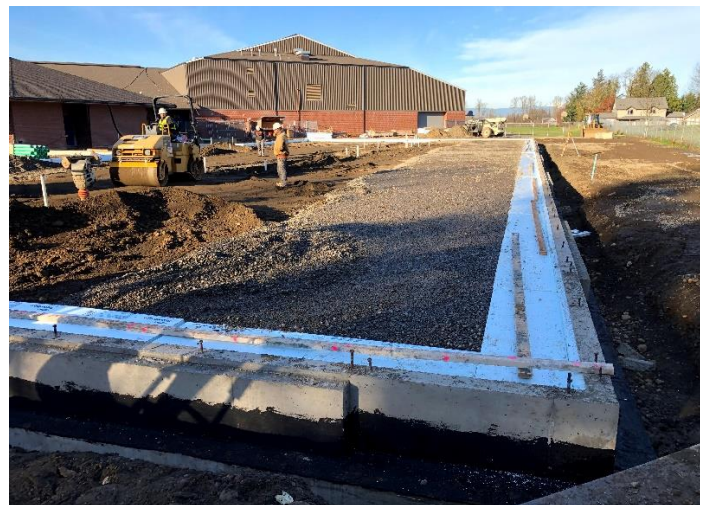
Perimeter foundation insulation and the capillary break are both shown in this photo.
