Fairfield Ludlowe High School Ventilation Study Issues Resolution

for
Fairfield Public Schools
Fairfield, CT

March 2, 2021

van Zelm Project #: 2020073.01

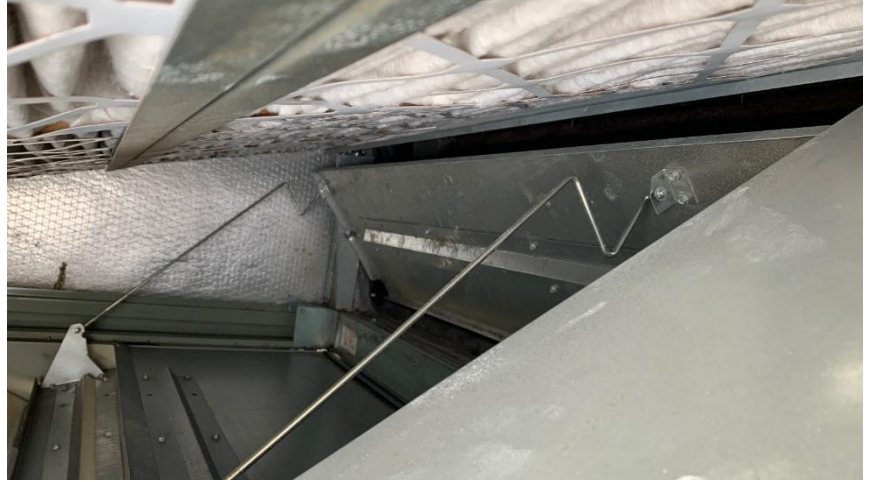
Item ID	Unit	#	Comment	IAQ or Maint.?	vZ Response	Picture
1	AC-4	1	What about concern about lack of air recirculation?	IAQ	Lack of air recirculation is not bad in and of itself, in fact 100% outside air is beneficial during the pandemic <i>if</i> the unit is capable of handling 100% outside air during given outside conditions. This remark was concerning that the unit was operating in 100% outside air when it was questionable since it was so humid, and unnecessary humidity could cause discomfort or other unideal space conditions. Seen in the photo, the mixing damper does operate.

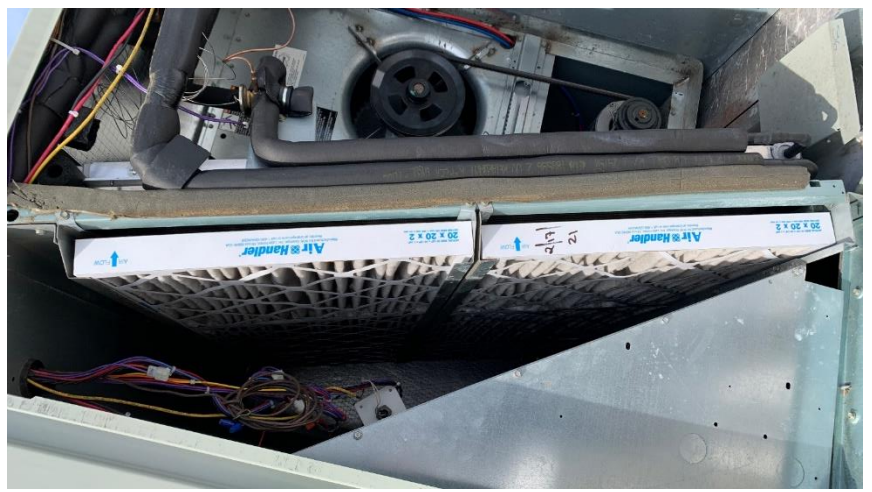
2	AC-4	2	Does this unit have filter(s)? If so, has/have then been changed? When & what type was/were installed?	IAQ	2" MERV 13 filters were installed 2/17/21.

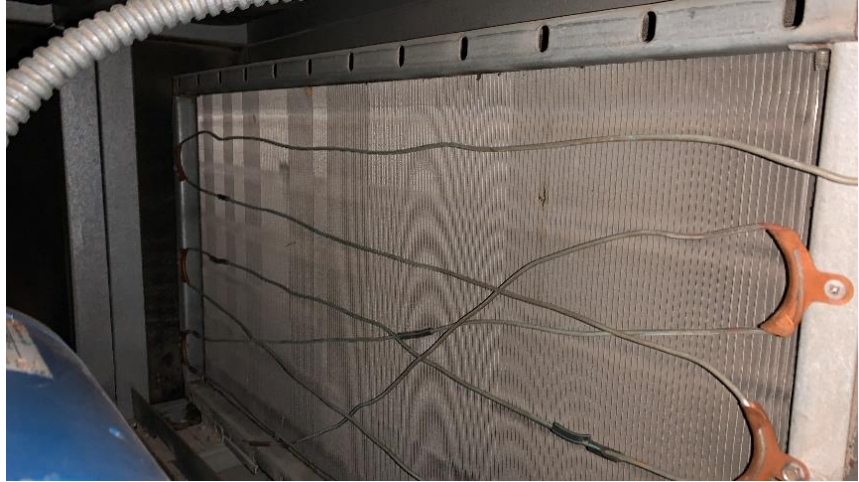
Item ID	Unit	#	Comment	IAQ or Maint.?	vZ Response	Picture
8	AHU-16	1	Was the coil cleaned?	IAQ	Yes, the coil was cleaned.

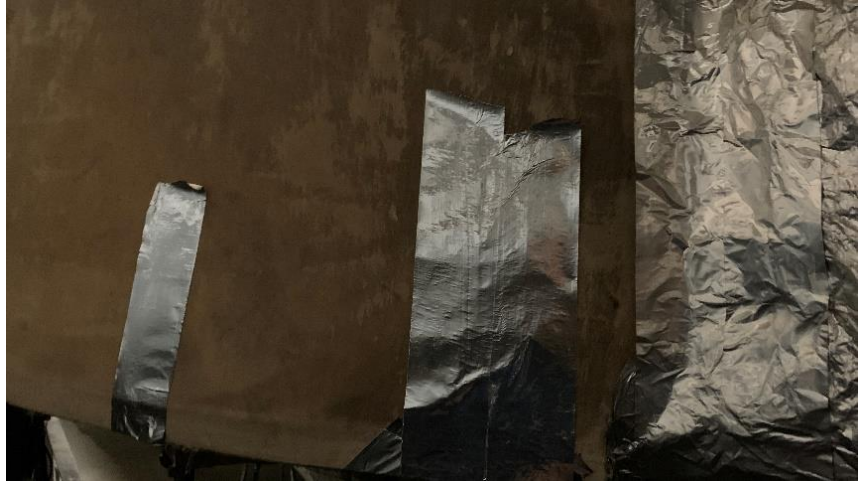
9	AHU-16	2	Insulation was replaced at appropriate locations (ductwork)?	Maint.	Yes, insulation was repaired or replaced.

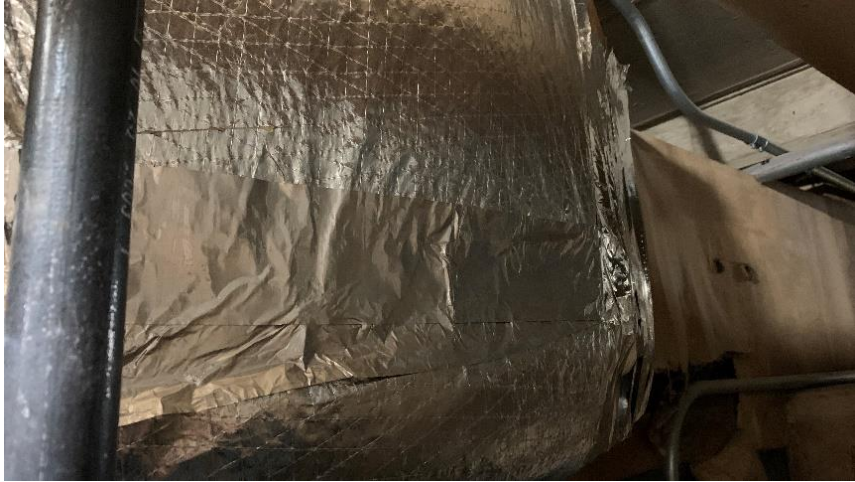
Item ID	Unit	#	Comment	IAQ or Maint.?	vZ Response	Picture
12	AHU-17	1	Insulation was replaced at appropriate locations (ductwork)?	Maint.	Yes, insulation was repaired or replaced.

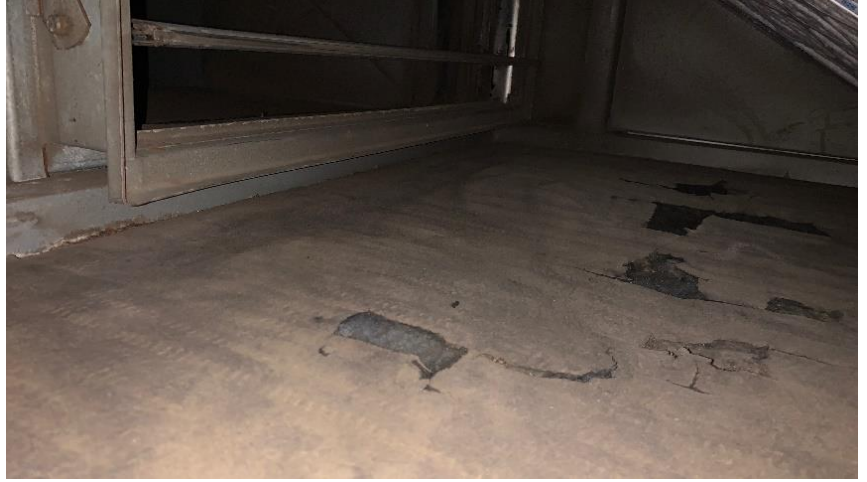
Item ID	Unit	#	Comment	IAQ or Maint.?	vZ Response	Picture
14	AHU-17	3	Was unit and squirrel cage cleaned of debris, dirt, and insulation?	IAQ	Yes, the cage and unit were cleaned.

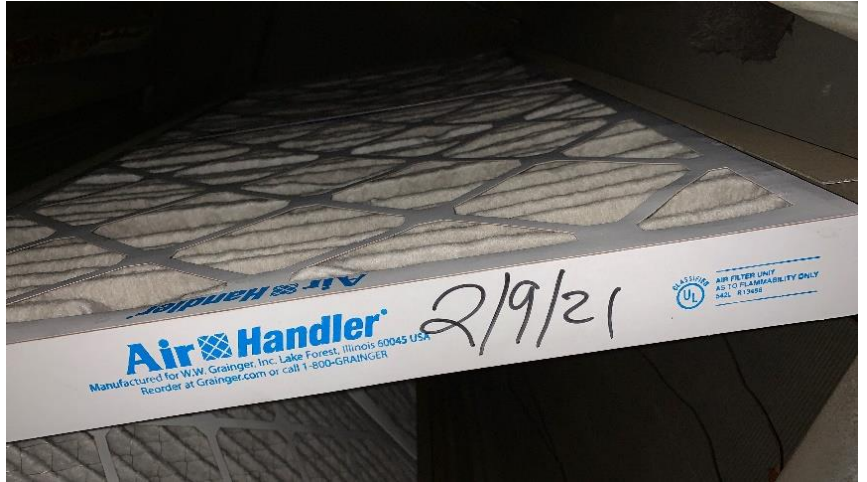
15	AHU-17	4	Is there more than one filter? If so, were all of them changed? What type was/were installed on 9/11/20?	IAQ	4x 2" MERV 13 filters were installed 2/9/21.

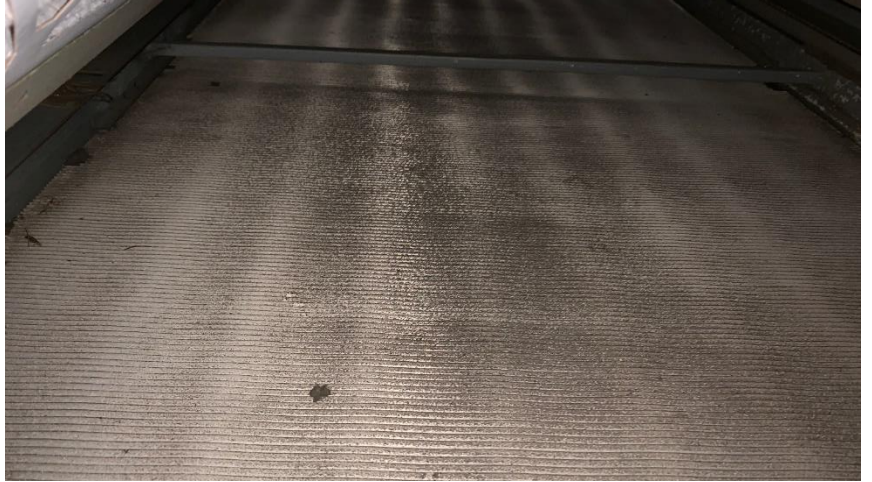
Item ID	Unit	#	Comment	IAQ or Maint.?	vZ Response	Picture
16	AHU-18	1	Coil was cleaned?	IAQ	Yes, the coil was cleaned.

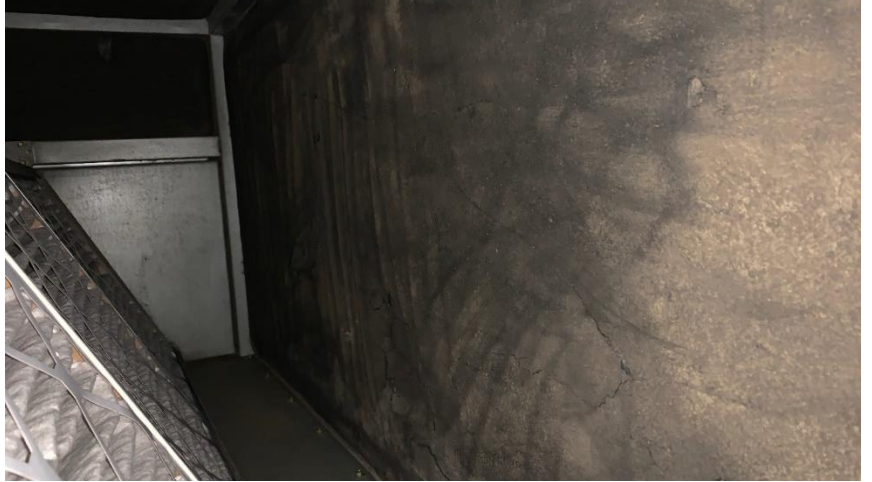
17	AHU-18	2	The interior unit was cleaned?	IAQ	Yes, the unit interior was cleaned.

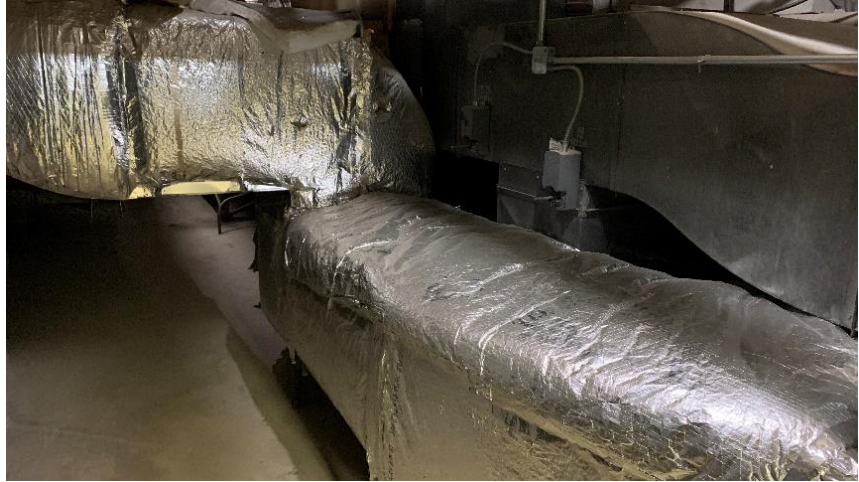
Item ID	Unit	#	Comment	IAQ or Maint.?	vZ Response	Picture
18	AHU-18	3	Insulation was replaced at appropriate locations (ductwork)?	Maint.	Yes, insulation was repaired or replaced.

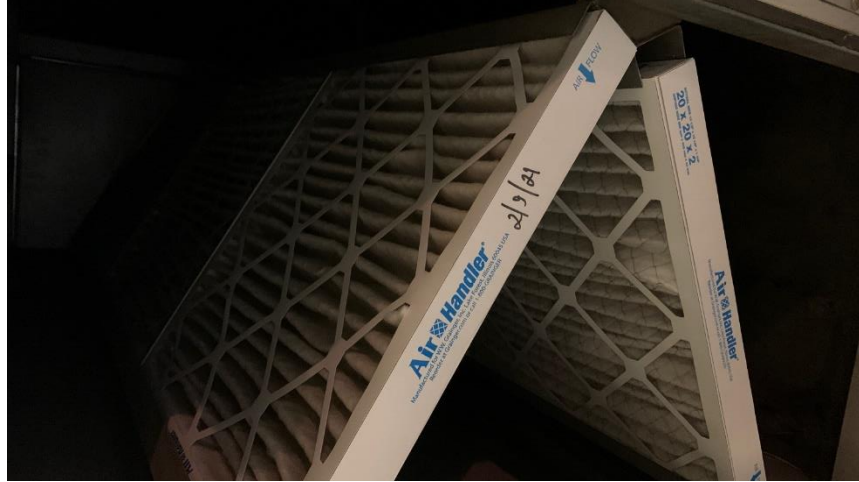
19	AHU-18	4	Is there more than one filter? If so, were all of them changed, when & what type?	IAQ	4x 2" MERV 13 filters were installed 2/9/21.

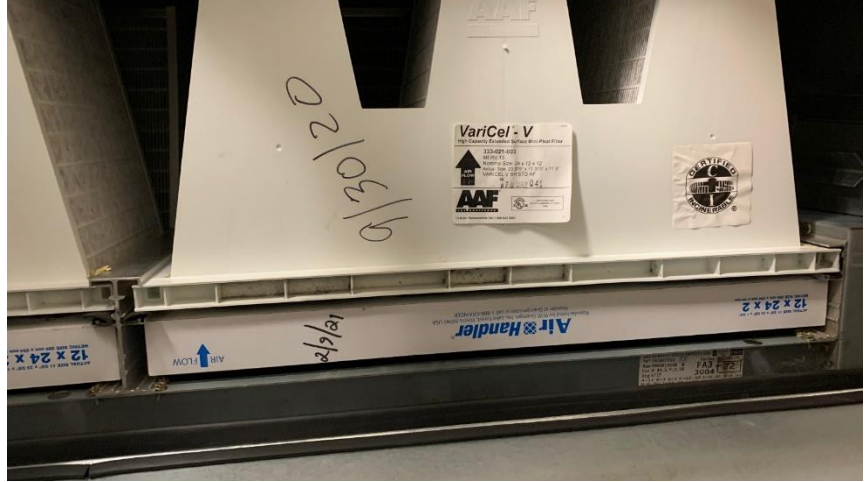
Item ID	Unit	#	Comment	IAQ or Maint.?	vZ Response	Picture
20	DOA-1	1	What is MERV rating for these replaced filters please?	IAQ	The filter rating is MERV 13 (for both the VariCel V and 2" pleated).

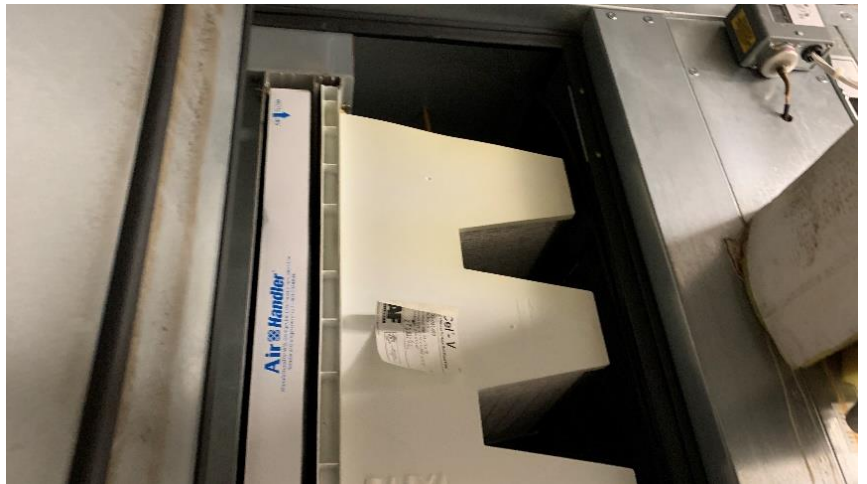
21	DOA-1	2	Have the repairs been completed on this Unit?	Maint.	Yes, the repairs were completed.

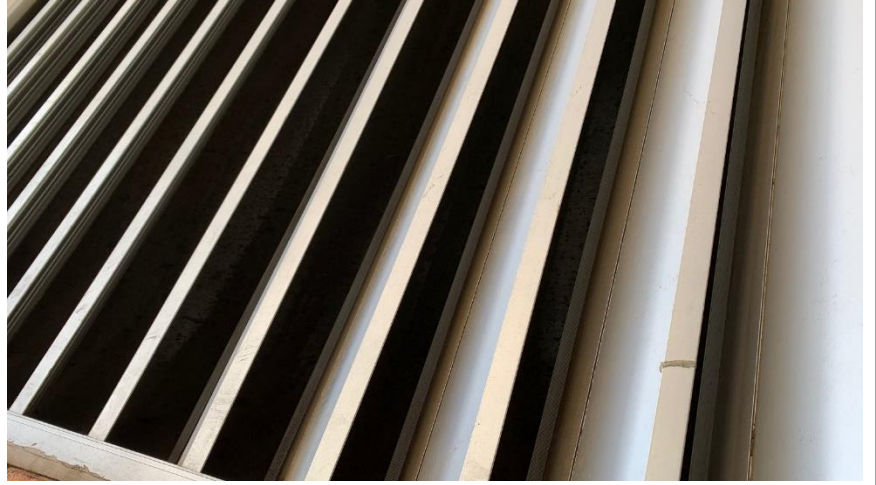
Item ID	Unit	#	Comment	IAQ or Maint.?	vZ Response	Picture
22	DOA-1	3	Bird screen installed?	Maint.	The bird screen is installed and was cleaned as best as possible with the permanently installed louver in the way.

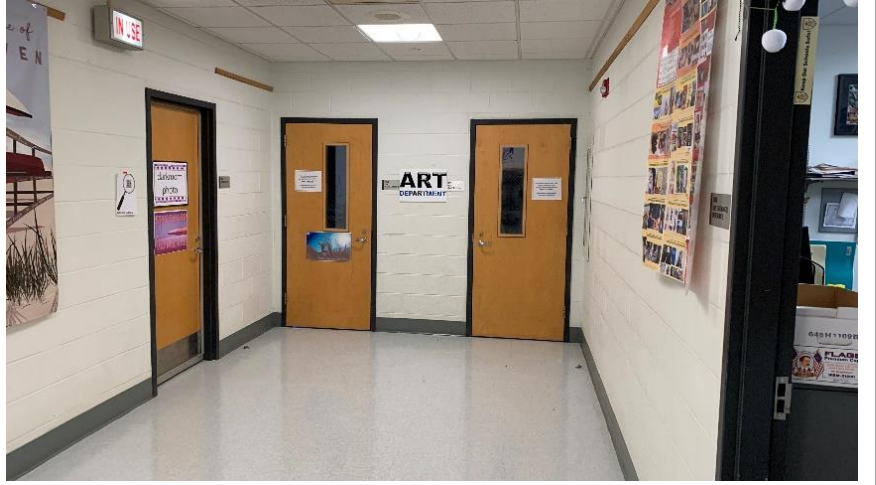
23	HV-1	1	Are OA & 007 still exhausted through 006?	Maint.	It is, as designed, but the repaired exhaust damper actuators have alleviated the issue. The excess exhaust is likely due to be used when the kiln is firing.

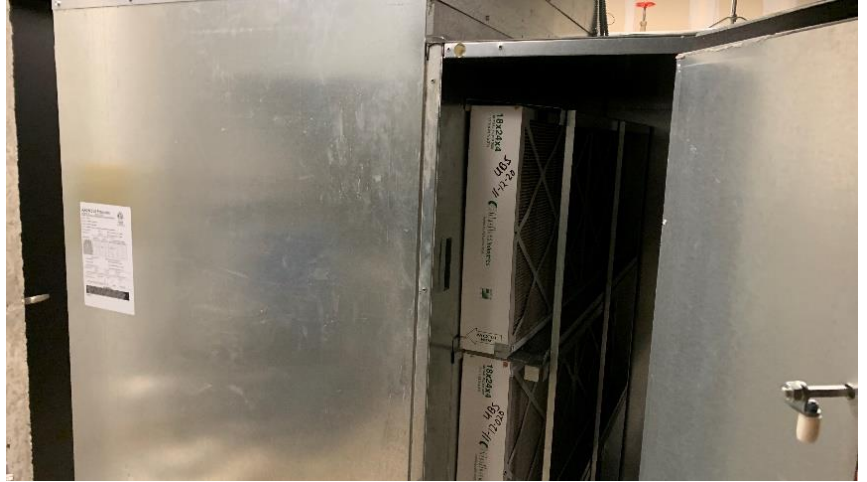
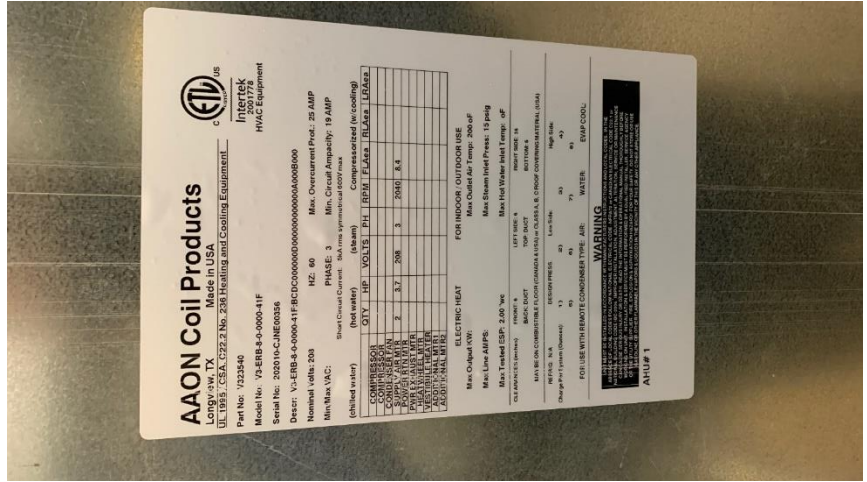
Item ID	Unit	#	Comment	IAQ or Maint.?	vZ Response	Picture
24	HV-1	2	Does 006 receive fresh air or is it still a "stiff negative"?	IAQ	Yes, fresh air is bring delivered by HV-1, which was completely replaced with a new unit including fresh new 4" MERV 13 filters and the damper repairs to the exhaust side.

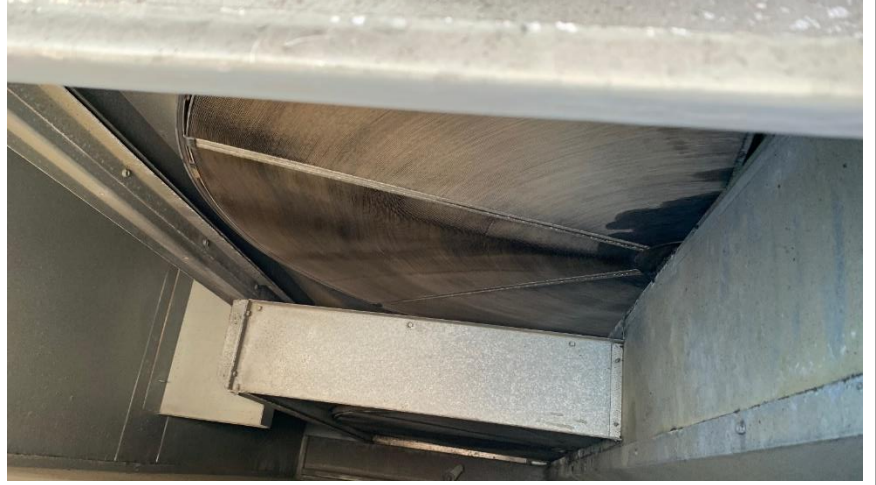
Item ID	Unit	#	Comment	IAQ or Maint.?	vZ Response	Picture
25	HV-2	1	Has the HVAC technician verified a clean energy wheel, metal debris removed and made secure?	IAQ	Yes, the wheel is cleaned and secured.

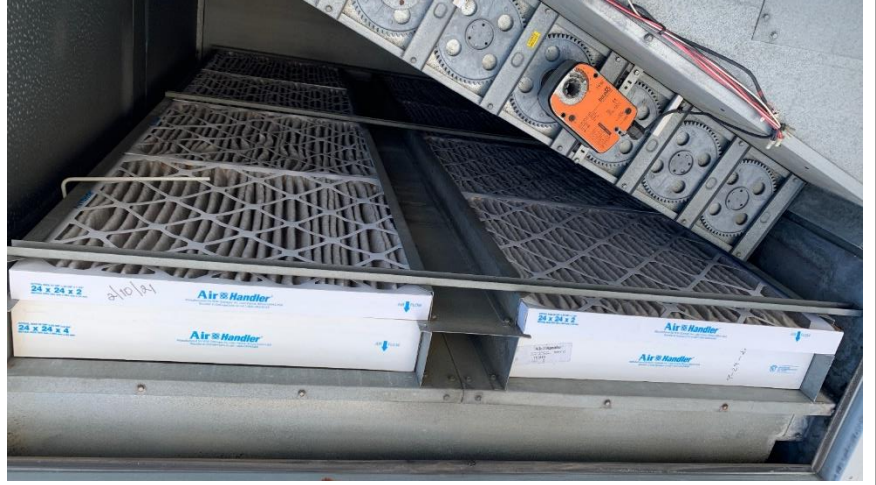
26	HV-2	2	What filter has been installed in this unit & when?	IAQ	4" MERV 13 filters were installed on 9/29/20 and 2" MERV 13 filters were installed on 2/10/21.

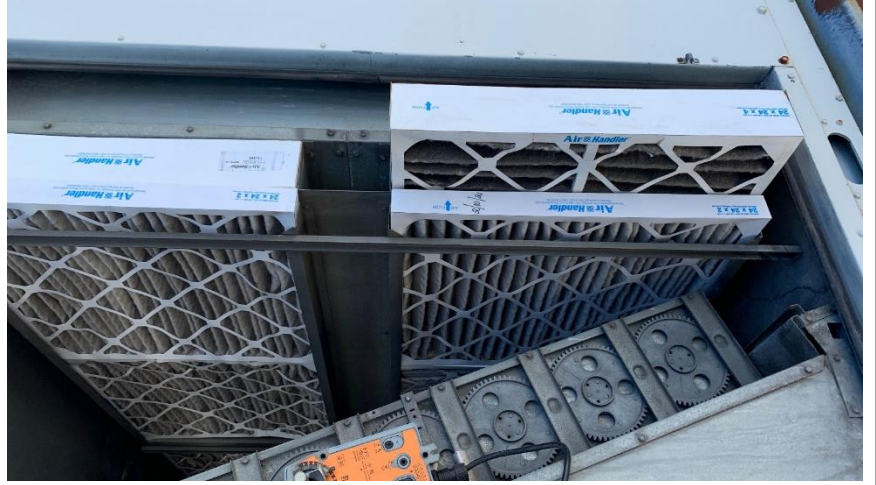
Item ID	Unit	#	Comment	IAQ or Maint.?	vZ Response	Picture
27	HV-3	1	Was/were any new filter(s) installed. If so, when & what type? If not, why not?	IAQ	4" MERV 13 filters were installed on 9/29/20 and 2" MERV 13 filters were installed on 2/10/21.

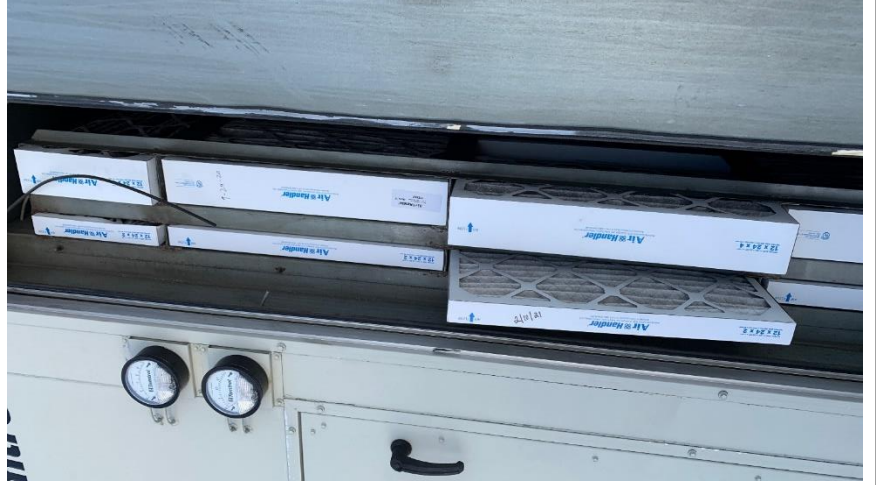
28	HV-4	1	How many filters were changed on 9/14/20? van Zelm report mentions "filters"; your note mentions "filter." When and what type was/were installed?	IAQ	Non-plural was a typo. The filter quantities are 12-24x24x2, 7-24x12x2, 12-24x24x4, 7-24x12x4. 4" MERV 13 filters were installed 9/29/20 and 2" MERV 13 filters were installed 2/10/21.

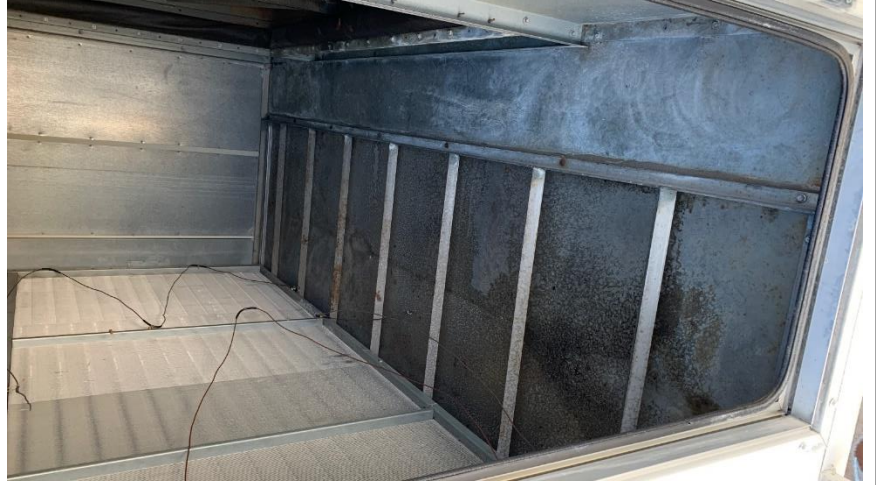
Item ID	Unit	#	Comment	IAQ or Maint.?	vZ Response	Picture
29	HV-4	2	How was the condensate pan addressed? Was its height adjusted?	IAQ	The condensate pan was thoroughly cleaned as well as the supply air louver section. The condensate trap was adjusted and appears to now be an acceptable height.

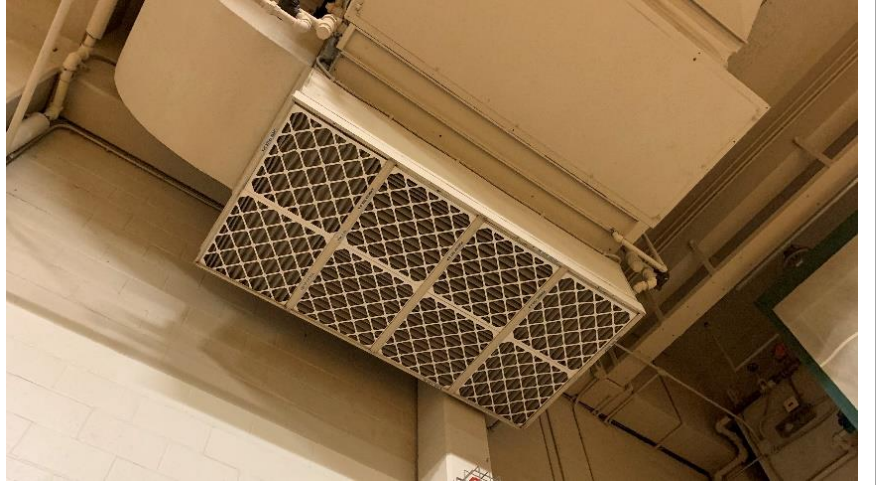
30	HV-5	1	Notes indicate that a filter was changed. van Zelm references more than one filter needed changing. Please advise.	IAQ	These were changed over holiday break periods because they are difficult to access while school is in session. They will need another change soon and it has been added to the maintenance list. Please note that the gym units can become dirty quicker than other units because of the activity within this space.

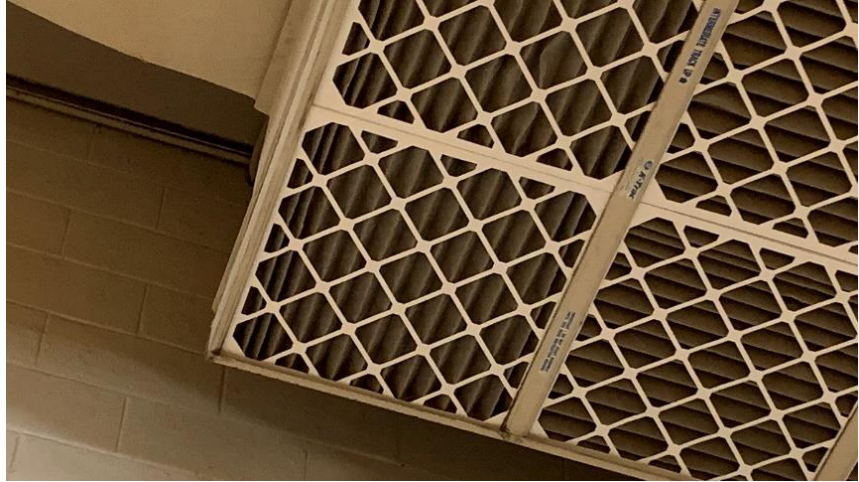
Item ID	Unit	#	Comment	IAQ or Maint.?	vZ Response	Picture
31	HV-5	2	What type of filter(s) were installed on 11/10/20?	Maint.	The new filters are MERV 13.

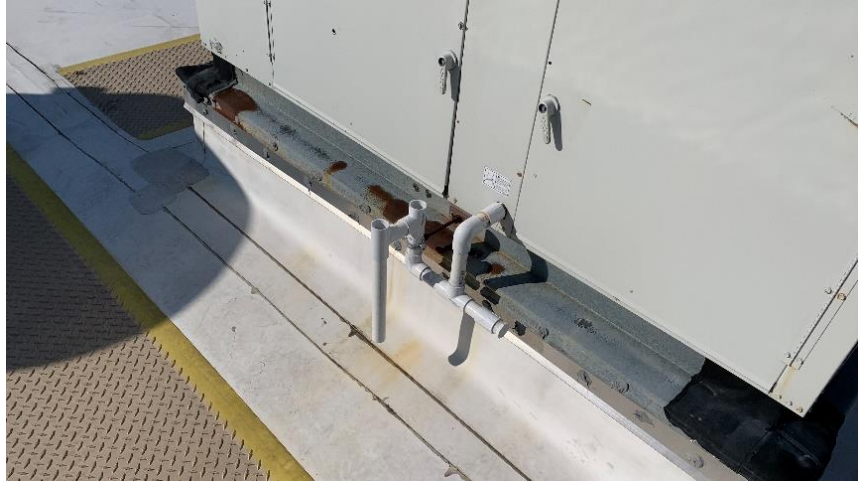
32	HV-6	1	Was the condensate trap addressed? How so?	IAQ	The condensate trap was replaced with new PVC piping.

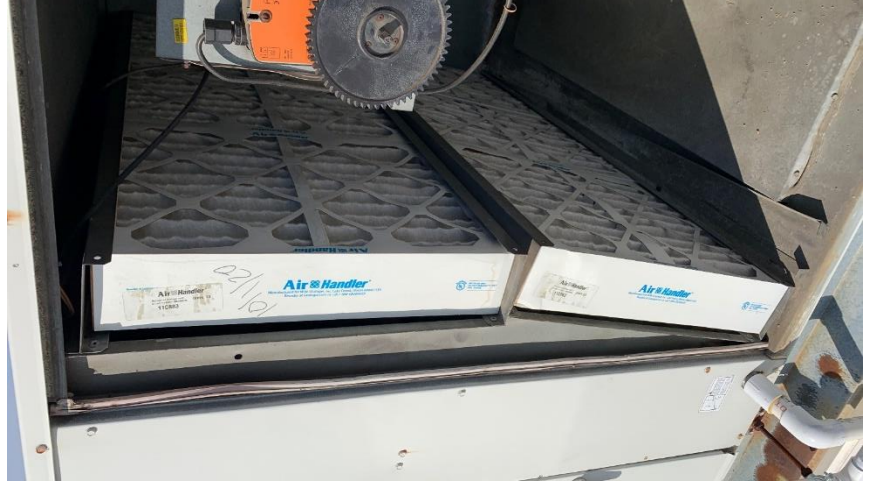
Item ID	Unit	#	Comment	IAQ or Maint.?	vZ Response	Picture
33	HV-6	2	Was/were any new filter(s) installed? If so, when and what type? If not, why not?	IAQ	New 4" MERV 13 filters were installed 10/1/20.

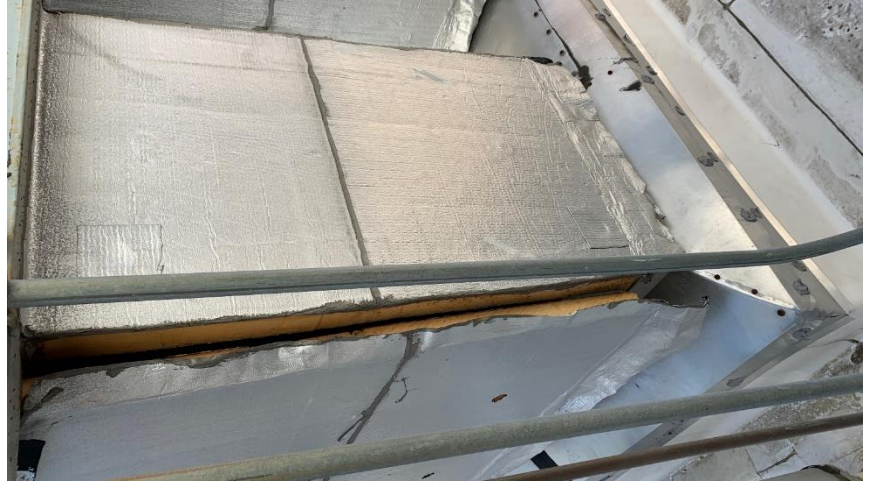
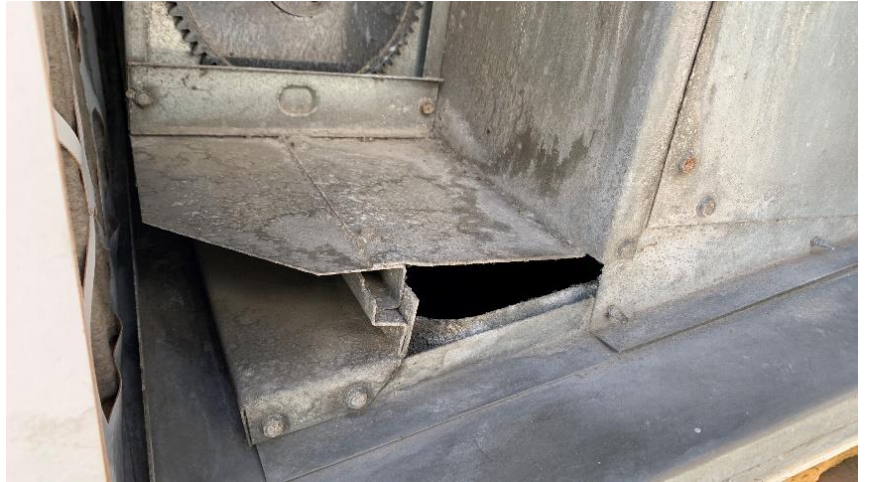
Item ID	Unit	#	Comment	IAQ or Maint.?	vZ Response	Picture
34	HV-7	1	Were the parts received to reseal air section and repair external duct work? If so, did FPS do these repairs? If not, when?	Maint.	These items have been added to the maintenance punchlist but do not affect IAQ since the air is still filtered properly.

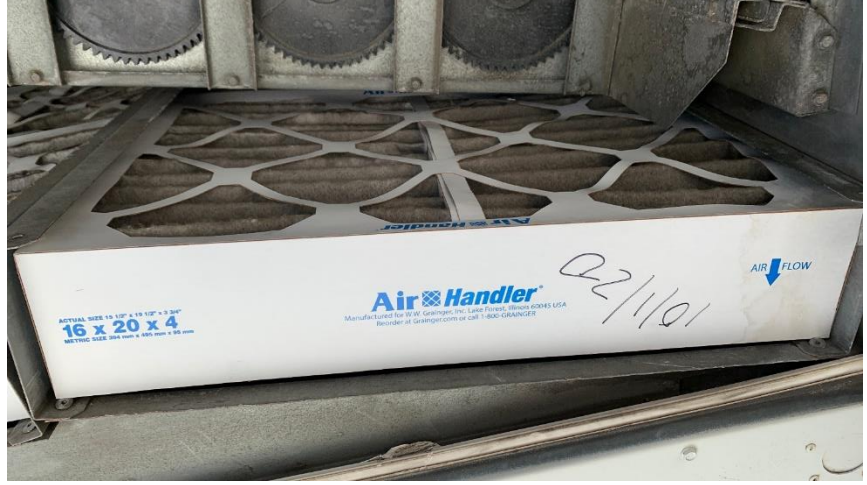
Item ID	Unit	#	Comment	IAQ or Maint.?	vZ Response	Picture
35	HV-7	2	Was/were any new filter(s) installed? If so, when and what type? If not, why not?	IAQ	4" MERV 13 filters were installed 10/1/20.

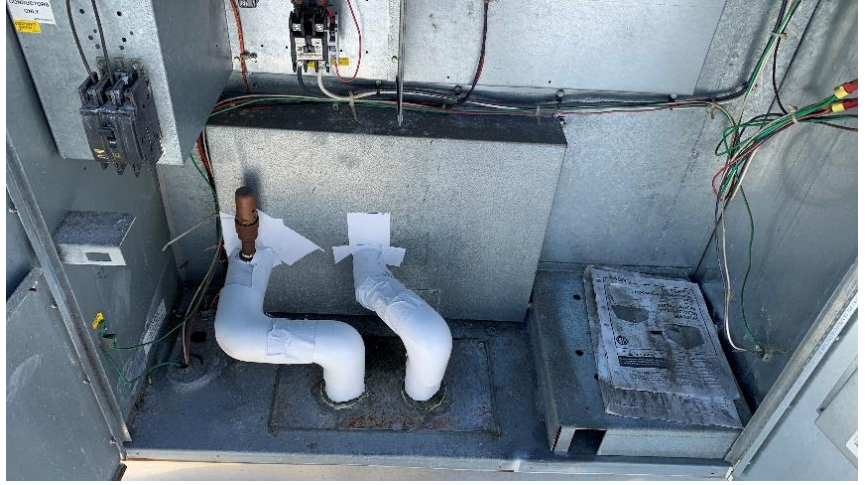
36	MUA-1	1	Was piping insulation repaired? If not, when?	Maint.	The piping insulation was repaired.

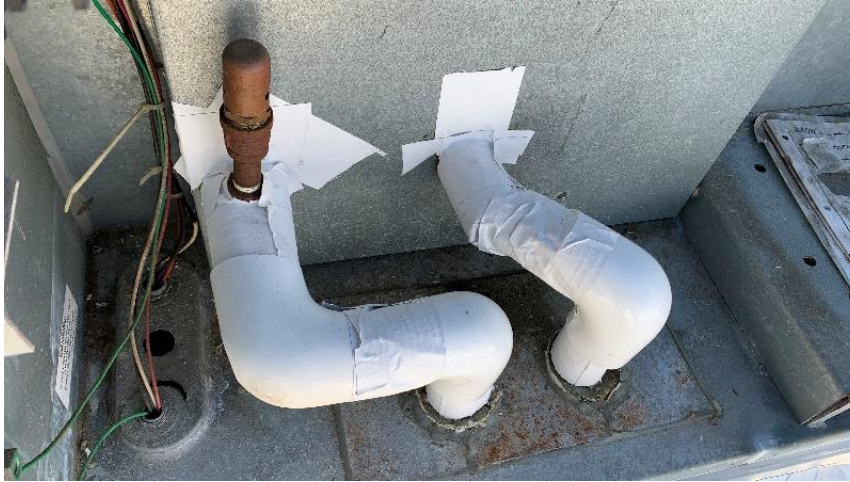
Item ID	Unit	#	Comment	IAQ or Maint.?	vZ Response	Picture
37	MUA-1	2	Was copper piping corrosion repaired?	Maint.	Yes, and new insulation will prevent it from developing

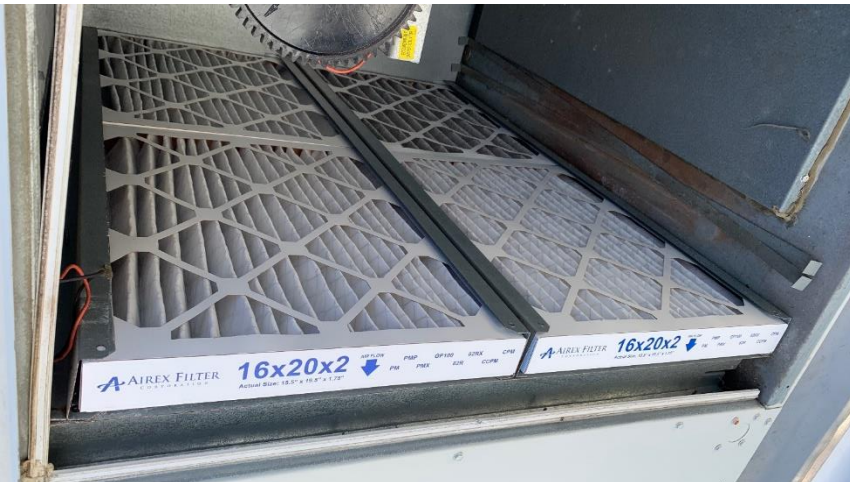
38	MUA-1	3	Was/were any new filter(s) installed? If so, when and what type? If not, why not?	IAQ	2" MERV 13 filters were installed on 2/10/21.

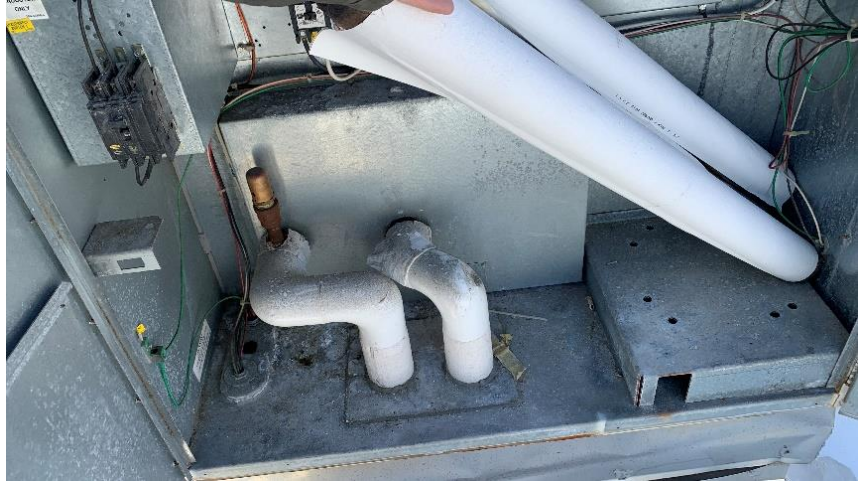
Item ID	Unit	#	Comment	IAQ or Maint.?	vZ Response	Picture
39	MUA-2	1	Is the corrosion interfering with the operation of this unit? (How much corrosion is considered to be "normal wear and tear"?)	Maint.	This will not have any effect as long as the insulation is maintained. Sustained corrosion can eventually cause leaks, but those leaks typically take years of no maintenance to fully develop. Facilities has provided extra insulation for future patching as seen in the photo.

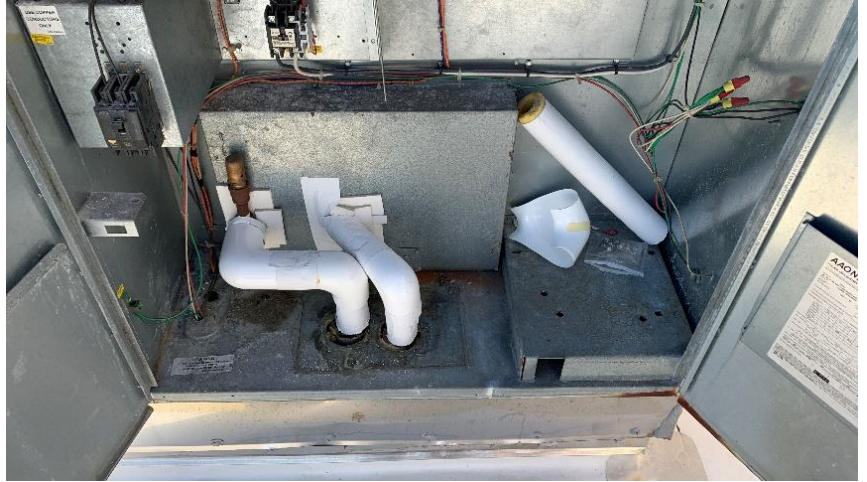
Item ID	Unit	#	Comment	IAQ or Maint.?	vZ Response	Picture
41	MUA-3	1	Was the new piping insulation installed?	Maint.	Yes, new piping insulation was installed.

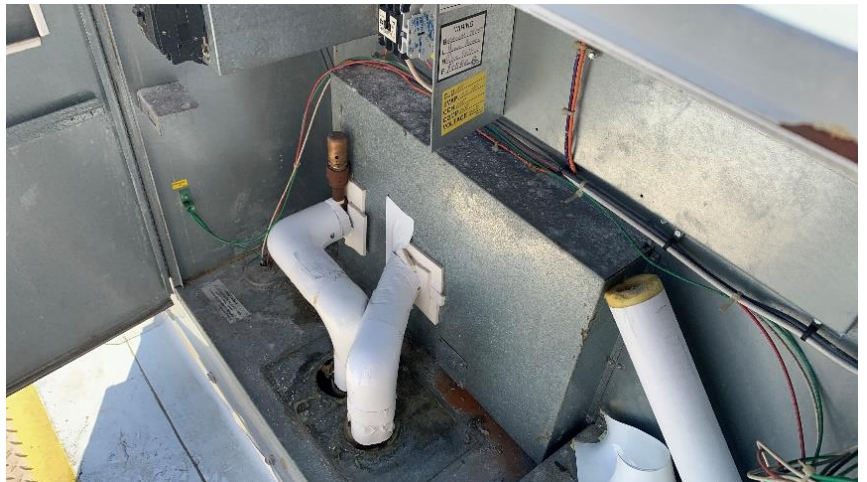
42	MUA-3	2	Is the corrosion interfering with the operation of this unit? (How much corrosion is considered to be "normal wear and tear"?)	Maint.	This will not have any effect as long as the insulation is maintained. Sustained corrosion can eventually cause leaks, but those leaks typically take years of no maintenance to fully develop. Facilities has provided extra insulation for future patching as seen in the photo.

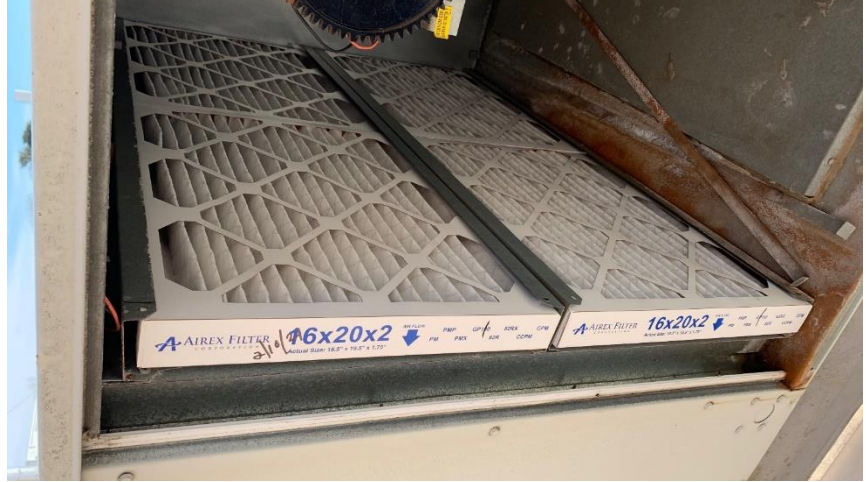
Item ID	Unit	#	Comment	IAQ or Maint.?	vZ Response	Picture
43	MUA-3	3	Was/were any new filter(s) installed? If so, when and what type? If not, why not?	IAQ	New 2" MERV 13 filters were installed on 2/10/21.

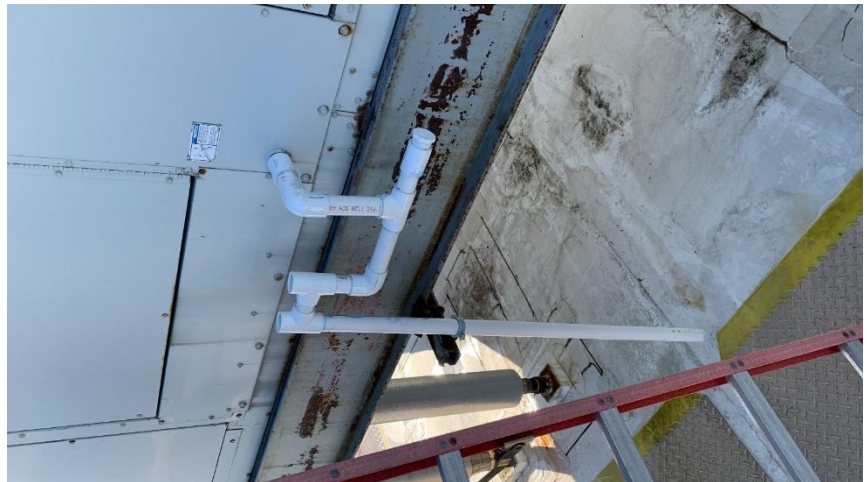
44	RTU-1	1	Was the condensate trap addressed? How so?	IAQ	The condensate trap was replaced with new PVC piping and was extended down to the roof to prevent drip damage.

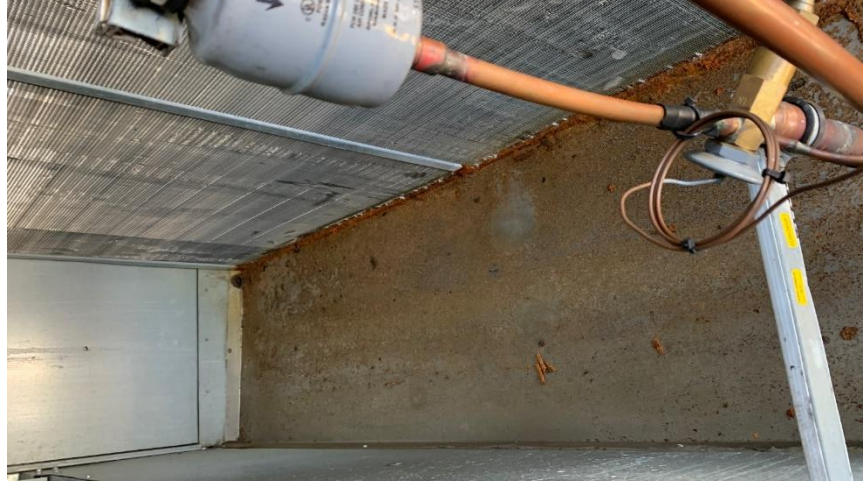
Item ID	Unit	#	Comment	IAQ or Maint.?	vZ Response	Picture
45	RTU-1	2	Was the condensate pan section repaired, including leaking/pooling?	Maint.	There possibly remains a small leak due to pan corrosion in the bottom under the coil. This will need to be reviewed by maintenance in the summer when condensate can form in order to pinpoint the location.

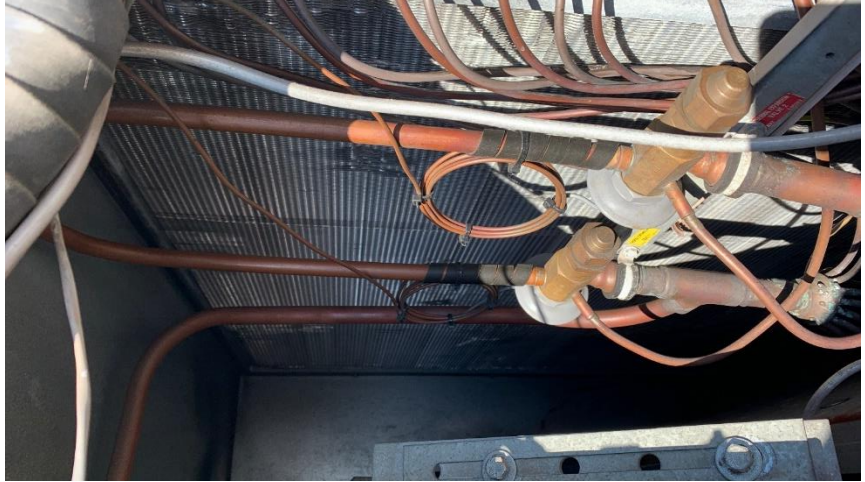
Item ID	Unit	#	Comment	IAQ or Maint.?	vZ Response	Picture
47	RTU-2	1	Was the coil combed to straighten out the fins?	Maint.	The coil was combed to straighten the fins.

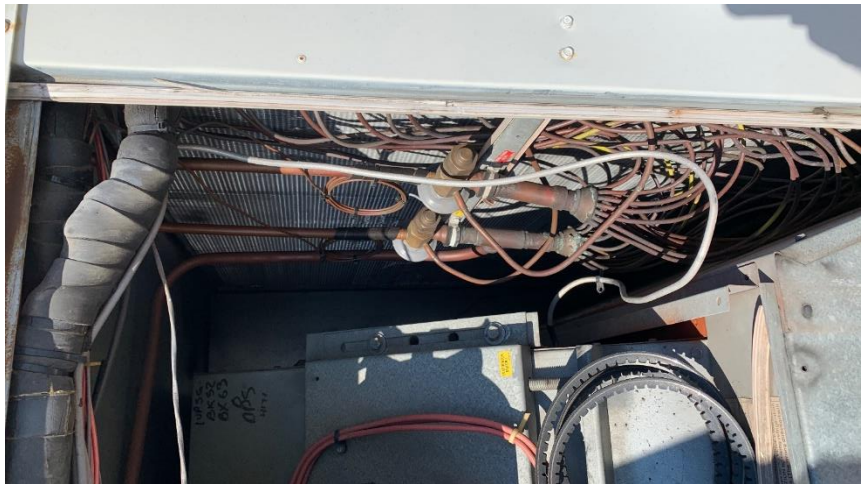
48	RTU-2	2	Or does this coil need to be replaced? If so, what are the plans for this?	Maint.	This coil does not need replacement at this time.

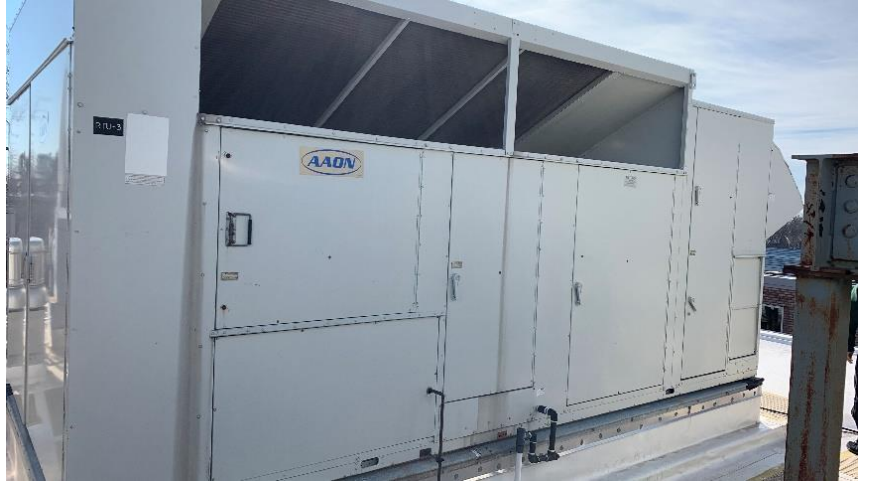
52	RTU-3	2	Why were these filters clean at the time of the van Zelm review since the filters had been installed on 5/21/20?	IAQ	This unit was down partially before COVID and did not accumulate dust like other similar units. Then all units were off while School was cancelled. The nature of the clean filters was coincidental, and the unit was observed running normally during this recent visit.

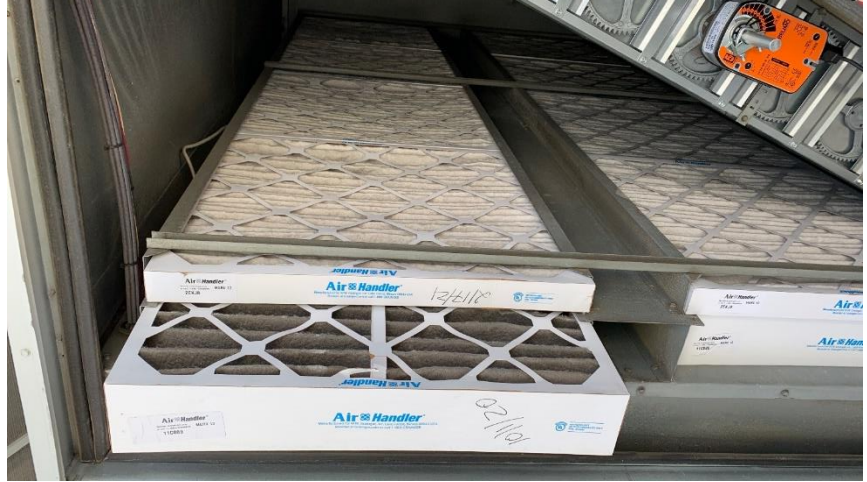
Item ID	Unit	#	Comment	IAQ or Maint.?	vZ Response	Picture
53	RTU-3	3	Were these filters changed? When and what type installed?	IAQ	4" MERV 13 filters were installed on 10/1/20 and 2" MERV 13 filters were installed on 2/17/21.

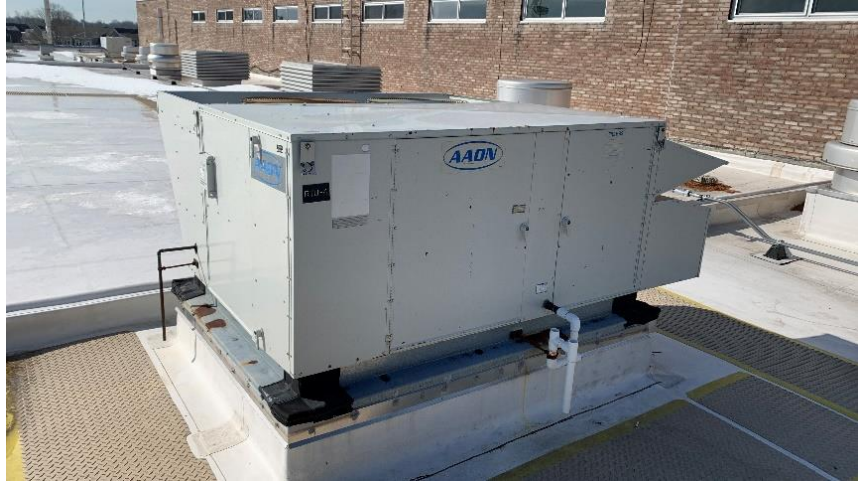
54	RTU-4	1	These notes are confusing. Was a new unit installed during the summer? If so, then why were there so many problems when van Zelm did its review?	Maint.	At the time of our initial visit, this unit was not new. Upon reinspection it is still the same unit, but it is running this time and the noted issues were corrected, as indicated in the following items.

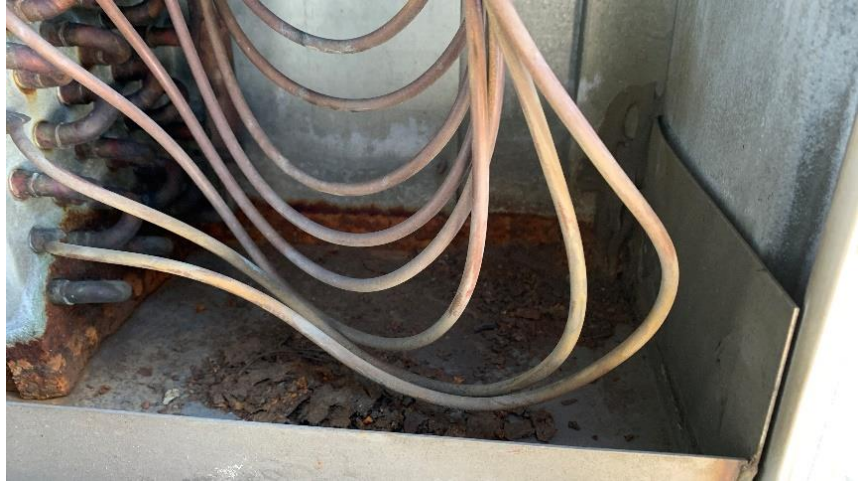
56	RTU-4	3	Is the refrigerant coil piping still resting in the condensate pan?	Maint.	No, and piping has been lifted out of the pan.

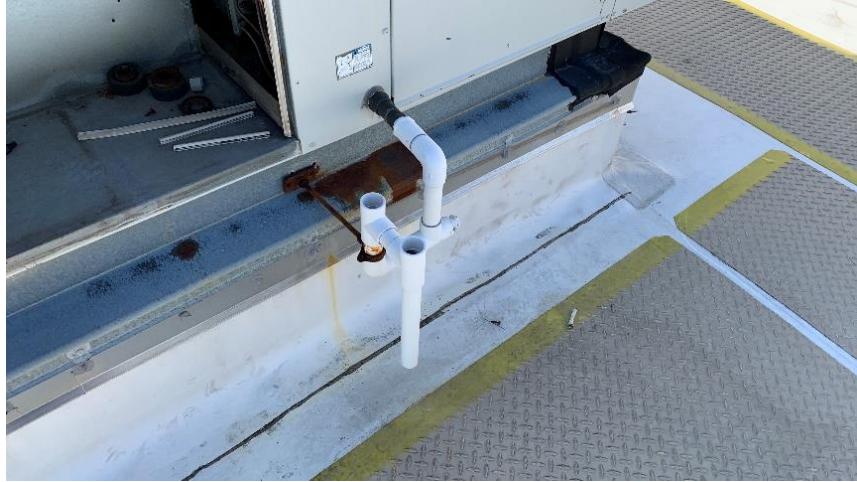
Item ID	Unit	#	Comment	IAQ or Maint.?	vZ Response	Picture
57	RTU-4	4	Has the trap height been assessed regarding whether it's at the proper height?	Maint.	The condensate trap has been repaired and adjusted. The height is acceptable for the unit configuration.

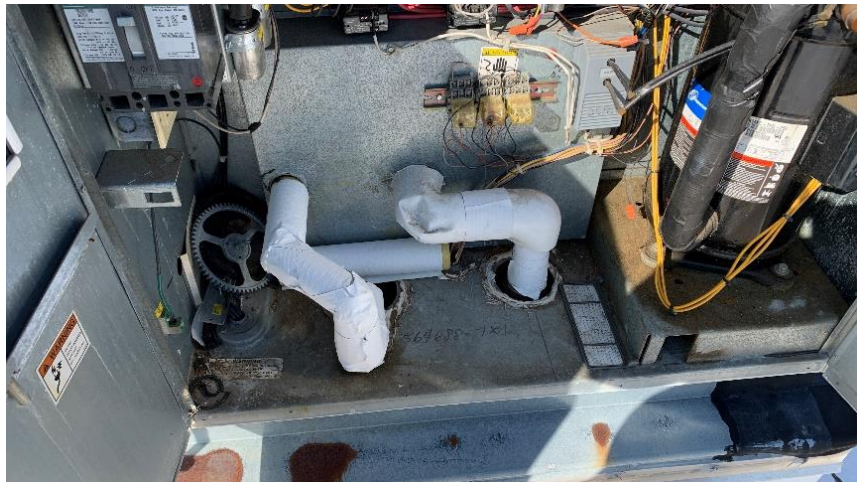
58	RTU-4	5	Was the piping insulation in the control unit repaired?	Maint.	The insulation was repaired.

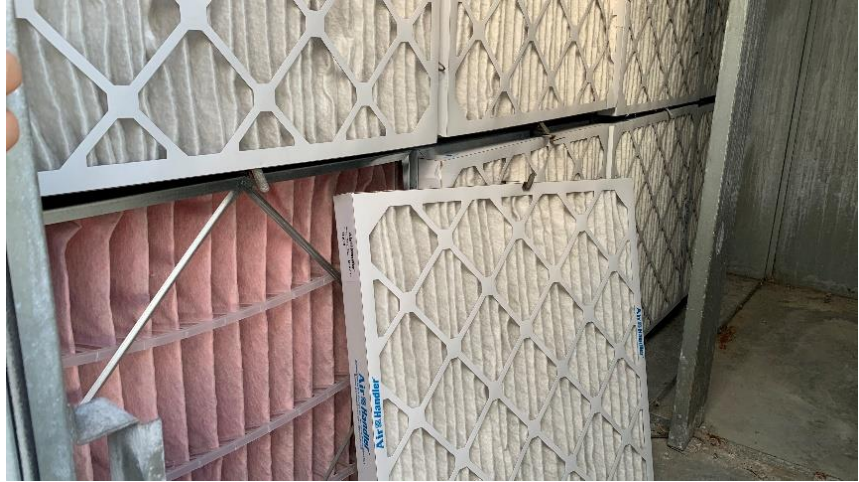
Item ID	Unit	#	Comment	IAQ or Maint.?	vZ Response	Picture
61	RTU-5	2	Were all filters changed? If so, how many, when and what type filters were installed?	IAQ	12" MERV 13 box filters were installed 10/1/20 and 2" MERV 13 filters were installed 2/17/21.

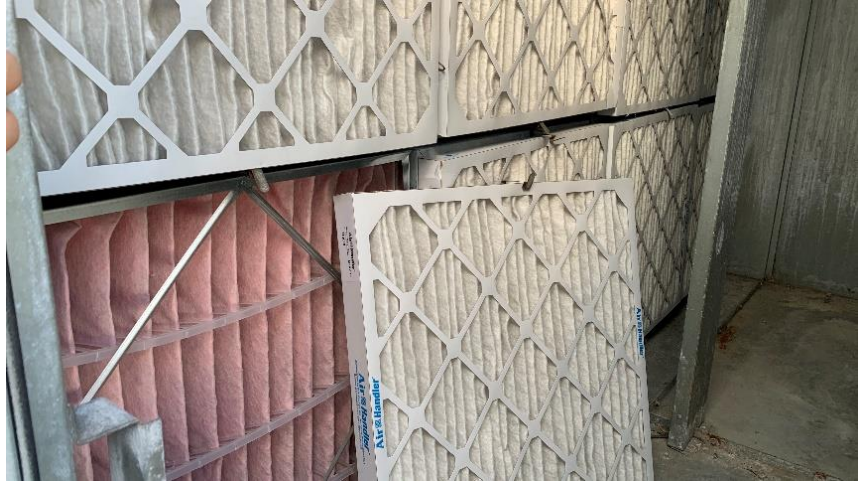
62	RTU-5	3	Were the filter rack clips replaced and repaired?	IAQ	The filter rack clips were adjusted and hold the filters in place now. The filter in the image was removed to show the cleanliness of the newer filters.
