Fairfield Ludlowe High School Ventilation Study Issues Resolution

for
Fairfield Public Schools
Fairfield, CT

March 2, 2021

van Zelm Project #: 2020073.01

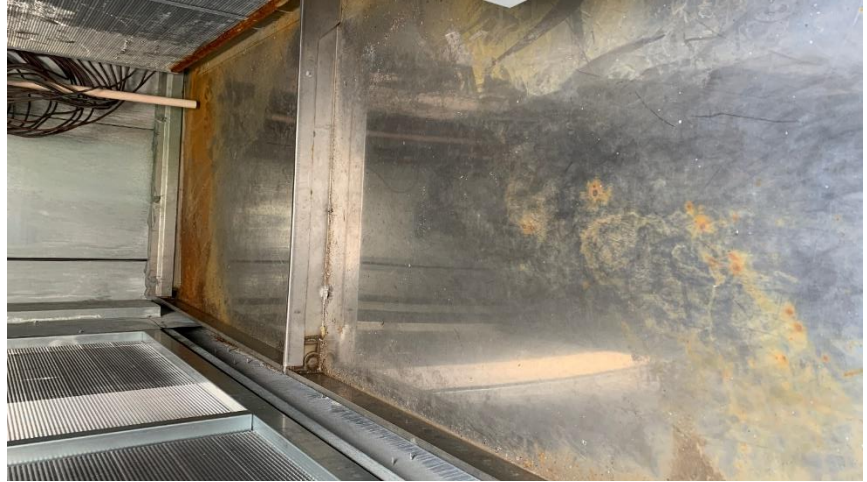
Item ID	Unit	#	Comment	IAQ or Maint.?	vZ Response	Picture
63	RTU-5	4	Is the corrosion interfering with unit operation?	Maint.	No, the corrosion will not interfere with unit operation and will not affect IAQ.

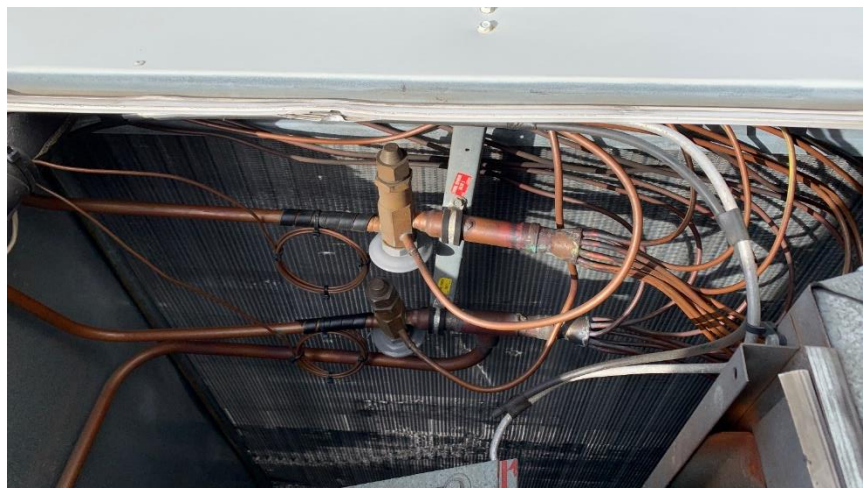
64	RTU-6	1	Has the refrigerant coil been cleaned & combed?	IAQ	Yes, the refrigerant coil has been cleaned and combed.

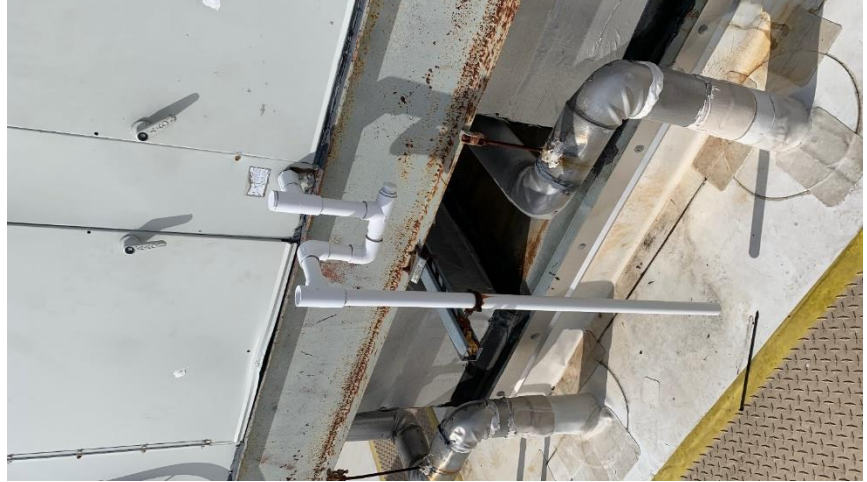
Item ID	Unit	#	Comment	IAQ or Maint.?	vZ Response	Picture
65	RTU-6	2	Has the condensate problem been addressed? If so, how?	Maint.	Note: The unit was not producing condensate as expected given the weather and operating conditions, but this does not necessarily mean it is not cooling properly. Facilities will continue to monitor this, but it is not an IAQ item.

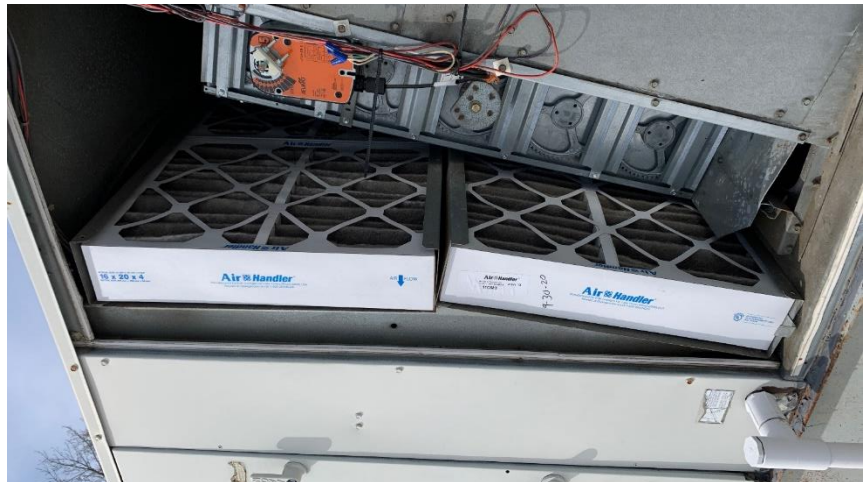
66	RTU-6	3	Were filters replaced? If so, how many, when and what type filters were installed? If not, why not?	IAQ	4" MERV 13 filters were installed 9/30/20.

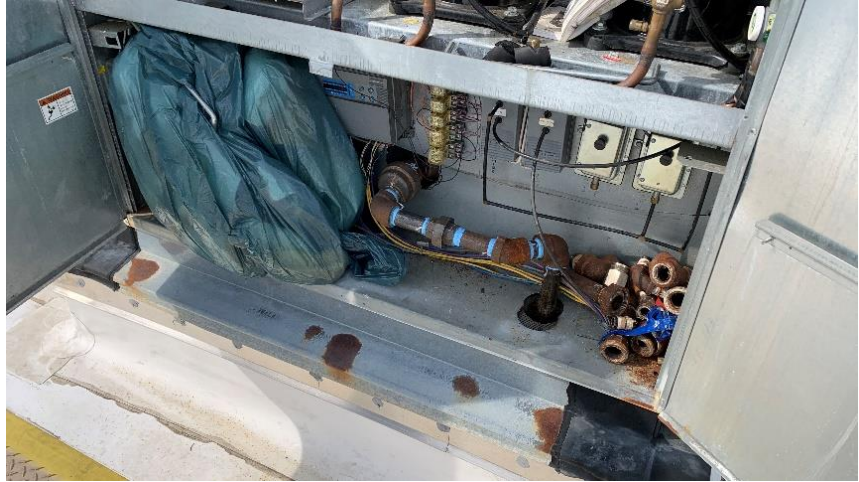
Item ID	Unit	#	Comment	IAQ or Maint.?	vZ Response	Picture
67	RTU-7	1	Has the piping in the control section been insulated?	Maint.	The piping in the control section has not yet been insulated. The coil was recently replaced, and facilities is working to complete insulation. This will not affect IAQ.

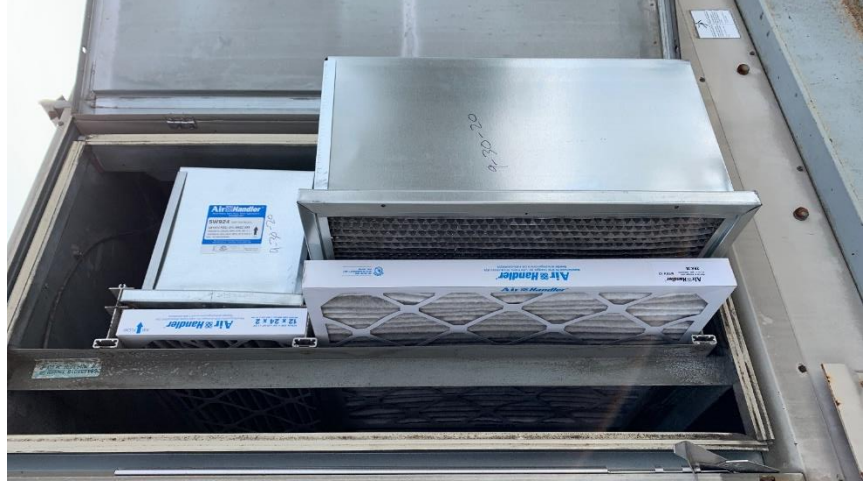
Item ID	Unit	#	Comment	IAQ or Maint.?	vZ Response	Picture
71	RTU-9	1	Have you verified that filters were changed? When did this occur? If filters were changed, how many and what type were installed? If not, why not?	IAQ	2" MERV 13 filters were installed 2/10/21 and 12" MERV 13 box filters were installed 9/30/20.

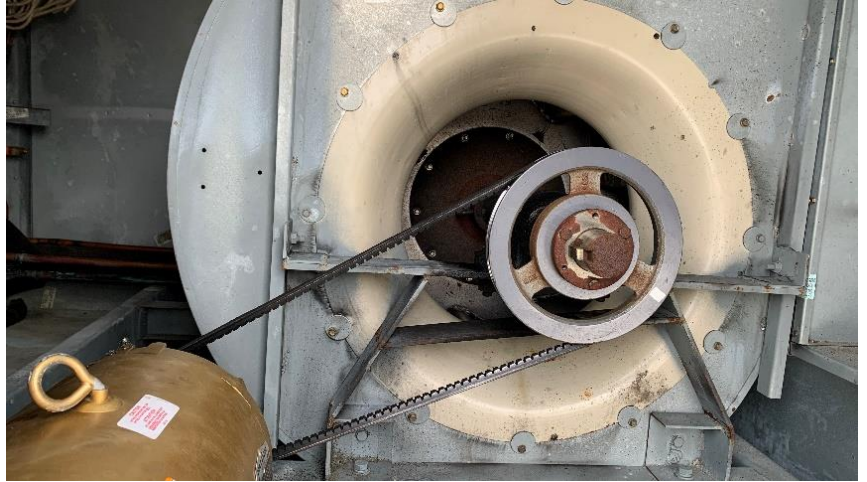
72	RTU-9	2	Have you verified that the fan belt is on properly?	Maint.	The fan belt was replaced and is properly sized for the unit.

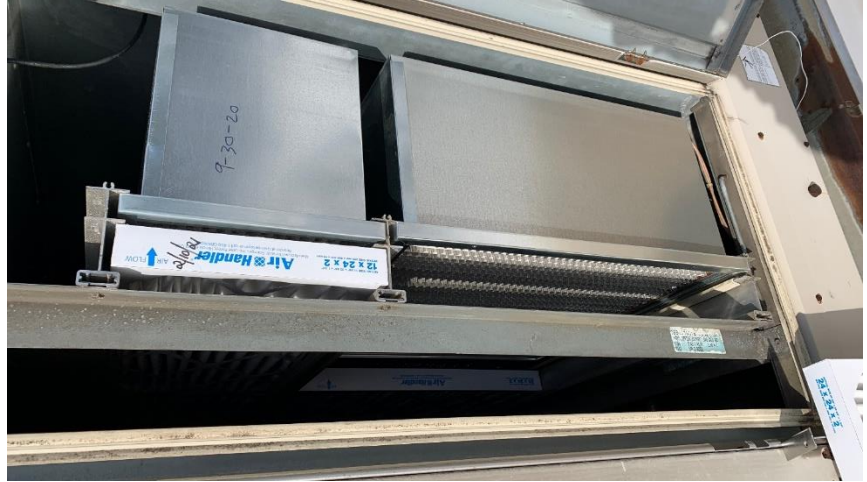
Item ID	Unit	#	Comment	IAQ or Maint.?	vZ Response	Picture
75	RTU-10	1	van Zelm references "filters." Your note referenced "filter" changed. How many filter(s) are there? Have they all been changed? If so, how many and what type changed on 9/14/20?	IAQ	Non-plural is a typo. 4-12x24x2 & 4-24x24x2" MERV 13 filters were installed 2/10/21 and 4-12x24x12, 4-24x24x12" MERV 13 box filters were installed 9/30/20.

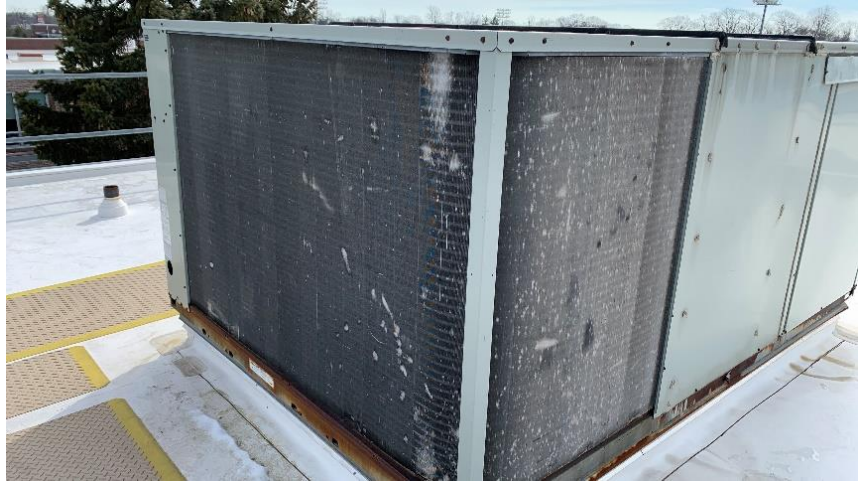
76	RTU-11	1	Were the condenser coils combed?	Maint.	Enough of the condenser coil is unblocked and will continue to operate. Because of the age of the unit, combing the coils out too much could cause them to break. Maintenance will continue to do what they can, but this will not affect IAQ.

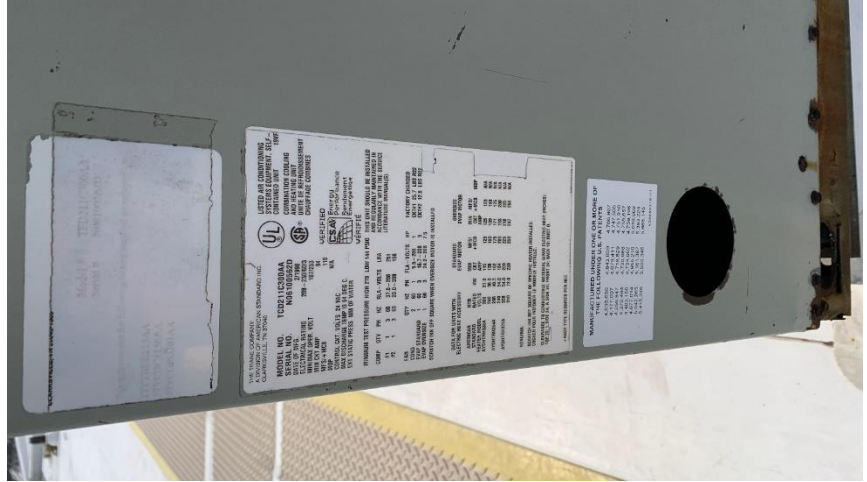
Item ID	Unit	#	Comment	IAQ or Maint.?	vZ Response	Picture
77	RTU-11	2	Has the charge been checked on this unit? What is this follow up?	Maint.	Mechanical technicians reviewed the unit last summer. There haven't been any complaints from occupants about rooms being too hot in the area served by this unit. However, facilities will continue to monitor this unit.

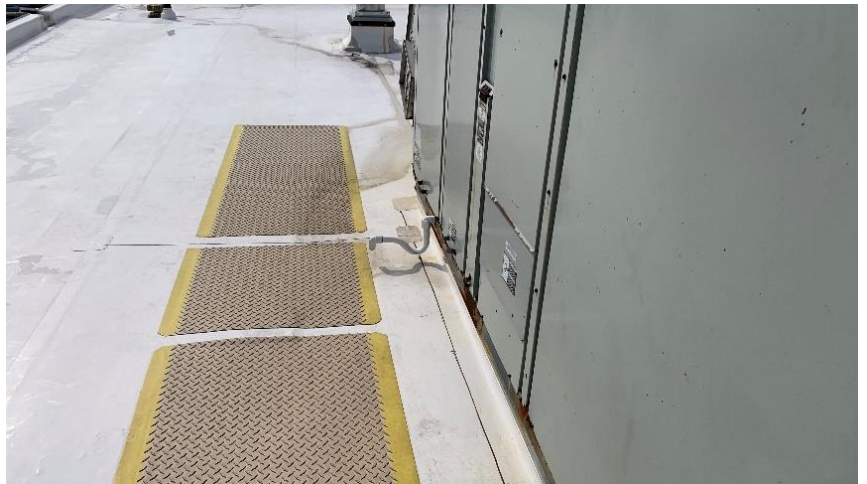
78	RTU-11	3	What is the status on the condensate trap?	Maint.	The condensate trap was repaired.

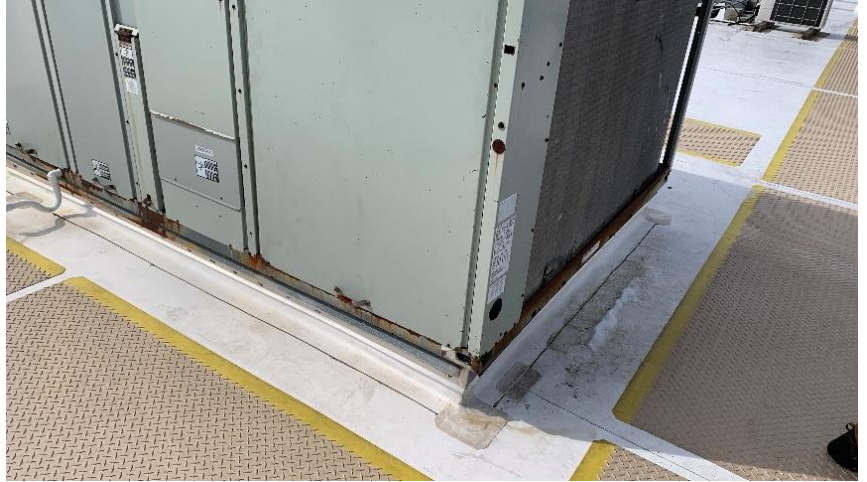
Item ID	Unit	#	Comment	IAQ or Maint.?	vZ Response	Picture
79	RTU-11	4	How is the structural rust impacting the operation of this unit?	Maint.	Structural rust will not impact performance but will be monitored by Facilities.

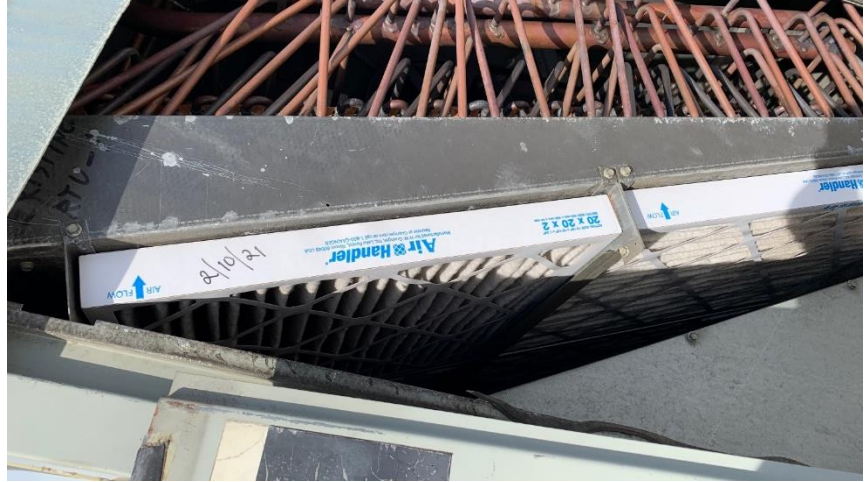
80	RTU-11	5	Were the filter(s) replaced? If so, when? What does it mean no date? What is the follow up here? What type of filter is in place?	IAQ	2" MERV 13 filters were installed 2/10/21. Typically, when a filter change is completed, the company or personnel responsible for the change will use a permanent marker or pen to indicate the date of the filter change. This is often written on one of the filters, preferably an outward-facing one. Sometimes they forget to write the date. The date was written on all filters observed during this visit, though.

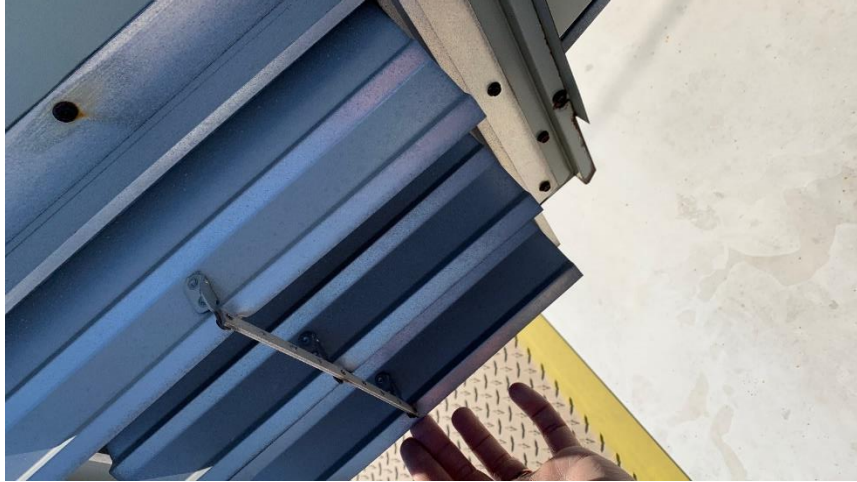
Item ID	Unit	#	Comment	IAQ or Maint.?	vZ Response	Picture
81	RTU-12	1	Has the hinge cap been repaired?	Maint.	Yes, the hinge cap was repaired.

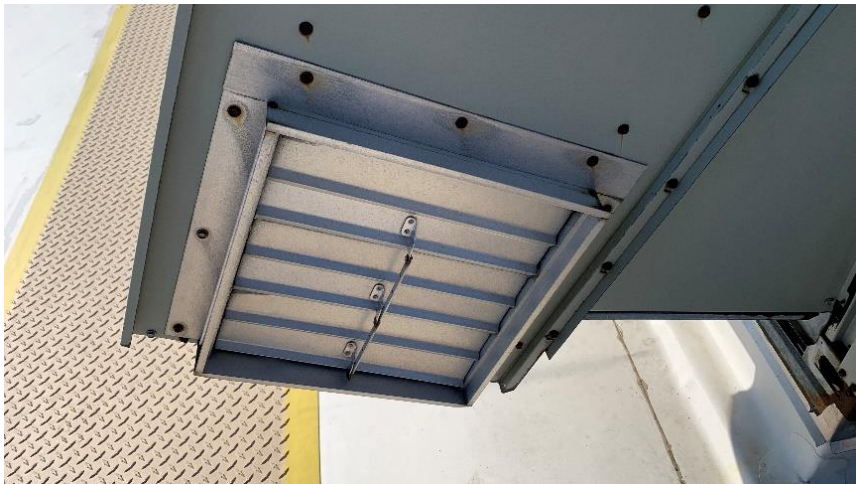
82	RTU-12	2	What about the blade that fell off due to the hinge bap being broken?	Maint.	The blade was reattached to the hinge after the cap was repaired.

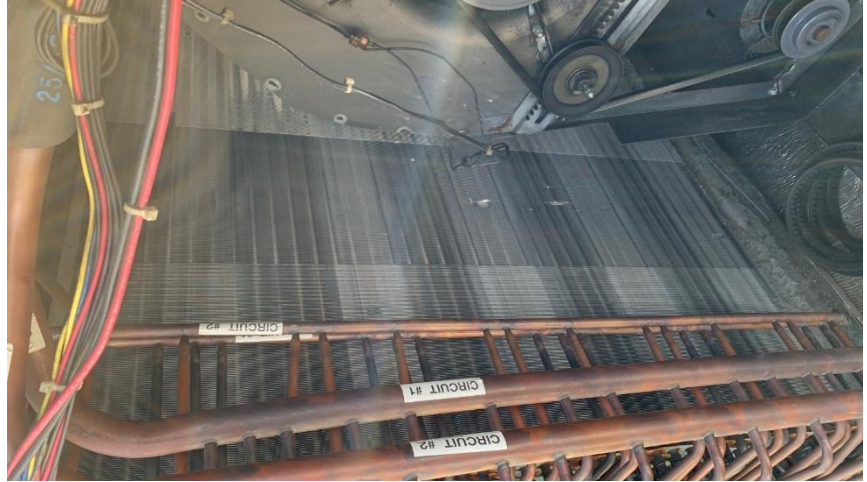
Item ID	Unit	#	Comment	IAQ or Maint.?	vZ Response	Picture
83	RTU-12	3	Saw your note about not combing out the coil. With this damage, what percent of it is operating?	Maint.	The coil has been combed and cleaned. The improvement of this one in particular is significant, with >95% unblocked now.

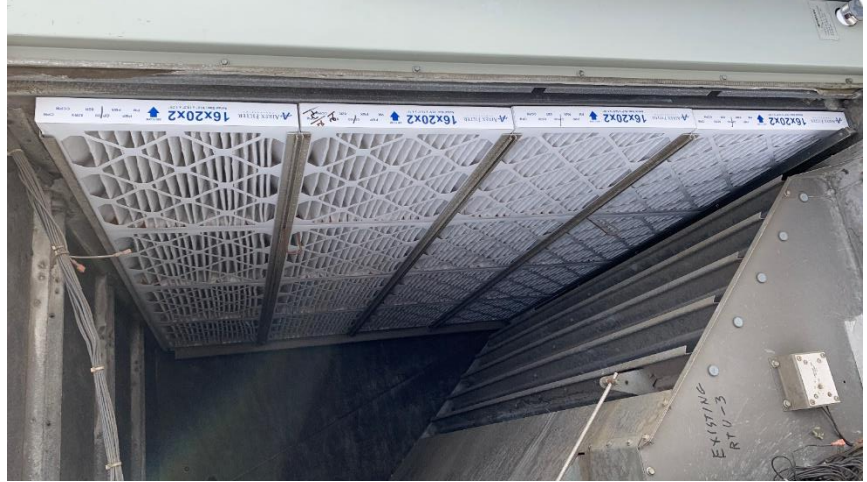
Item ID	Unit	#	Comment	IAQ or Maint.?	vZ Response	Picture
85	RTU-13	1	van Zelm references "filters." Your note referenced "filter" changed. How many filter(s) are there? Were they all changed on 9/14/20? What type of filter was installed?	IAQ	Non-plural was a typo. 16-16x20x2" MERV 13 filters were installed 2/17/21.

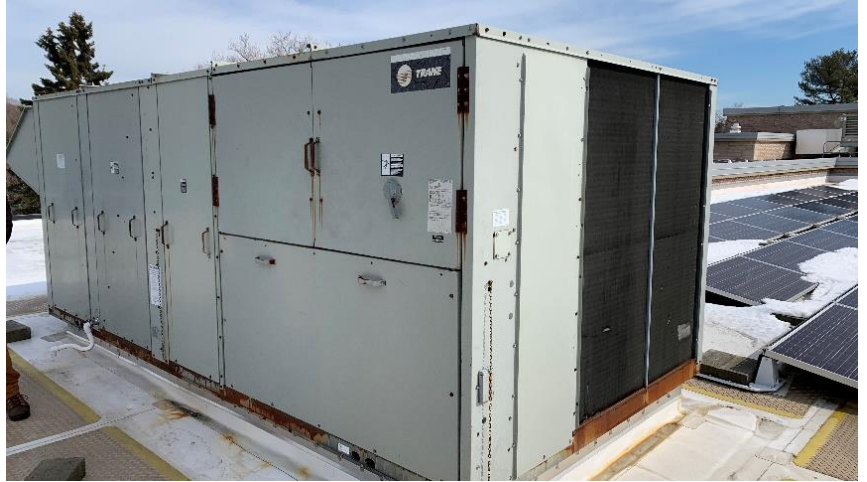
86	RTU-13	2	How does the rust/corrosion affect the operation of this unit?	Maint.	The unit is running well, and the rust was cleaned up. The remaining rust is mostly cosmetic and will not affect unit performance. It's worth noting that this and its sibling units 11, 12, & 14 are ~ 25 years old and still operating. This also does not affect IAQ.

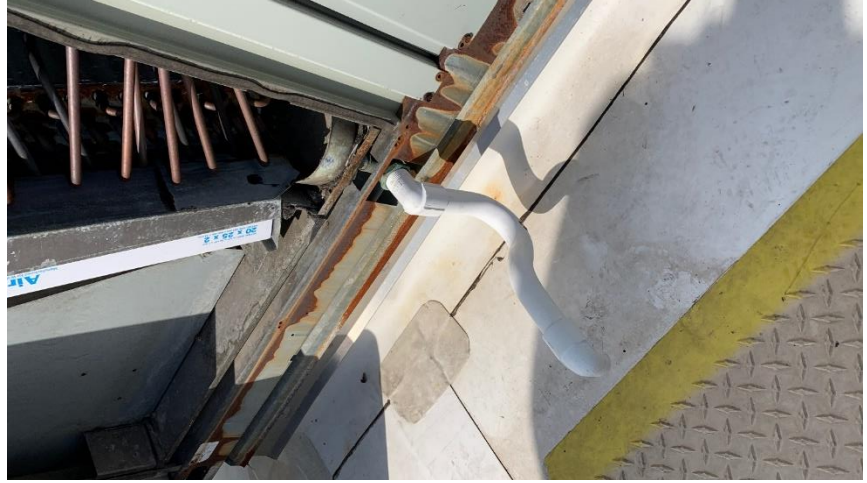
Item ID	Unit	#	Comment	IAQ or Maint.?	vZ Response	Picture
87	RTU-14	1	How does the inability to change the drain impact the fact that it isn't at a sufficient height for operation in this unit?	Maint.	New drain is installed and does comply with height requirements, using a low clearance style.

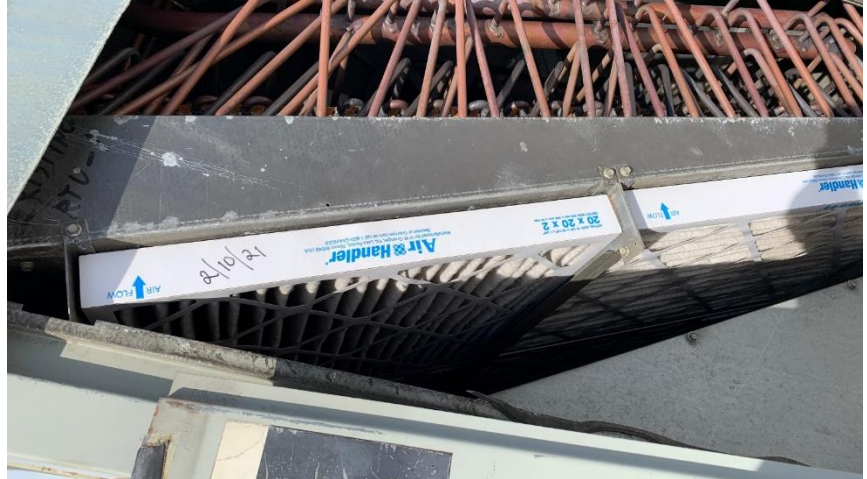
Item ID	Unit	#	Comment	IAQ or Maint.?	vZ Response	Picture
88	RTU-14	2	Have the filter(s) on this unit been changed? If so, when & what type was/were installed?	IAQ	2" MERV 13 filters were installed 2/10/21.

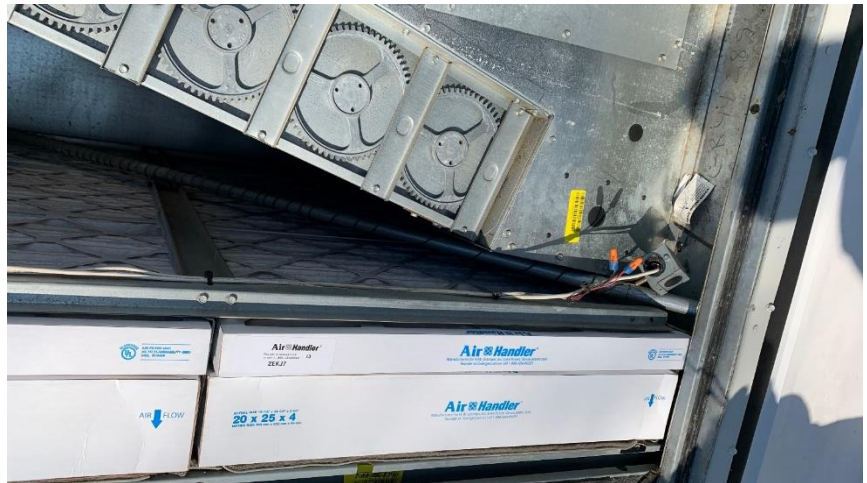
89	RTU-1R1	1	Was the mixed air sensor reattached?	Maint.	The Mixed Air (MA) sensor still needs to be replaced but this does not affect IAQ. This has been added to the maintenance punchlist.
