**ROCHESTER COMMUNITY SCHOOL DISTRICT
ADMINISTRATION BUILDING**

**KINGSCOTT ASSOCIATES, PC
CLARK CONSTRUCTION COMPANY
STRATEGIC ENERGY SOLUTIONS INC.
CBRE
BUR VALUATION GROUP**

**FACILITIES NEEDS ASSESSMENT
September 2019**

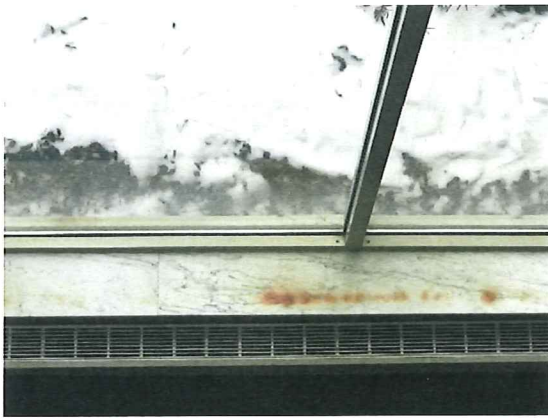
Picture #5: Staining of finish material due to water penetration of slope glazing in "Atrium". Further examples of issues with the "Atrium" are shown further in this photo survey.

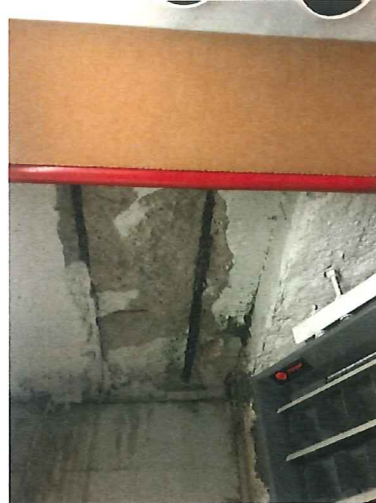
Picture #8: Room under exterior walkway. This room has no area above it or grade. Damage is caused by the infiltration of water and environmental containments. Rooms should be demolished.

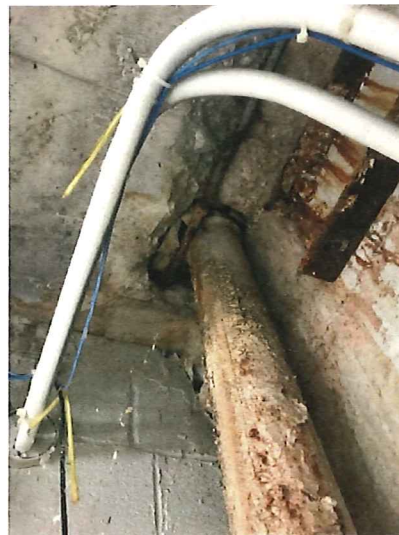
Picture #9: Same area as picture #8

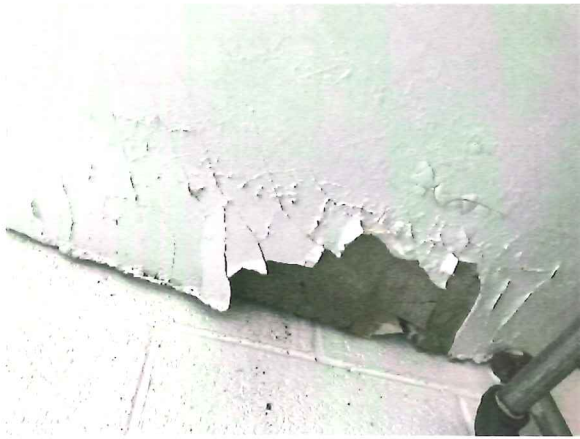
Picture #17: Ceiling damage due to water penetration. Stairwell #5, but this can be found in areas throughout. Especially level 3.

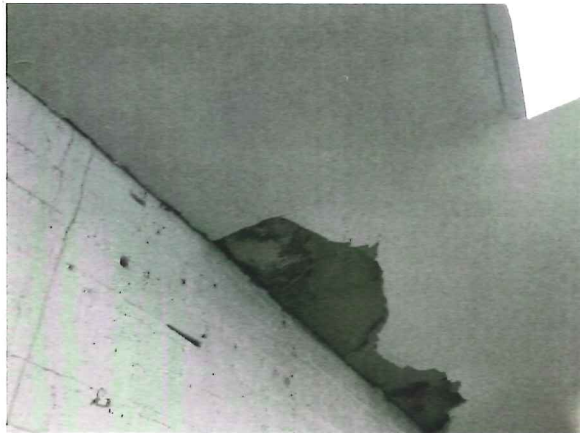
Picture #18: Same area as picture #17 in different location.

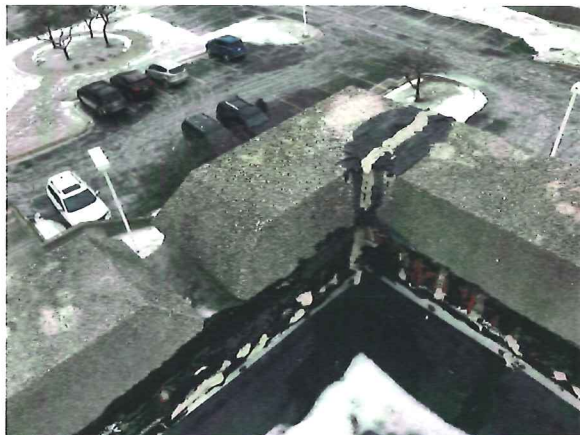
Picture #19: Typical issue for the top of the wall where there is stone coping. Improper prior attempt to fix the coping grout between stones. Roof membrane should go up the wall and under the stone coping.

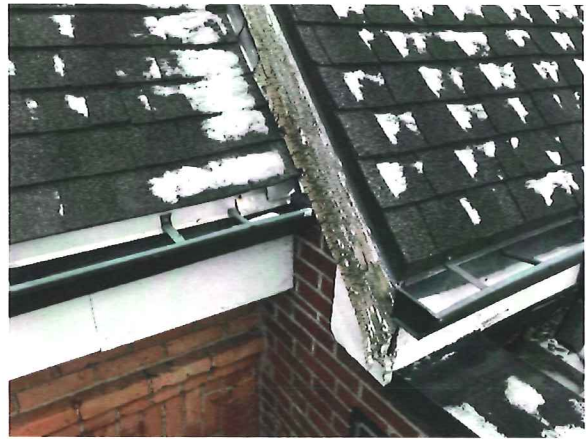
Picture #22: Typical aged wood trim. Limited amount required to be replaced.

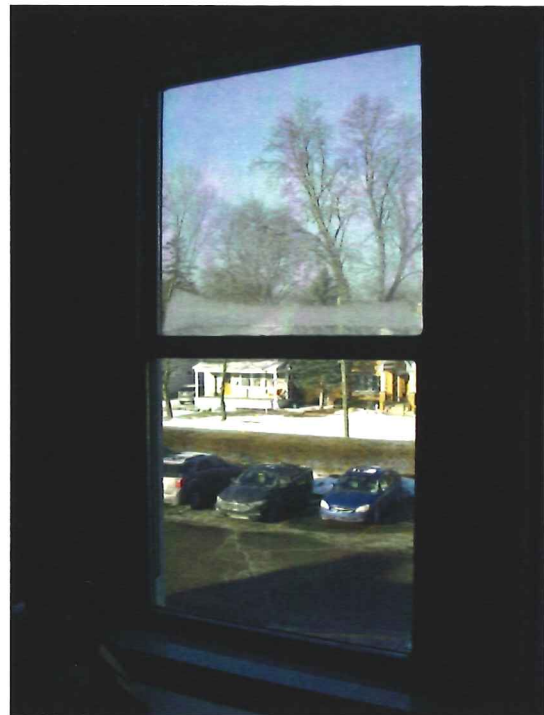
Picture #38: Typical Window Issue.

All windows in the facility are recommended to be replaced. While not all windows are showing signs of failure, it is of the opinion that they will in the future begin to fail as well. It is also believed that this issue is in direct relation to the issue of the roof leakage problem at the parapets, as well as no weep holes seem to be present at the window heads. It was also noted that a great majority of the windows had failing sealant which could also contribute to the problem.

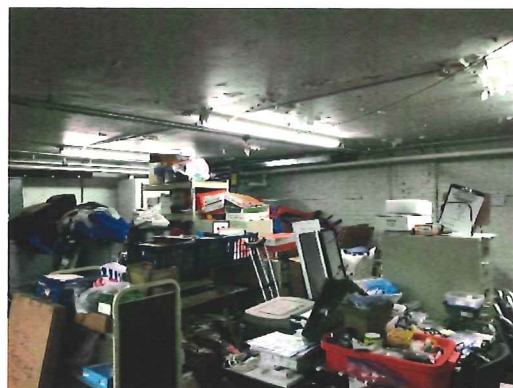
Picture #30: Typical ceiling is due to atmospheric moisture in the basement of the original portion of the building on the property.

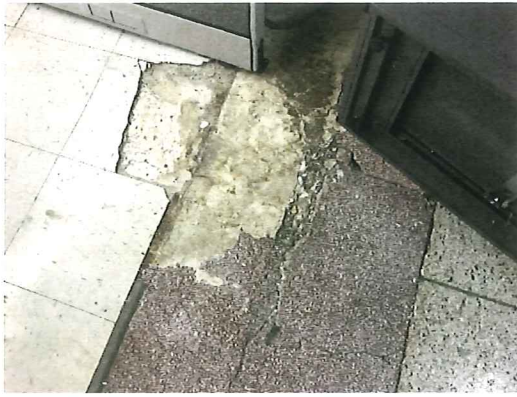
Picture #33: Typical floor remediation required at exposed original terrazzo floor.

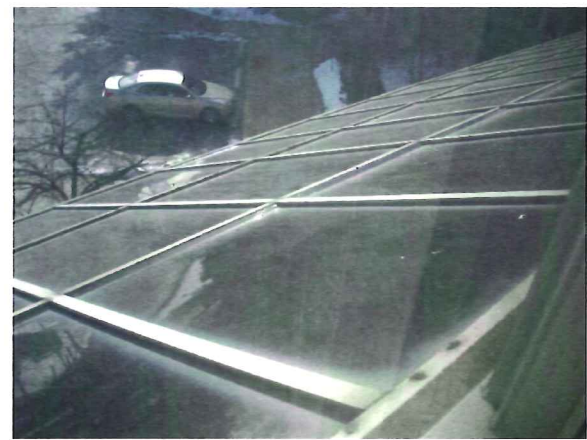
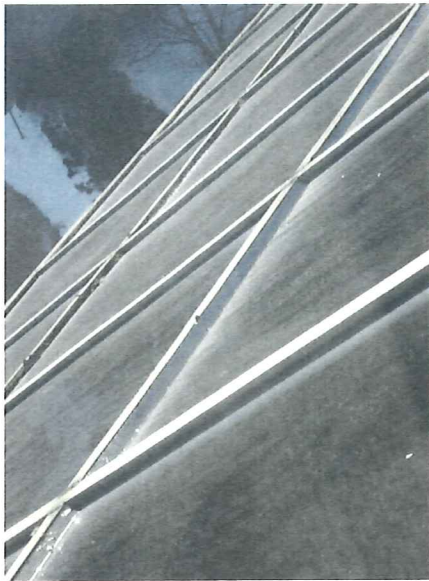
Pictures #48-50: Typical condition of main corridor sloped skylight. Design does not allow for the free flow of moisture.

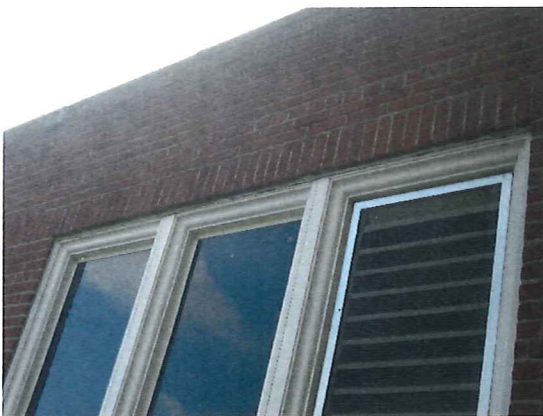
Picture #54 (#55 similar): Typical condition of exterior side of windows. Re-caulk all.

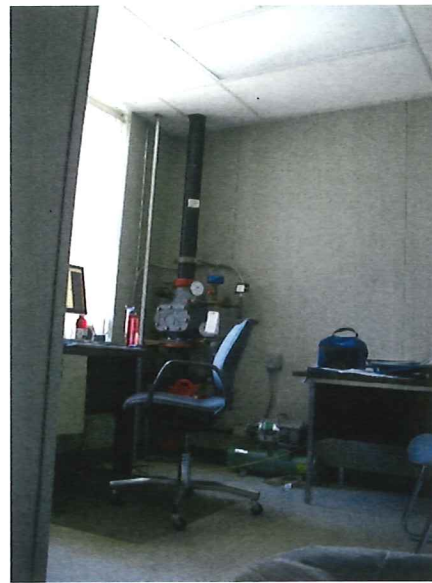
Picture #56: Storage/Office space. Replace door with 1 hour rated door, frame and threshold to prevent smoke infiltration.

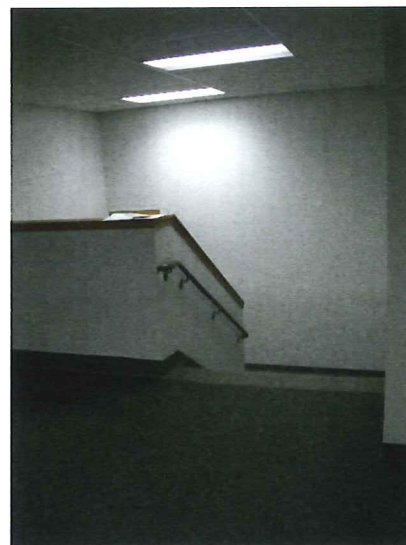
Picture #57: combustible material replaced. I.E. wall cap, carpet, etc. Under a major renovation, code dictates these be replaced.

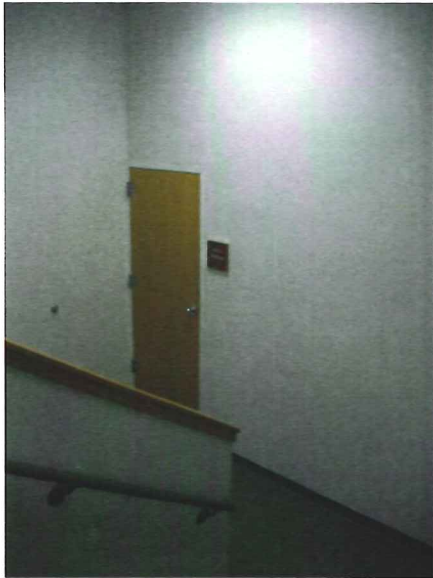
Picture #58: Door swing incorrect. Door to be rated. Wall in which door resides shall meet 1 hour rating. Further investigation would be required.

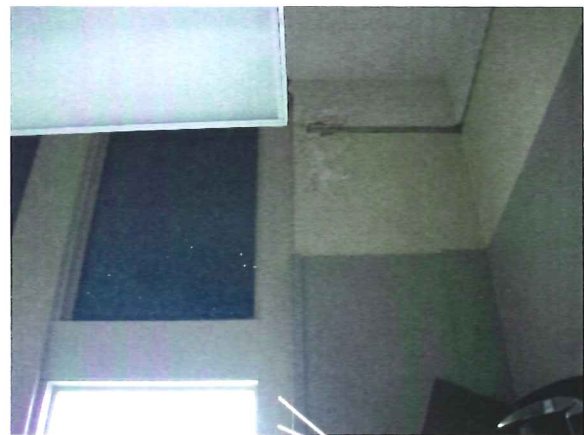
Picture #62: Typical window head on the third level-water damage to window head and wall.

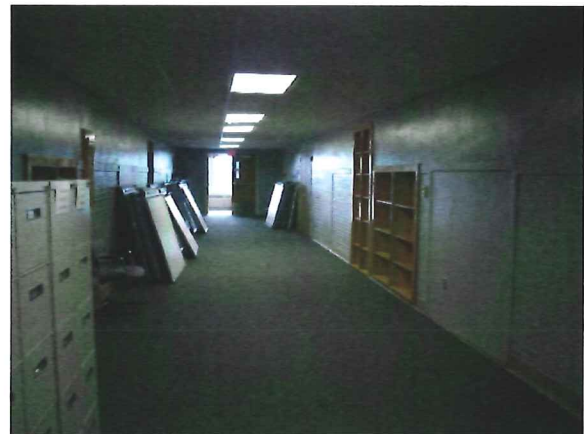
Picture #65: Typical corridor issues

- 1) Combustible construction material, I.E. shelving, wood infill etc. Not acceptable in corridors for this facility.
- 2) Corridors shall remain free from all moveable objects.
- 3) Above ceiling may have non-sealed wall penetrations as seen in other areas.

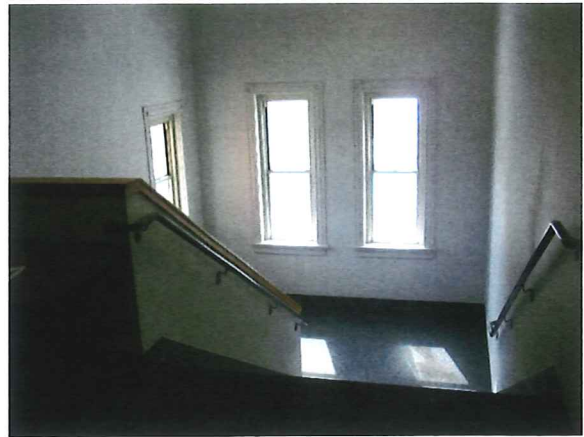
Picture #69 (#70 Sim.): Stair to be enclosed and combustible material replaced. I.E. wall cap, etc. Under a major renovation, code dictates stairs to be enclosed.

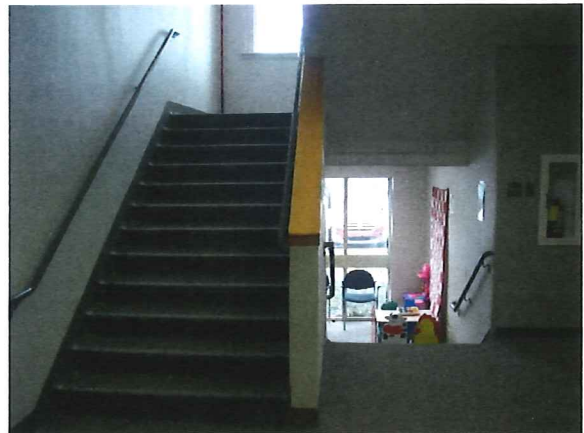
Picture #71: Similar circumstance as picture #69, different stair.

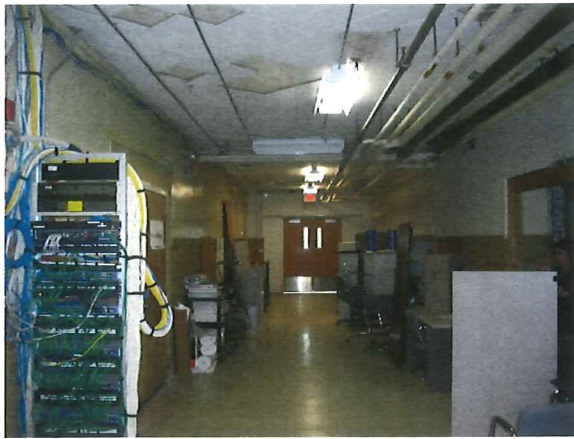
Picture #81: All items removed from corridor, including I.T. Ceiling to be repair or drop ceiling to be installed. Any wall and ceiling penetrations to be sealed.

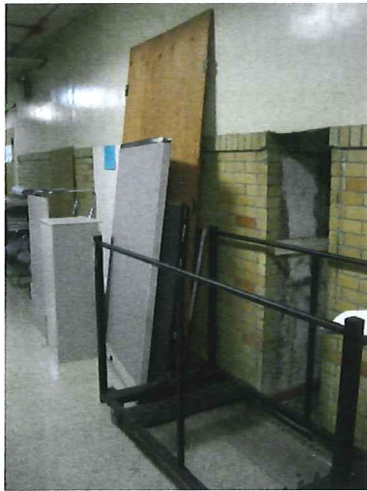
Picture #82: Same corridor as picture 81

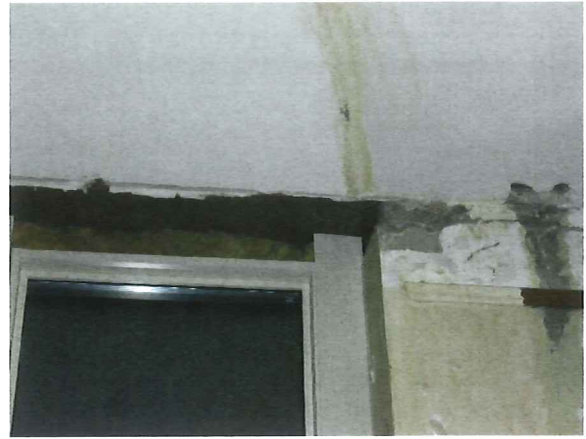
Picture #85: Same water damage at the window head that occurs on level 3.

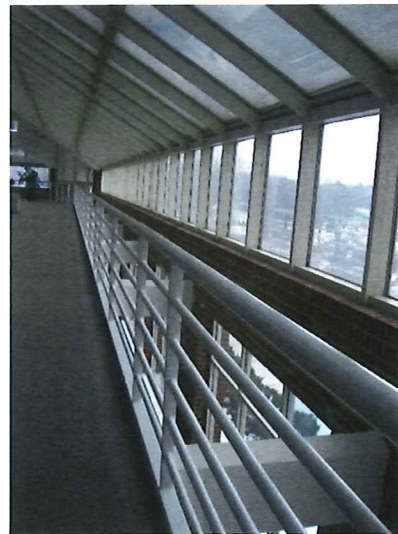
Picture #87: Guardrail does not meet current codes and would require it to be removed and replaced or upgraded to today's codes.

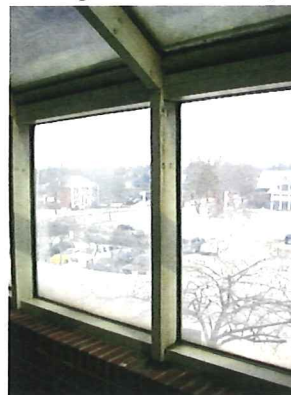
Picture #89

Pictures #89-#93: Current glass sloped roof of the corridor "Atrium" has significant water penetrations problems. There is staining to finishes and damage to the system. As well as damage to the underlying structure below.

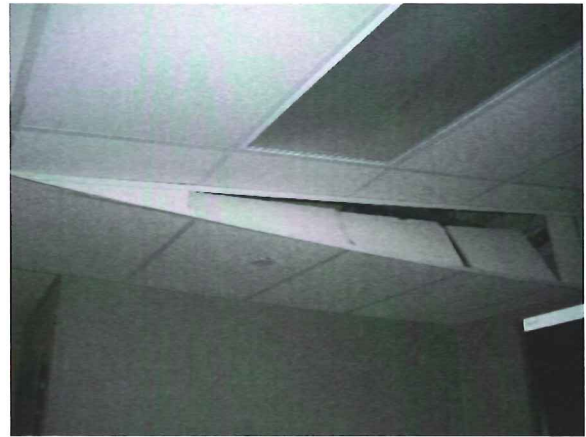
Picture #96: Example of ceiling finish that needs to be remedied.

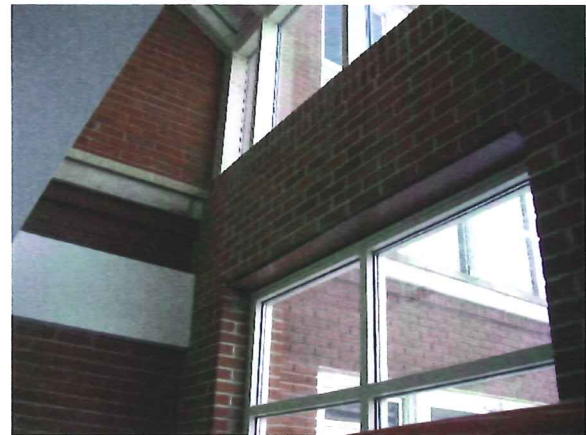
Picture #97

Pictures #97-#104: Various locations of damage, including structural, of the leaking sloped windows in the "Atrium". Although currently not an extreme hazard, it would become a danger in the not to distant future.

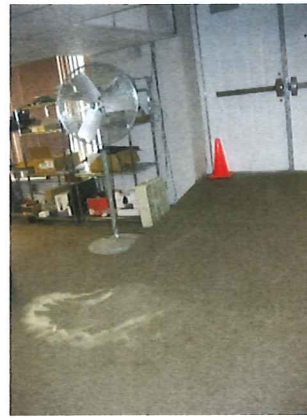
Picture #105: Door requires new weather seals and the surrounding construction be remediated because of damage and weather sealed. In view in the staining due to moisture through the door and door edges.

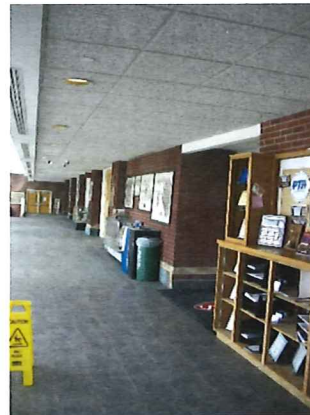
Picture #106: Existing "Atrium". To be rebuilt due to the leaking sloped glazing and damage to the exterior wall.

The second major issue is the 1989 lobby addition. The glazing and frame over the lobby and corridor is holding water at the individual panes of glass. This is caused by there not being; one, weep holes in the frame to allow the passage of water to the gutter, and two, the frames of the "skylight" system is above the glass surface which causes the water to pool at the frame edges. This is causing damage to the structure above the lobby and corridor windows. There is no remediation to this issue. The whole 1989 lobby addition needs to be removed and rebuilt.

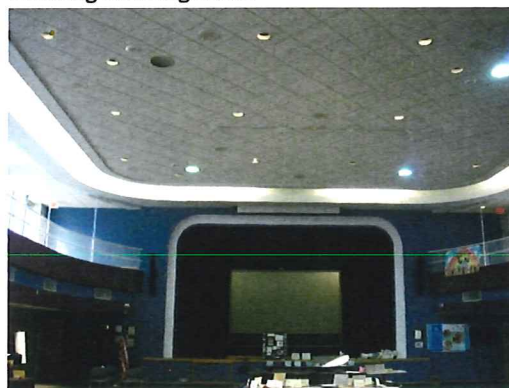
Picture #107

Pictures #107-#110 (#108 & #109 not shown): Complete renovation of finishes in space to provide an modern and appropriate atmosphere. Upper floor guardrails to be replaced with new guardrails meeting building code.

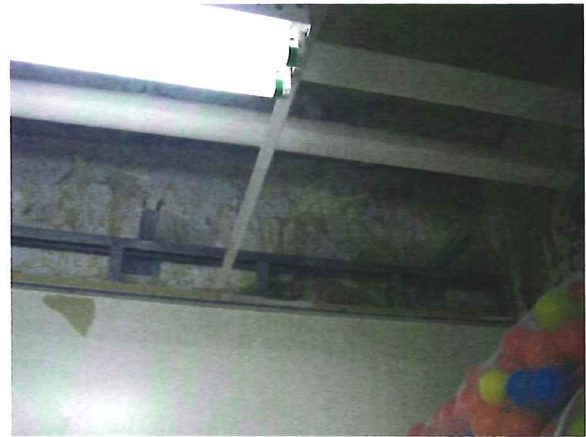
Picture #113: Exterior wall (below grade) deteriorating.

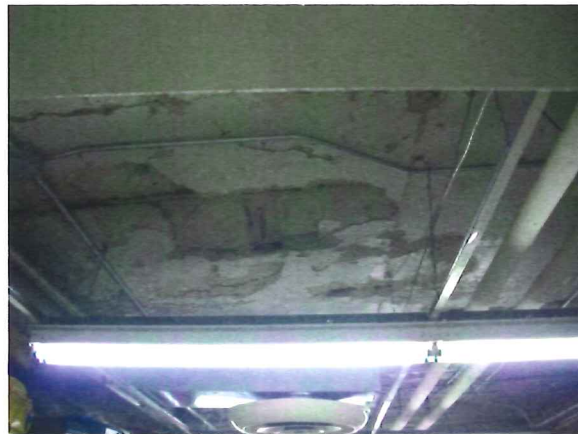
Picture #111

Pictures #111-#113: Storage space under concrete flat area (grade) is significantly damaged to water and environmental containments penetrating into the space and damaging the structure. This space does not have floor space above it or grade. This area should be demolished.
