IEA, INC.

2020 - 2021 IAQ Walkthrough

Fridley ISD #14 Area Learning Center

Walkthrough Date & Time:
Thursday, February 18, 2021
12:00 PM to 2:00 PM

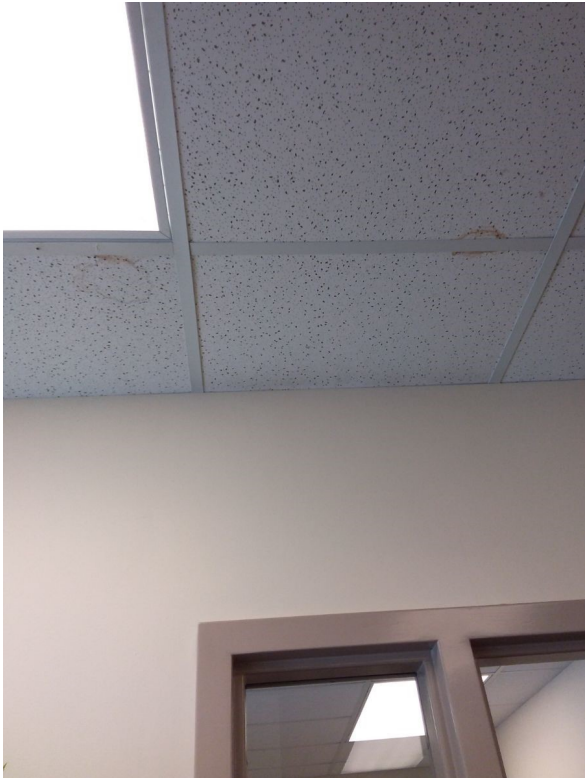
MAIN RECEPTION
Stained Ceiling Tiles

Stained ceiling tiles were found in the room(s) shown below. The impacted ceiling tiles should be removed and replaced, and the cause of the moisture repaired.

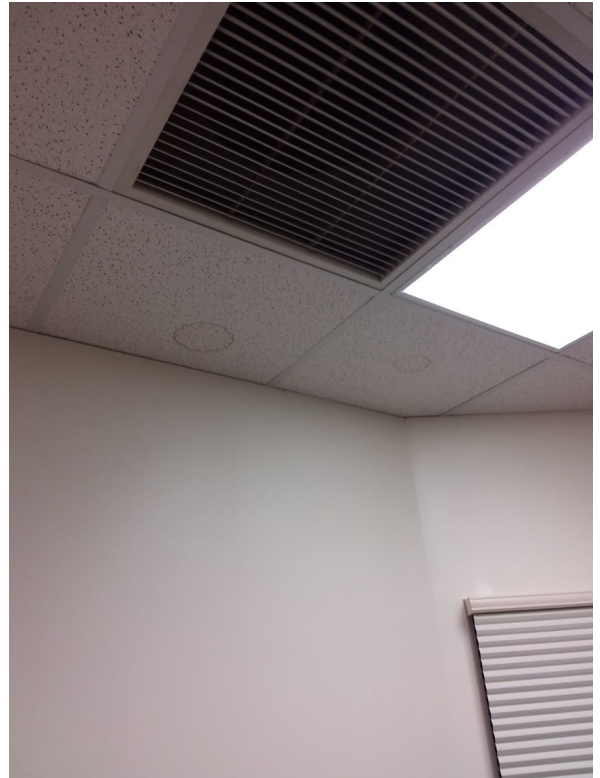
125
Stained Ceiling Tiles

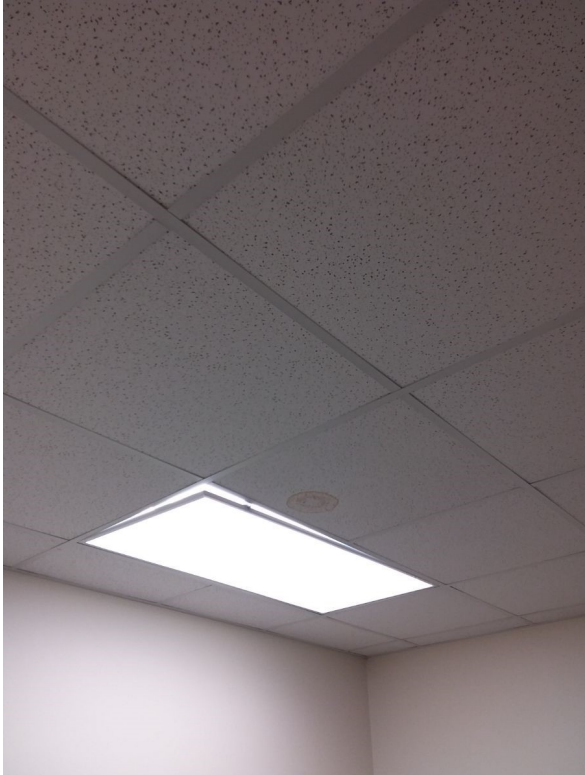
112
Stained Ceiling Tiles

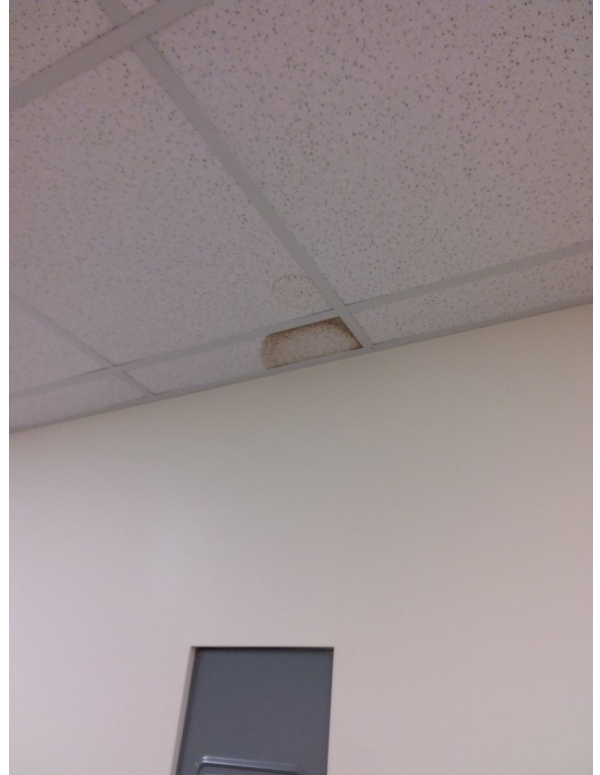
114
Stained Ceiling Tiles

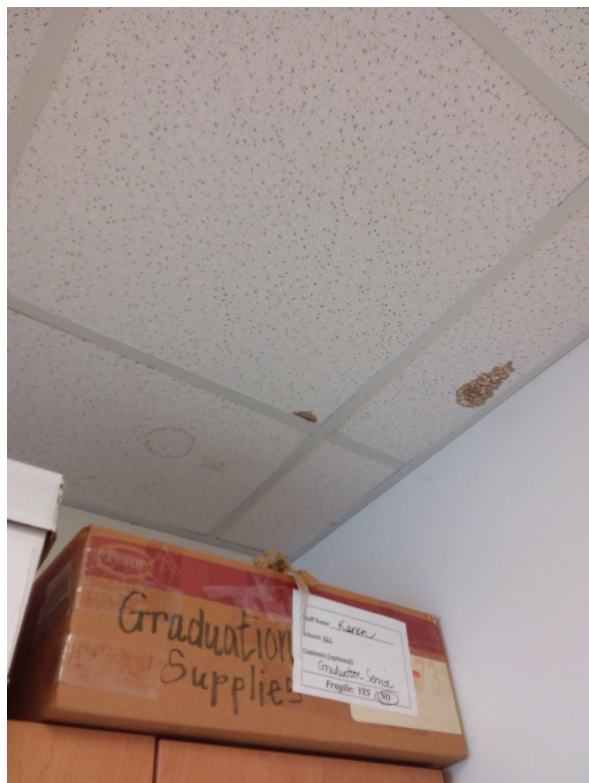
119
Stained Ceiling Tiles

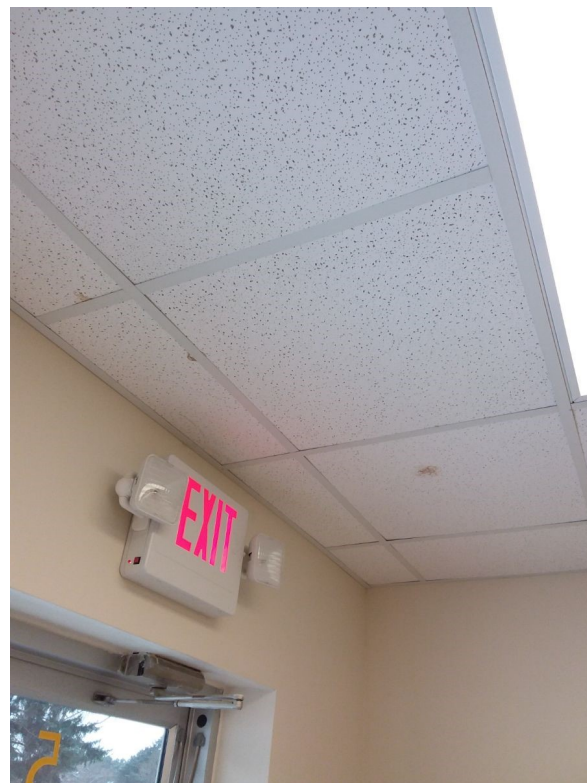
119
Stained Ceiling Tiles
