2020 - 2021 IAQ Walkthrough

Fridley ISD #14 Fridley Middle School

Walkthrough Date & Time:
Thursday, February 18, 2021
8:00 AM to 12:00 PM

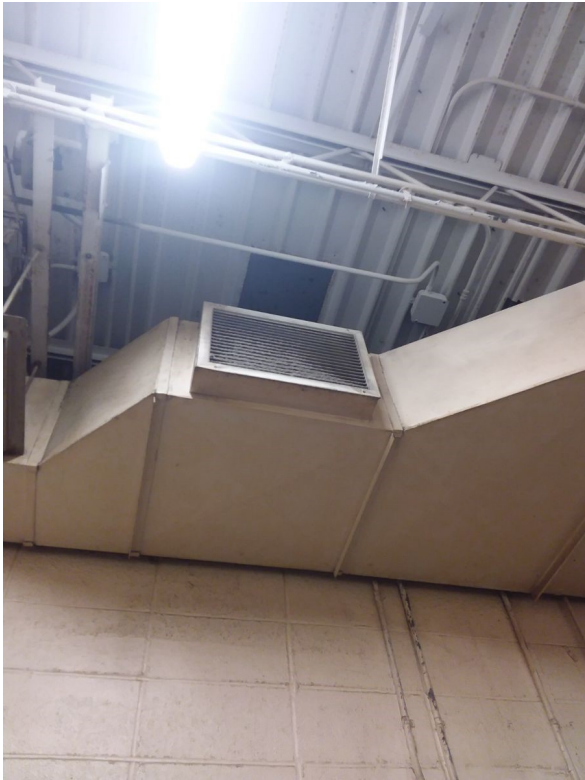
- 185 *Air Supply*
- GYMNASIUM *Air Return;*
184 *Diffusers*
 accumulating dust

185
Dust

IEA observed dust accumulation in the following room(s) and recommend that the specified area is wiped clean using a damp rag.

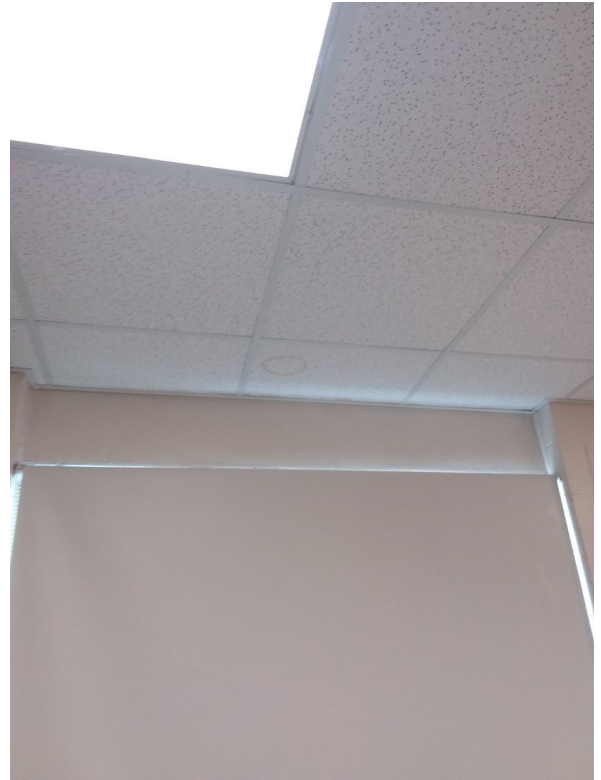
142
Stained Ceiling Tiles

Stained ceiling tiles were found in the room(s) shown below. The impacted ceiling tiles should be removed and replaced, and the cause of the moisture repaired.

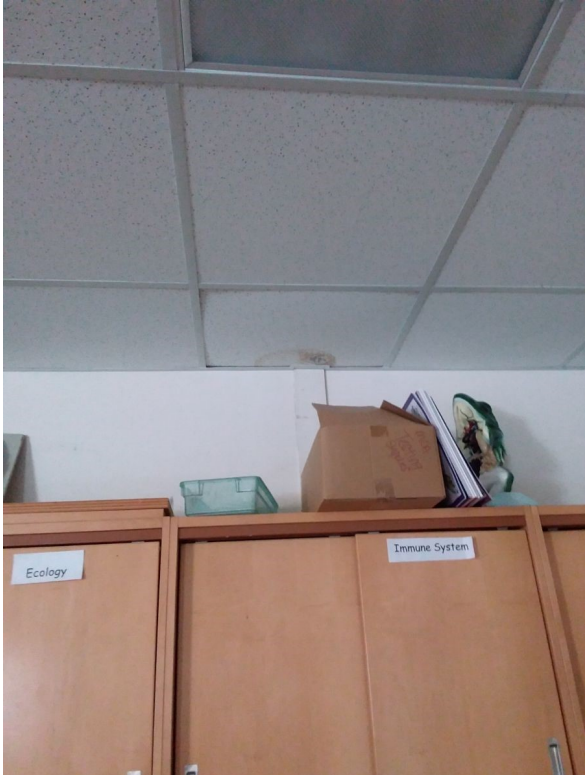
133
Stained Ceiling Tiles
