2020 - 2021 IAQ Walkthrough

Fridley ISD #14 Fridley High School

Walkthrough Date & Time:
Wednesday, February 17, 2021
9:00 AM to 2:00 PM

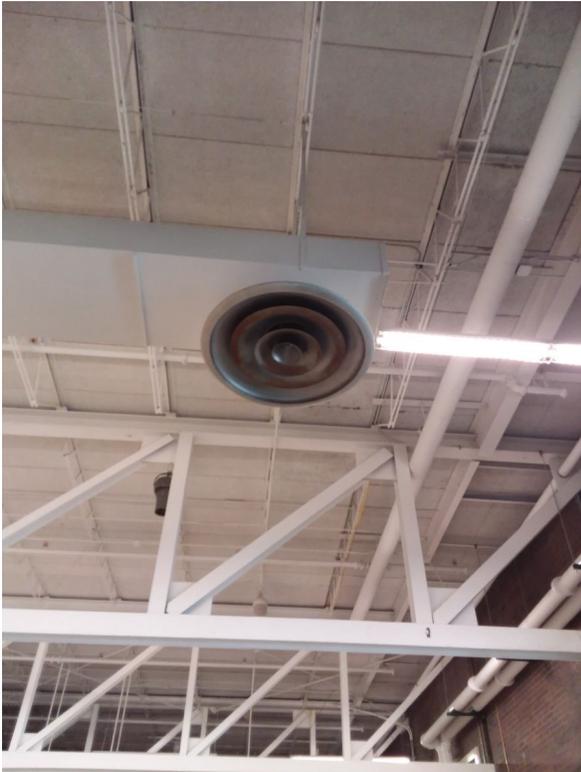
MEZZANINE

Moisture Impacted Materials

Moisture-impacted building materials should be repaired or replaced when discoloration or water staining is observed. Moisture-impacted building materials can be a source for microbial growth. The source for the moisture infiltration should be investigated and repaired if not easily identified.

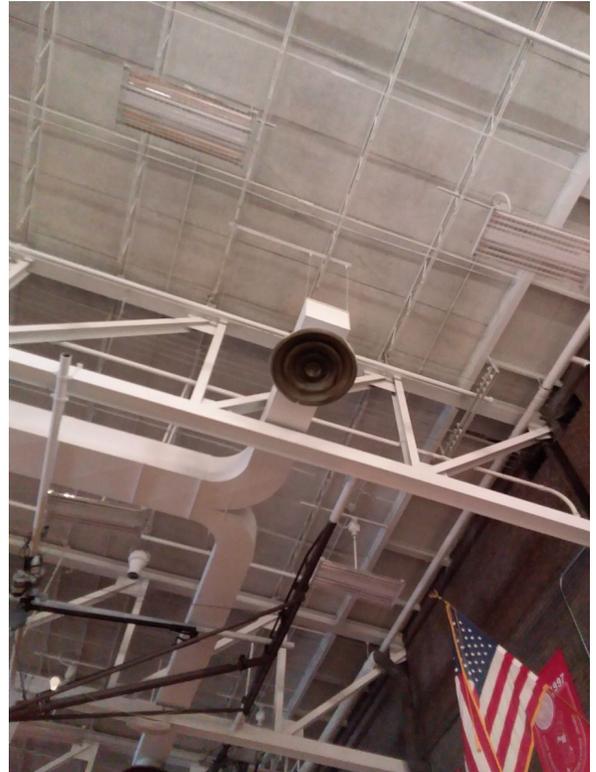
MAIN GYMNASIUM

Moisture Impacted Materials

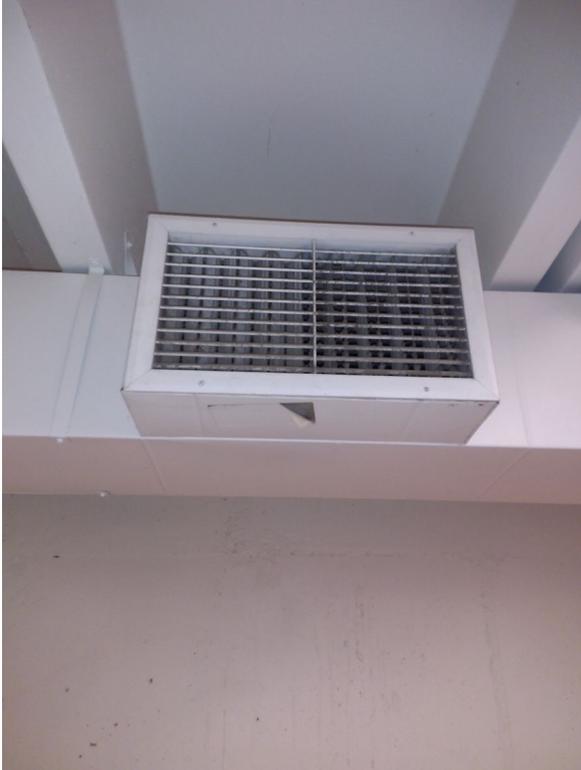
GIRLS LOCKER ROOM

Dust

IEA observed dust accumulation in the following room(s) and recommend that the specified area is wiped clean using a damp rag.

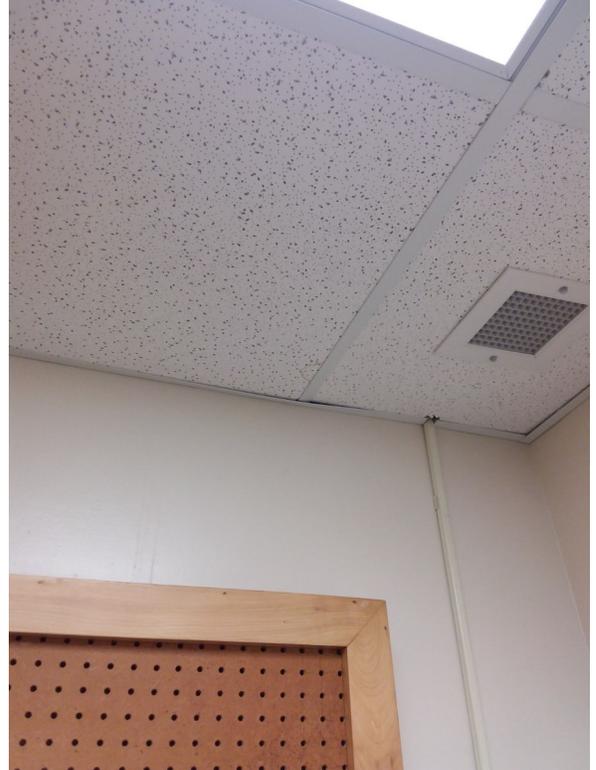
126

Stained Ceiling Tiles

Stained ceiling tiles were found in the room(s) shown below. The impacted ceiling tiles should be removed and replaced, and the cause of the moisture repaired.

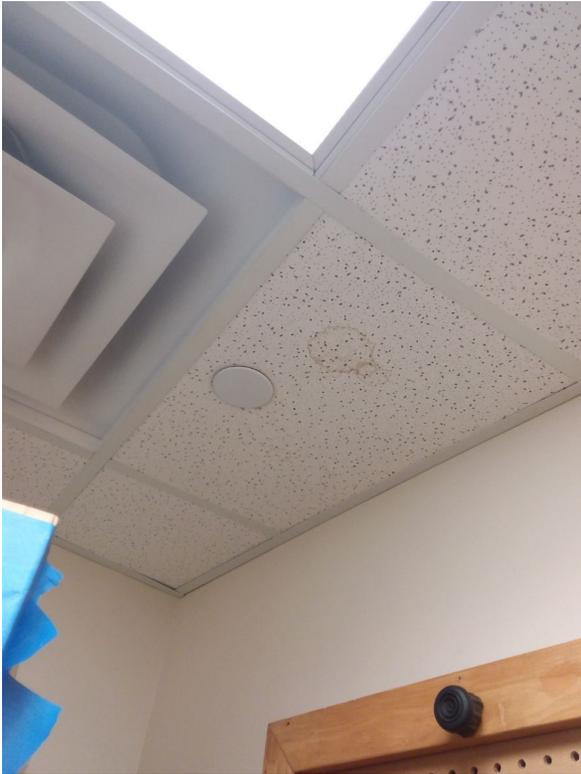
126
Stained Ceiling Tiles

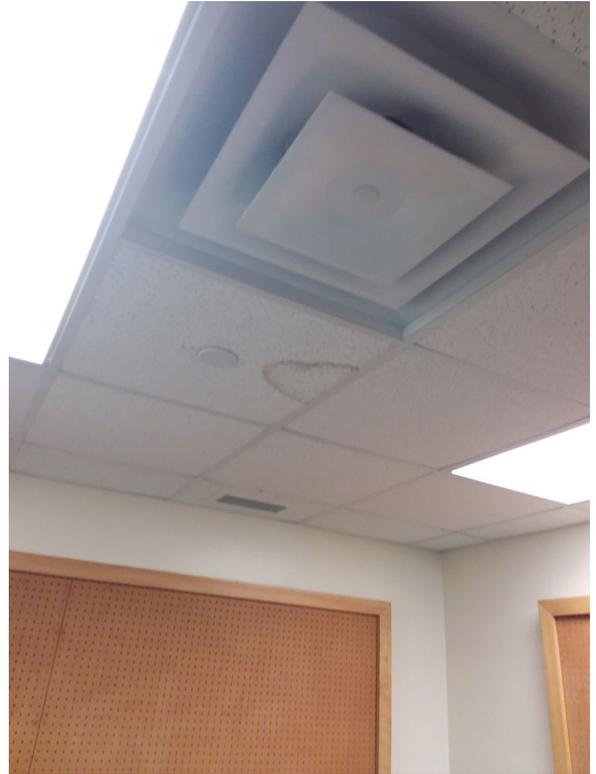
128
Stained Ceiling Tiles

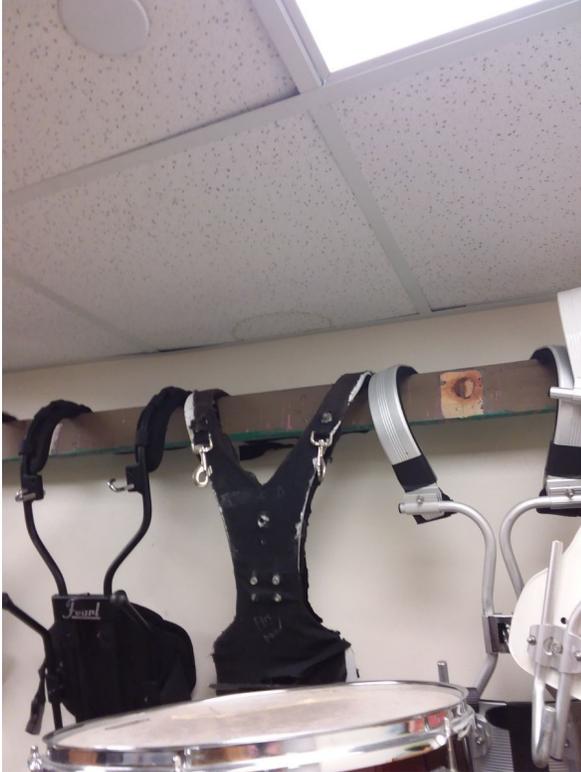
132
Stained Ceiling Tiles

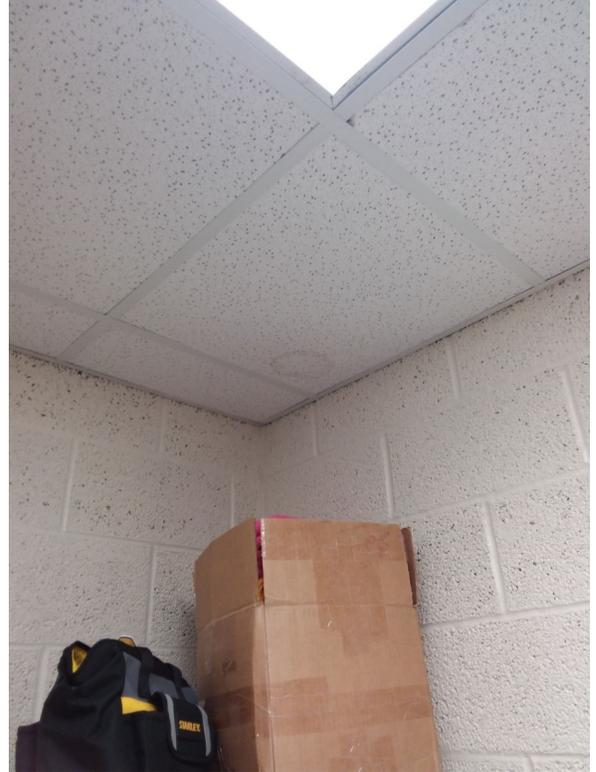
136
Stained Ceiling Tiles

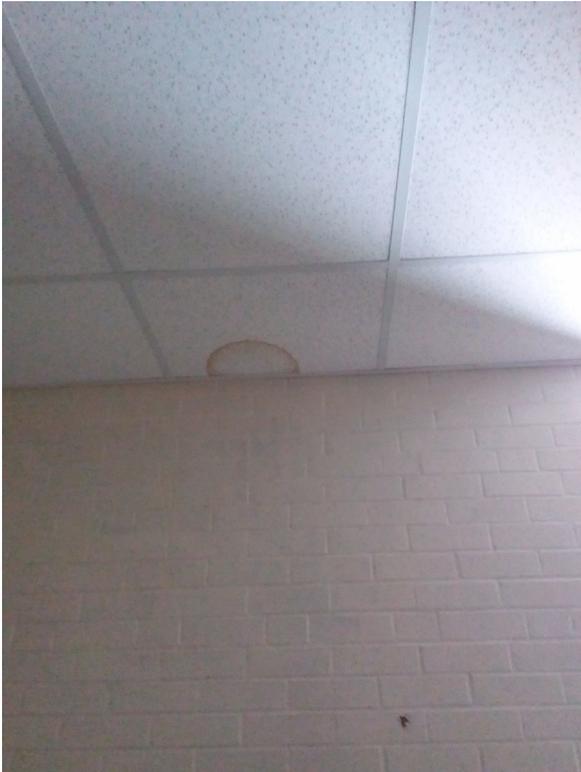
136 OFFICE
Stained Ceiling Tiles

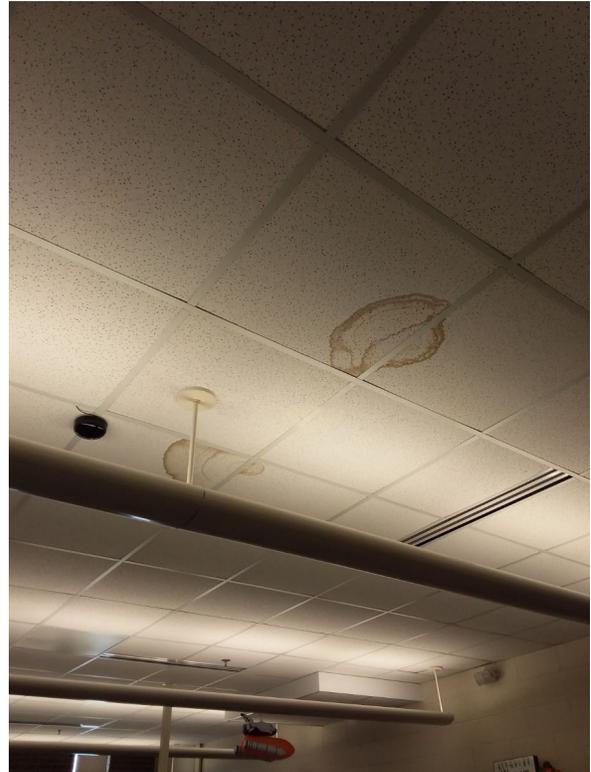
140
Stained Ceiling Tiles

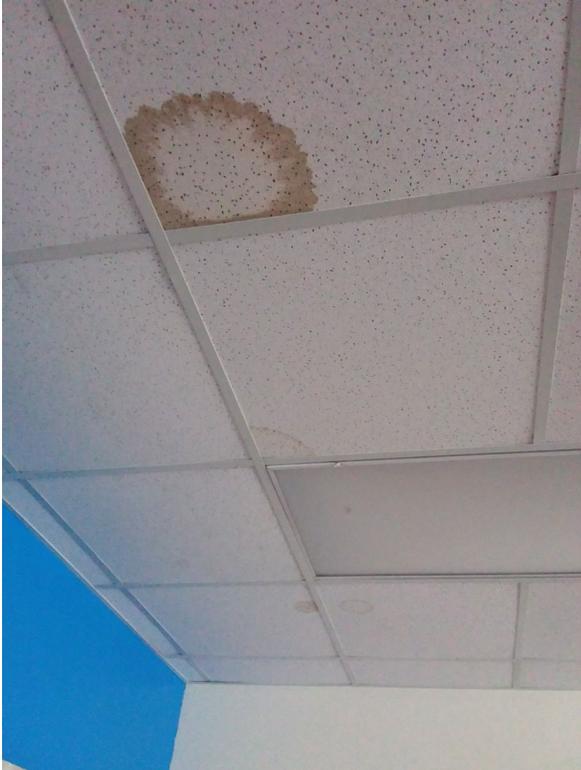
141
Stained Ceiling Tiles

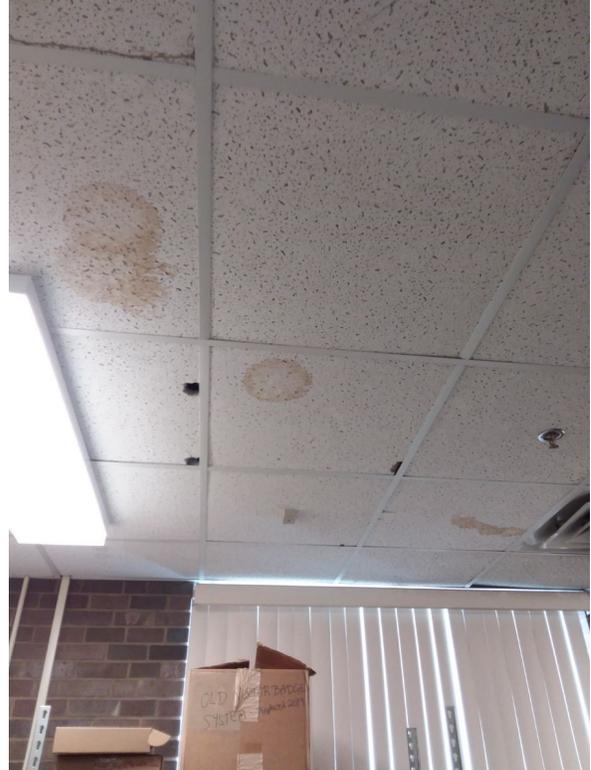
143B
Stained Ceiling Tiles

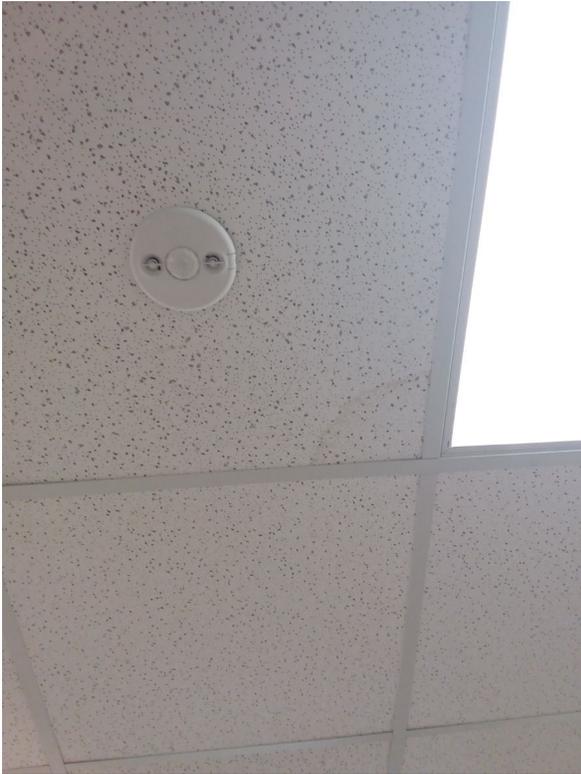
145
Stained Ceiling Tiles

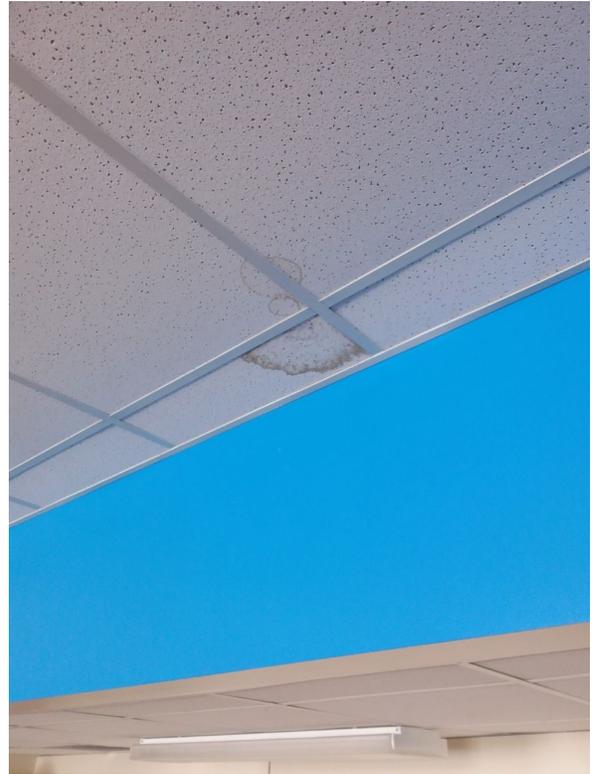
146
Stained Ceiling Tiles

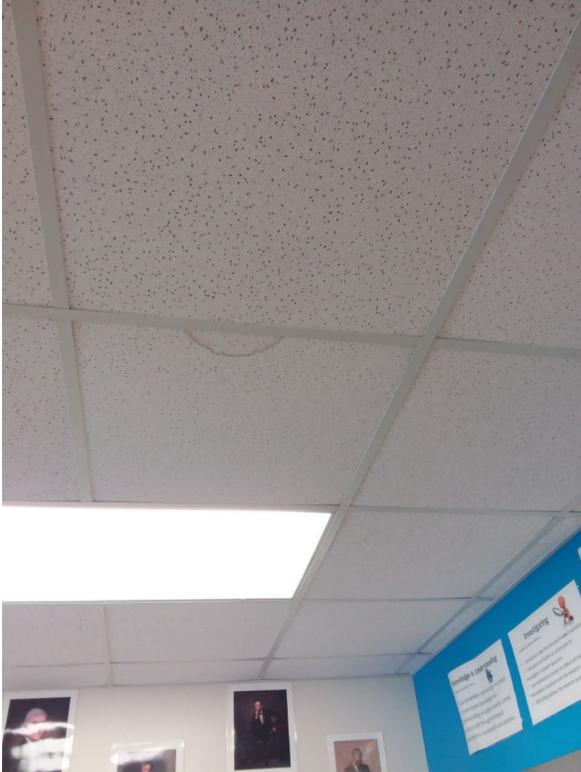
148
Stained Ceiling Tiles

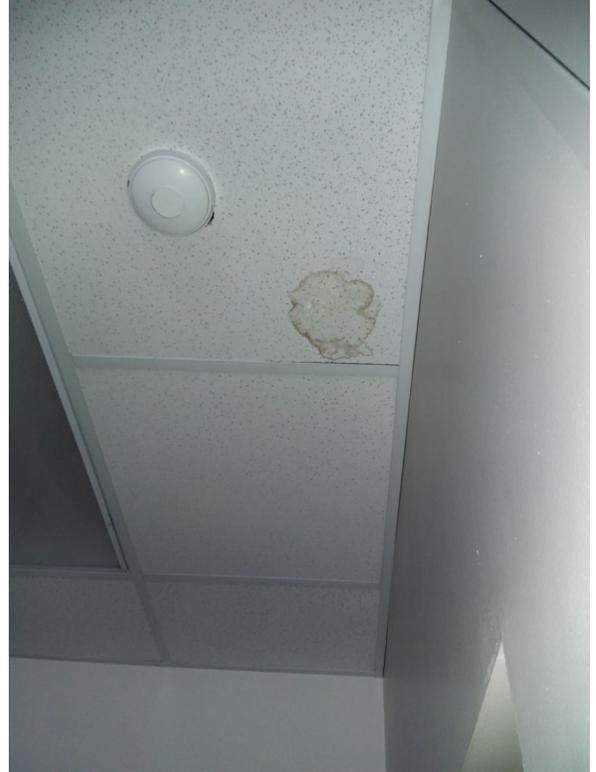
163
Stained Ceiling Tiles

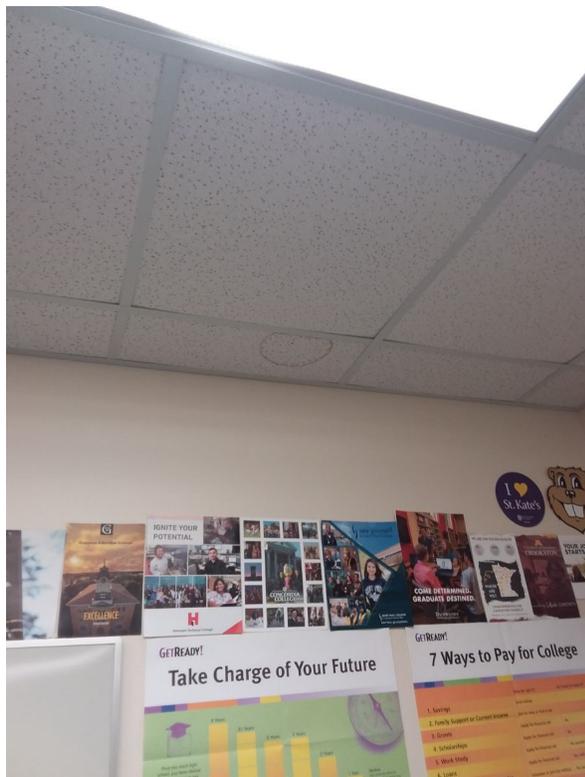
109A
Stained Ceiling Tiles

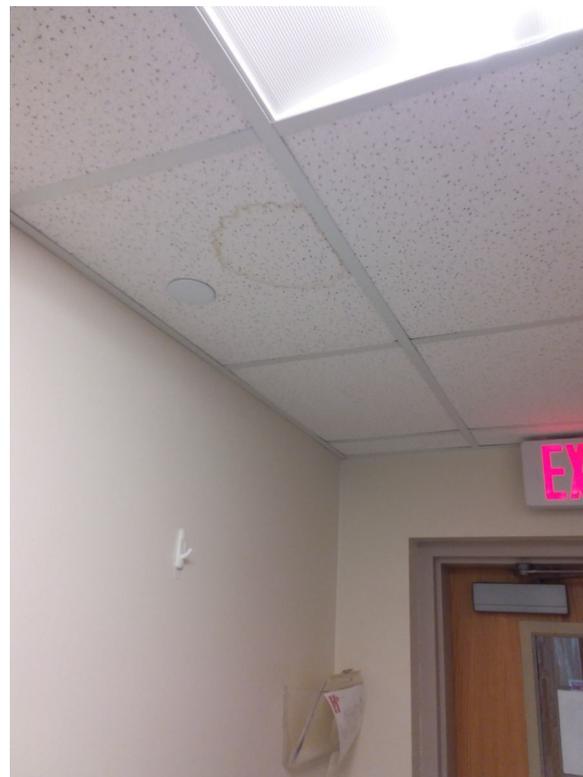
HEALTH SERVICES
Stained Ceiling Tiles

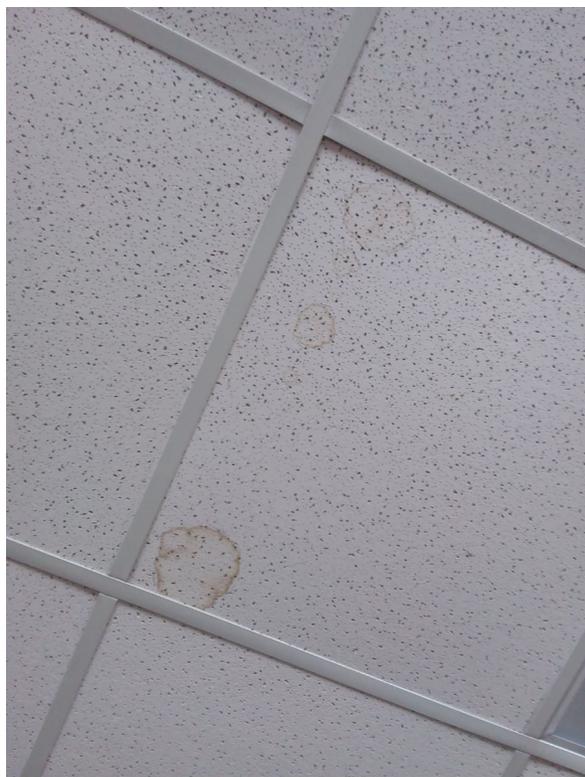
106
Stained Ceiling Tiles

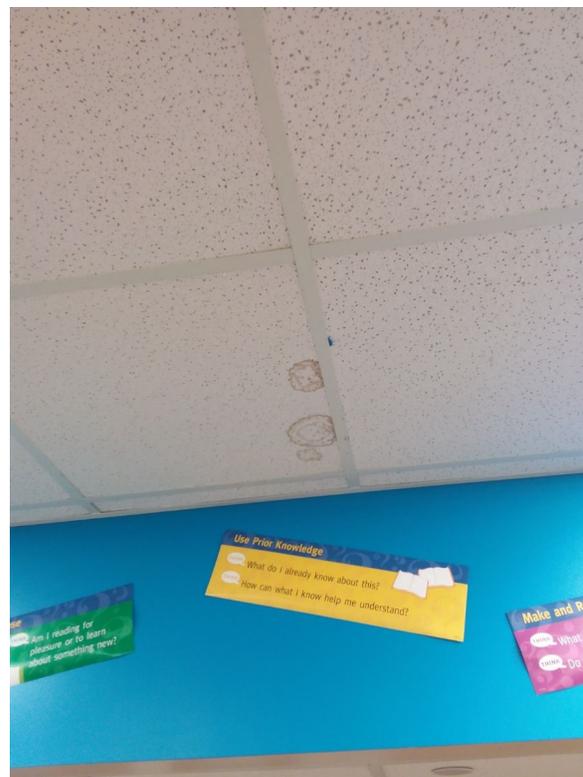
121
Stained Ceiling Tiles

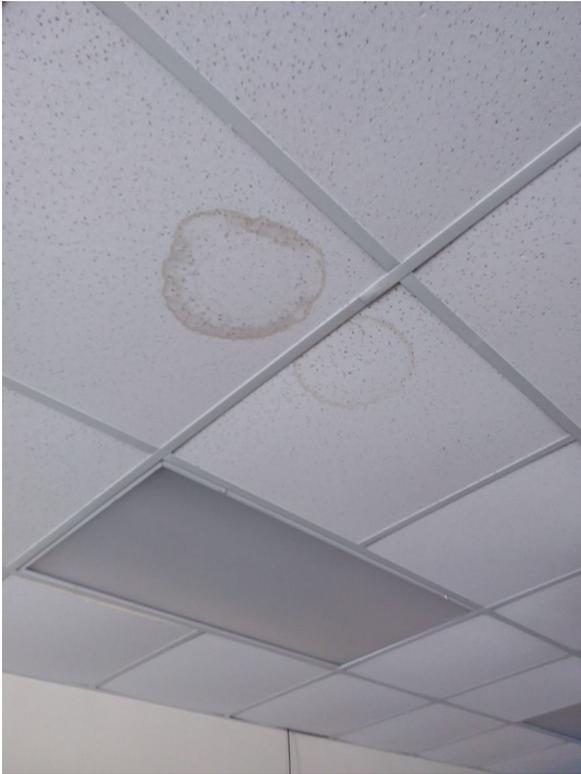
120
Stained Ceiling Tiles

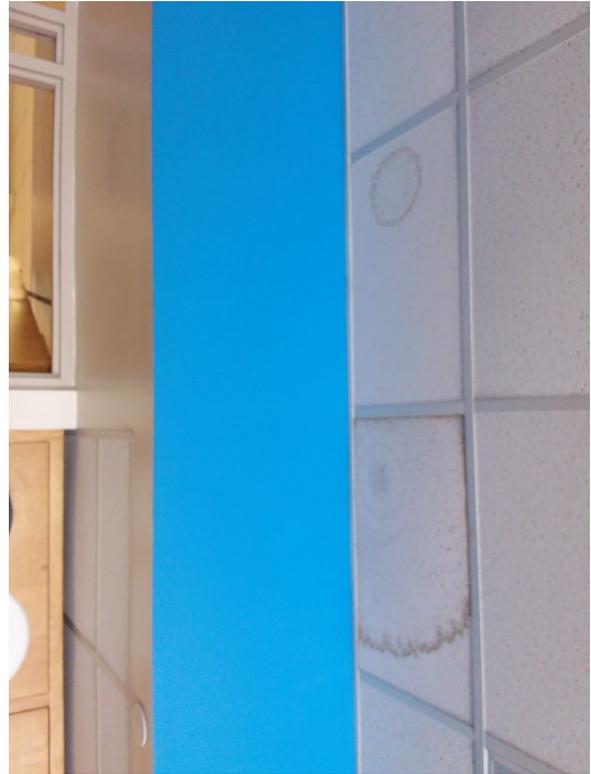
117
Stained Ceiling Tiles
