TOWN OF SUFFIELD

Municipal Facilities Master Plan

A. Ward Spaulding School

Grades	Building Area / Site	Age / Construction
PK-2	71,406 SF / 19.5 acres	1954 (67), 1961(60), 1985 (36), 1988 (33)

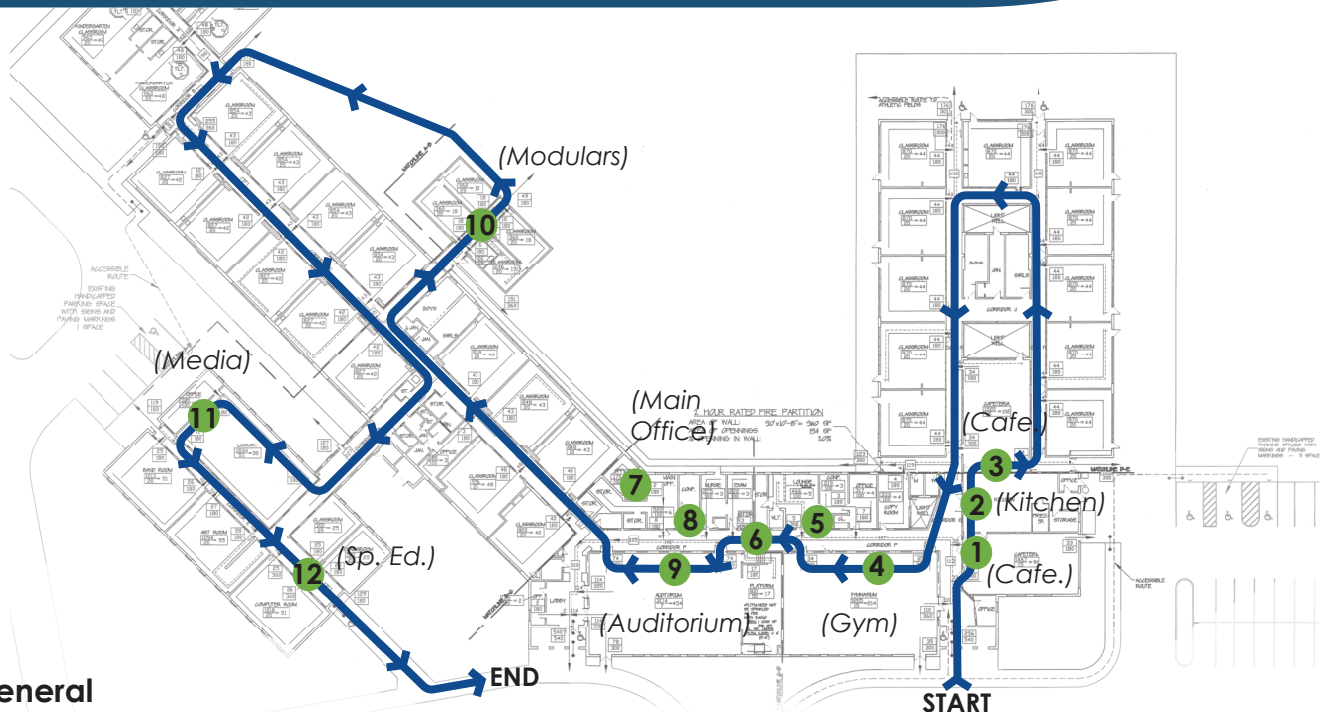
- 2 • Keep two cafeterias, but separate them
- 3 • Before & After program uses the cafeteria but need their own space
- Food service in fair condition, loading and receiving needs attention

- Gym is in fair condition
- Original masonry bearing, steel roof joist, truss & wood plank
- Need gross motor space / sensory space
- Acoustics are poor
- Equipment storage is undersized

- Minimal space, lack of storage

- 7 • Poor visibility to Main Entry
- Need to escort visitors through the building – security concern
- Administrative spaces are small, disjointed and need meeting space

- Small room - general lack of meeting space

- Auditorium is in fair to good condition
- Original masonry bearing, steel roof joist, truss & wood plank
- Used 3-4 times per year, and sitting empty the rest of the time
- For a better, more daily use of space (and growing need due to COVID) it was re-purposed to a Learning Lab
- Want to continue this use as a Learning Lab for targeted intervention, English language, small group breakout space and online learning

- Modular use is an ongoing concern and expense
- Poor condition – past useful life, but need the space

- Poor connection with specials that results in more travel and less educational time
- Specials should be centralized
- Needs reinvention from library to 21st C space

- Limited specialized education, intervention, testing areas
- Poorly located, wasted time due to travel
- De-escalation a concern – want de-escalation areas within each classroom
- Ideally adjacent to classroom pods
