TOWN OF SUFFIELD

Municipal Facilities Master Plan

Suffield Middle School

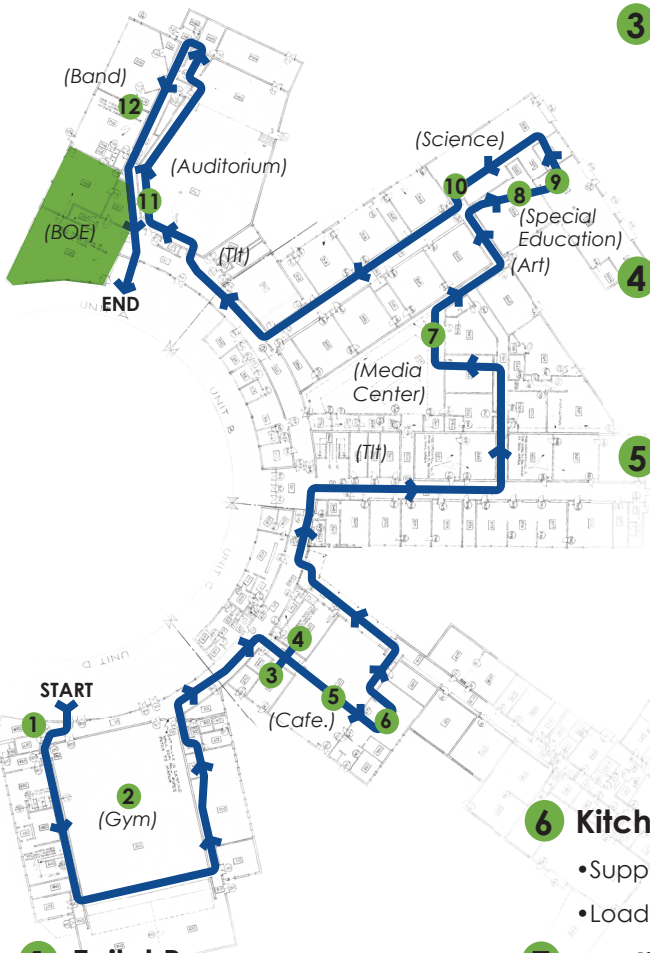
3 Electric Room:

- Electrical system has many vintages – while service is newer, it feeds back into original systems
- Overall mechanical, electrical and plumbing need a complete overhaul

4 Boiler Room:

- No central domestic hot water plant. Have several distributed boilers which leads to more maintenance and repairs

5 Cafeteria:

- Poor acoustics and queuing
- Ceiling is too low – volume level is intense
- Closed serving line does not allow for grab & go. Takes time away from eating as students wait in the queue/line to be served
- There are no bathrooms in close proximity to the Cafeteria

6 Kitchen

- Support space (kitchen/freezer) is adequate
- Loading/receiving is problematic

7 Media Center:

- This addition blocked natural daylight from two wings of classrooms
- Should be the heart of the school but currently hidden
- Need designated spaces for collaboration and project-based learning
- Lacks access to the outdoors

8 Art:

- Want a Fine Arts wing
- Outdated for future of art - focused on graphic or modern art, spray paint room
- Art wants to collaborate with Media and Tech, but current location prevents this

9 Special Education

- Poorly located - currently have to circulate through classrooms to attend special education
- Too spread out – would like to centralize and share these spaces to save on travel time and reinvest in the students' experience
- OT/PT needs a designated space – currently takes place in the Gym
- Need office space and small meeting areas for Special Education teachers
- Reading specialist currently uses a mobile cart, needs dedicated space
- Need Special Education office and educational space

10 Science:

- Inefficient rooms – they were not built for middle school students
- Not outfitted with the wiring required for today's STEM classrooms

11 Auditorium/Support Space:

- Function is obsolete
- Backstage needs renovation – the electrical and sprinkler systems are poorly constructed
- Finishes are poor condition

12 Band:

- Specials and core facilities are a major concern
- Band room is inappropriate space for middle school students, does not support program
- Need instrument storage space
- Need practice rooms

1 Toilet Rooms:

- Poor condition due to age and use, some abandoned in place and/or functionally obsolete (typical)

2 Gymnasium:

- Adequate size but lacks functionality
- Under utilized space in locker areas
- Need yoga/workout room and storage
- Auxiliary Gym lacks flexibility for multiple functions
- Need a classroom for Health
- Need appropriate offices for Gym teachers
