SUFFIELD FACILITIES MASTER PLAN

PBC UPDATE PRESENTATION

SUFFIELD, CT

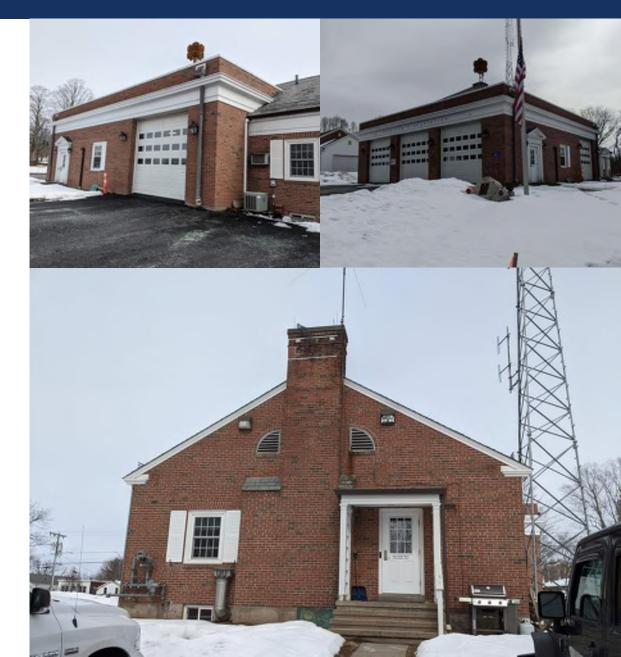
Address	73 Mountain Road
Building Area/Site	4,200 sf / 3.49 acres
Age/Construction	1962(61)

- 1. Recent expansion to paved site area
- 2. Differential settlement and cracking in existing concrete sidewalks
- 3. Apparatus Bay apron is in good condition

- 1. Masonry restoration required at chimney
- 2. Minor rot repair and repainting at wood trim work, railings, and louvers
- 3. Minor downspout repairs/replacement of downspout clips

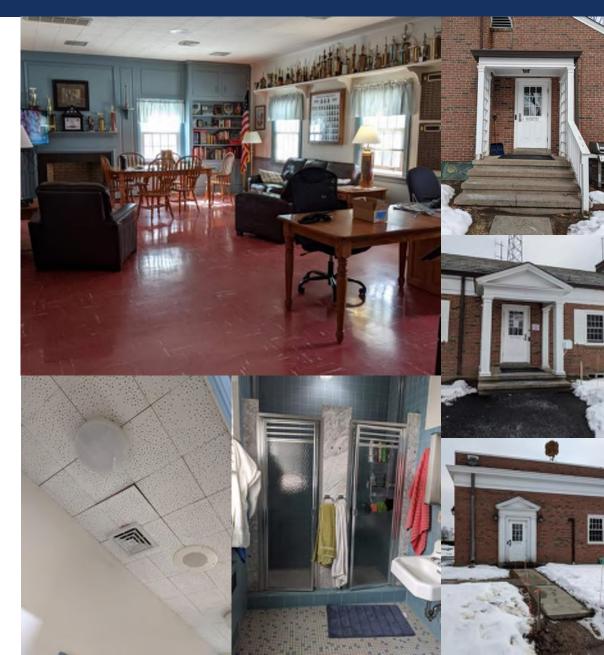
Address	73 Mountain Road
Building Area/Site	4,200 sf / 3.49 acres
Age/Construction	1962(61)

- 1. All MEP Systems are old and past their useful life.
- 2. Needs full replacement of all systems

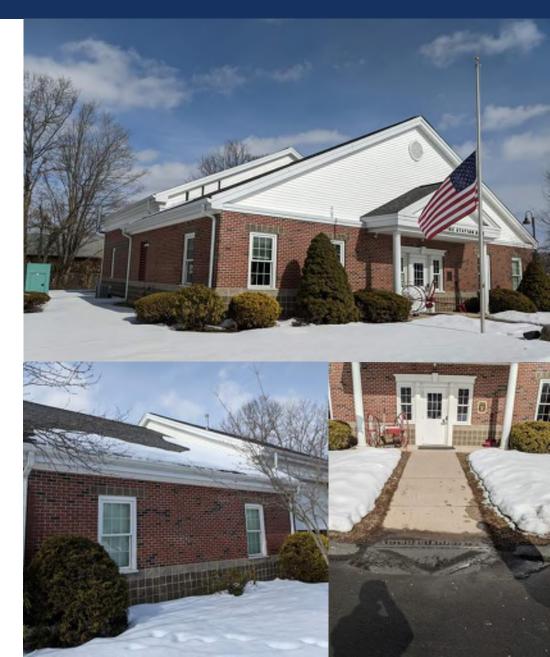
Address	9 Ratley Road
Building Area/Site	3,906 sf / 6.89
Age/Construction	2004 (17)

- 1. Newer station, well built, good apparatus space, in relatively good condition
- 2. Some ponding at transition between sidewalk and drive
- 3. Minor rusting at bottom of bollards

- Ice dams present at time of walkthrough, persistent issue for some time. May cause damage elsewhere if not properly addressed.
- 2. Exterior materials are in good condition.

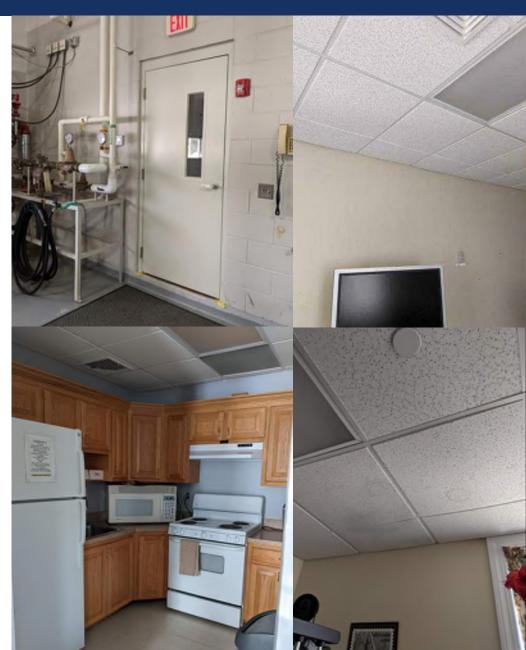
Address	9 Ratley Road
Building Area/Site	3,906 sf / 6.89
Age/Construction	2004 (17)

- 1. Signs of moisture infiltration, possibly from ice dam
- 2. Ceiling tiles sagging throughout, possibly due to humidity issue
- 3. Currently used for department training

- 1. Building is newer. All systems in good working condition.
- 2. Building is 15 years old and will need more maintenance in the next 5 10 years.

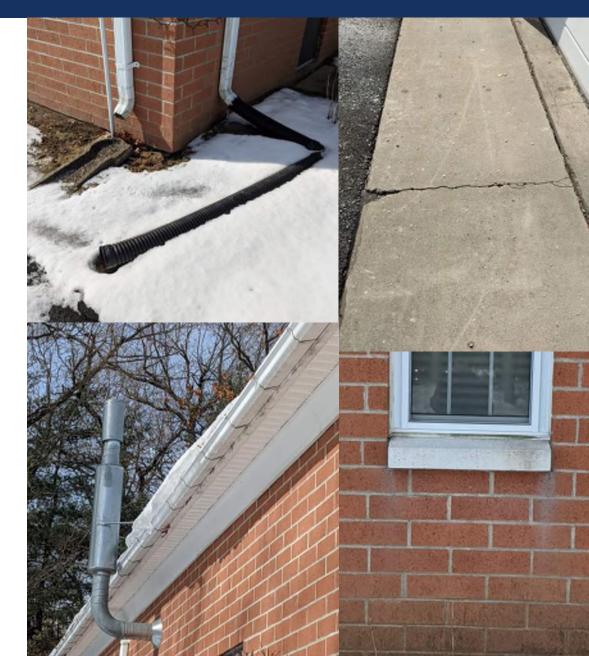
Address	3 Copperhill Road
Building Area/Site	3,256 sf / 1.08 acres
Age/Construction	1985 (36)

- 1. Poor site drainage causing hazardous conditions with ice, grading revisions
- 2. Minor cracking at apparatus bay apron
- 3. Anecdotal reference to storm water infiltrating tight tank

- 1. Older building but in relatively good condition for its age
- 2. Some signs of ice damming present
- 3. Minor staining on brick from water shed
- 4. Recommend preventative maintenance to extend useful life (caulking, sealants, etc.)

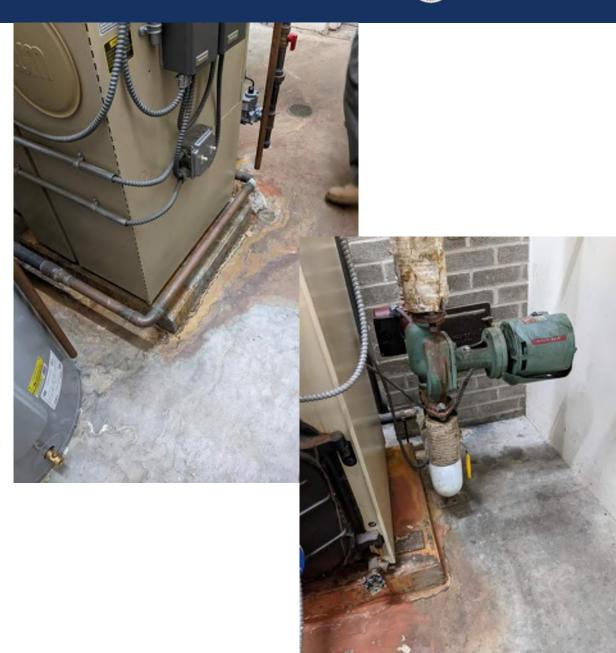
Address	3 Copperhill Road
Building Area/Site	3,256 sf / 1.08 acres
Age/Construction	1985 (36)

- Suspected mold on apparatus bay ceiling, possible condensation buildup
- 2. Possible accumulation of exhaust from vehicles settling on radiant heater resulting in wall staining, lack of hot/cold transition zone

Minor cracking on interior side of exterior CMU walls

- 1. MEP systems are in acceptable working condition.
- 2. Nearing the end of their useful life.
- 3. Will need replacement in about 5 10 years.

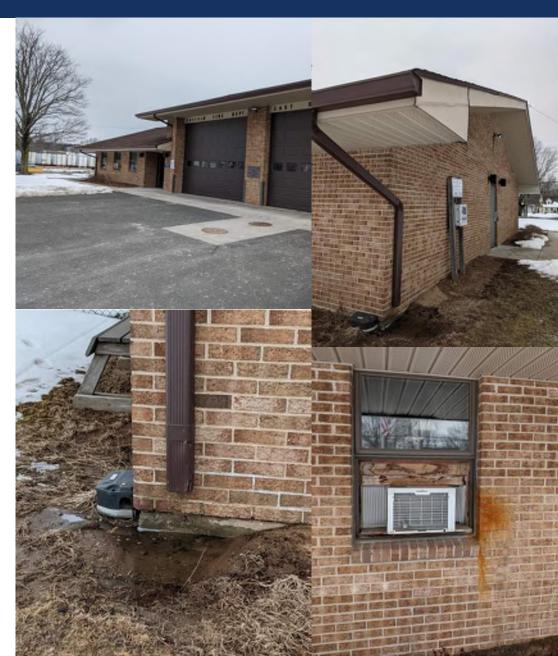
Address	776 Thompsonville Road
Building Area/Site	2,702 sf / 3.46 acres
Age/Construction	1975 (46)

- 1. Minor cracking in asphalt
- 2. Lack of tie-in or splash block at downspout causing soil erosion

- 1. In good condition relative to its age.
- 2. Minor cracking at foundation/sidewalk
- 3. Improper fit of window air conditioning unit and staining of adjacent brick wall.

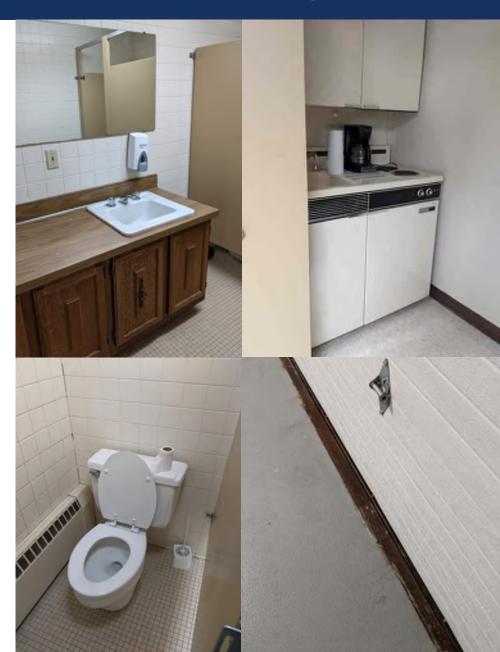
Address	776 Thompsonville Road
Building Area/Site	2,702 sf / 3.46 acres
Age/Construction	1975 (46)

- 1. Finishes in fair condition considering age of building
- 2. Angle beginning to rust at apparatus bay doors

- 1. MEP systems are at the end of their useful life.
- 2. Should think about replacement in near future 2-3 Years.

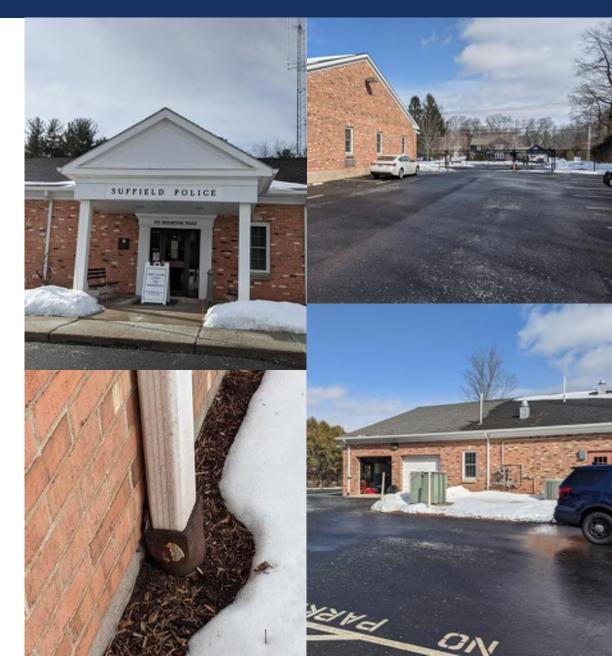
Address	911 Mountain Road
Building Area/Site	8,955 sf / 2.69 acres
Age/Construction	1988 (33)

- 1. Minor cracking at sidewalk control joints
- 2. Rust present at downspout boots
- 3. New paving and fence
- Recommend preventative maintenance program to extend useful life.

- 1. In good condition relative to its age well maintained and built.
- 2. Minor snow build up and possible damming at roof valleys
- 3. Exterior materials have been well maintained
- 4. Snow melt on roof uneven due to super heating of garage spaces

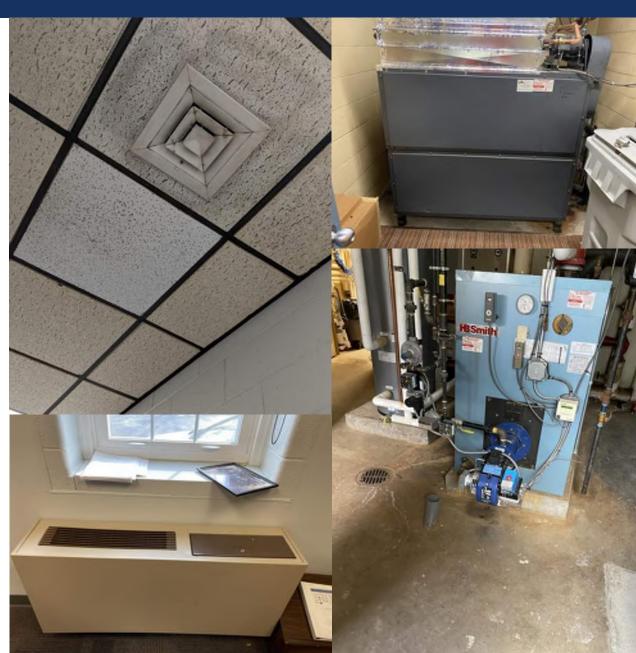
Address	911 Mountain Road
Building Area/Site	8,955 sf / 2.69 acres
Age/Construction	1988 (33)

- 1. Drywall cracking present at window lintels
- 2. Discoloration of ceiling tiles due to age.
- 3. Relatively minor cracking at multiple interior CMU walls, non structural issue.

- 1. MEP Systems all old and need to be upgraded.
- 2. Garage spaces overheating, temperature control issue?
- 3. Almost all systems original to building. 33 years old
- 4. No automatic sprinkler system within building.
- 5. Only 1 boiler. No redundancy. If boiler was to go down for repair or maintenance. No heat.
- 6. No exhaust systems in garages. Required by current code.

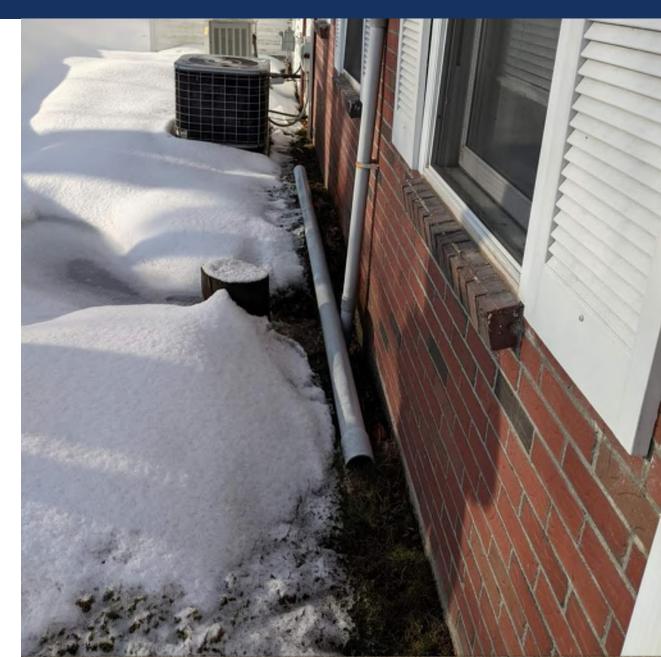
Address	97 Mountain Road
Building Area/Site	2,060 sf / 1.62 acres
Age/Construction	1976 (45)

- 1. Pavement cracking throughout parking lot
- 2. Cracking and deterioration at garage door aprons
- 3. Storm water ponding at exterior wall

- 1. Appears to be pre-engineered structure with conventional wall framing
- 2. General cleaning of exterior masonry and foundation walls needed
- 3. Missing trim at joint between brick and siding
- 4. Corrosion of exterior hollow metal door
- Damage to corner trim, trim between garage doors, and siding near grade
- 6. Re-caulk windows and clean up excess sealant

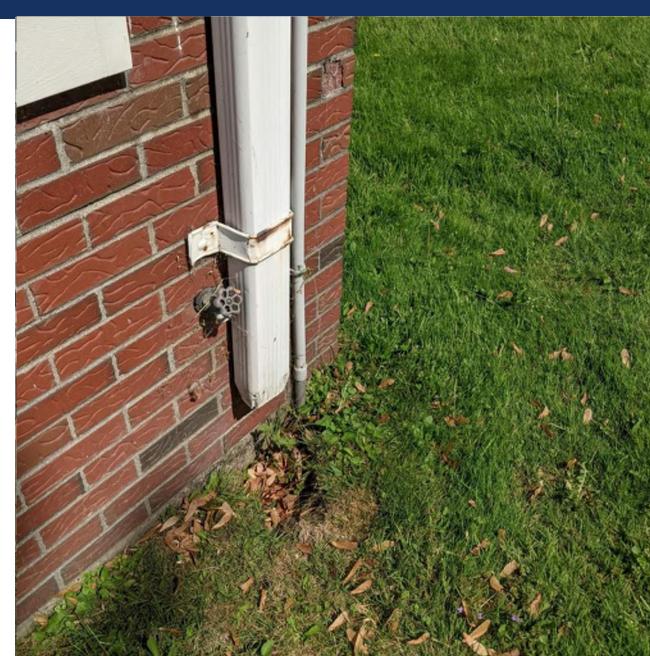
Address	97 Mountain Road
Building Area/Site	2,060 sf / 1.62 acres
Age/Construction	1976 (45)

- 1. Pavement cracking throughout parking lot
- Cracking and deterioration at garage door aprons
- 3. Storm water ponding at exterior wall

- General cleaning of exterior masonry and foundation walls needed
- 2. Remove excess sealant and re-caulk windowsills
- 3. Damage to corner trim, trim between garage doors, and siding near grade
- 4. Missing trim board between siding and brick
- 5. Corrosion of exterior hollow metal doors
- 6. Damage to Overhead door
- 7. Downspout damage

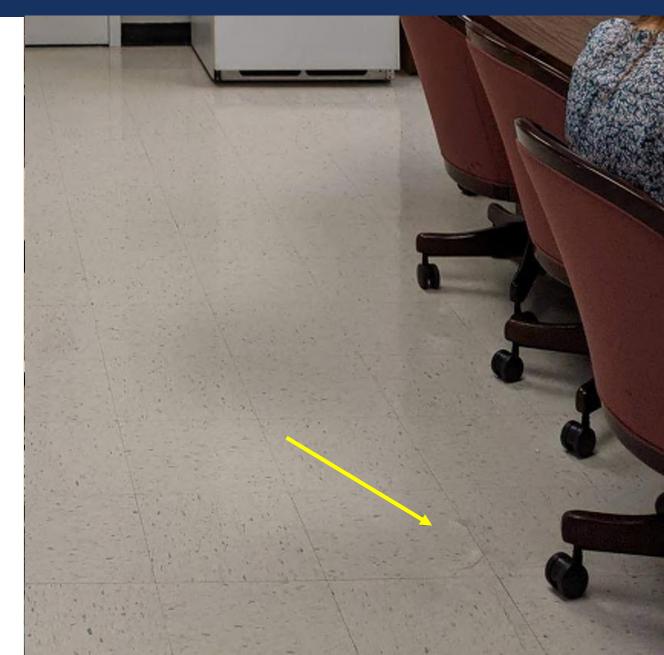
Address	97 Mountain Road
Building Area/Site	2,060 sf / 1.62 acres
Age/Construction	1976 (45)

- 1. Ripped insulation lining throughout garage
- 2. Moisture infiltration at exterior garage doors
- 3. Concrete slab chipping along control joint
- 4. Minor cracking in VCT

1. Toilet facilities missing grab bar

- 1. No automatic sprinkler system within building.
- 2. Mechanical systems is small furnaces. OK Condition.
- 3. Electrical Older. OK Condition.
- 4. Plumbing Older. OK Condition.

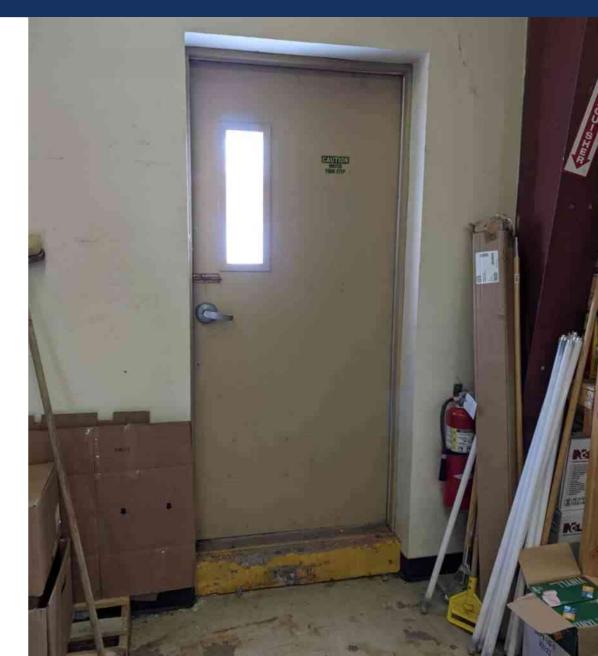
Address	97 Mountain Road
Building Area/Site	2,060 sf / 1.62 acres
Age/Construction	1976 (45)

- 1. Ripped insulation lining throughout garage
- 2. Moisture infiltration at exterior garage doors
- 3. Concrete slab chipping along control joint
- 4. Minor cracking in VCT

- 1. Toilet facilities missing grab bar
- 2. Steps into garage storage areas

- 1. No automatic sprinkler system within building.
- 2. Mechanical systems is small furnaces. OK Condition.
- 3. Electrical Older. OK Condition.
- 4. Plumbing Older. OK Condition.

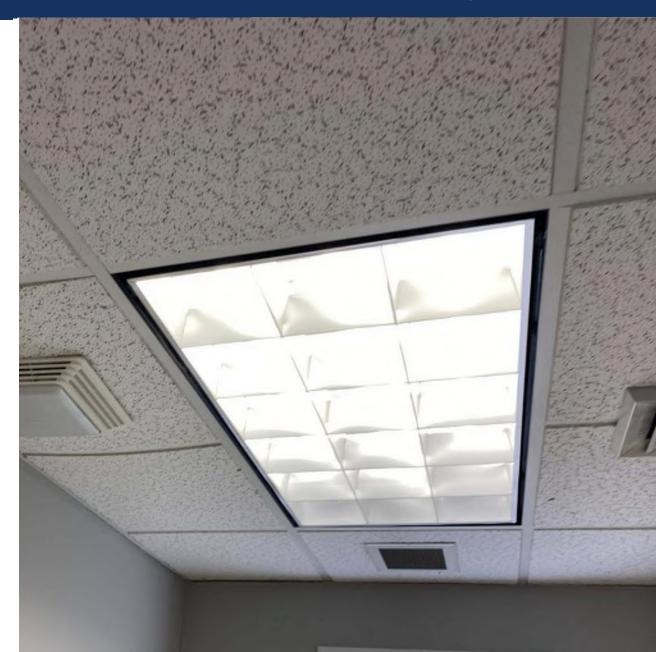
Address	97 Mountain Road
Building Area/Site	2,060 sf / 1.62 acres
Age/Construction	1976 (45)

- 1. Ripped insulation lining throughout garage
- 2. Moisture infiltration at exterior garage doors
- 3. Concrete slab chipping along control joint
- 4. Minor cracking in VCT

1. Toilet facilities missing grab bar

- 1. No automatic sprinkler system within building.
- 2. Plumbing, Older. Fair Condition.
- Mechanical systems is small furnaces. Fair Condition.
- 4. Electrical, Older. Fair Condition.

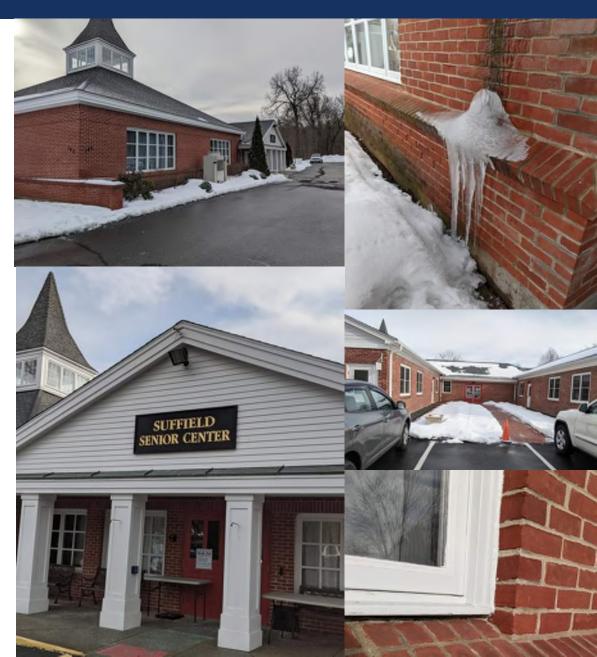
Address	145 Bridge Street
Building Area/Site	11,702 sf / 3.27 acres
Age/Construction	1950 (71)

- 1. Cracking in pavement throughout
- 2. Uneven brick patio in courtyard

- 1. Recent renovations (2009) in good condition.
- 2. Lack of gutters at large hip roof and main entrance
- 3. Brick staining at windows
- Exterior wood windows may need replacement within 5-10 years
- 5. General brick cleaning needed
- 6. Lack of gutter causing ice building up at exterior wall

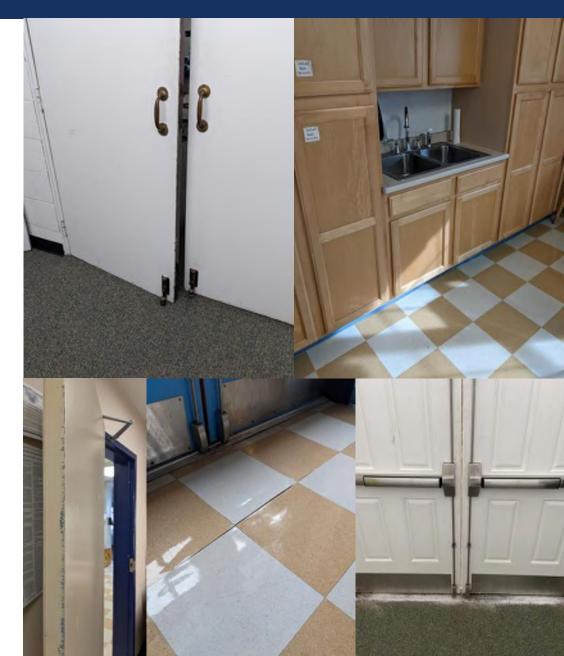
Address	145 Bridge Street
Building Area/Site	11,702 sf / 3.27 acres
Age/Construction	1950 (71)

- 1. Hollow metal doors rubbing on frames, causing paint damage
- 2. Movement of VCT flooring near exterior door threshold causing separation
- 3. Lack of weatherstripping at chapel exterior door causing air infiltration

- 1. Youth Services and Parks & Rec do not have accessible entrances from exterior
- 2. Non-accessible sink at Youth Services
- 3. Damaged VCT at Youth Services

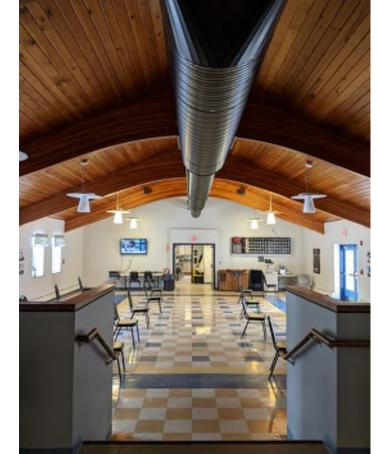
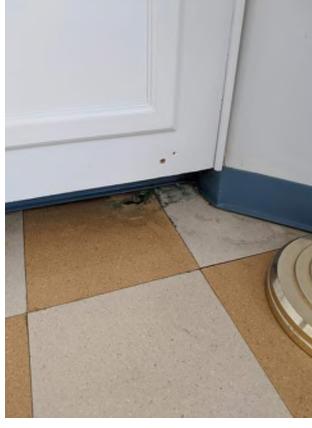
Address	145 Bridge Street
Building Area/Site	11,702 sf / 3.27 acres
Age/Construction	1950 (71)

- 1. No Automatic Sprinkler System.
- 2. Renovated recently.
- 3. Most MEP in good condition.
- 4. Will start to need more maintenance in the next 5 10 years.
- 5. Perimeter radiant heating units leaking, causing damage to flooring

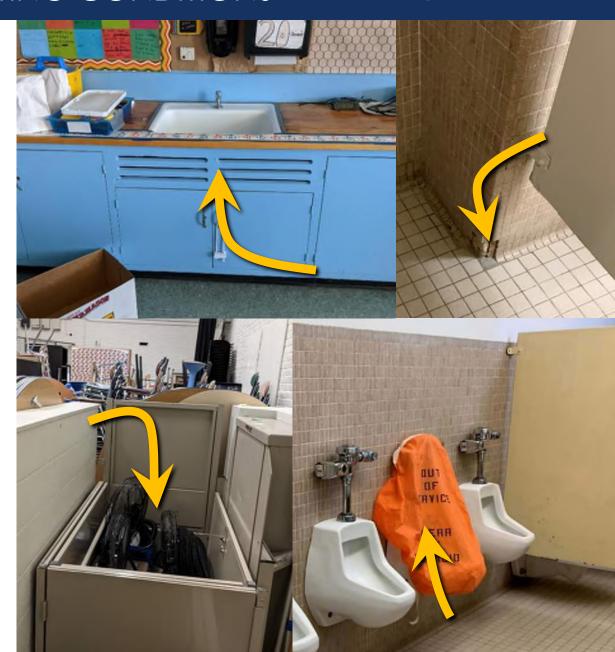
Site ~ Site traffic, parking and perimeter security major concerns for site (pedestrian and vehicular safety), play areas exposed, no definition of school boundary, pavement & site lighting are in poor condition

Architectural Exterior ~ Several improvements over time, many poorly functioning windows, persistent water infiltration/leaks at windows, doors, roofs

Architectural Interior ~ Overall well built, some replacement of finishes, majority of finishes past useful life (millwork, floors, doors, ceilings), gym, lockers, toilets all poor. Significant noise transfer in original wood plank floors/struct.

Code/Accessibility/Life Safety ~ Many toilet areas non accessible, Several compliance issues at floor clearances/reach at entranceways, sinks, and millwork, lift at stage.

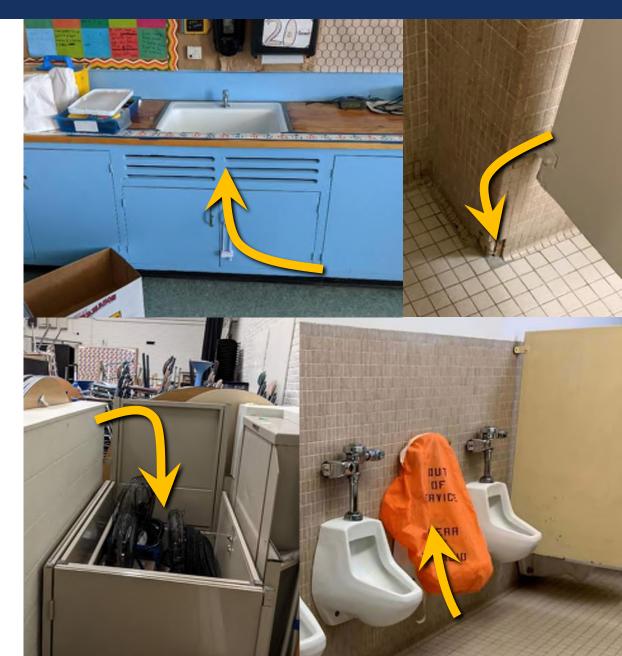
Site ~ Site traffic, parking and perimeter security major concerns for site (pedestrian and vehicular safety), play areas exposed, no definition of school boundary, pavement & site lighting poor condition

Architectural Exterior ~ Several improvements over time, many poorly functioning windows, persistent water infiltration/leaks at windows, doors, roofs

Architectural Interior ~ Overall well built, some replacement of finishes, majority of finishes past useful life (millwork, floors, doors, ceilings), gym, lockers, toilets all poor. Significant noise transfer in original wood plank floors/struct.

Code/Accessibility/Life Safety ~ Many toilet areas non accessible, Several compliance issues at floor clearances/reach at entranceways, sinks, and millwork, lift at stage.

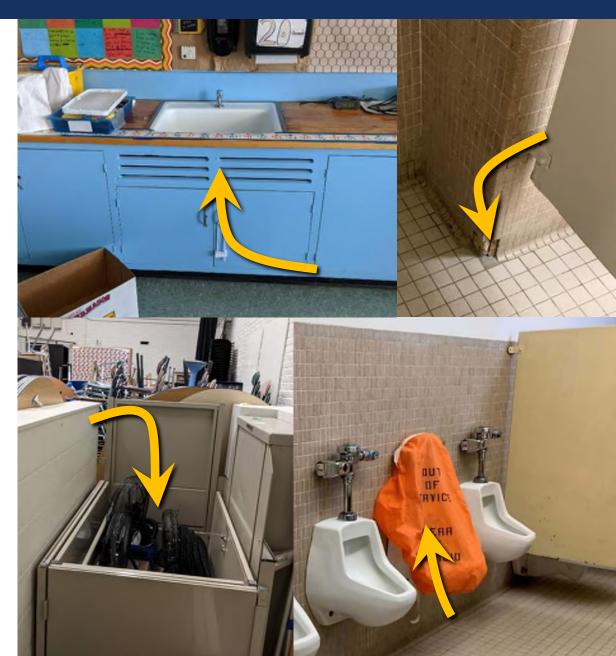
Site ~ Site traffic, parking and perimeter security major concerns for site (pedestrian and vehicular safety), play areas exposed, no definition of school boundary, pavement & site lighting poor condition

Architectural Exterior ~ Several improvements over time, many poorly functioning windows, persistent water infiltration/leaks at windows, doors, roofs

Architectural Interior ~ Overall well built, some replacement of finishes, majority of finishes past useful life (millwork, floors, doors, ceilings), gym, lockers, toilets all poor. Significant noise transfer in original wood plank floors/struct.

Code/Accessibility/Life Safety ~ Many toilet areas non accessible, Several compliance issues at floor clearances/reach at entranceways, sinks, and millwork, lift at stage.

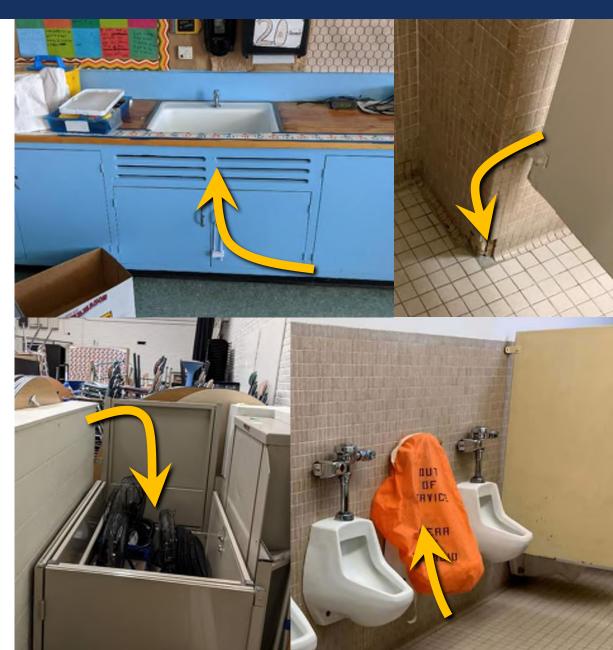
Site ~ Site traffic, parking and perimeter security major concerns for site (pedestrian and vehicular safety), play areas exposed, no definition of school boundary, pavement & site lighting poor condition

Code/Accessibility/Life Safety ~ Many toilet areas non accessible, several compliance issues at floor clearances/reach at entranceways, sinks, and millwork, lift at stage.

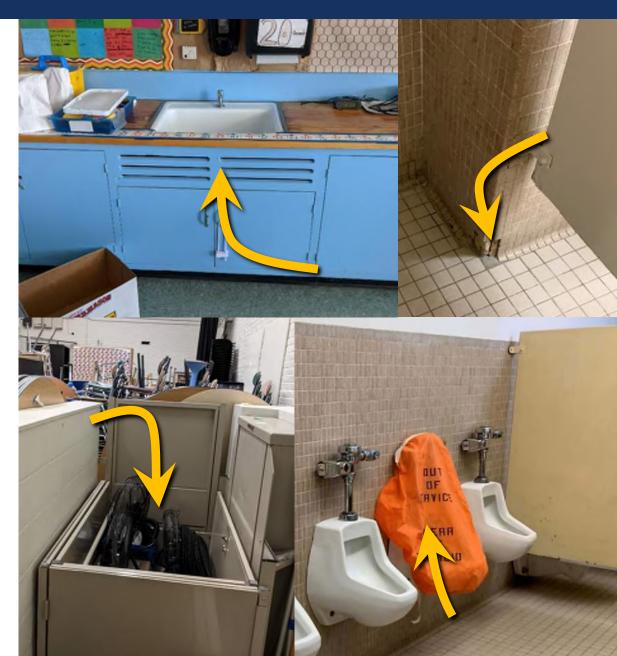
Code/Accessibility/Life Safety ~ Many toilet areas non accessible, Several compliance issues at floor clearances/reach at entranceways, sinks, and millwork, lift at stage.

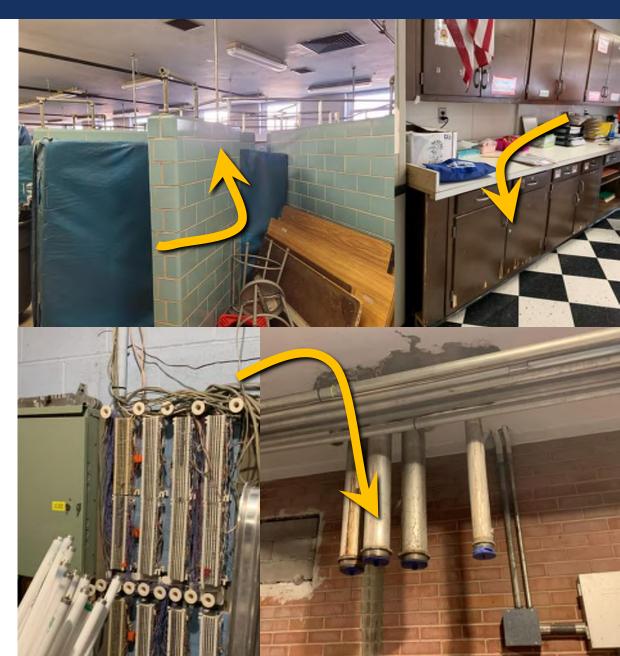
Site ~ Site conditions are in fair to poor condition for; sidewalks, curbs, paving, drainage issues, site traffic flow, parking, security major concerns. Areas of poor drainage on west/southwest side of site.

Building Systems ~ Many renovations and varying vintages of systems makes for complex infrastructure, difficult to maintain, inefficient system, most major mechanical systems past or at the end of their useful life.

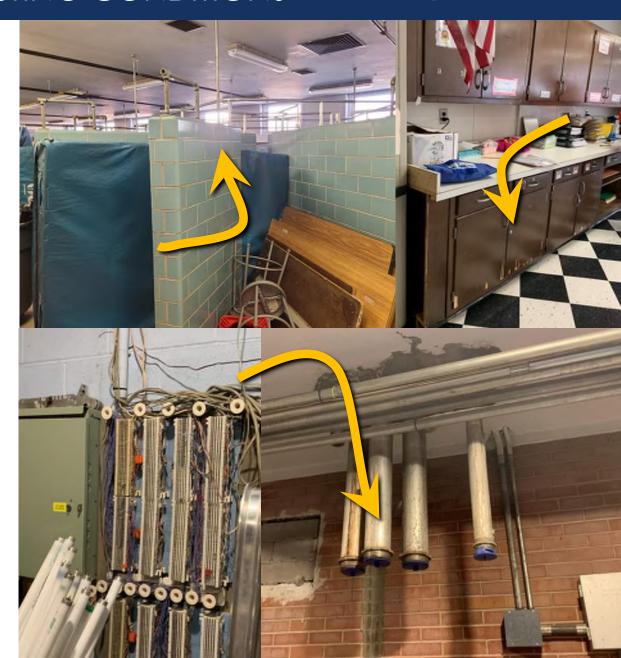
Site ~ Site conditions are in fair to poor condition for; sidewalks, curbs, paving, drainage issues, site traffic flow, parking, security major concerns. Areas of poor drainage on west/southwest side of site.

Building Systems ~ Many renovations and varying vintages of systems makes for complex infrastructure, difficult to maintain, inefficient system, most major mechanical systems past or at the end of their useful life.

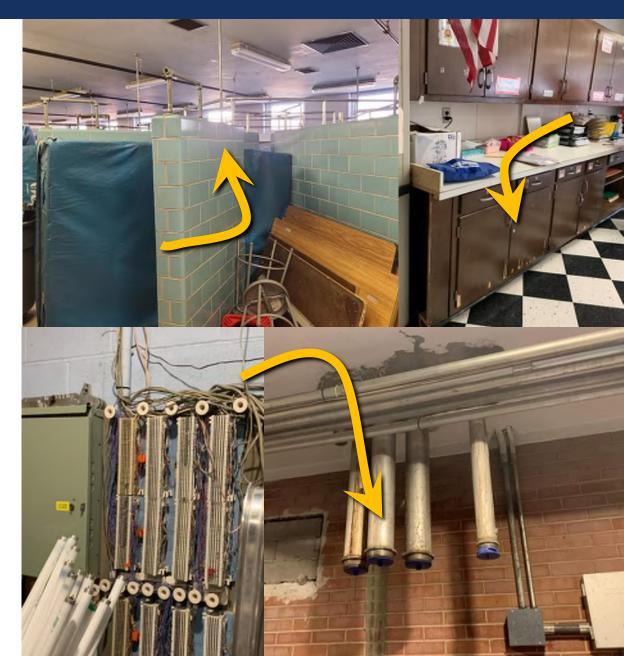
Site ~ Site conditions are in fair to poor condition for;

Building Systems ~ Many renovations and varying vintages of systems makes for complex infrastructure, difficult to maintain, inefficient system, most major mechanical systems past or at the end of their useful life.

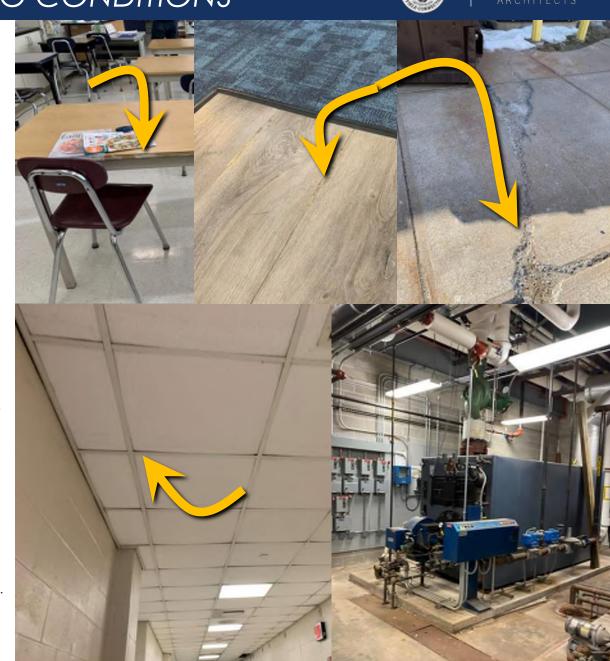
Architectural Interior ~ Overall, well maintained, some areas of questionable quality of original construction. Building has worn faster than anticipated. Slab cracking with possible water/vapor infiltration, persistent issue, finishes/glue to bubble, curious curling ceiling tiles HVAC balancing issue. Fairly significant deterioration of furniture in areas, in some cases it is mismatched.

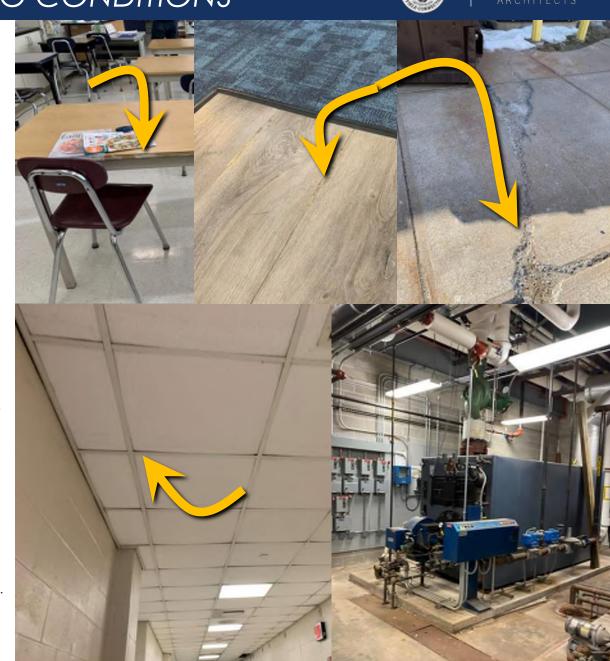
Architectural Interior ~ Overall, well maintained, some areas of questionable quality of original construction. Building has worn faster than anticipated. Slab cracking with possible water/vapor infiltration, persistent issue, finishes/glue to bubble, curious curling ceiling tiles HVAC balancing issue. Fairly significant deterioration of furniture in areas, in some cases it is mismatched.

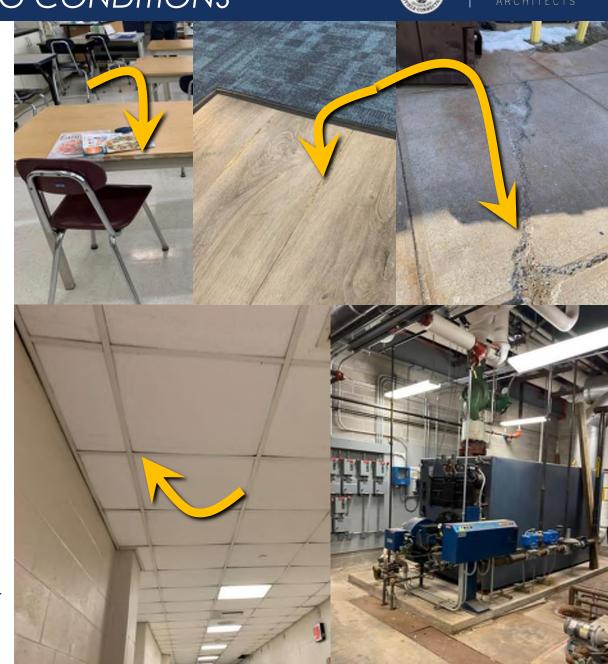
Architectural Interior ~ Overall, well maintained, some areas of questionable quality of original construction. Building has worn faster than anticipated. Slab cracking with possible water/vapor infiltration, persistent issue, finishes/glue to bubble, curious curling ceiling tiles HVAC balancing issue. Fairly significant deterioration of furniture in areas, in some cases it is mismatched.

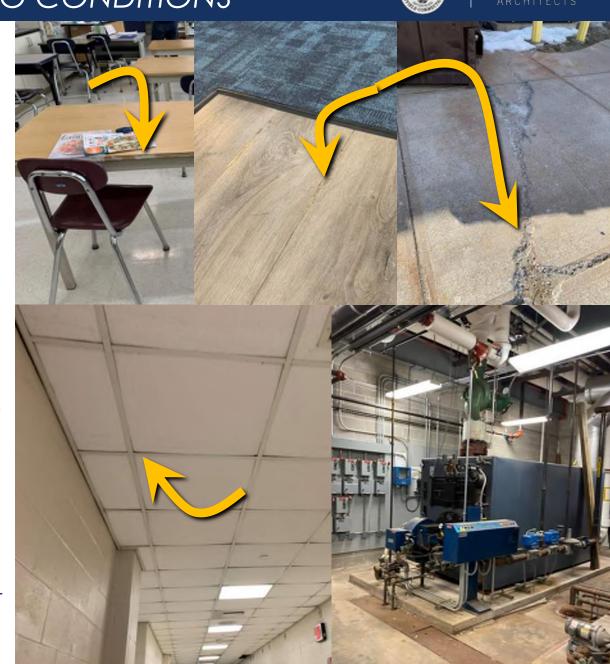
Architectural Interior ~ Overall, well maintained, some areas of questionable quality of original construction. Building has worn faster than anticipated. Slab cracking with possible water/vapor infiltration, persistent issue, finishes/glue to bubble, curious curling ceiling tiles HVAC balancing issue. Fairly significant deterioration of furniture in areas, in some cases it is mismatched.
