MINUTEMAN HIGH SCHOOL STRUCTURAL EVALUATION - 2012 UPDATE

758 MARRETT ROAD
LEXINGTON, MASSACHUSETTS 02421

July 30, 2012

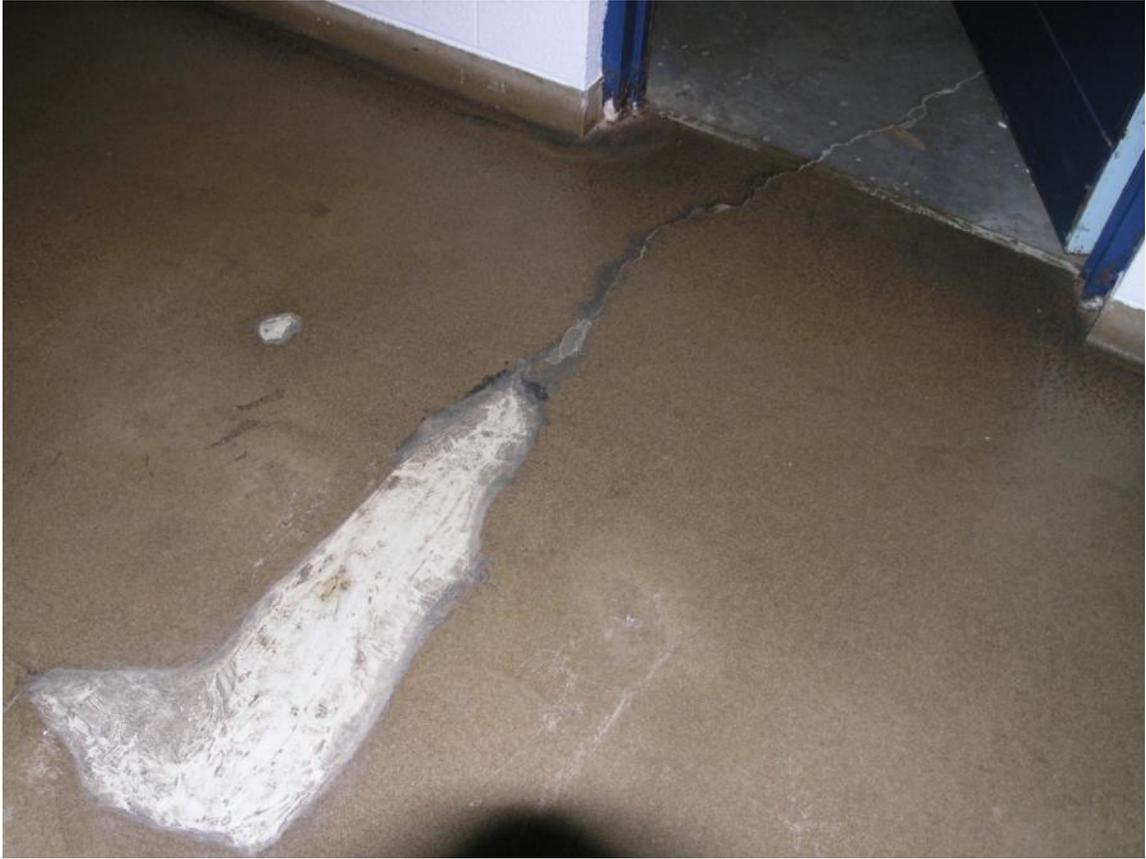
Photo #1

- **Cracks in the concrete floor slab-on-grade throughout the school building:** Numerous cracks were observed in the ground floor concrete slab on grade. **(Photo #1)**
 - **COMMENT:** The cracks in the Ground Floor concrete slab on grade appear to be shrinkage cracks caused by improper construction or improper curing of the concrete floor slab. These cracks degrade the usefulness and serviceability of the concrete floor slab, but are not structurally detrimental.

Photo of one of the many cracks in the ground floor concrete slab on grade found throughout the school building.

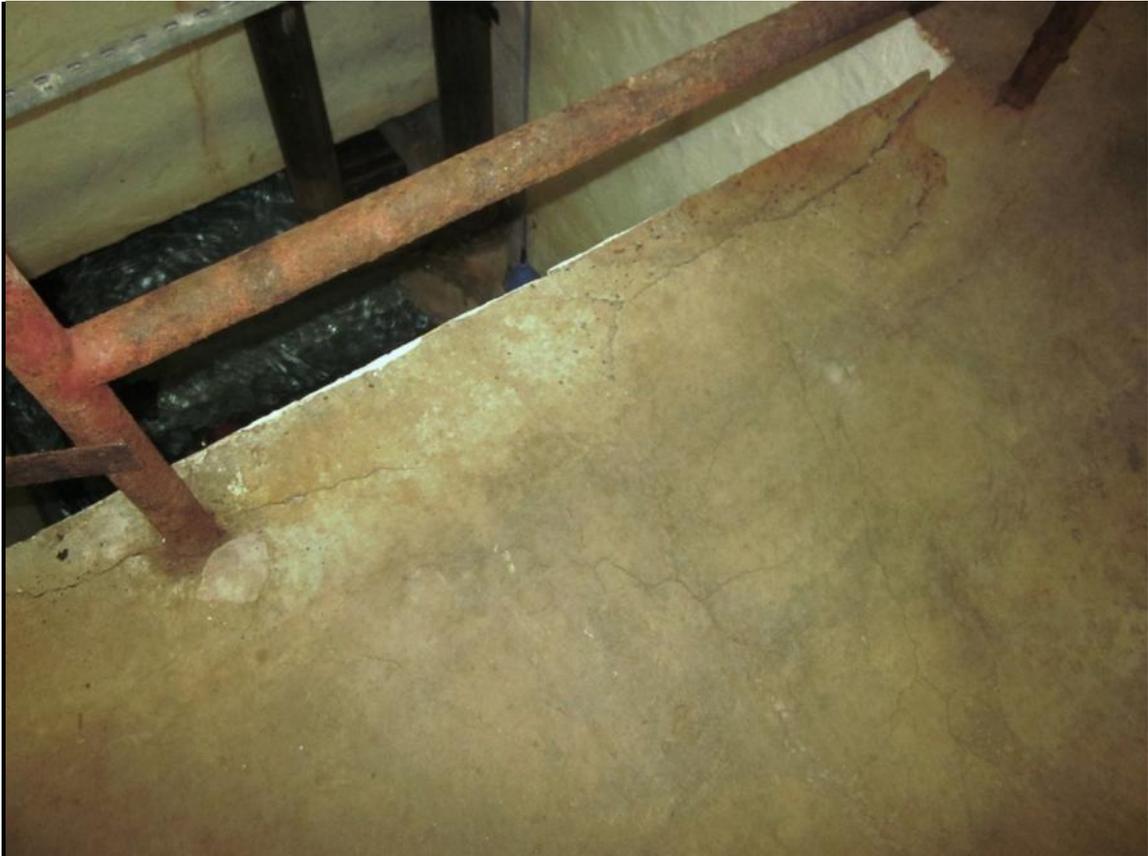
Photo #2

- **Cracks and spalls in the concrete floor slab in the natatorium and abutting pool filter room:** Several cracks and spalls were observed in the concrete apron around the swimming pool and in the floor of the adjacent filter room. **(Photo #2.)**
 - **COMMENT:** The cracks and spalls in the apron around the swimming pool and in the pool filter room are likely exacerbated by the corrosive action of the chlorine that is contained both in the water and in the air in these rooms. Preventative actions should be taken to repair these cracks and spalls to arrest further degradation of the floor slabs in these rooms.

This photo shows some of the cracks and spalls in the natatorium and pool filter room concrete floor slab.

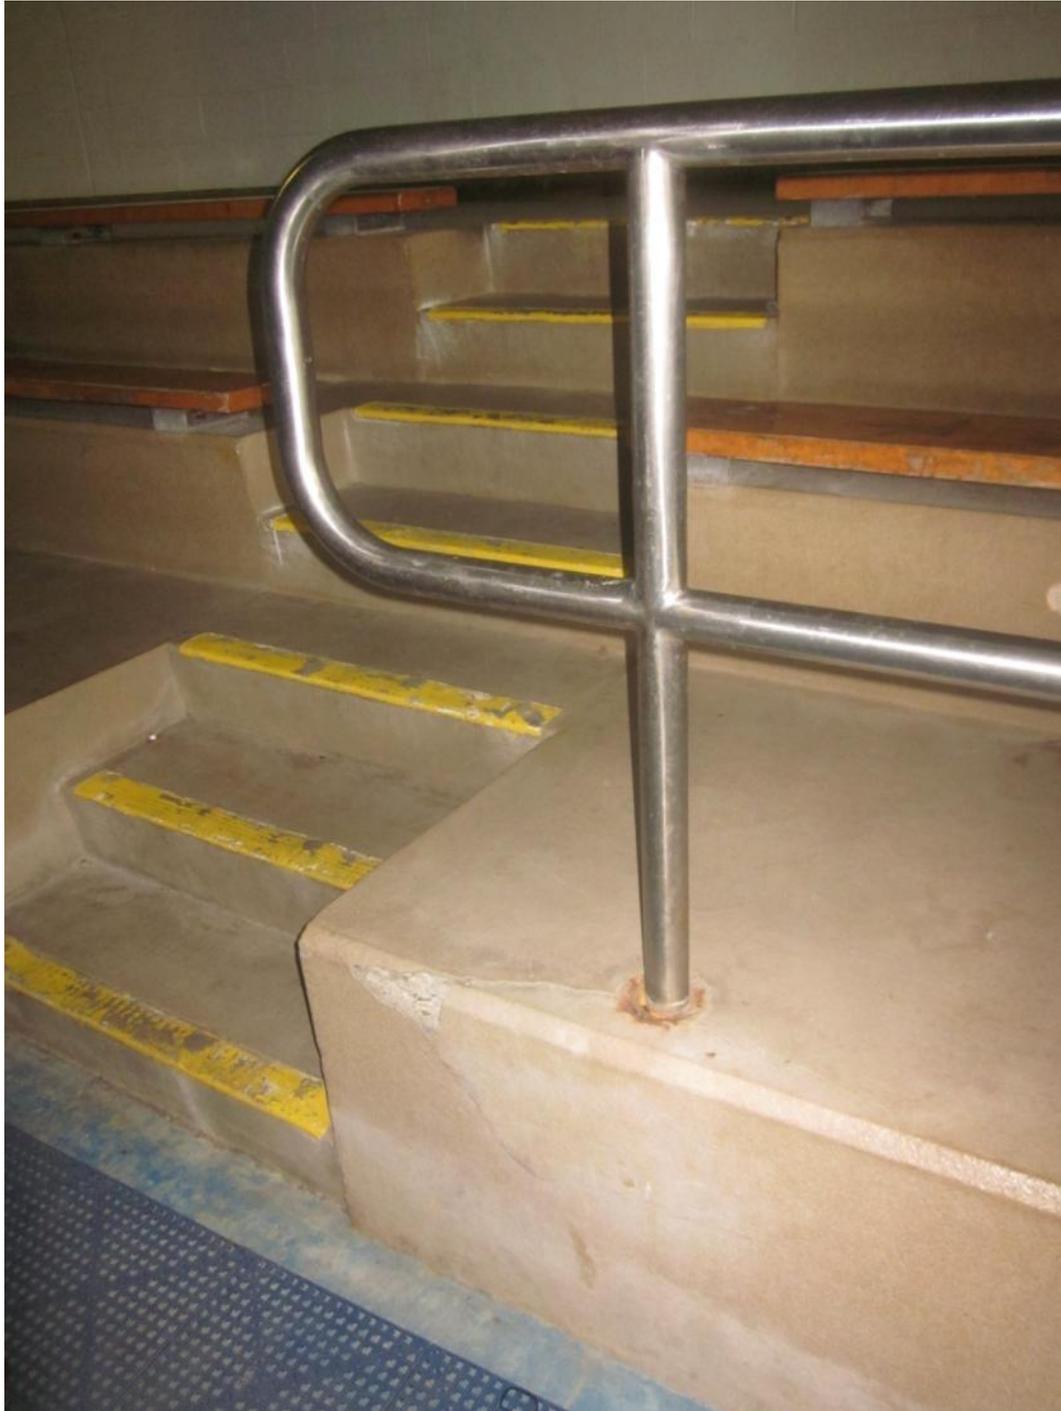
Photo #3

- **Cracks and spalls in the natatorium concrete bleachers at guardrail inserts:** Large cracks and spalls have occurred at several locations in the natatorium where the guardrails for the bleacher seating around the swimming pool are pocketed into the concrete. **(Photos #3 and #4.)**
 - **COMMENT:** The cracks and spalls in the concrete where guardrails are pocketed into the concrete bleachers appear to be caused by the expansive corrosion of the steel inserts that secure the ends of stainless steel guardrail posts. Under the current conditions, the guardrails may not be able to resist the thrust for which they were designed. Odeh Engineers recommends that the guardrail steel inserts be replaced with stainless steel inserts and the cracked and spalled concrete be repaired with modern, high-performance concrete repair products.

This photo shows one of the several locations where cracks and spalls have occurred where the natatorium bleacher seating guardrails are pocketed in the concrete.

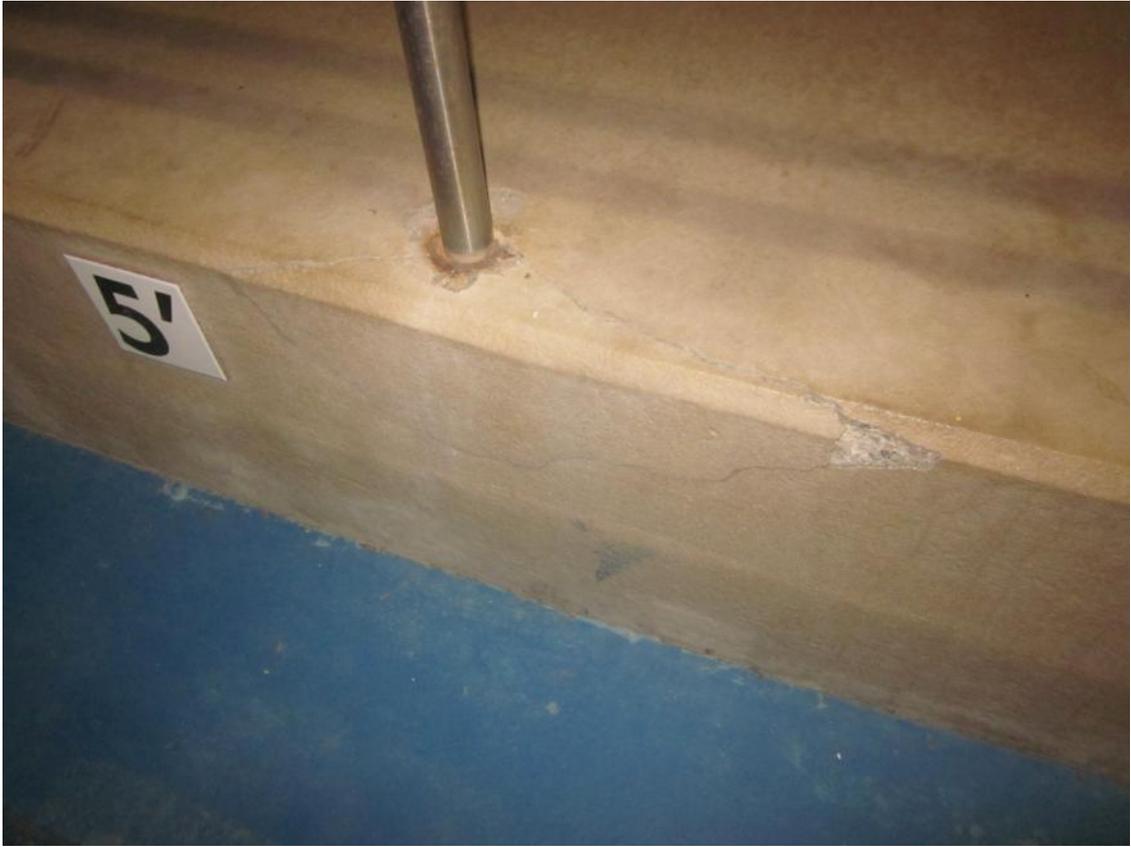
Photo #4

This photo shows another location where cracking and spalling of the natatorium bleacher seating has occurred where the guardrails are pocketed in the concrete.

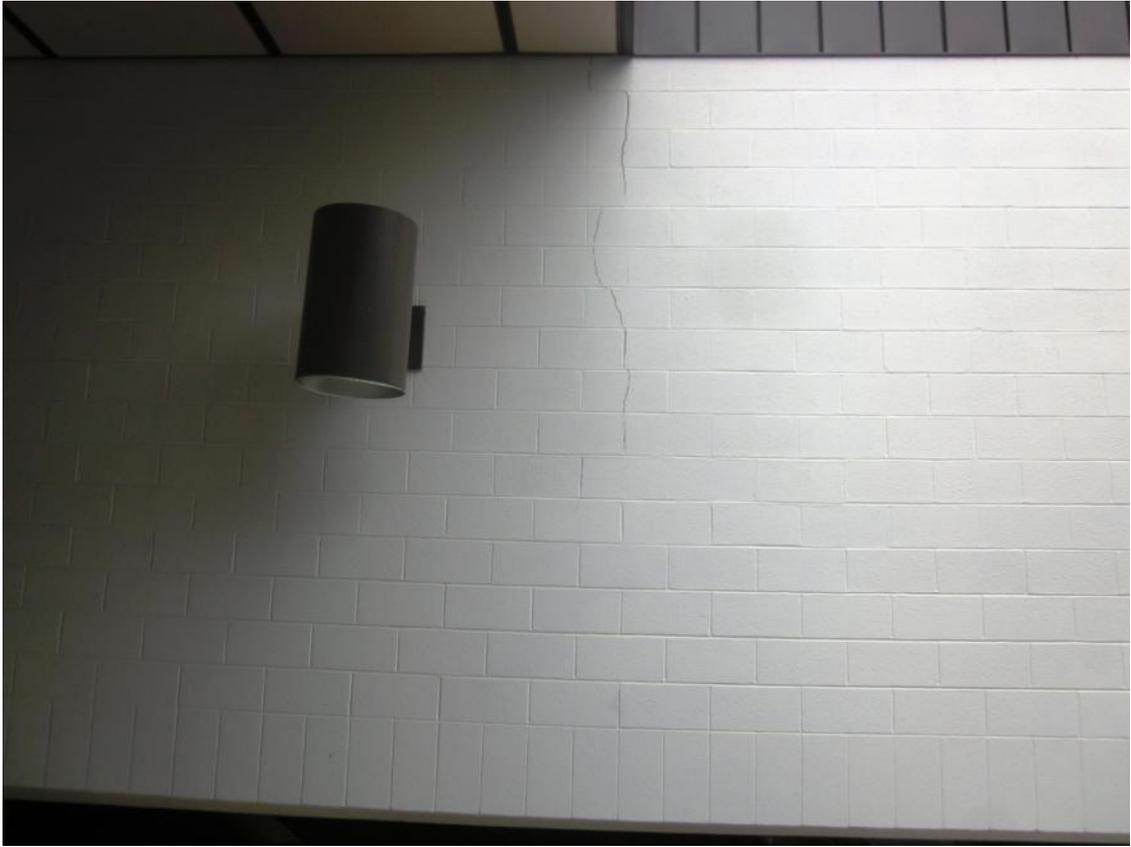
Photo #5

- **Numerous cracks in interior masonry block partition walls:** Throughout the school building, many cracks were observed in the non-bearing concrete masonry block partition walls. The cracks are typically found where the building steel columns are contained within these walls. **(Photos #5 and #6.)**

- **COMMENT:** The cracks in the interior masonry block partition walls appear to have occurred due to two main reasons. Apparently during construction of these walls, there was not sufficient room provided within the wall cavities to accommodate the movement of the building structural frame. Compounding this problem is the fact that weaknesses in the blocks are created by having to notch the masonry block webs and face shells to accommodate the structural members. The movement of the structural frame due to lateral loads and thermal dimensional changes may impinge upon the notched blocks, causing the walls to move and crack. Secondly, there are virtually no control joints in the masonry walls to allow for dimensional changes in the masonry due to temperature and moisture variations. A third possible factor causing the cracks and displacements in the masonry may involve the expansion joints in the multi-story building. This factor will be addressed later in this section of the report. Although the walls are structurally stable in their current condition, the cracks in the masonry block partition walls substantially reduce the strength of these walls to resist lateral movements during severe wind or seismic events. In addition, fragments of masonry block may fall out of these cracks over time and could cause personal injury.

This photo shows one of the many cracks found in the non-bearing interior masonry block partition walls.

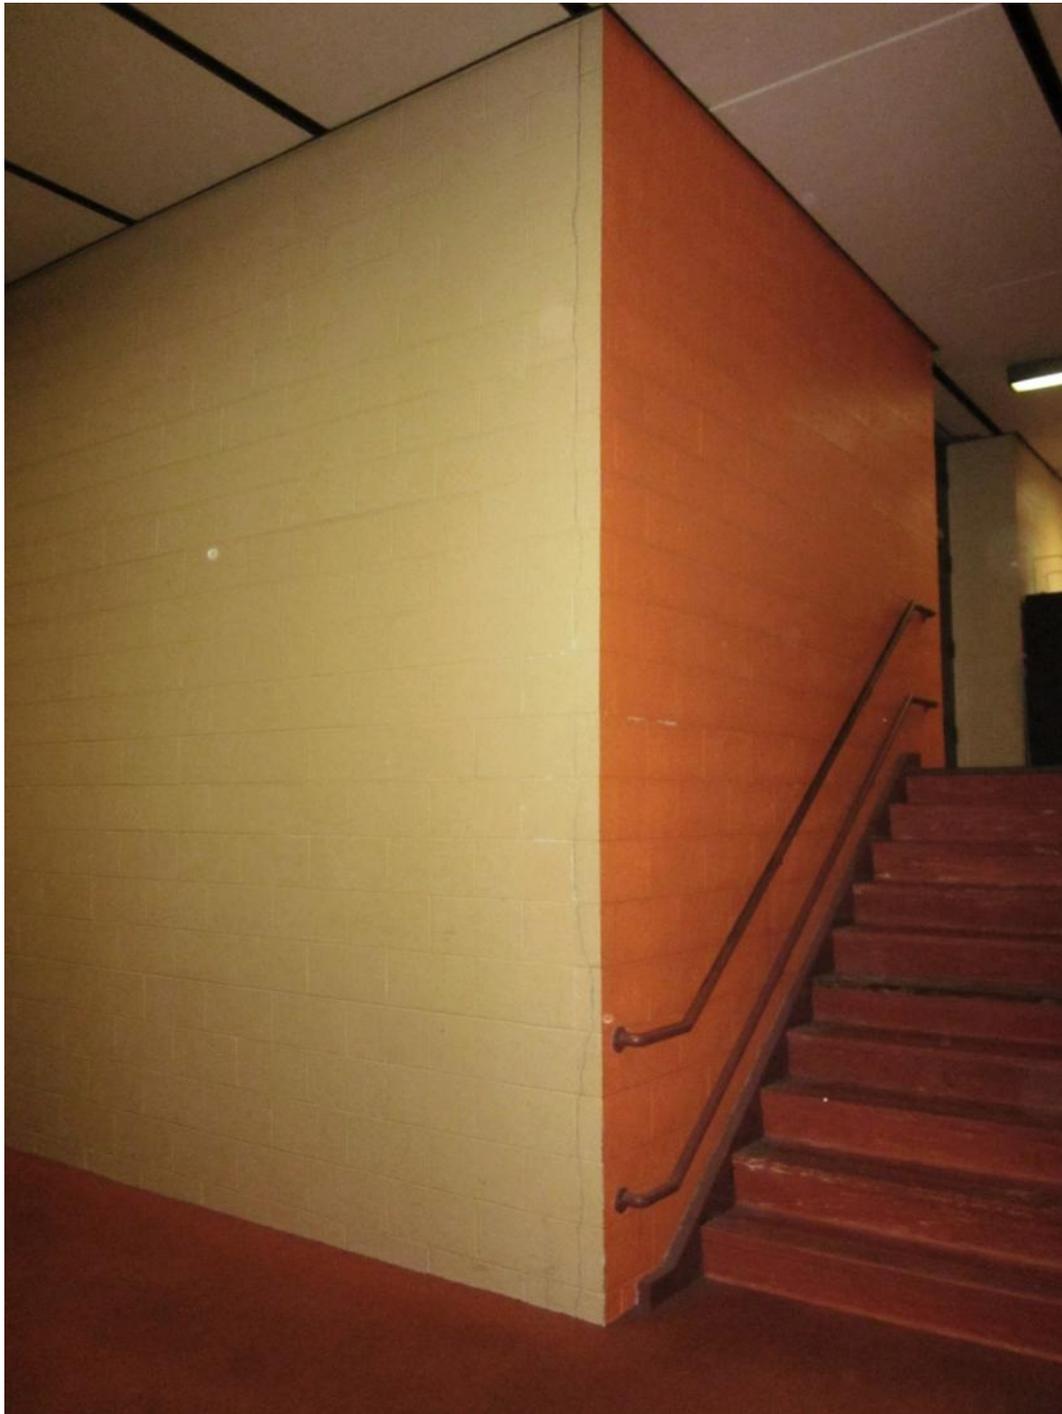
Photo #6

This photo shows another of the many locations throughout the school building where the interior masonry block partition walls are cracked.

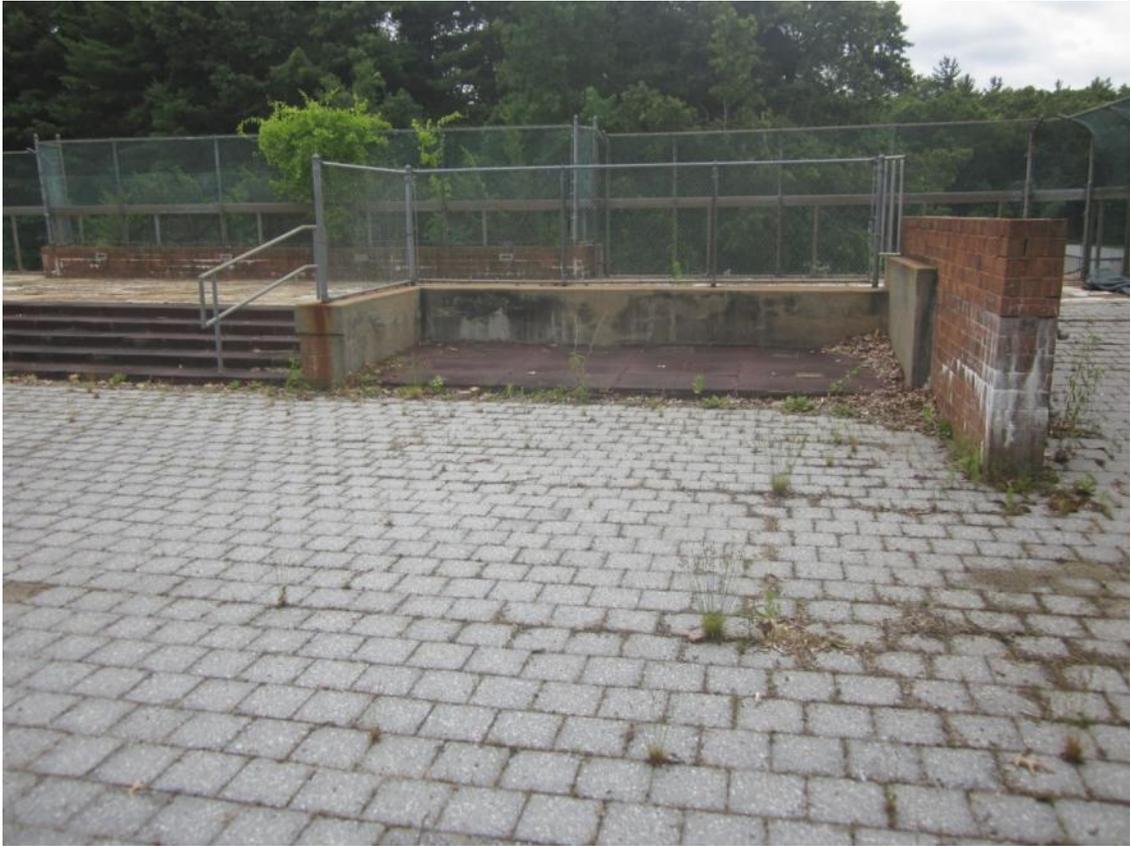
Photo #7

- **Water infiltration and the growth of vegetation has damaged the exterior brick walls of the Boiler Room building and the terrace walls and pavers above the Boiler Room building:** Long term water infiltration and the subsequent growth of vegetation has damaged the exterior brick walls of the Boiler Room building and the brick walls and the patio pavers of the terrace above the roof of the Boiler Room building. **(Photos #7 to #11.)**

- **COMMENT:** In addition to damaging the exterior walls of the Boiler Room building, and the terrace walls and pavers above, the water infiltration may be jeopardizing the structural concrete roof slab of the Boiler Room building. It was reported to Odeh Engineers that some minor repairs to the exterior brick veneer walls of the Boiler Room building had been performed since Odeh Engineers previous investigation in 2008. However, no long-term, systematic repairs to these exterior brick walls have been undertaken.

This photo shows the damage to the brick walls and the patio pavers at the terrace above the roof of the Boiler Room building due to long-term water infiltration and vegetative growth.

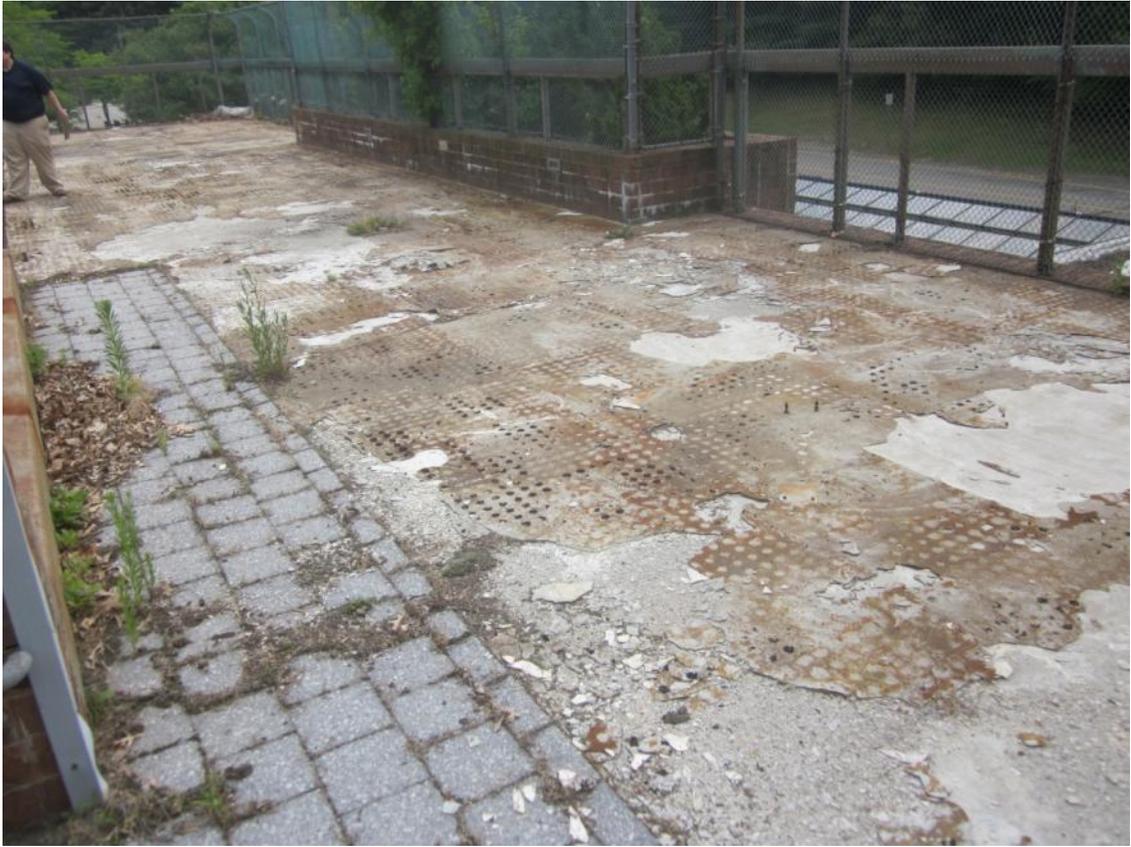
Photo #8

This photo shows another view of the damage done to the terrace above the Boiler Room roof from long-term moisture infiltration and vegetative growth.

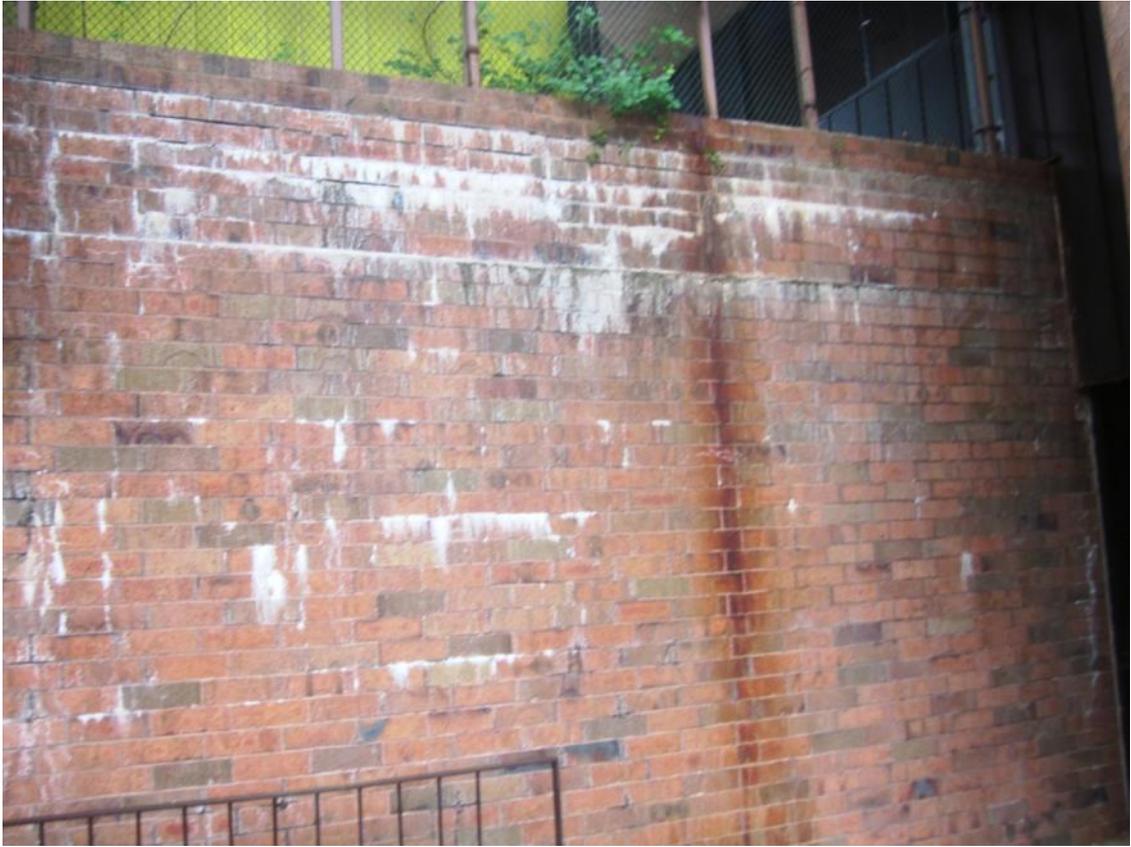
Photo #9

This photo shows the efflorescence leaching from the exterior brick walls along the east side of the Boiler Room building resulting from water infiltrating these walls from the terrace above.

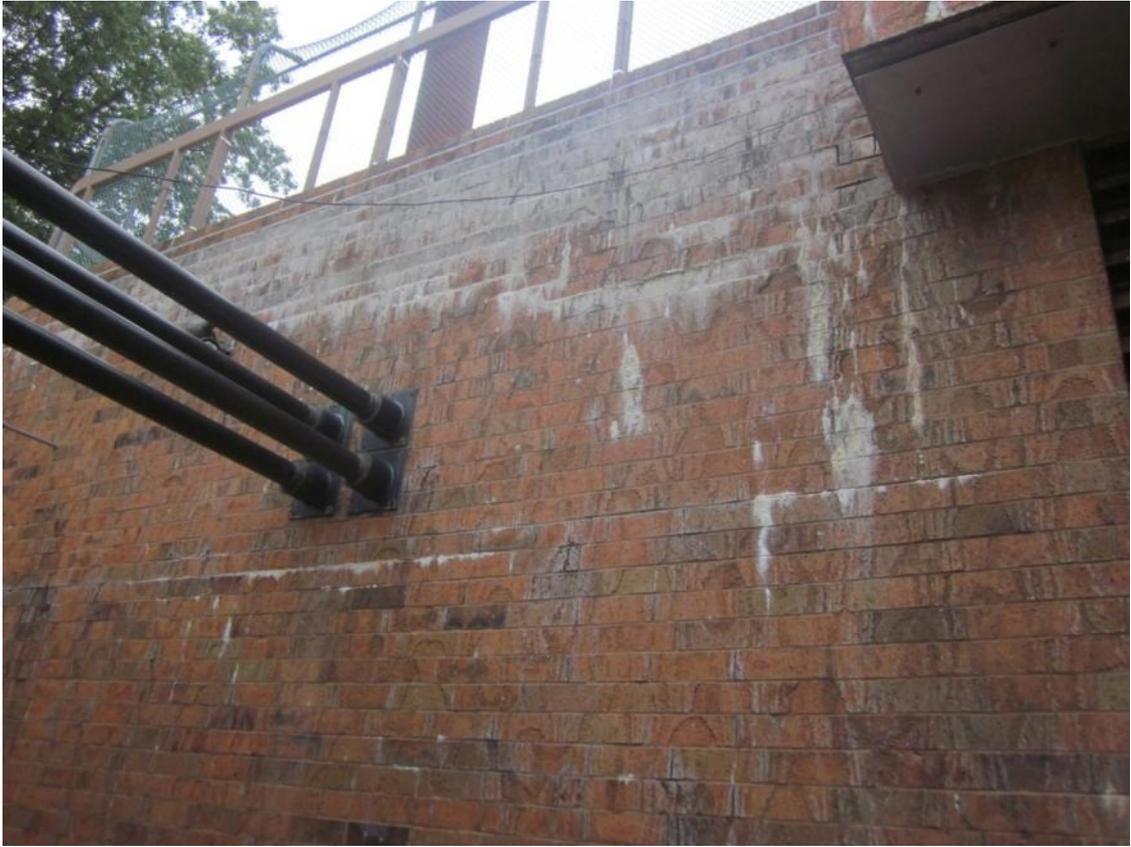
Photo #10

This photo shows another view where water infiltration from the terrace above is damaging the south brick wall of the Boiler Room building.

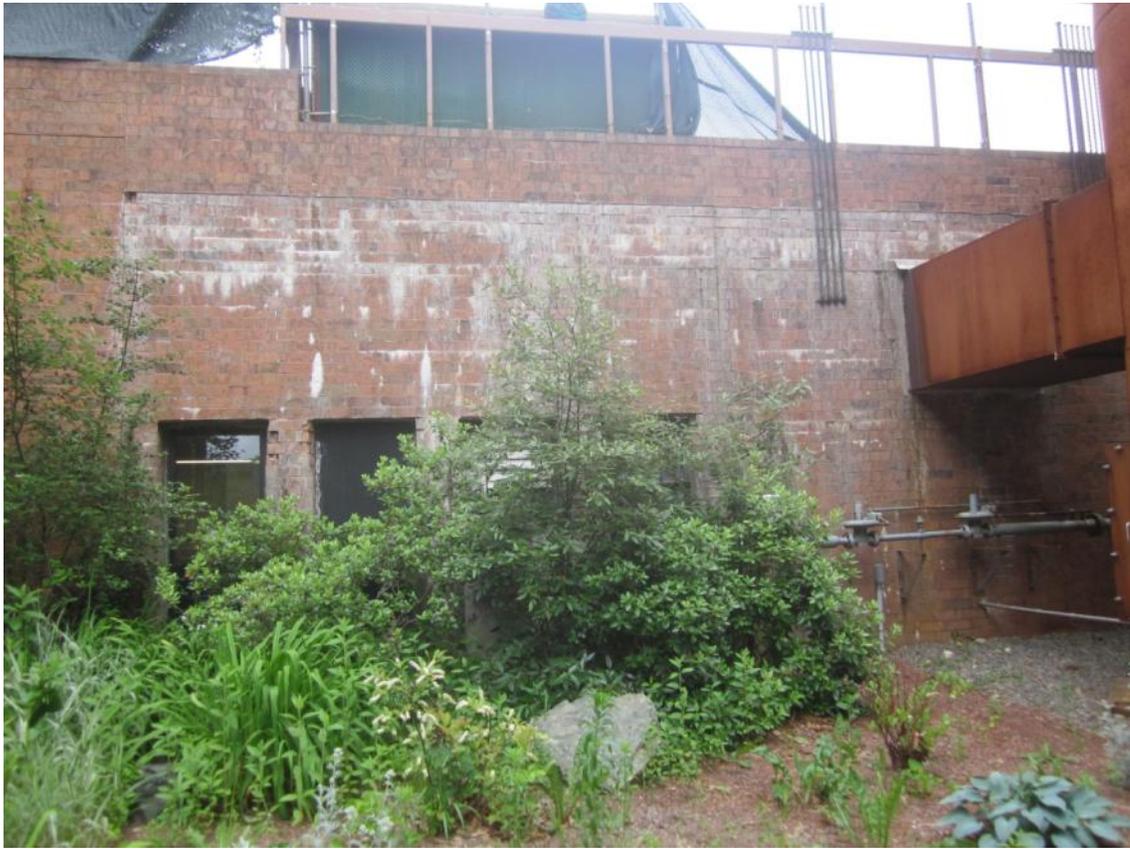
Photo #11

This photo shows the efflorescence leaching from the west exterior wall of the Boiler Room building due to water infiltration from the terrace above.

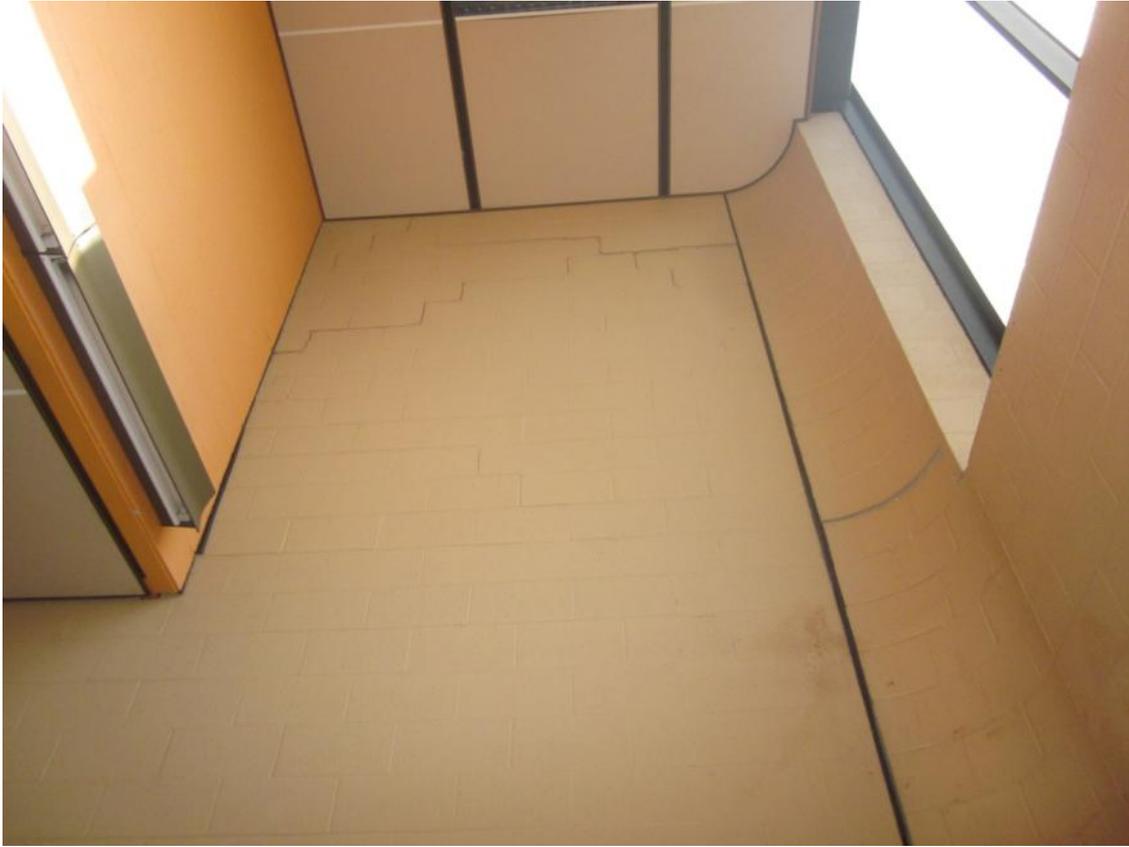
Photo #12

- **The load-bearing masonry block walls at the two pairs of stair towers located at the east and west ends of the school building are cracked and displaced:** The masonry block walls at the two pairs of stair towers are cracked and displaced. The most significant cracks occur in the masonry pillars on each side of the window openings just below the high roof framing elevation. **(Photos #12 to #16.)**

- **COMMENT:** Based on our recent examination of these structures, it appears that the cracking and displacements of the load-bearing masonry block walls of these stair towers may be due to the movement of the steel frame of the building from thermal expansion and contraction (see discussion of improperly constructed roof expansion joints below), and/or from lateral wind loads.
Additionally, the tall slender nature of the masonry pillars (which appear to be unreinforced), make them particularly susceptible to flexural cracking due to lateral movement of the stair tower. At the high roof level, the stair structure is not tied back to the main superstructure and therefore these pillars may be moving excessively under wind loads.
In order to mitigate additional cracking and deterioration of the masonry stairway walls, Odeh Engineers recommends that the slender “pillars” at the top of each stairwell be removed and reconstructed using solid grouted and reinforced masonry piers.

This photo shows the typical cracking of the masonry block walls found at each of the multi-story stair towers located at the east and west ends of the school building.

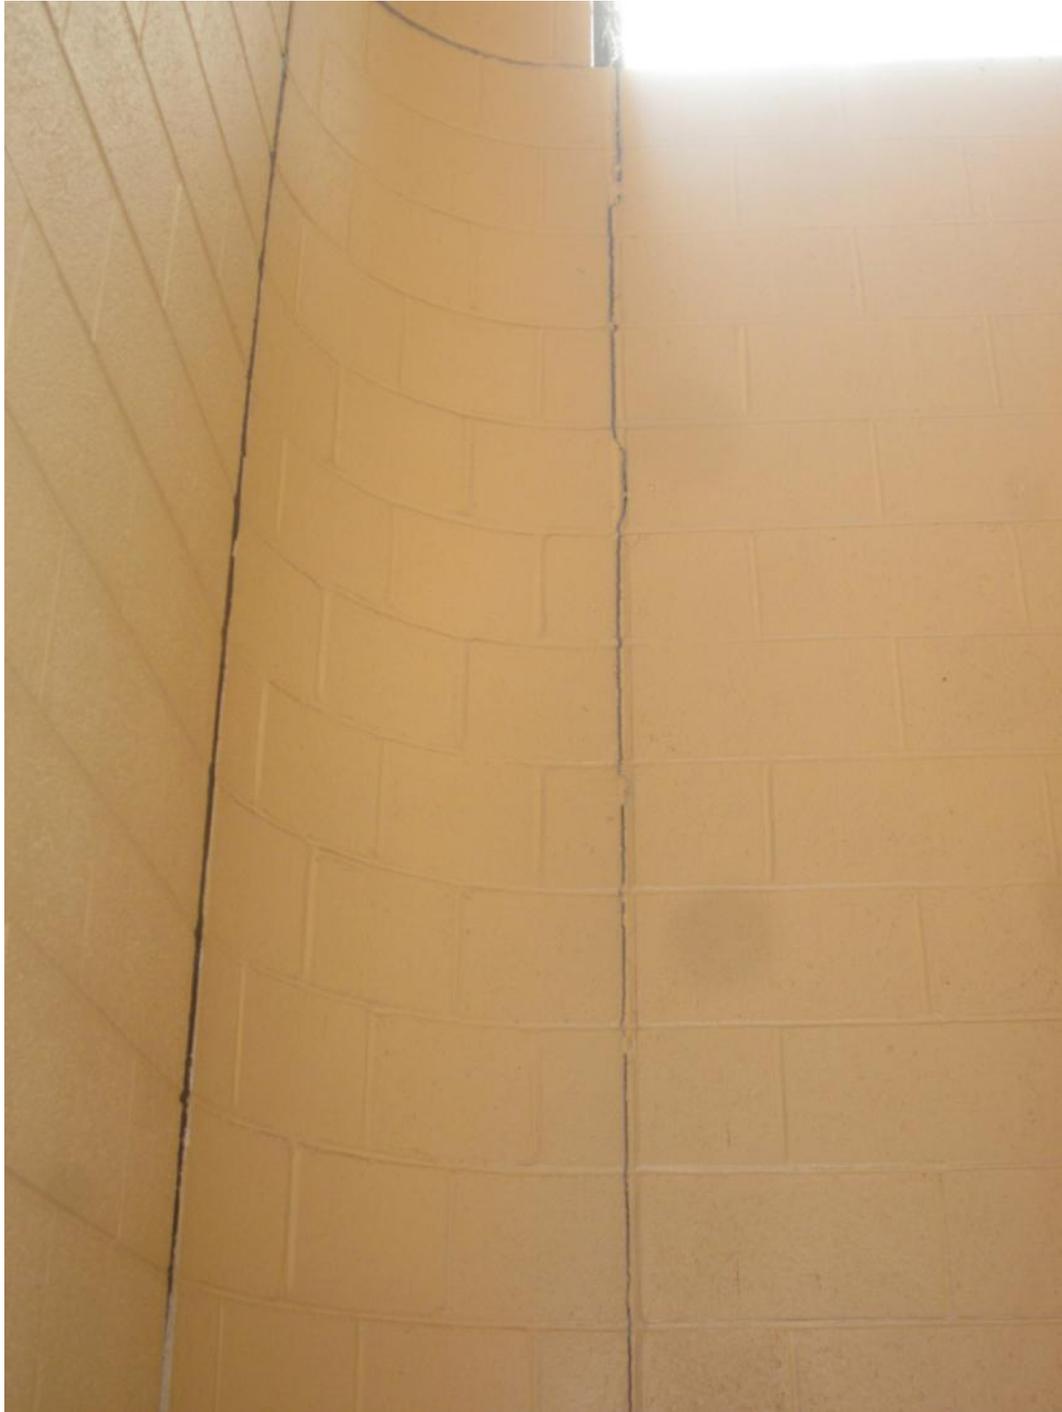
Photo #13

This photo shows the vertical crack in the load-bearing masonry block walls of one of the multi-story stair towers at the east and west ends of the building.

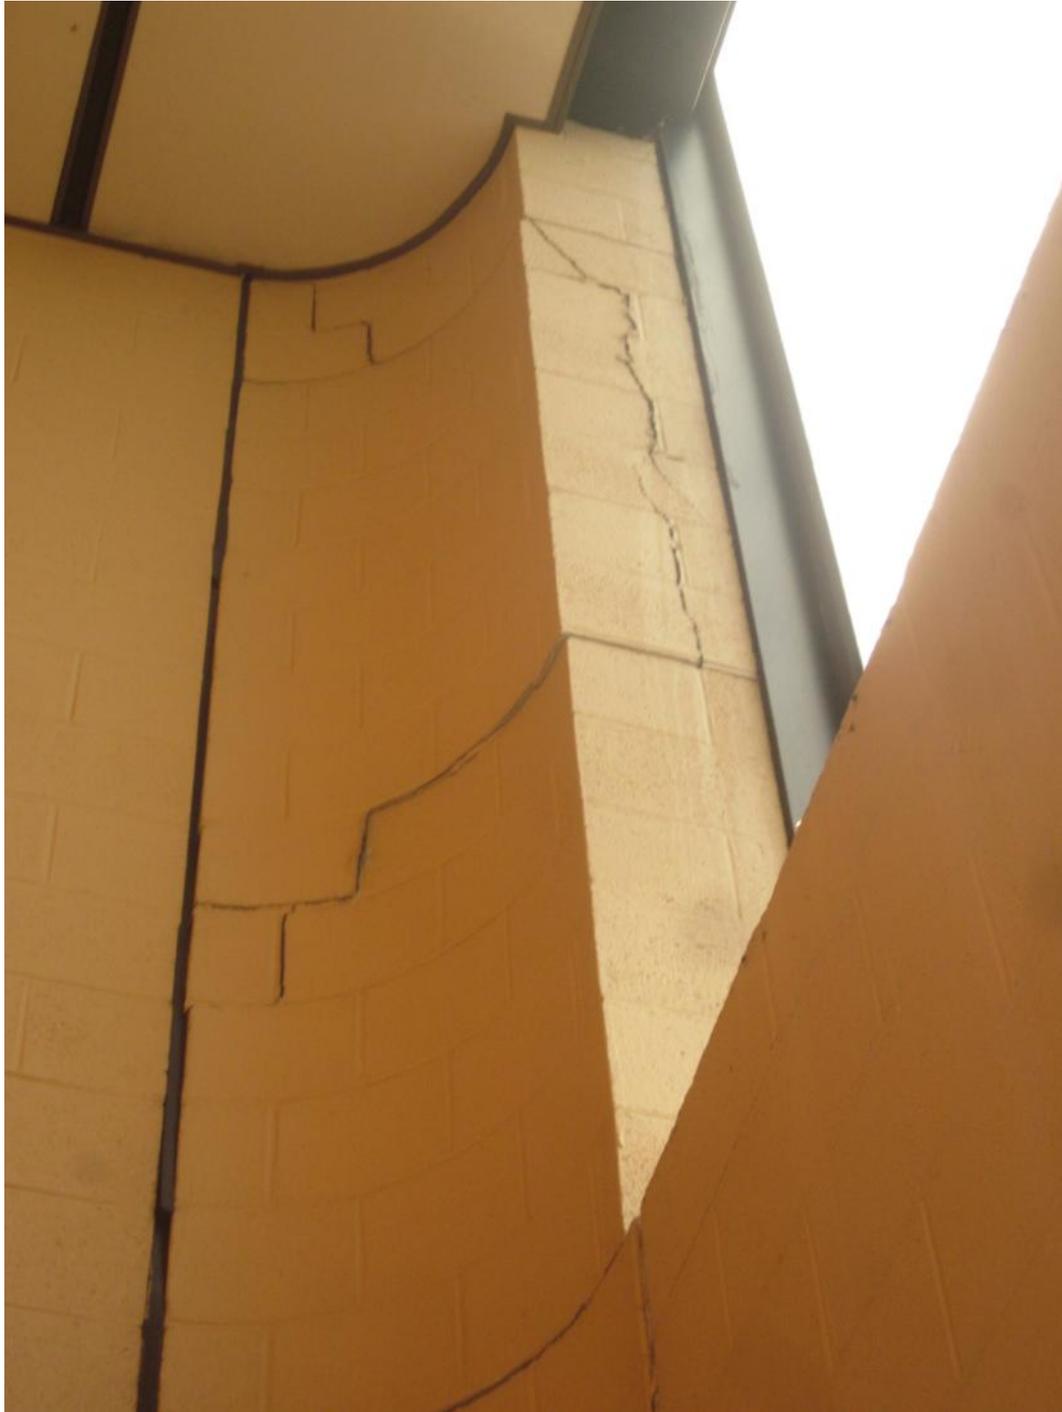
Photo #14

This photo shows the cracking and displacements of the masonry pier along the window of the multi-story stair towers at the east and west ends of the school building.

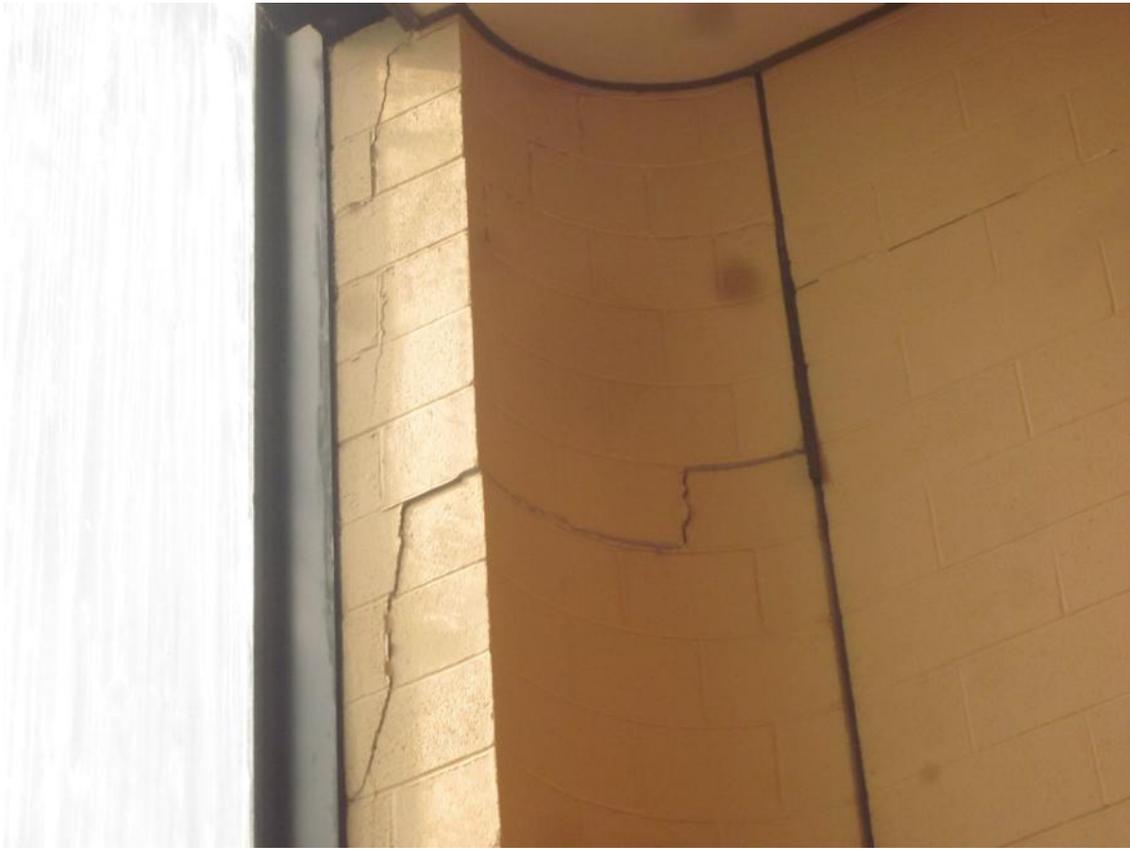
Photo #15

This photo shows the cracking and displacement of another of the concrete block walls in the stair towers at the east and west ends of the school building.

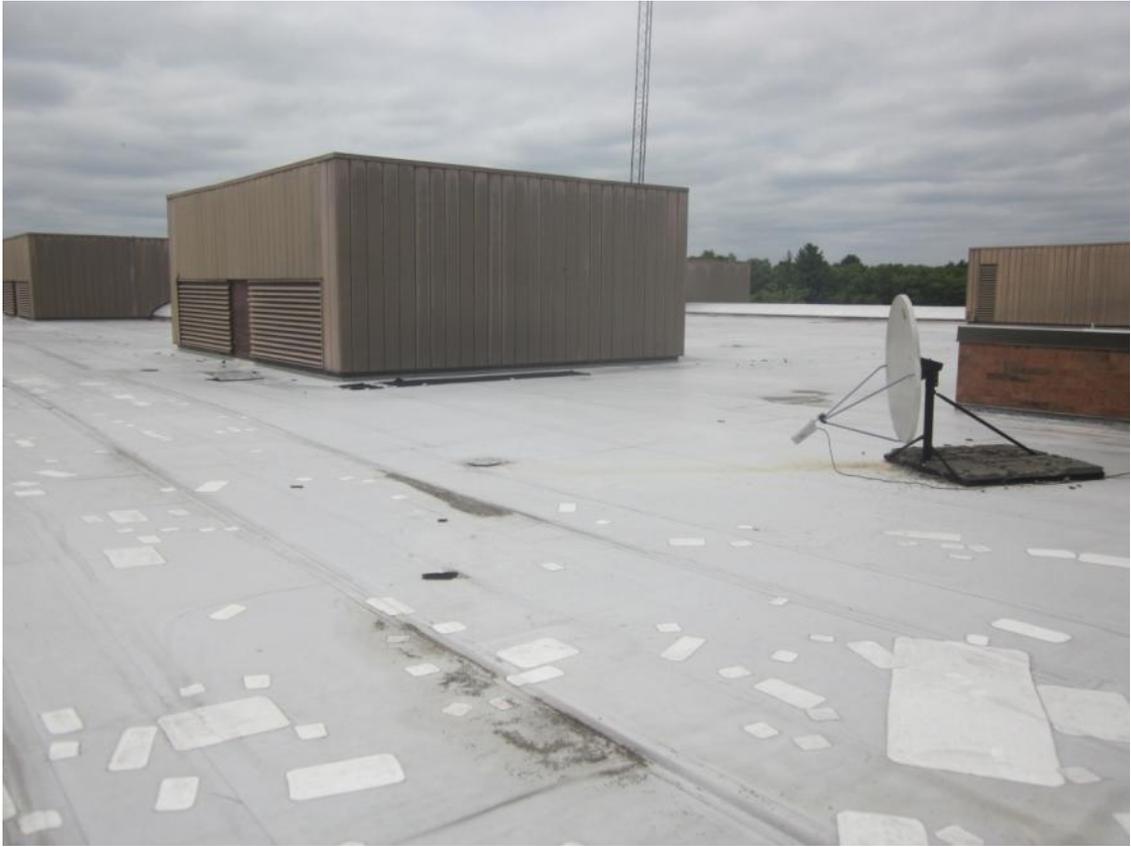
Photo #17

- **The roofing system on the school building has reached the end of its useful life:** The rubber roofing membrane on the roof of the building has reportedly been patched many times. The failed roofing system has led to roof leaks into the building. The roof leaks have caused some corrosion and deterioration of the composite metal roof decking. Many of these roof leaks have occurred at, or near the roof drains, and along the two expansion joints in the building. **(Photos #17 to #20.)**
 - **COMMENT:** The roofing system needs to be replaced as soon as possible. Continuing roof leaks may cause significant deterioration of the composite metal roof decking and the concrete slab. Long-term roof leaks can create serious structural issues if left unattended.

This photo shows some of the many patches in the aged roofing system on the school building roof.

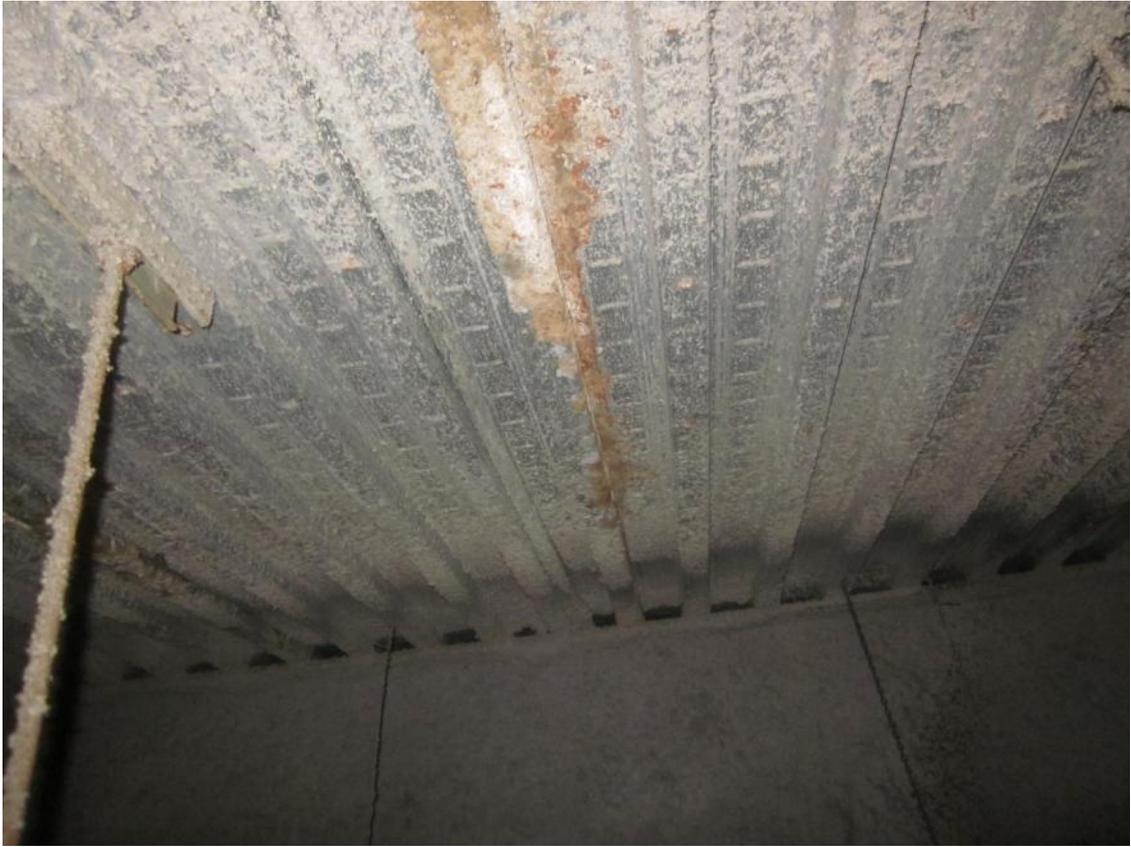
Photo #18

This photo shows one of the locations where minor corrosion of the composite metal roof deck has occurred apparently from leaks in the roofing membrane.

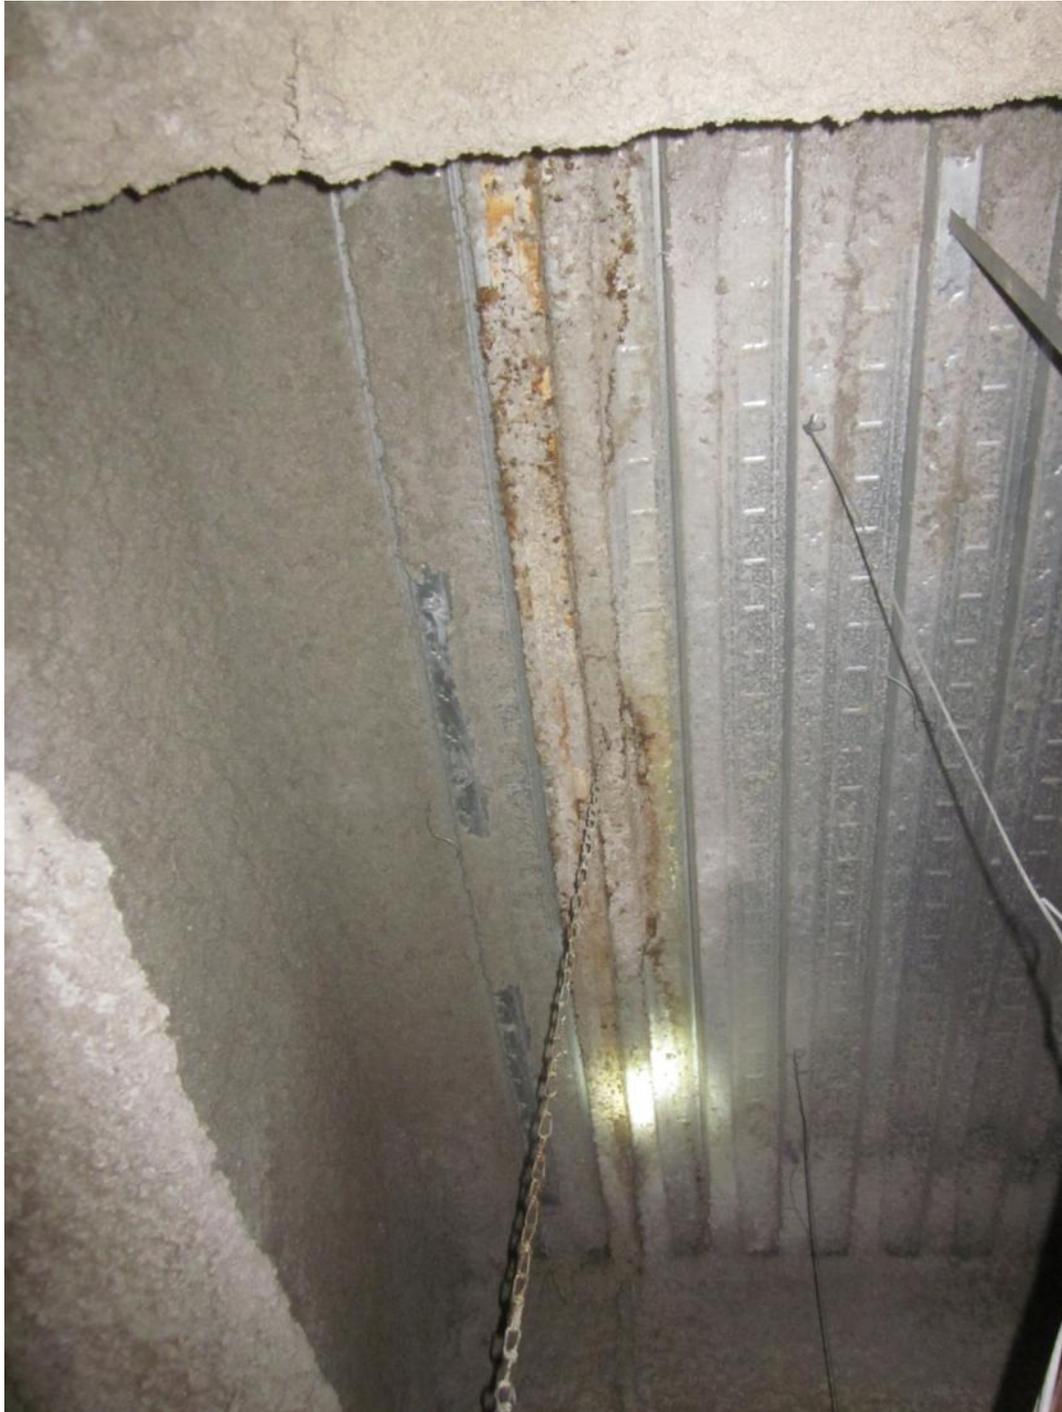
Photo #19

This photo shows the corrosion of the composite metal roof decking along one of the expansion joints in the roof of the school building.
