MINUTEMAN HIGH SCHOOL STRUCTURAL EVALUATION - 2012 UPDATE

758 MARRETT ROAD
LEXINGTON, MASSACHUSETTS 02421

July 30, 2012

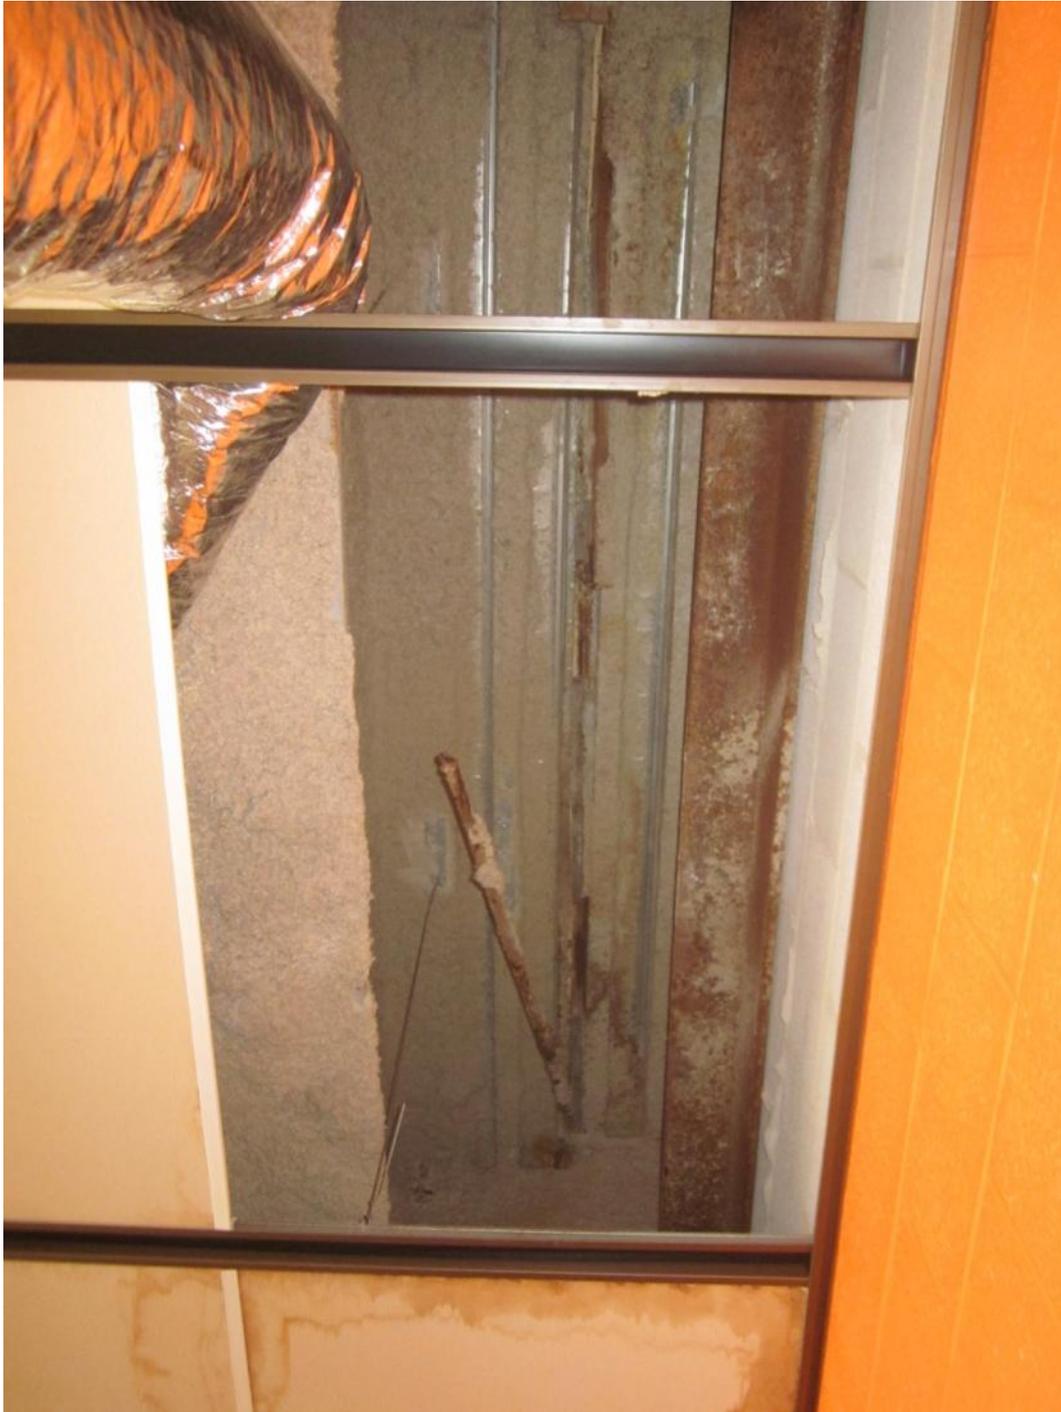
Photo #20

- **The roofing system on the school building has reached the end of its useful life:** The rubber roofing membrane on the roof of the building has reportedly been patched many times. The failed roofing system has led to roof leaks into the building. The roof leaks have caused some corrosion and deterioration of the composite metal roof decking. Many of these roof leaks have occurred at, or near the roof drains, and along the two expansion joints in the building. **(Photos #17 to #20.)**
 - **COMMENT:** The roofing system needs to be replaced as soon as possible. Continuing roof leaks may cause significant deterioration of the composite metal roof decking and the concrete slab. Long-term roof leaks can create serious structural issues if left unattended.

This photo shows another of the roof leaks that has occurred along the expansion joint adjacent to the Instructional Media Center.

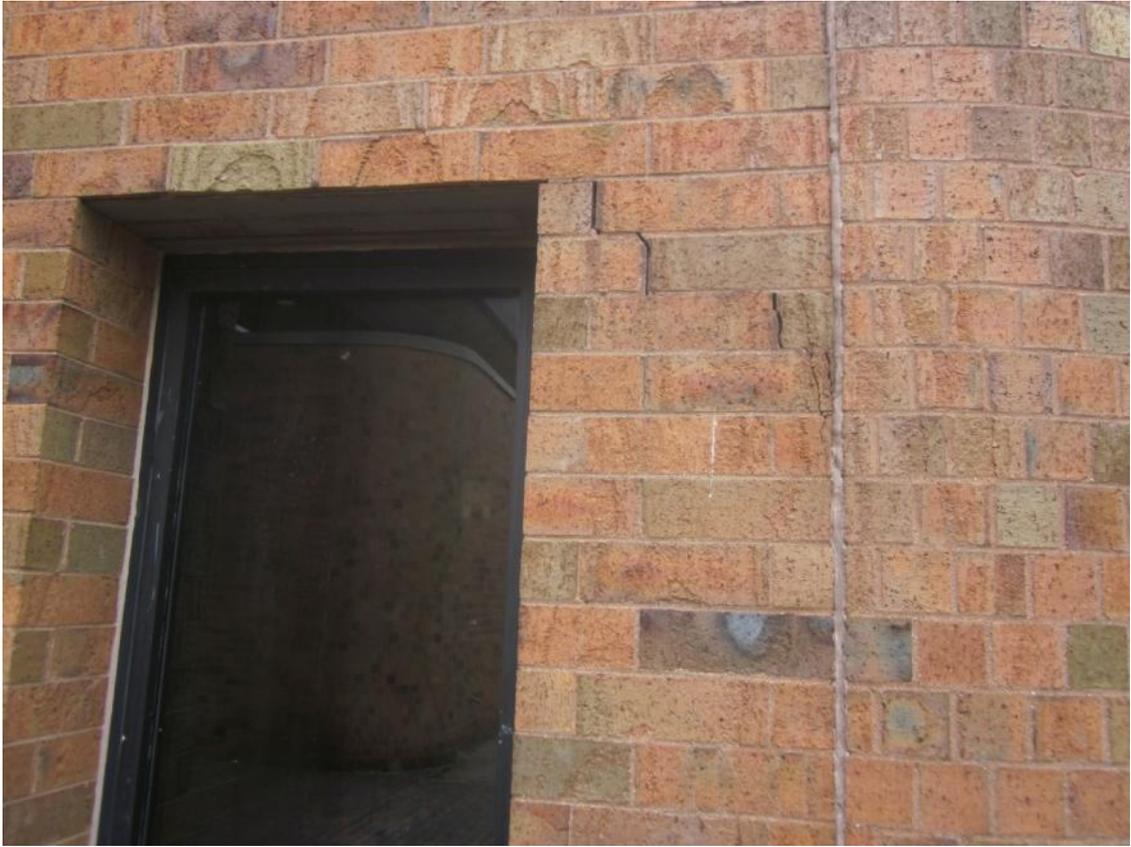
Photo #21

- **Minor cracking of the exterior brick walls:** Minor cracking of the exterior brick walls was noted at several locations. **(Photos #21 and #22.)**
 - **COMMENT:** In general, the cracking of the brick veneer appears to be the result of an insufficient number of control joints to allow for the expansion and contraction of the brick. A maintenance program of repairing the bricks

This photo shows one of the locations where minor cracking of the exterior brick veneer has occurred.

and raking and repointing the mortar joints should be established to prevent water from entering the building envelope through these cracks. The creation of additional control joints should be considered.

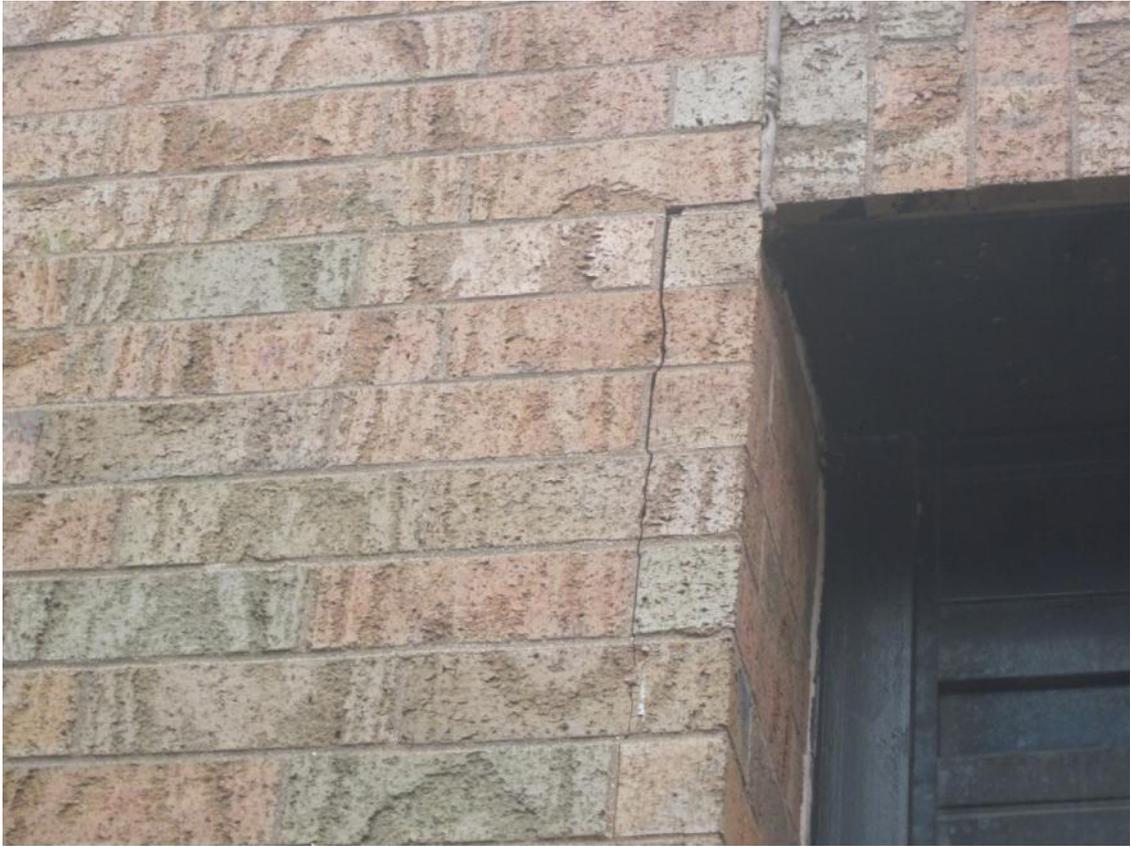
Photo #22

This photo shows another location where cracking of the brick veneer has occurred.

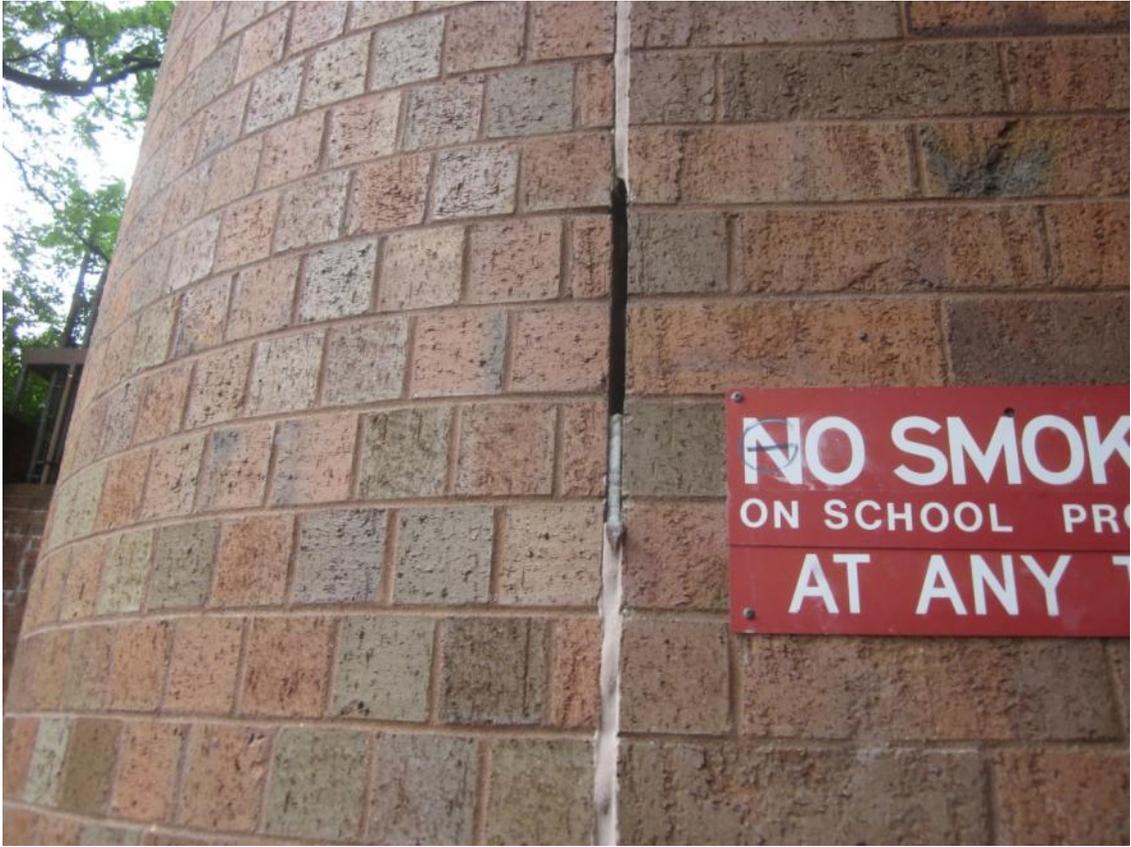
Photo #23

- **Failed or missing joint sealants in the exterior brick walls:** Odeh Engineers noted several locations where the sealants in the existing control joints in the exterior brick walls has failed or is missing. **(Photos #23 to #25.)**
 - **COMMENT:** A maintenance program should be established to restore the sealants and the functionality of the control joints to prevent water infiltration and to assure the long-term performance of the brick veneer.

This photo shows one of the many locations where the joint sealant in the exterior brick wall control joint is partially missing.

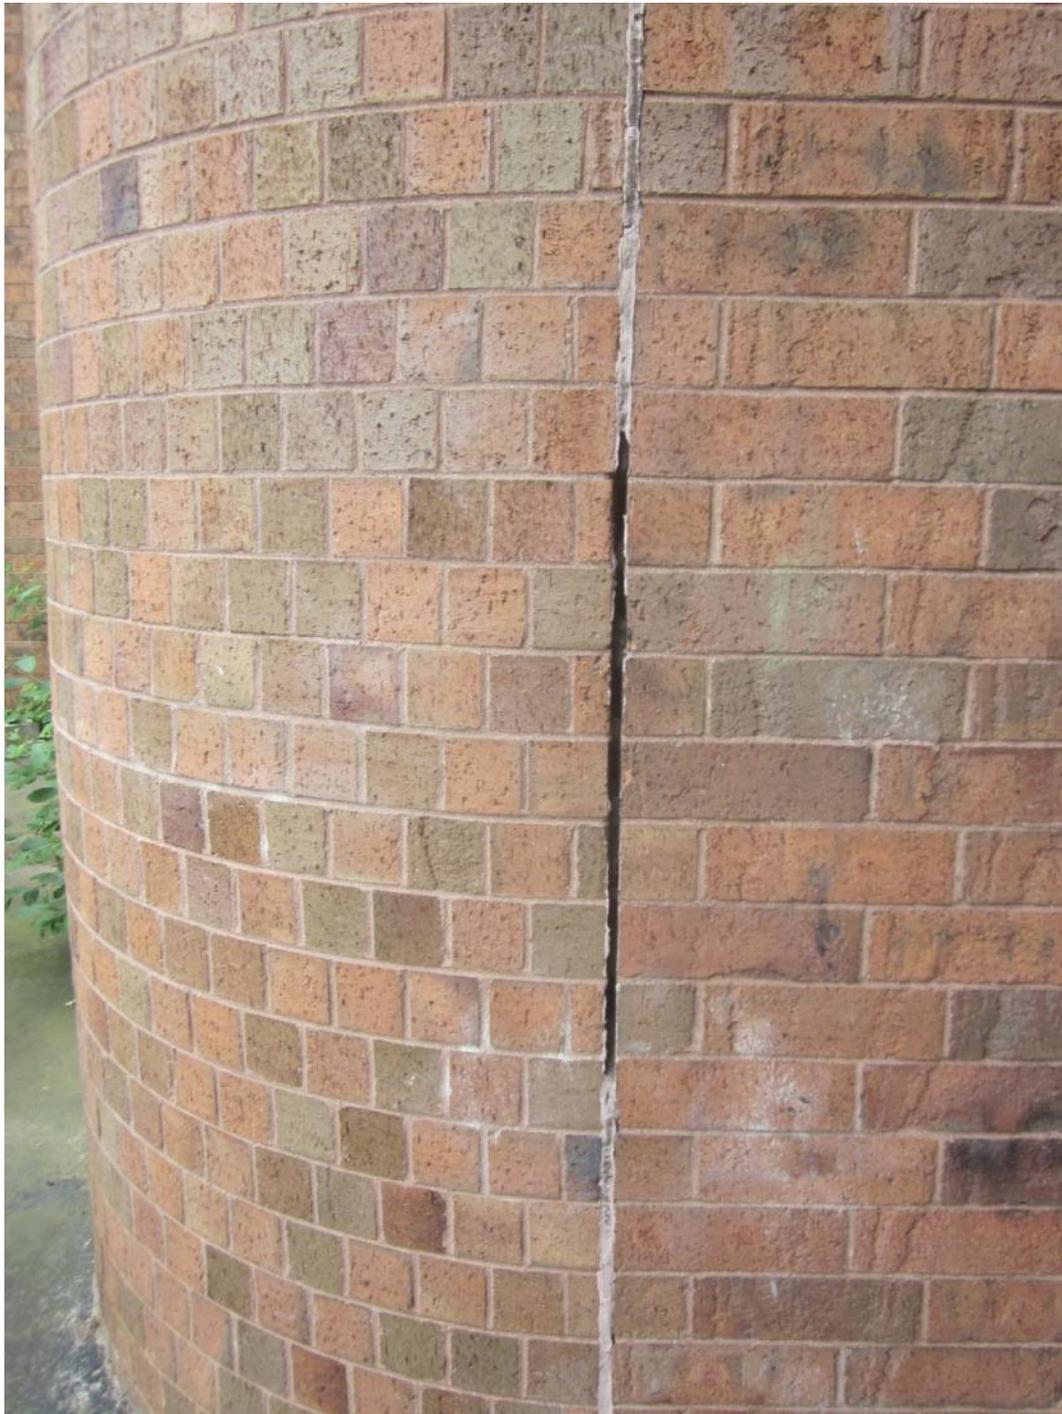
Photo #24

This photo shows another location where the sealant in the exterior brick wall control joint is missing.

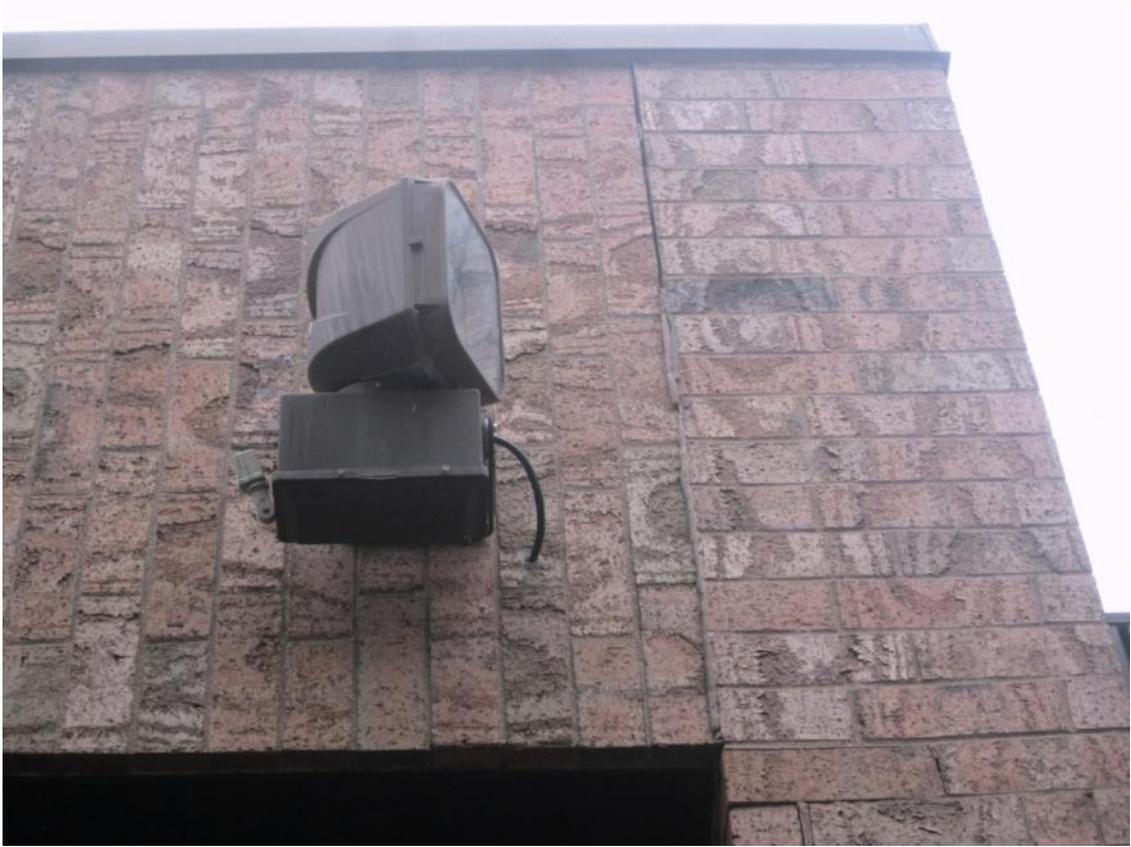
Photo #25

This photo shows another location where the sealant is missing from the top of the control joint, and the sealant is being squeezed out from the lower portion of the exterior brick veneer control joint.

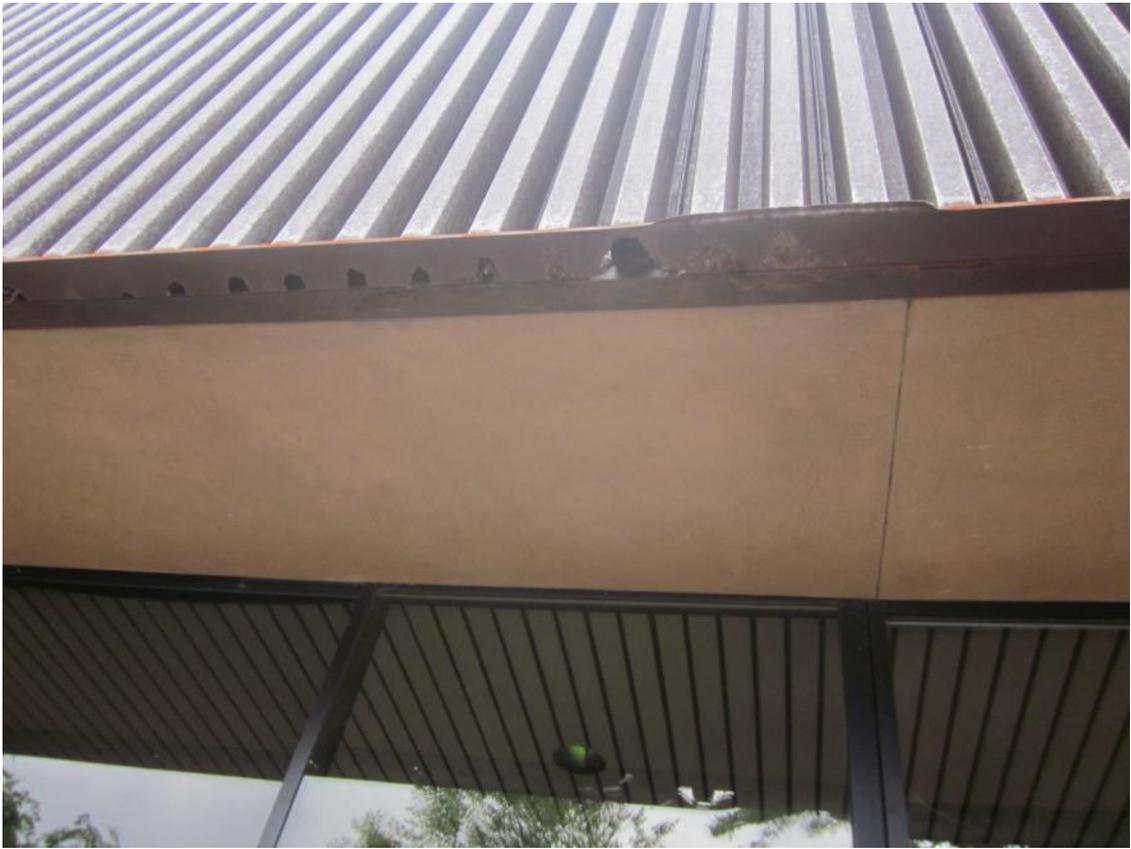
Photo #26

- **Deteriorated closure plates on base of Cor-Ten siding:** The closure plates at the base of the exterior wall vertical metal siding panels have deteriorated at many locations around the building. It was reported to Odeh Engineers that the deterioration of some of the bottom closure plates was so severe that the closure plates were removed. Birds and bees are nesting in the voids of the metal siding panels that are exposed by the deteriorated or missing closure plates. **(Photos #26 and #27.)**
 - **COMMENT:** The deteriorated bottom closure plates for the exterior wall metal siding panels are not structural. This is an architectural issue.

This photo shows the deterioration of the bottom closure plate at the base of the Cor-Ten metal siding on the west side of the school building.

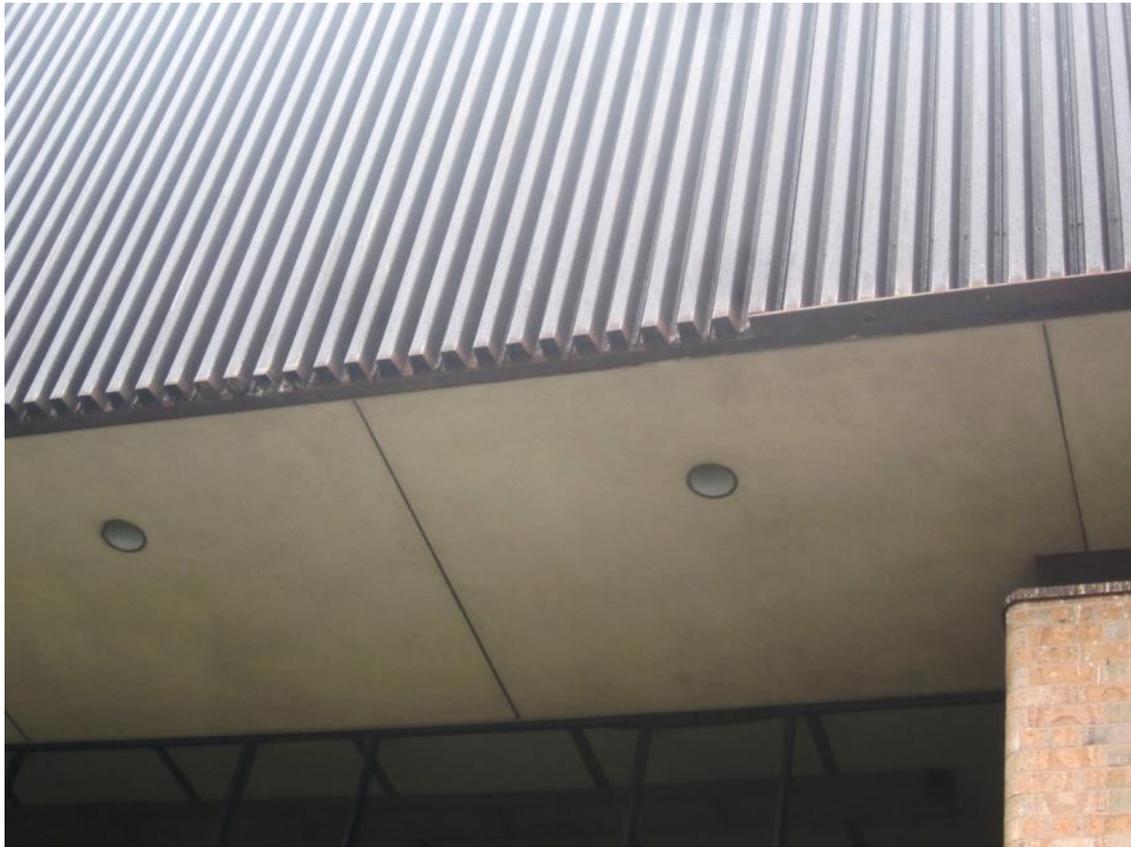
Photo #27

This photo shows a location where the bottom closure plate for the exterior wall metal siding panels was reportedly removed due to significant deterioration of the closure plate.

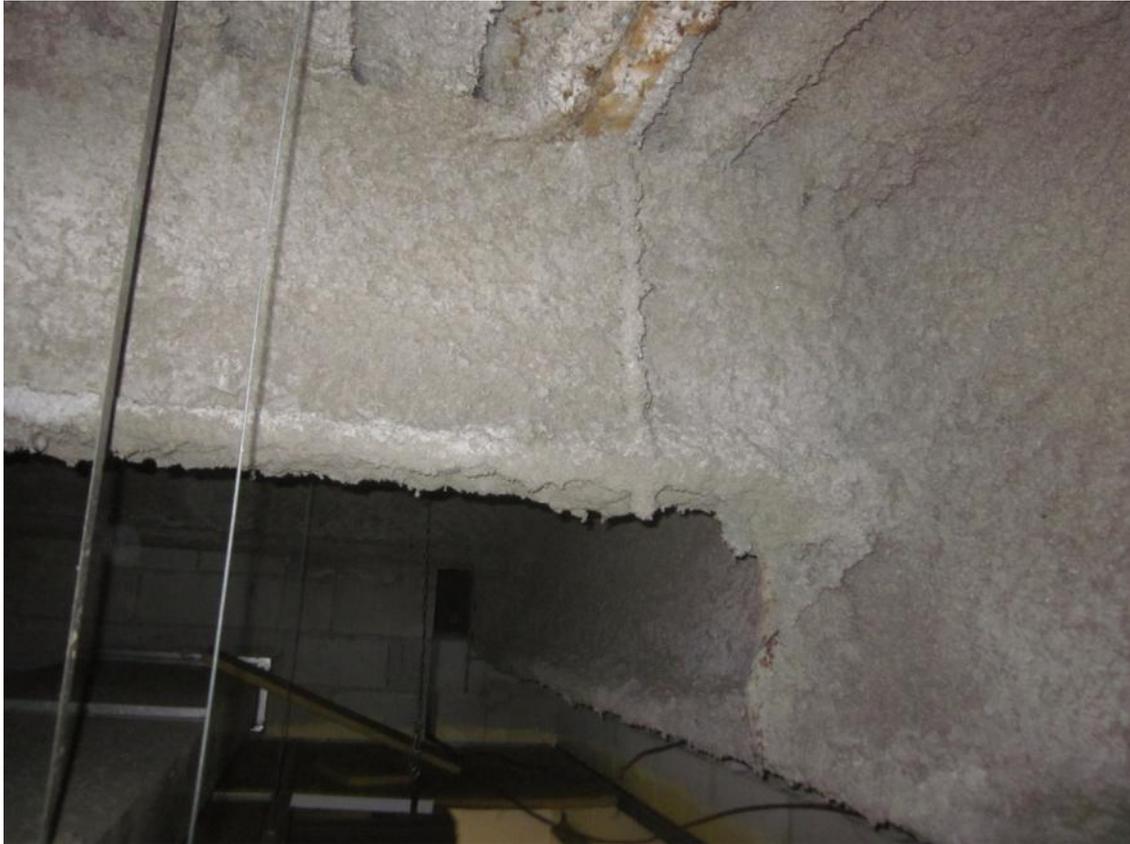
Photo #28

- **No sliding movements of structural frame members was observed at either of the multi-story building roof framing expansion joints:** At all roof framing expansion joint connections observed by Odeh Engineers, there was no evidence of the sliding movements of the roof framing members that is expected at the expansion joints. Furthermore, the roof level expansion joints were not constructed in conformance with the structural details. **(Photos #28 to #31.)**

- **COMMENT:** The steel members at the roof level expansion joints typically have the greatest amount of movement due to the changes in temperature from the heat of the sun and the winter cold. The roof framing members at the expansion joints are typically covered with a thick, stiff coating of spray-applied fire resistance material (SFRM). Assuming that the expansion joints were functioning properly, cracks should have developed in the SFRM where the opposing sides of the roof framing structural members at the expansion joints would move relative to each other. No cracks in the SFRM or any other indications of movement of the opposing members on each side of the expansion joints were in evidence.
In addition, the original structural details of the roof level expansion joints show a bent plate supporting the concrete slab from the adjacent girder to the joint. In the existing construction, no bent plate was installed and the metal decking extending from the roof girder to the joint supports the concrete roof slab. This means that the concrete roof slab effectively ties together both sides of the expansion joint, likely restraining the movement of the joint.

The apparent lack of functioning expansion joints may cause excessive movements of the steel framing over the length of the building and may be

exacerbating the cracking and displacements of the masonry walls found throughout the building.

This photo shows one of the steel roof beams framing into a steel roof girder along the west expansion joint of the multi-story building. The gray material on the roof beam and girder is the spray-applied fire resistance material (SFRM). The roof beam is seated on a slide-bearing assembly mounted on the roof girder. No visible evidence of cracking of the SFRM or other indications of movement of the steel framing on opposite sides of the expansion joint can be seen.

As part of any renovation, Odeh Engineers recommends that the expansion joints be reviewed and perhaps repaired to allow for improved movement in the steel frame. Odeh Engineers will also address concerns related to seismic loading through these joints in a separate report on seismic deficiencies in the building.

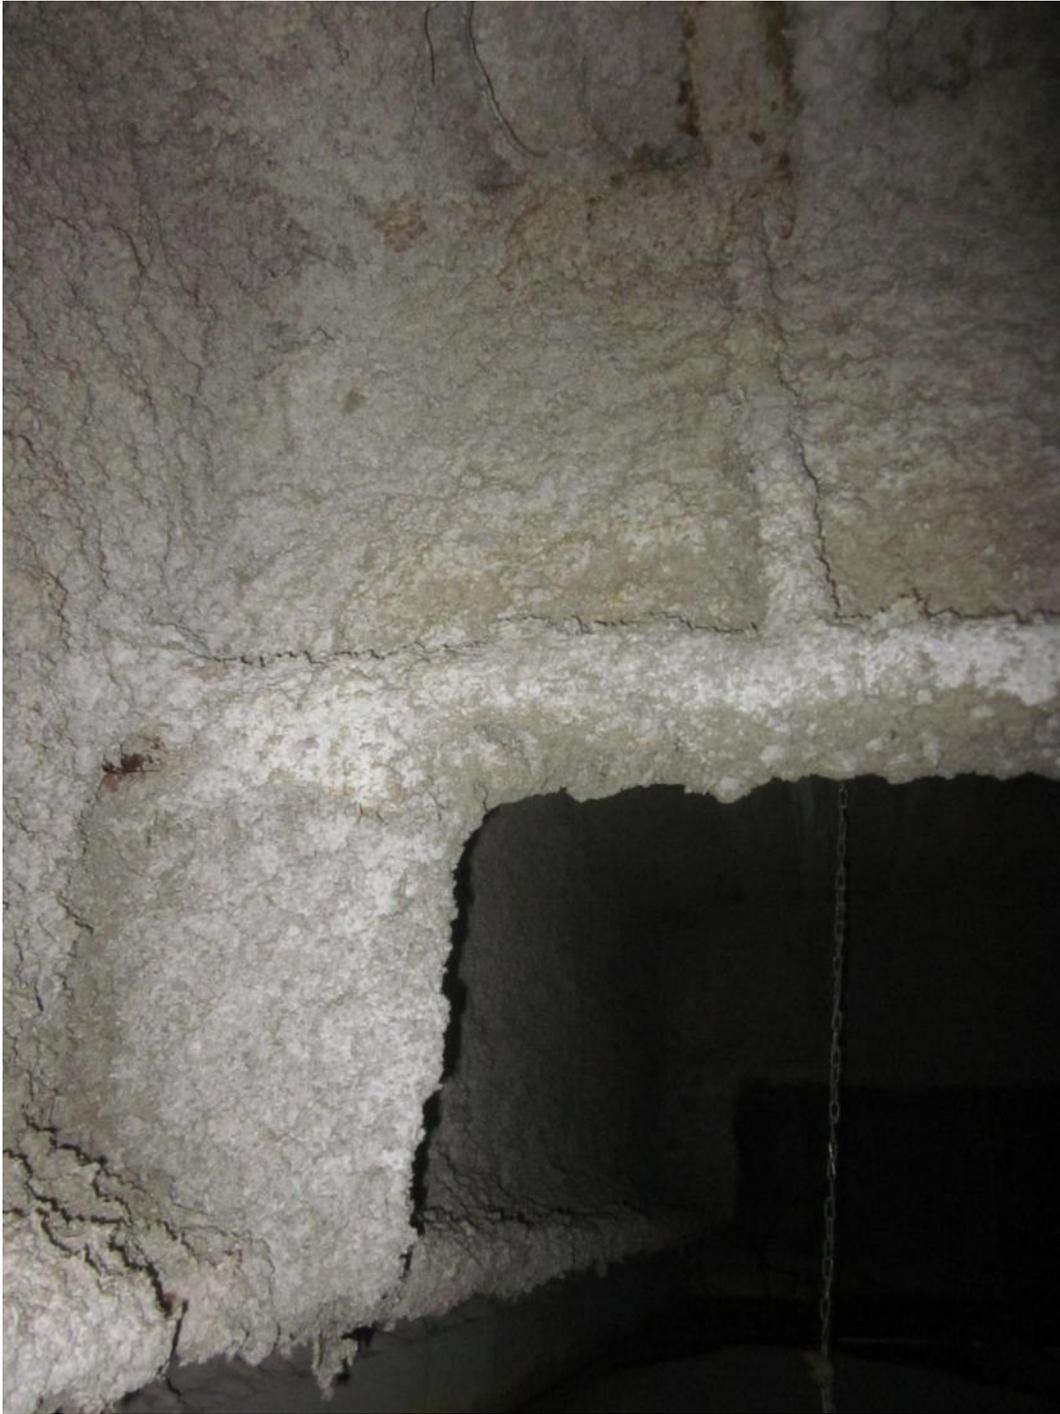
Photo #29

This photo shows another of the sliding-bearing assemblies located along the west expansion joint of the multi-story building. Again no evidence of the expected movement of the framing members on opposing sides of the joint can be seen.

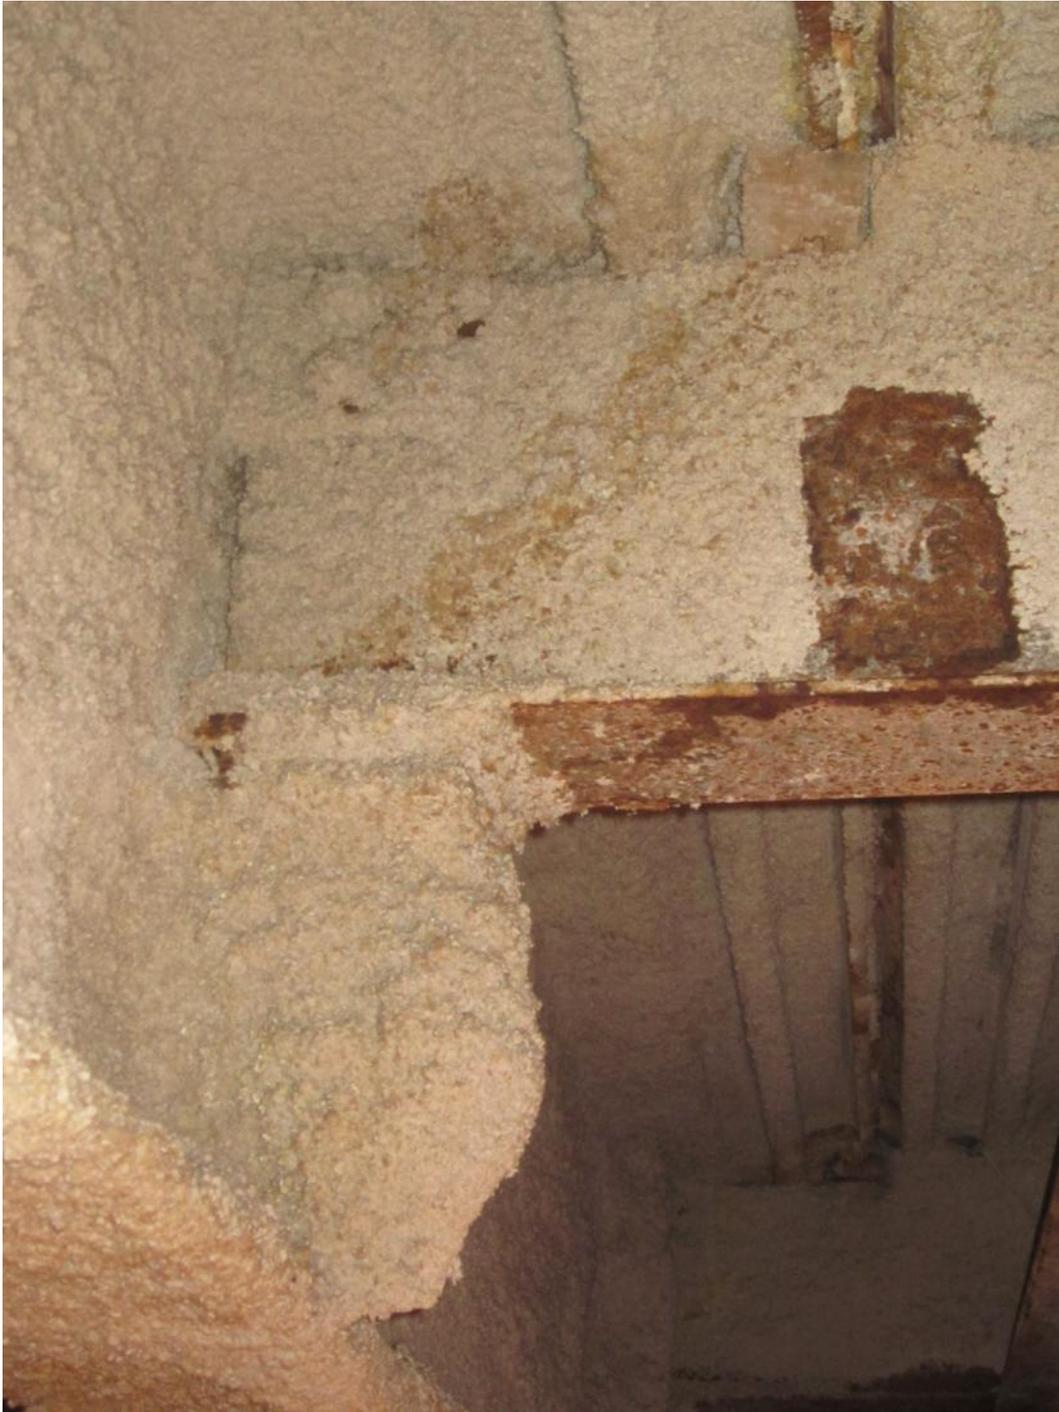
Photo #30

This photo shows the sliding-bearing assembly located along the east expansion joint of the multi-story building. Note the lack of the bent plate and the installation of the metal roof decking between the roof girder and the joint.

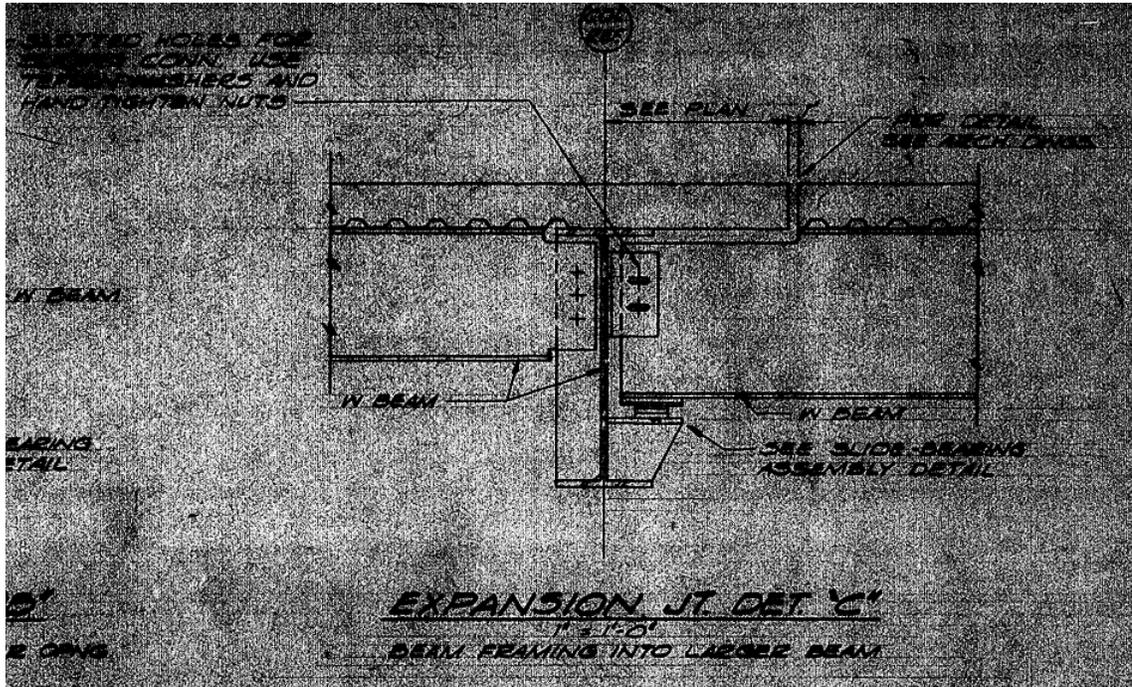
Photo #31

This photo shows a copy of the typical roof framing level expansion joint detail in the multi-story building. Notice the steel bent plate that was to extend from the roof girder to the slab expansion joint.
