Siemens Building Technology MEP Existing Conditions

Minuteman Regional High School
758 Marrett Road
Lexington, MA 02421

Electrical Existing Conditions Report

HVAC Existing Conditions Report

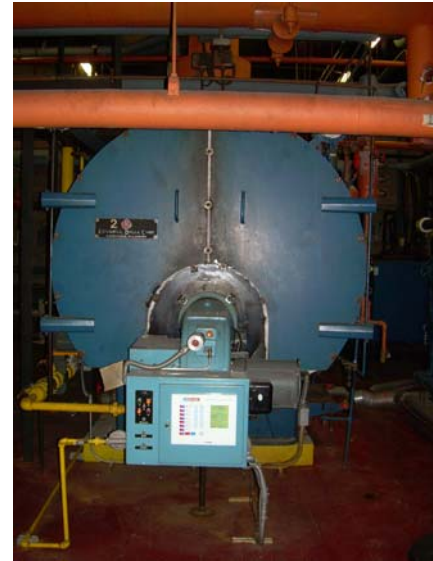
The boiler room is provided with two individual Kewanee fire tube boilers. Each boiler was installed during the original construction in approximately 1974 and operates on low pressure steam. Steam from each boiler is distributed to a single overhead header which serves as a central distribution point for two domestic hot water heaters, one steam absorption chiller, and two steam to hot water heat exchangers for the building heating system. Each boiler is provided with dual low water cut offs as well as all operating and safety controls. The condition of each boiler shell was noted to be very good considering their age. It was not possible to view the internal fire tubes; however, considering the very good maintenance that the boilers have received it would not appear to contain tube perforation or fire box damage. Historical data does suggest that boilers of this nature should have a life expectancy of approximately 40 years considering normal maintenance, however, with continued very good maintenance additional service life will be achieved.

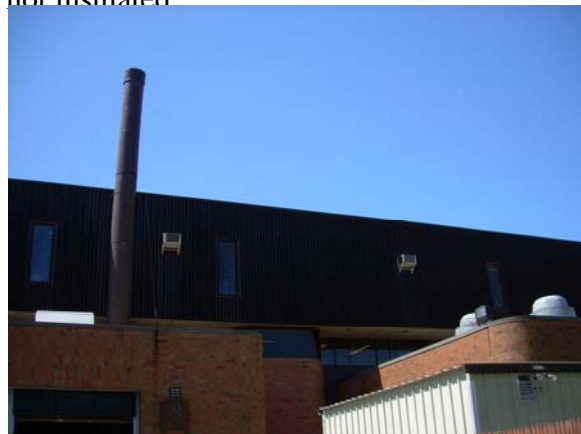
The breeching from the boilers appears to be of the single wall welded black steel design and is insulated with what appears to be calcium silicate insulation (or asbestos) with a canvas jacket. Samples of this material should be tested for the presence of asbestos and remediated if noted positive. The breeching was provided with a single cleanout at the end of the common breeching. The chimney is of the premanufactured steel and refractory type and appears to be of adequate height to maintain proper draft. The entire installation of breeching and chimney was noted to be in good condition and operating as intended.

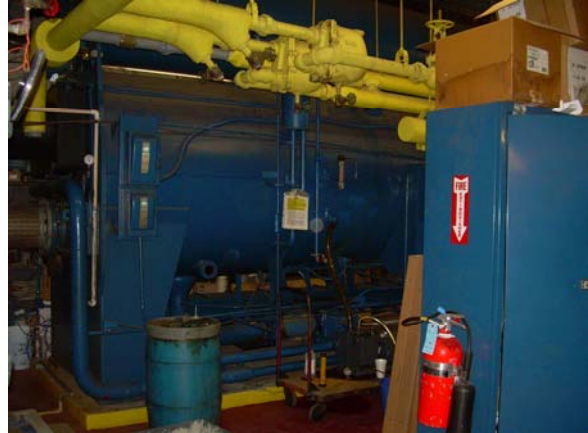
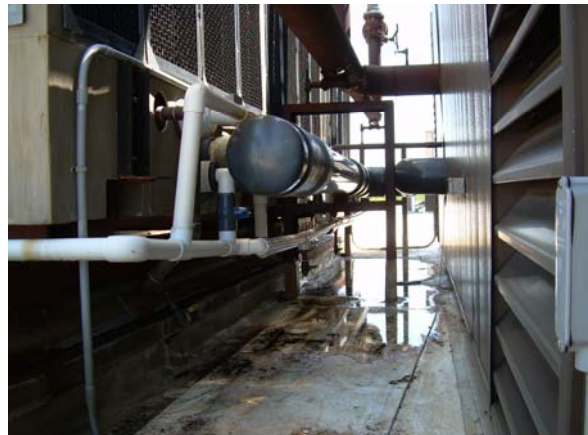
Also located within the boiler room is a low-pressure steam absorption chiller. The chiller is the original installed in 1972 and provides a chilled water supply to the entire building. Located at the rear of the chiller are two base mounted condenser water pumps which communicate to a roof mounted PVC cooling tower. The single condenser water pump is of the horizontal split case design and communicates to the cooling tower through an uninsulated schedule 40 black steel piping system. The cooling tower appears to have been replaced within the last three years. Maintenance personnel have indicated that the new cooling towers continue to leak and the units are showing a general state of disrepair with numerous warped structural panels and leaking piping. Chilled water is distributed by a single horizontal split case distribution pumping system. Chilled water is provided to the entire building through a fiberglass insulated schedule 40 piping system. Both the condenser water piping system and chilled water piping system appear to be in very good condition and maintenance personnel has indicated that they have not been problematic in the past. It does appear that proper chemical treatment is being provided for the cooling tower. The absorption chiller is a very uneconomical operating chiller which requires the steam boilers to run throughout the summer months to create the cooling energy required within the chiller. Consideration should be given to a complete upgrade of the chiller, however, the condenser water and chilled water piping and pumps are capable of being reused. It does appear that the cooling tower is in need of replacement.

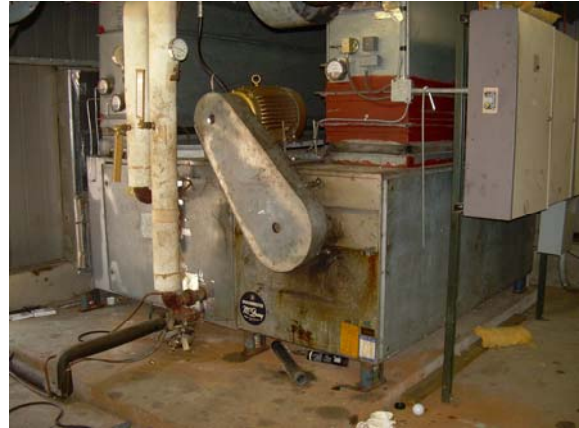
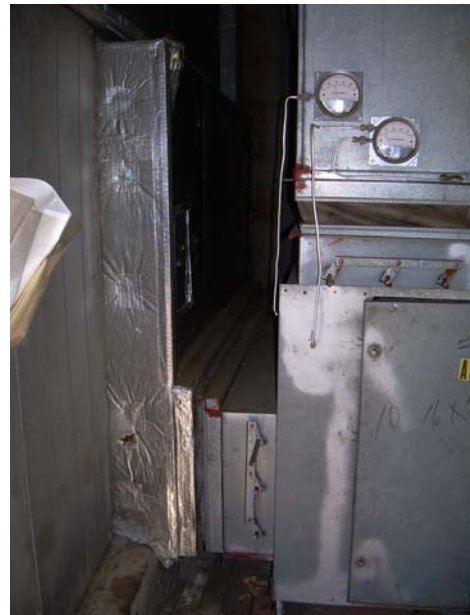
The entire heating ventilation and air-conditioning system originates in (10) roof mounted mechanical penthouses. Each mechanical Penthouse is provided with either one or two floor mounted air handling units each of which are provided with a combination of supply fans, chilled water cooling coil, hot water heating coil, filter section, and a combination return air outside air mixing box. Each air handling unit receives a direct source of outside ventilation air from a continuous intake louver which runs the entire length of each mechanical Penthouse. Located on the opposite wall is also a continuous louver which is utilized for relief and exhaust air. It was noted that the intake louvers primarily on the intake side had been modified to allow for entrance doors into each space. It appears that the louvers were modified in the field and were not supported adequately allowing the louver blades to be unsupported vertically at each side of the door. It was also noted that the fresh air intake and the relief air connections to the louvers did not meet adequate design standards allowing the effective free area of the louvers to be minimized due to the very short connection of sheet metal. The outside air intake ductwork was insulated with rigid fiberglass insulation much of which was noted to have surface damage. The supply air in return air ductwork was not insulated. The air handling units whether they are air-conditioning or heating and ventilation, all units were noted to have extensive surface contamination and soiling, limited to extensive damage on the fan casings, and generally suggesting that they have reached their maximum serviceable life.

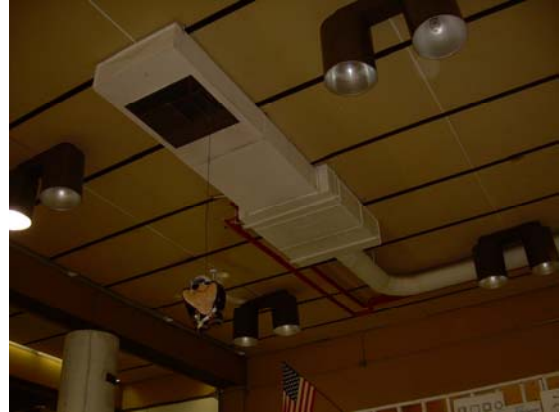
Each terminal unit is a static velocity reduction box which is of galvanized sheetmetal, internally lined with acoustic liner. Each velocity reduction box is also provided with a hot water heating coil which ties into the recirculating hot water distribution system. Each coil is provided with a modulating hot water valve controlled by a pneumatic wall mounted thermostat.

At the discharge of each velocity reduction terminal unit, is a small length of uninsulated galvanized sheetmetal ductwork with a single supply diffuser for providing ventilation and temperature air to each occupied area. All ceiling diffusers were noted to have surface soiling with overall condition consistent with their age of approximately 35 years.

All supply ductwork was soiled on the exterior however was not damaged and appeared capable of reuse. All velocity reduction terminal units, discharge ductwork beyond the velocity reduction terminal units, and supply diffusers have reached their maximum serviceable life and should be replaced.

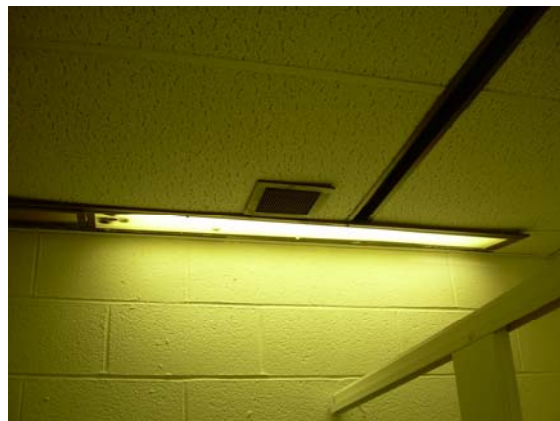
The individual public toilet areas are provided with a combination of ceiling and wall mounted exhaust registers generally located in the area of the plumbing fixtures. All exhaust registers were noted to be slightly soiled and in some damaged. The exhaust system is made up of galvanized sheet metal ductwork which terminates with roof mounted exhaust fans. Limited ventilation control is being maintained throughout all toilet spaces and it does appear that the exhaust fans are running; however, we cannot be certain if the air volumes

are in compliance with building code conditions at this time. Considering the approximate 30 year age of all systems and general poor performance consideration should be given to an overall upgrade at this time.

It was noted that there was no mechanical make up air provided for any of the toilet spaces. It appears that all make up air for the spaces is through the combination of undercut doors and door louvers. This could be contributing to the poor ventilation control noted.

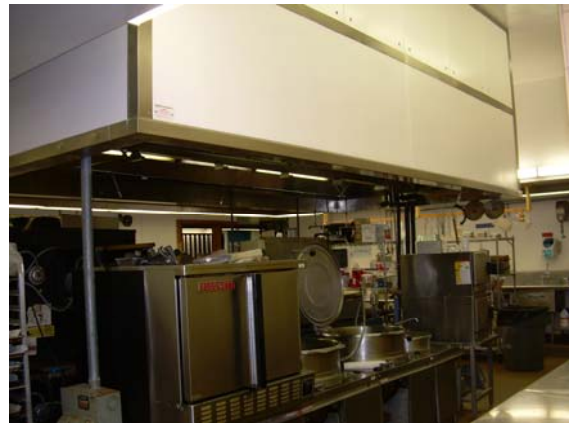
In addition to the above, the kitchen is provided with two additional air handling units which are located at the ceiling of the kitchen itself. Each air handling unit is provided with a supply fan, hot water heating coil with face and bypass control, and a direct source of outside air through wall mounted intake louver. Each unit is of the 100% outside air design and are intended as makeup air for a centrally located exhaust hood located within the kitchen. The overall condition of all ductwork, equipment, and supply diffusers is generally typical and reaching their maximum serviceable life.

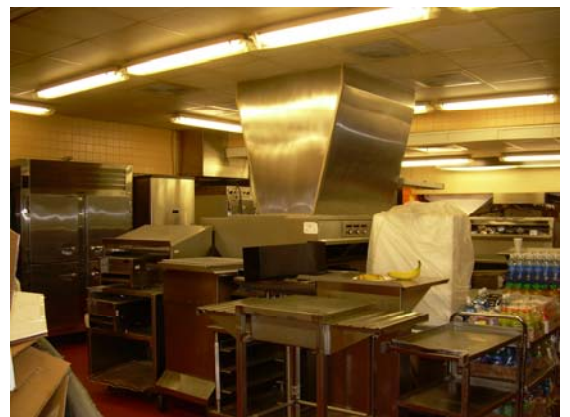
A secondary kitchen is located adjacent to the primary kitchen which was at one time used as a McDonald's restaurant. The secondary kitchen is provided with a first-class kitchen preparation area including stainless steel exhaust hood with roof mounted exhaust fan, and a gas-fired rooftop make up air unit. The exhaust hood is noted to be in excellent condition and is of the proper size and height for the area served. The rooftop unit is showing signs of surface contamination due to

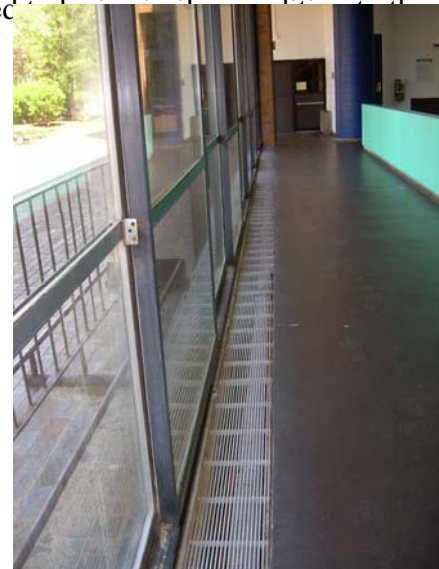
Located along the exterior wall of the pool is a continuous length of fin tube radiation located beneath the slab. Although the amount of heat provided is adequate to a set draft, convective air currents are reduced due to the location of the fin element obstructing make up air from entering the fin element. As a result overall output of the heating is dramatically reduced. It was also noted that there was extensive soiling and contamination on the discharge grille in fin tube elements.

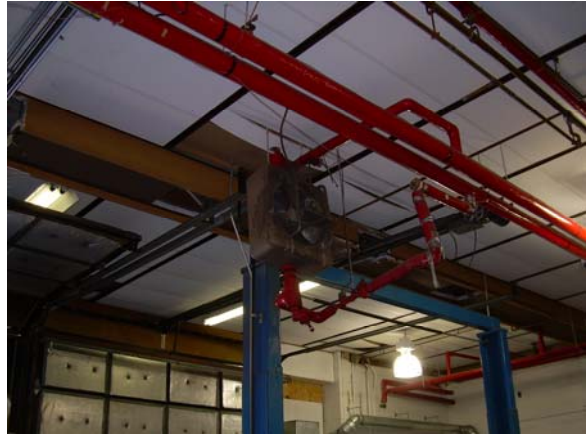
Also located within this space were various hot water horizontal unit heaters generally intended for space heating. As we understand it two of the three unit heaters do not operate at this time and generally one heater is maintaining all temperature control. All unit heaters were noted to be dirty and contaminated and generally in need of replacement.

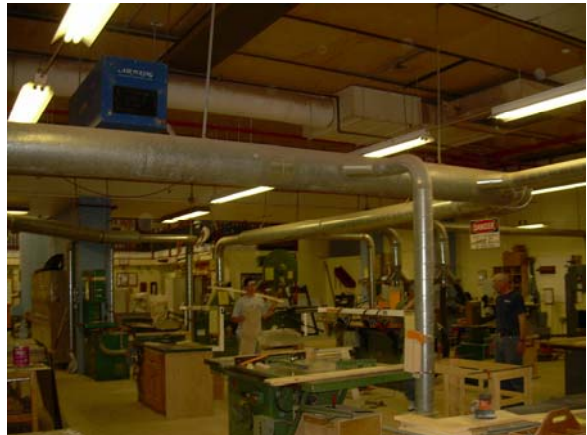
The woodworking area is provided with a dust collection system and through the communication of a spiral wound galvanized exhaust system, conveys all woodworking particulate between machinery and an outside mounted dust collection unit. This dust collection unit is of the 100% recirculation type and all exhaust from the space is distributed back to the space at the in-line filters. The outside dust collection unit is extremely rusty and antiquated and at the time of our visit the system was not operating. Consideration should be given to an overall upgrade at this time.

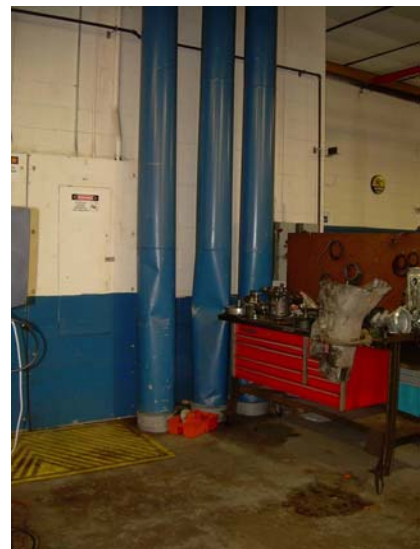
The welding area is provided with a series of welding benches located at one side of the space. Each welding bench is provided with a flexible exhaust captures system which collects in an overhead common exhaust duct which communicates to a space mounted centrifugal exhaust fan. The exhaust system does operate and appears to be sized with common industrial ventilation standards. Because of its use the system is extremely contaminated and upgraded the system is recommended.

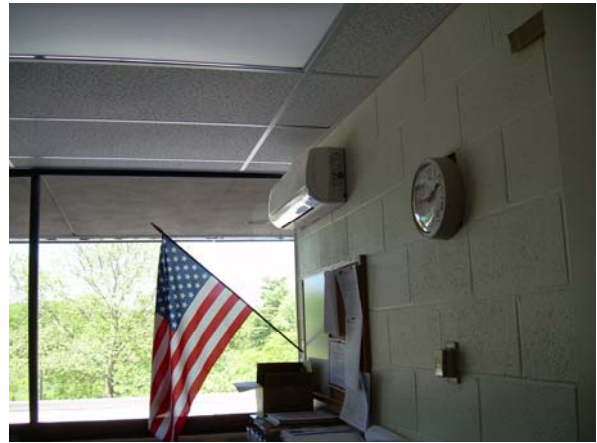
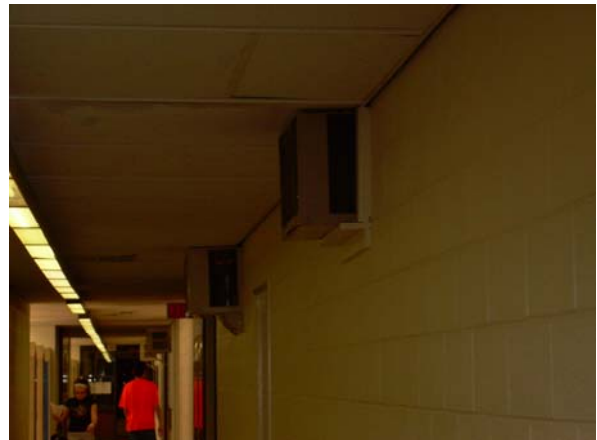
The administration area has suffered from a lack of air-conditioning capacity which could be related to an undersized air handling unit, undersized cooling coil within the air handling unit, a poor balancing. As a result, secondary air conditioning units in the form of window air-conditioning units and wall mounted air-conditioning units have been installed in the offices to compensate for the deficiency. At approximately 6 locations window style air-conditioning units are mounted in interior wall with the condensing sections discharging condensate and heat into an adjacent circulating corridor. This resulting condition is causing the communicating corridor to overheat and impose an additional air-conditioning load into this corridor. The entire condition should be upgraded.

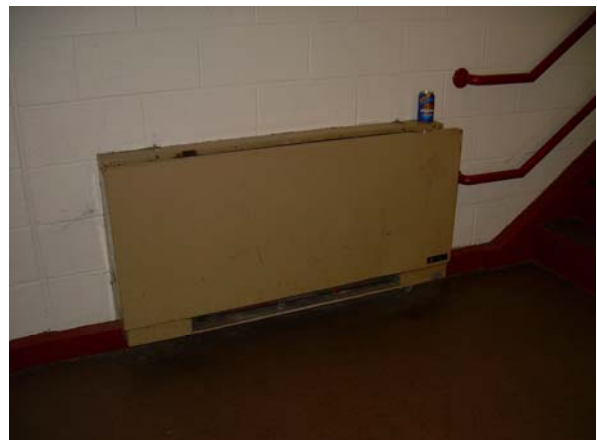
The main entrances and vestibules were all provided with hot water cabinet unit heaters adjacent to each doorway. It was noted that generally all heaters were slightly damaged, dirty, and contaminated, however as we understand it do operate and maintain reasonable heating control at all entrances and doorways. All units are generally in need of cleaning and considering the 35 year age and general state of disrepair consideration should be given to an overall
