**LOWER LEVEL PLAN**  
**13001.00**  
**Minuteman Career and Technical High School**  
**Space Use Planning**

***Evaluation of Existing Conditions***

The following existing conditions reports for Minuteman Regional Vocational Technical School (MMRVTS) provides a detailed analysis of systems related to: Code Compliance (Building and Accessibility), Landscape, Architecture, Food Service, Structural (Building and Seismic), Plumbing, Fire Protection, Mechanical, Electrical, and Technology, Site Environmental, and Hazardous Materials. The purpose of this portion of the study is to evaluate and identify deficiencies of the existing facility as a repair only benchmark for evaluation of other alternatives for renovations, additions, or new construction.

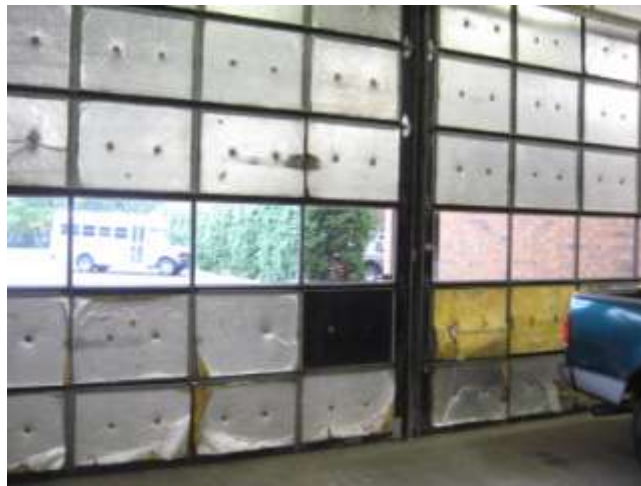
Most of the sectional overhead doors (garage type) are original to the building and are in poor condition from almost 40 years of continued use.

- Recommendation: All existing exterior steel doors should be replaced with insulated door panels with new hardware. All aluminum entrances should be replaced with new aluminum thermally broken doors and storefront frames to increase thermally efficiency and comfort. At the main entrance and main public entrances at the Pool and other locations, interior vestibules should be provided to minimize heat loss and exterior air infiltration. All exterior sectional overhead doors should be replaced with new insulated units to increase thermally efficiency and comfort.

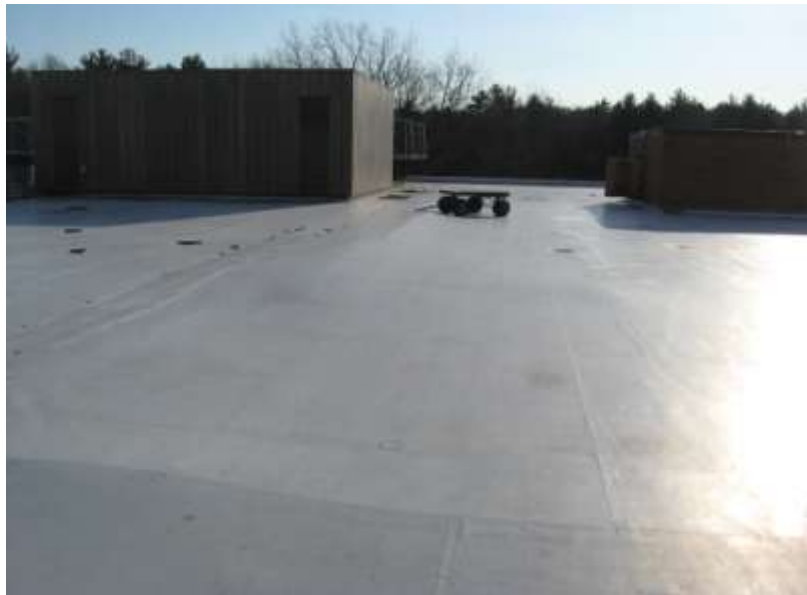
condition had continued to seriously deteriorate. At some locations, water had infiltrated at roof drains and saturated large areas of the insulation below. In some instances, the insulation had delaminated from both the membrane and the deck and had become completely unfastened. Insulation panels were observed to have moved and stacked one on top of the other in piles apparently moved by the effect of wind uplift and fluttering of the membrane. As this type of delamination can result in catastrophic failure from progressive delamination, the District was alerted immediately. Ballast has been placed as a stopgap measure to temporarily mitigate continued delamination, however, the water infiltration continues. As the insulation becomes water saturated, thermal effectiveness is lost and the roof becomes a great source of heat loss. Also, this water infiltration has created many leaks in the building affecting equipment and disrupting the learning environment. In the Robotics Lab, for example, the continuing leak prevents one portion of the lab from being used as a plastic sheet is needed to funnel the water to a collection barrel. In addition, in the same room, another leak prevents use of a lab table because a water collection barrel is needed after each rain event.

Skylights extend along the roof between the roof mechanical penthouses and are a source of water infiltration. At the penthouse walls, the skylights are not flashed properly and appear to be fastened to the face of the penthouse insulated wall panels. The skylights, in an effort to mitigate the water infiltration, are covered with translucent tarps and duct tape.

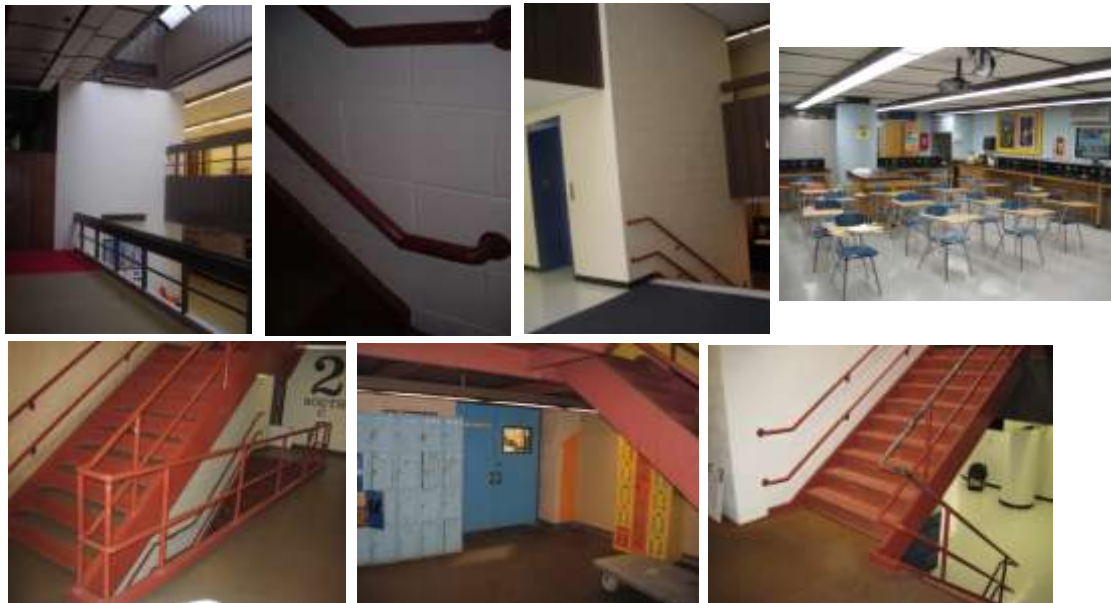
The main lobby stairs have rubber treads and risers applied to the metal pan stair system. The handrail extensions are also a code violation on these stairs as well.

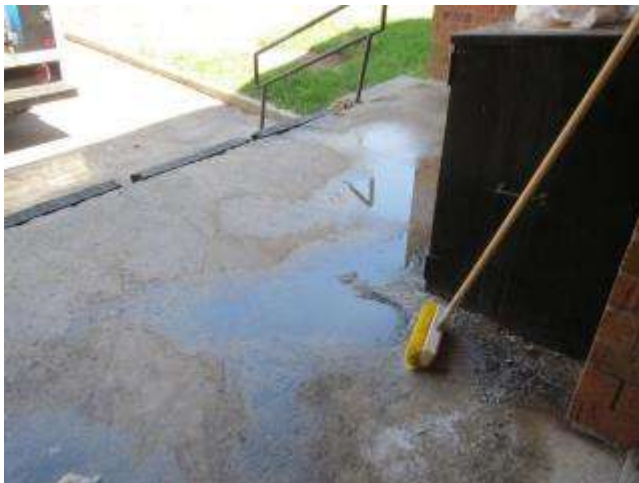
Receiving Exterior: Minimal water capture. Puddles throughout the area. Hazardous to foot traffic.

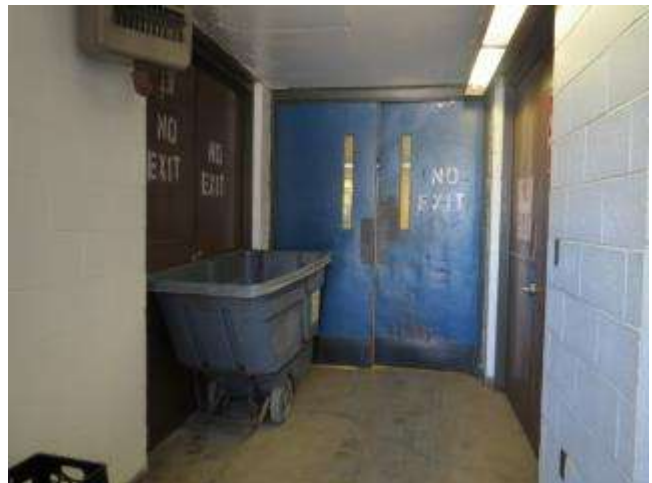
Receiving Interior: Ceilings and floors have degraded and are unsanitary.

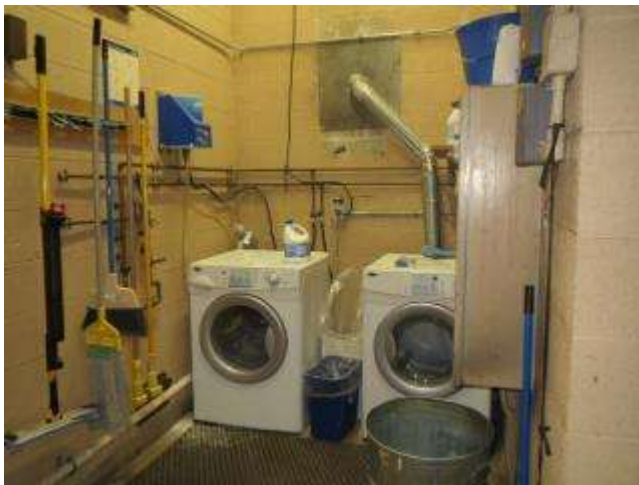
J.C. & Laundry: This room is congested. Washer & dryer are shared with Culinary Arts.

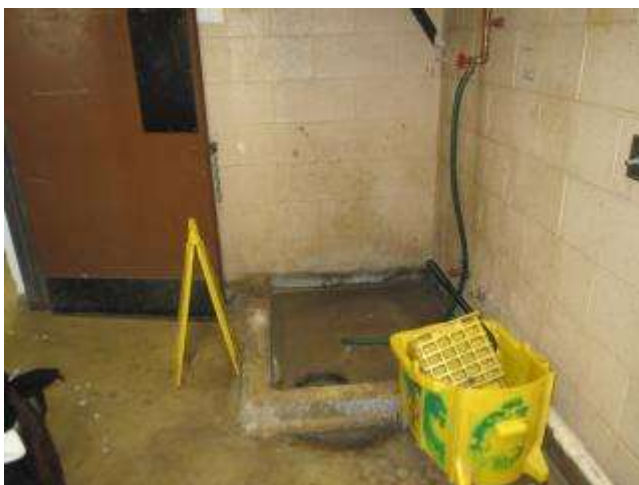
J.C. & Laundry: There is no dedicated waste for the laundry washer to drain into. Unit's waste is piped at the opposite end of the room.

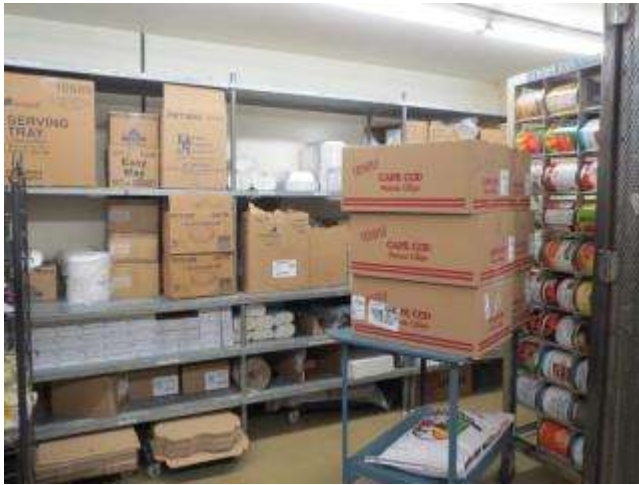
Dry Food & Paper Storage Room: This room is congested.

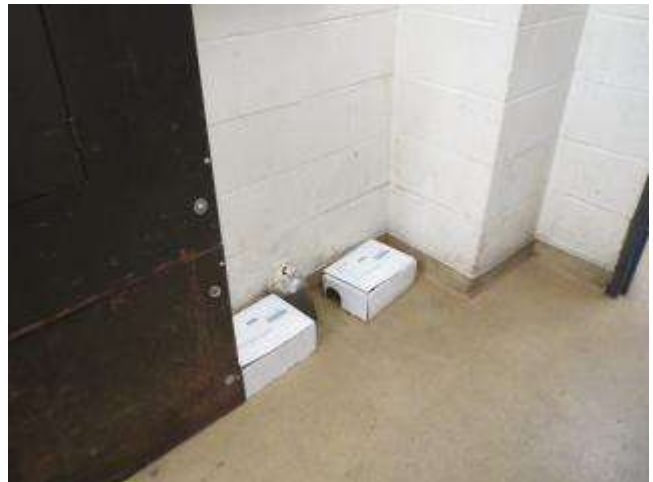
Dry Food & Paper Storage Room: There appears to be evidence of insect/rodent infiltration throughout this area.

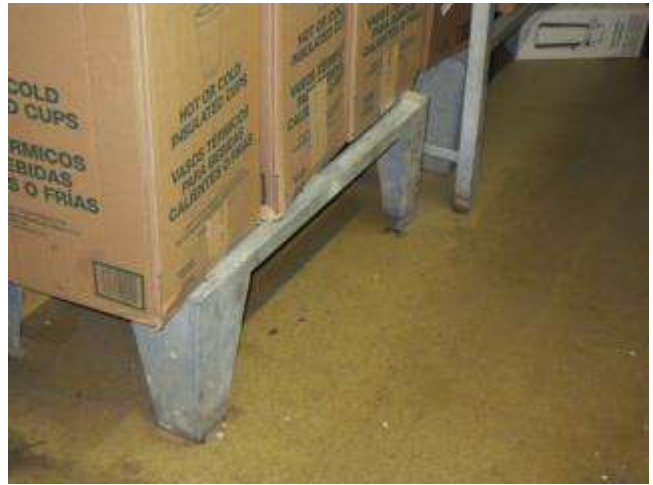
**Catering/Special Function Storage:** Shelving is constructed of inappropriate materials. Floors have degraded; unsanitary.

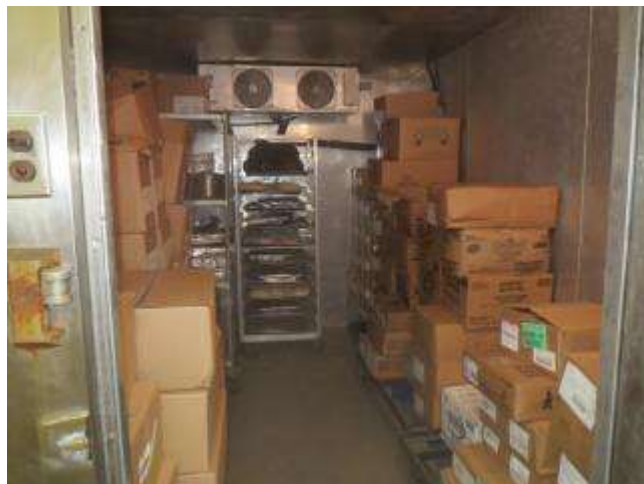
Walk-In Refrigerators and Freezers:  
Shelving is constructed of inappropriate materials;  
inadequate in quantity; overcrowded.

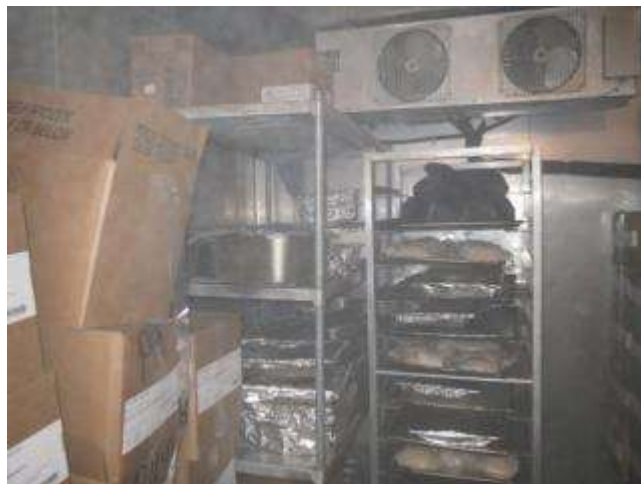
Walk-In Refrigerators and Freezers:  
Units are antiquated and undersized. Significantly  
overcrowded. Lighting is poor.

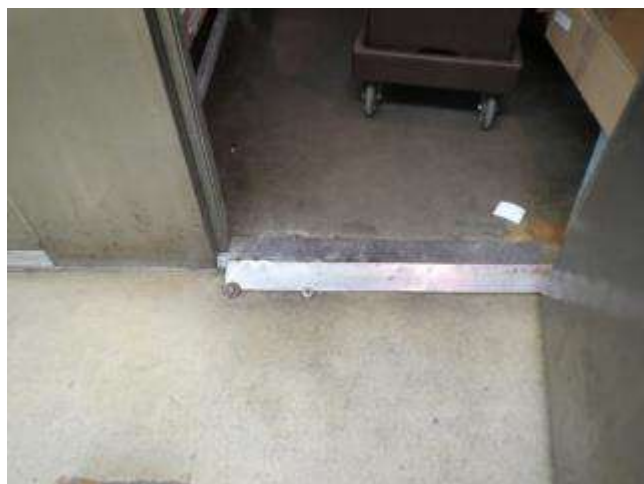
Walk-In Refrigerators and Freezers:  
Interior floor finishes and some door thresholds have  
degraded; unsanitary. Some areas are hazardous to  
foot traffic.

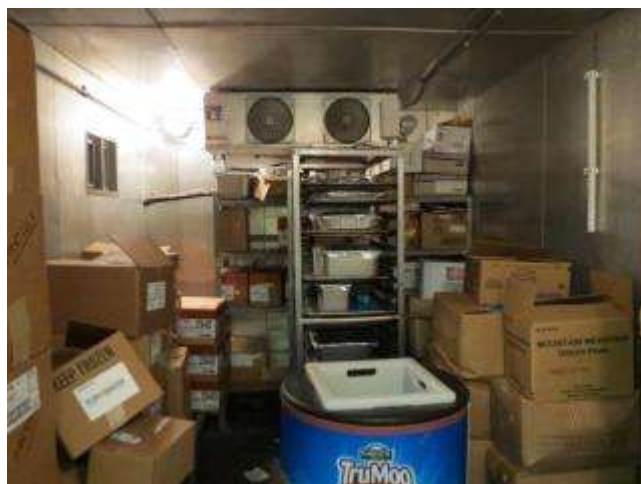
Walk-In Refrigerators and Freezers:  
Shelving is constructed of inappropriate materials;  
inadequate in quantity; overcrowded. Some, insulation  
at drain piping has deteriorated.

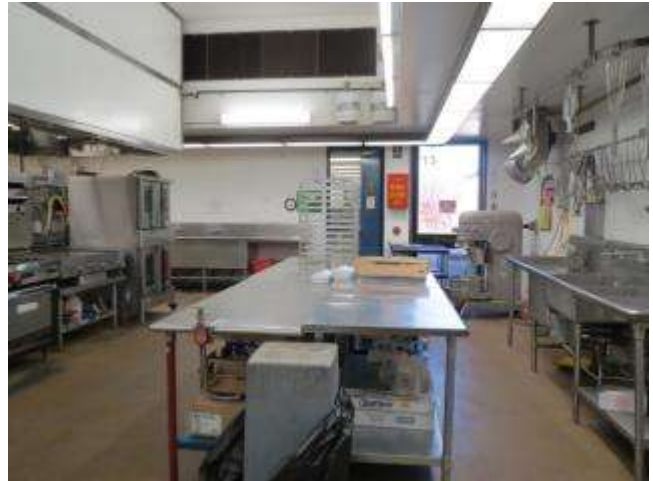
Preparation: Most table, utensil racks, pot & pan racks, etc. are constructed of inappropriate materials (galvanized steel or painted steel), which have degraded and should be considered unsanitary.

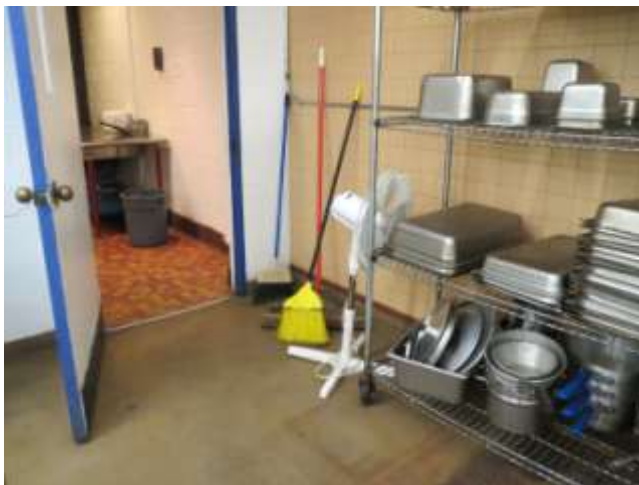
Preparation: Fans are used to circulate air. These fans tend to spread dust throughout the entire food facility. Floors have degraded.

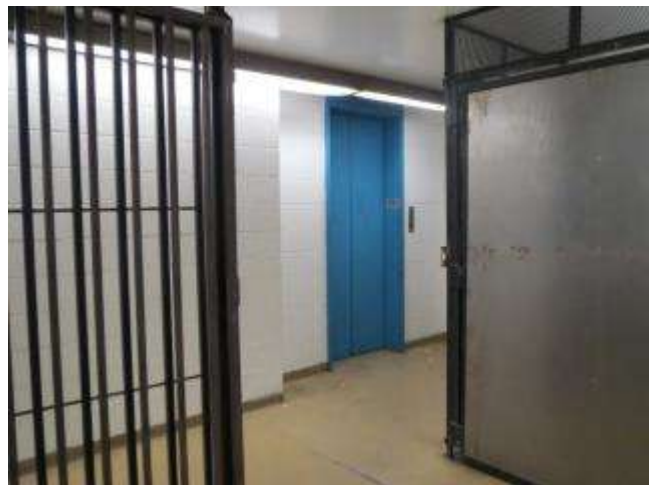
Preparation: The main kitchen is opened to a general corridor. Deliveries for culinary and baking must to pass through the main kitchen (production and soiled areas) and general corridor to access an elevator to the upper level.

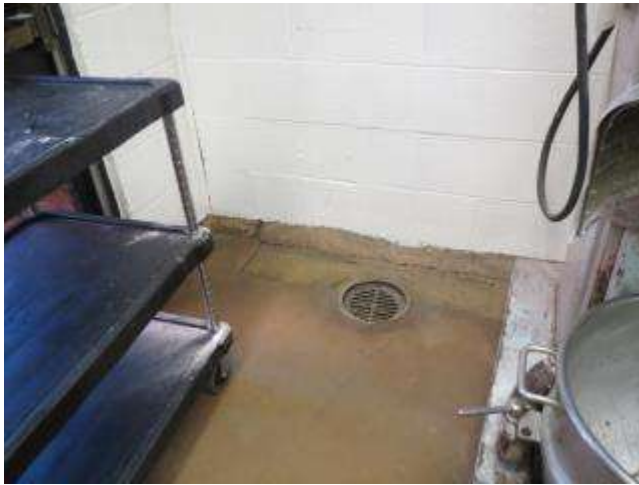
Preparation: There are an inadequate number of floor drains to enhance housekeeping. Wall and floors have degraded.

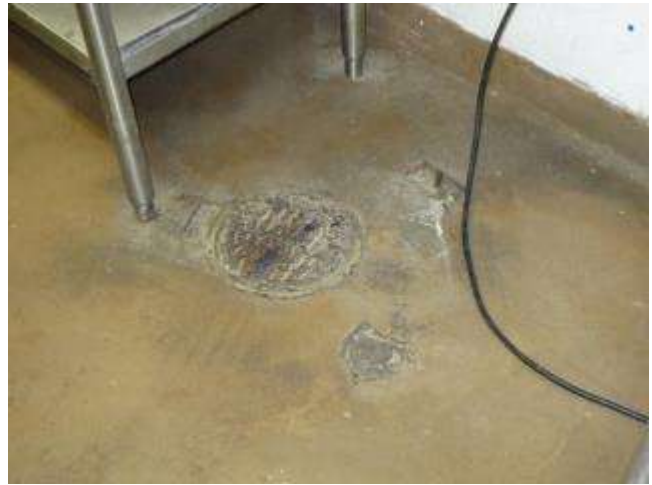
Preparation: Some existing floor drains appear to be clogged and drainage is extremely poor. Floors have degraded.

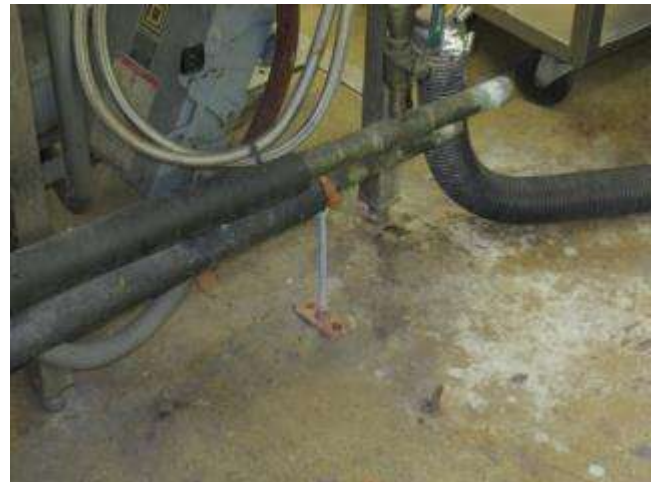
**Cooking Equipment:** Floors have severely degraded and are unsanitary. Exposed piping renders this area extremely difficult to maintain as a sanitary environment.

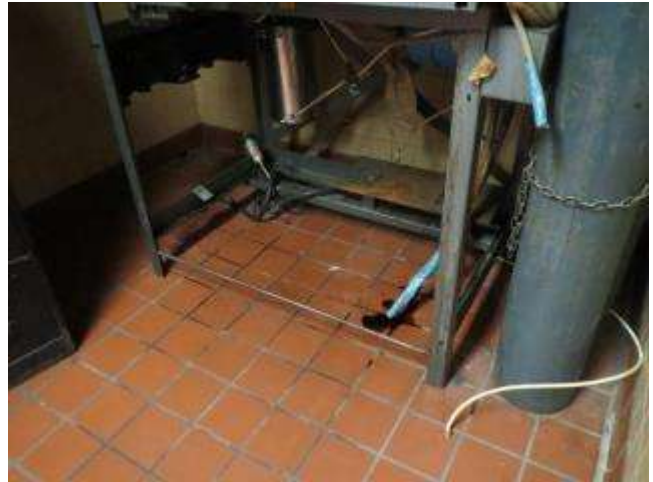
Serving Lines (Grill Station- Full Service):  
Leaking syrup lines at soda system. Exposed piping renders this area nearly impossible to clean..

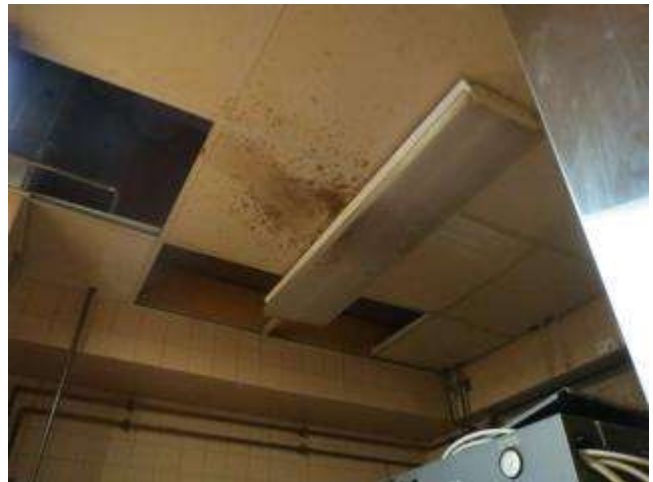
Serving Lines (Grill Station- Full Service):  
Walls and ceilings have degraded; unsanitary. Lighting is poor.

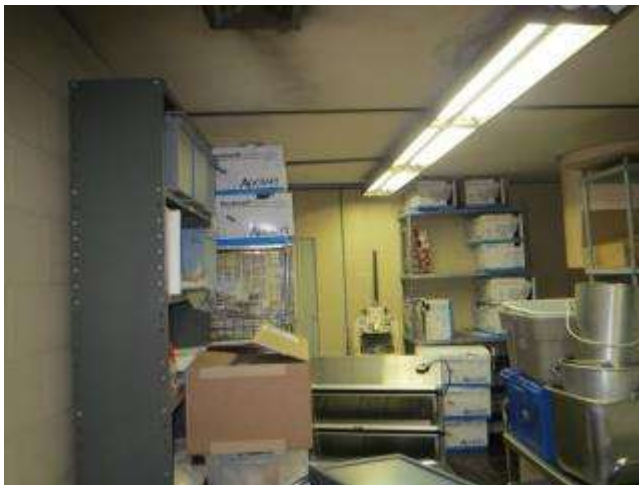
**Dry Food & General Storage Room:** This room is congested. Shelving is constructed of inappropriate materials and inadequate in quantity.

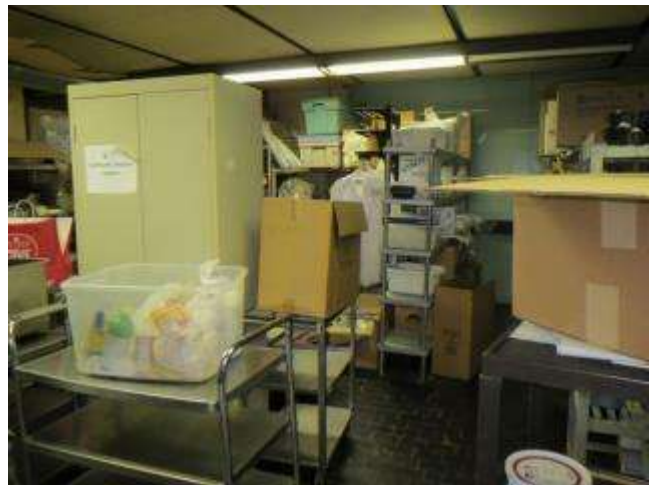
**Dry Food & Paper Storage Room:** Light fixtures lack protective covers and therefore not code compliant. Walls, floors and ceilings have degraded and are unsanitary.

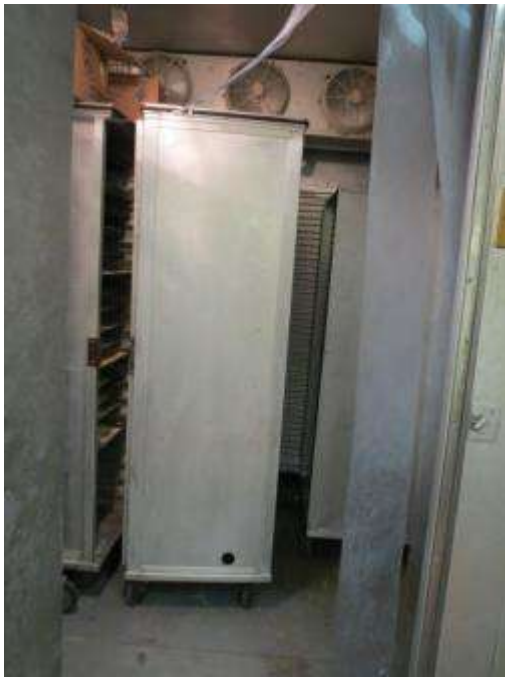
**Bakery Walk-In Freezer:** Interior floor finishes have degraded; unsanitary.

Lighting is poor.

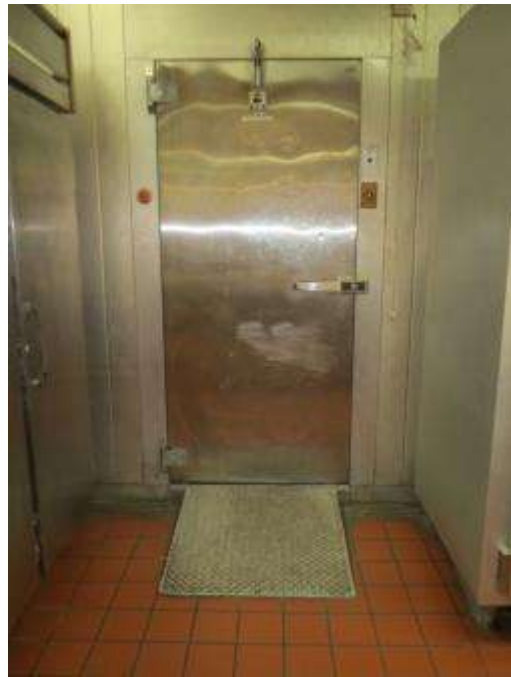
**Bakery Walk-In Freezer:** A portable exterior ramp is used to enter and exit, which makes it extremely difficult to transport mobile racks into the box; hazardous to foot traffic.

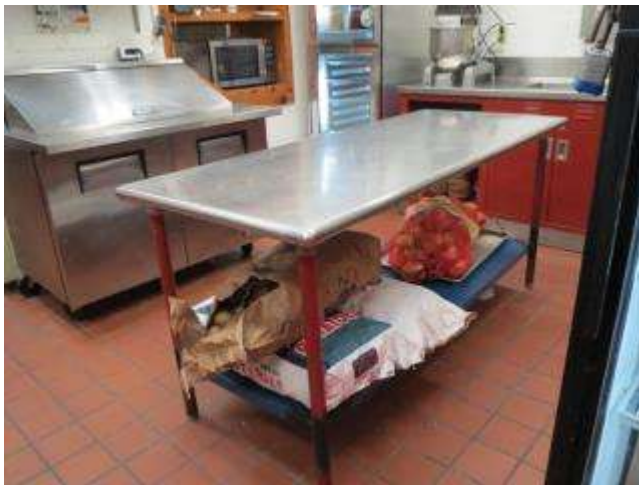
**Culinary Arts Preparation:** Most table understructures are constructed of inappropriate materials (galvanized steel or painted steel), which have degraded and should be considered unsanitary.

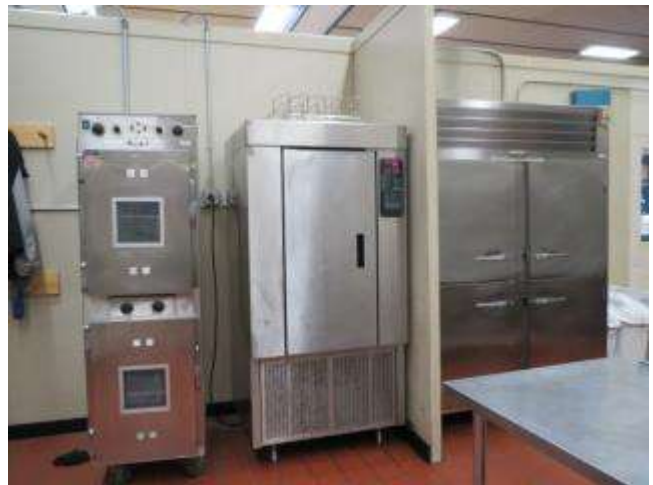
**Culinary Arts Preparation:** Particulate walls, unfinished ceilings with exposed piping, conduit, etc. that render these preparation areas impossible to clean.

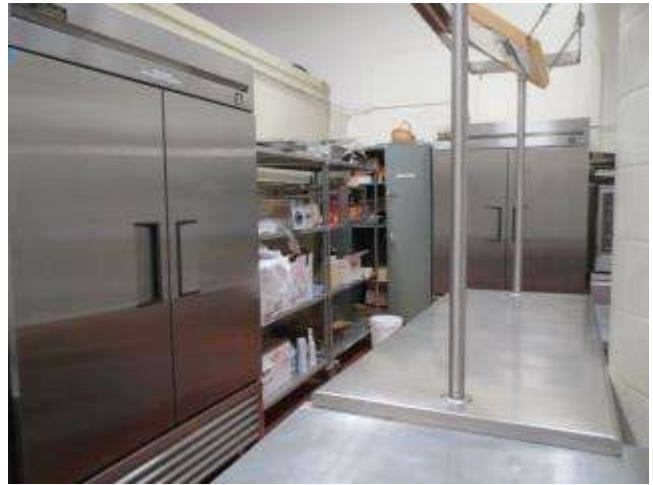
Culinary Arts Preparation: Storage is minimal. Some shelving is constructed of inappropriate materials and inadequate in quantity.

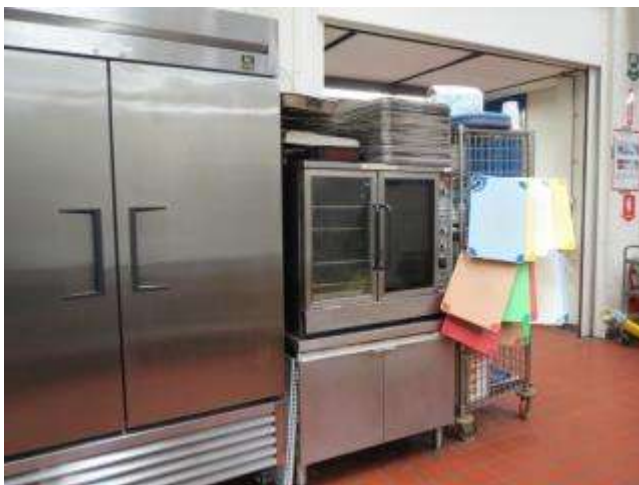
Culinary Arts Preparation: Convection oven is not positioned under an exhaust ventilator with fire suppression system. Not code compliant and should be considered a life safety issue. (Final determination for code compliance is subject to local authorities have jurisdiction.)

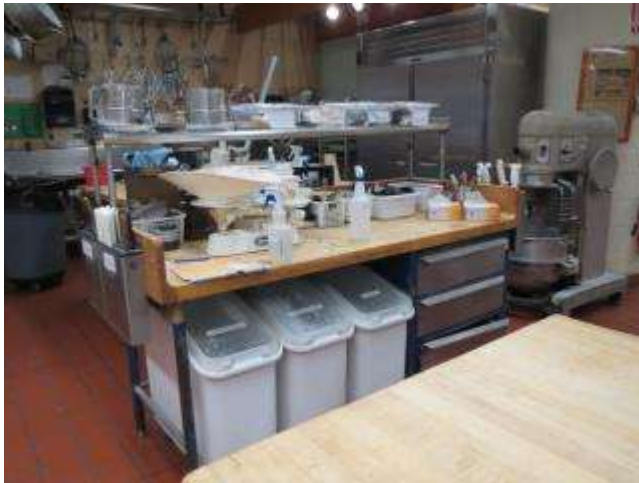
Bakery Preparation: Area is congested.

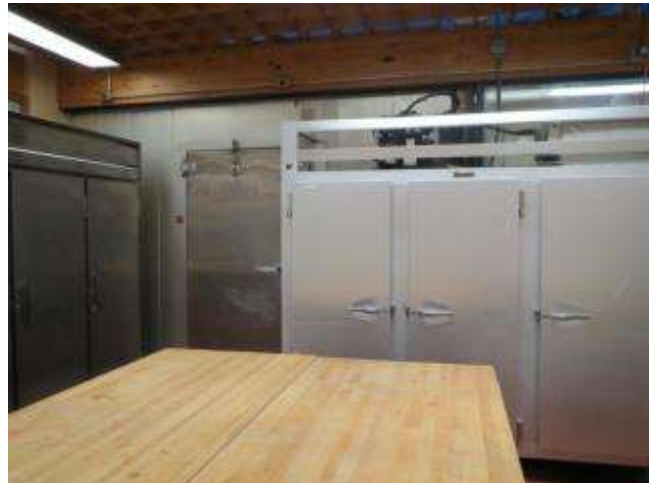
Bakery Preparation: Top compressor of reach-in is opened to the space where accumulated dust will be caught in any “air stream” and spread around this area.

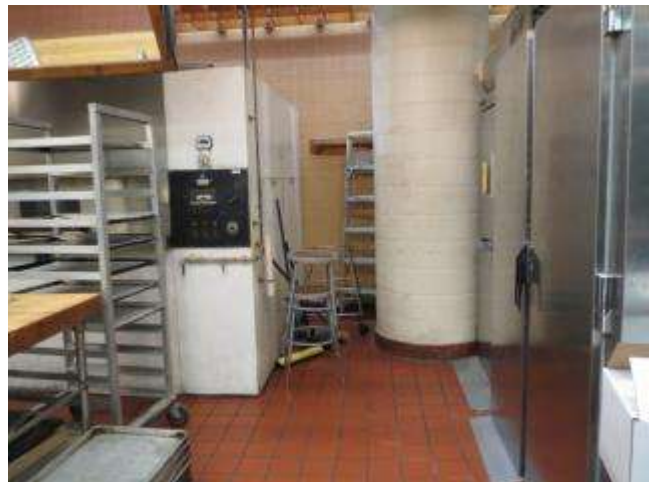
Bakery Preparation: No dedicated janitorial areas. Housekeeping items such as brooms, mops, trash cans, detergents, etc. are located throughout this area.

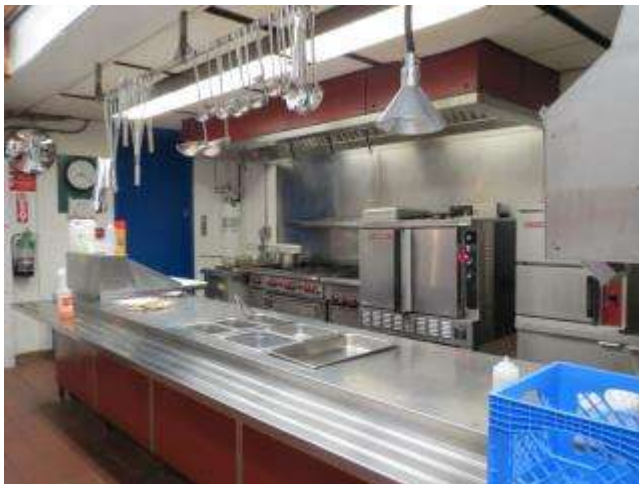
**Culinary Arts Cooking Equipment:** The cooking battery is under-equipped. Some of the cooking equipment is antiquated, poorly arranged, unsanitary and not energy efficient.

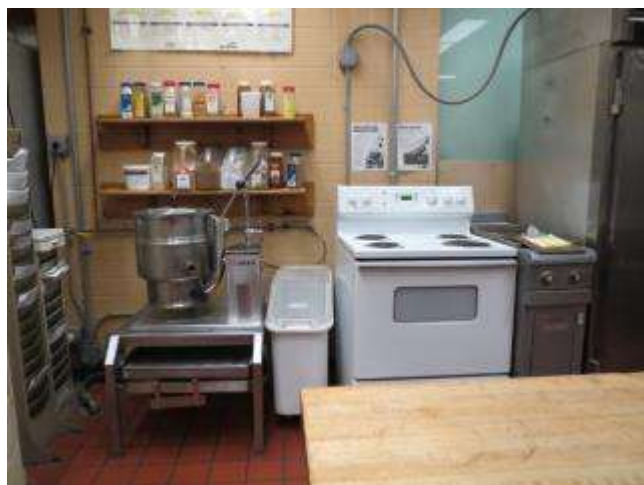
**Bakery Cooking Equipment:** Tilting kettle is not positioned under the exhaust ventilator with fire suppression system. This is a life safety issue and not code compliant, however, final determination for code compliance is subject to local authorities have jurisdiction.

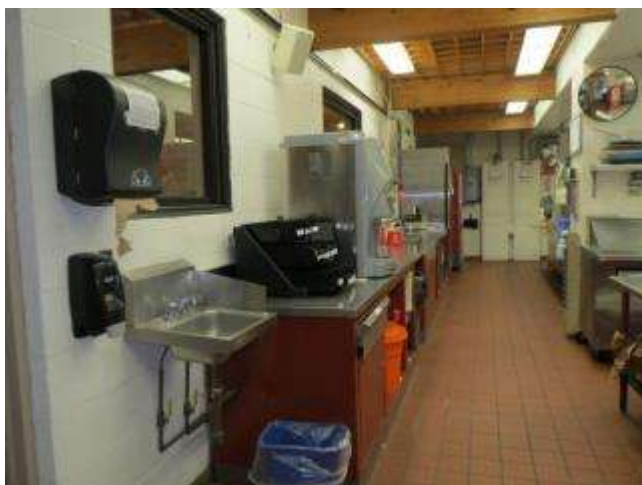
Culinary Arts Wait Stations: There is an insufficient quantity of code mandated hand sinks. This is the only hand sink located in this area, which includes cooking, some preparation and dishwashing.

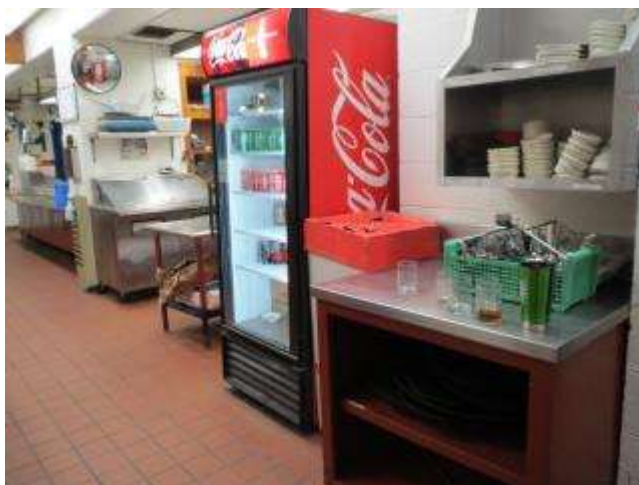
Culinary Arts Wait Stations: Table understructures and cabinetry are constructed of inappropriate materials (galvanized steel or painted steel), which have degraded and should be considered unsanitary.

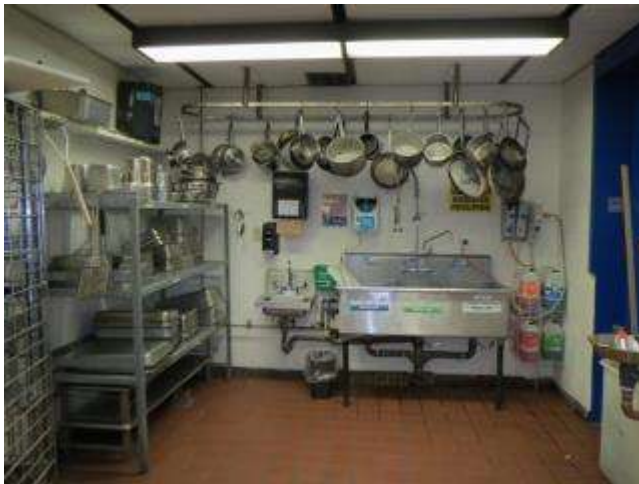
Culinary Arts Pot Washing Area: All clean activities are located on the soiled end of the pot sink. Shelving, wall shelf and pot rack have degraded and are constructed of inappropriate materials.

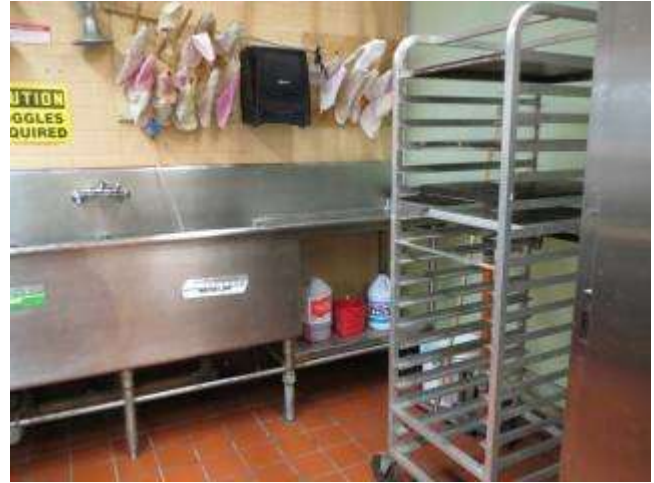
**Bakery Pot Washing Area:** Some detergents are stored exposed under the clean drain-board along with housekeeping items such as brooms and trash cans.

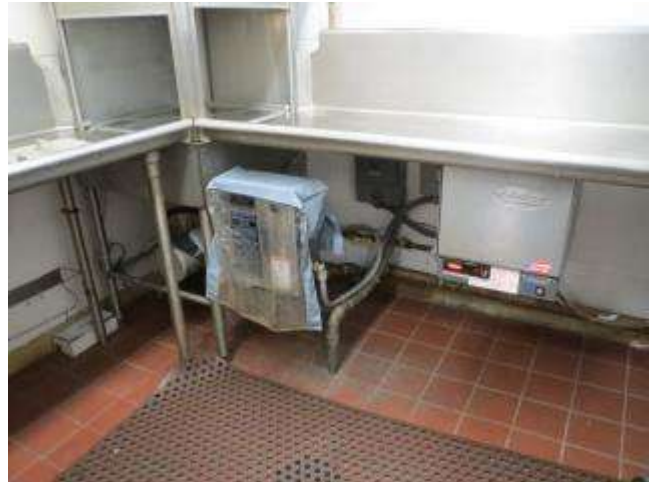
Culinary Arts Ware Washing Area: Exposed piping and conduit render this area nearly impossible to maintain and clean.

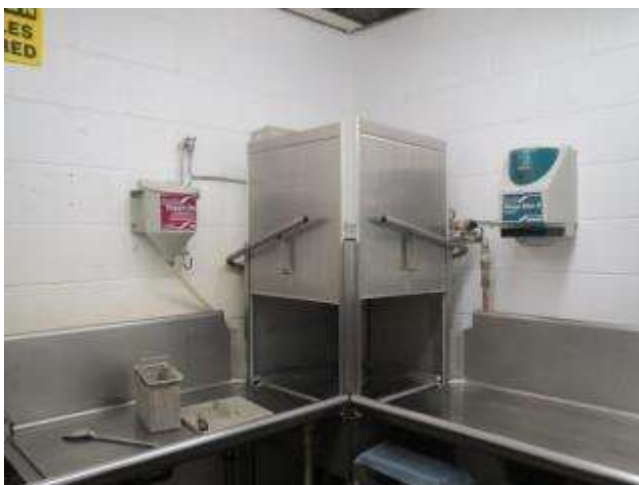
Culinary Arts Ware Washing Area: There is no condensate hood over the dish machine to capture heat and steam.

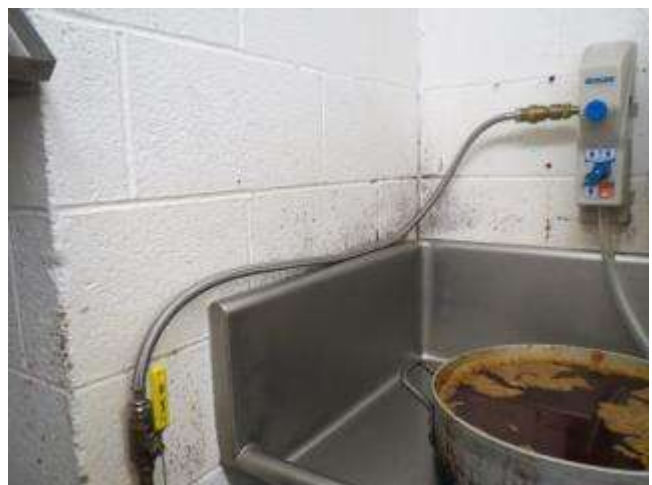
Culinary Arts Ware Washing Area: Evidence of mold on the walls, which is a serious health hazard.

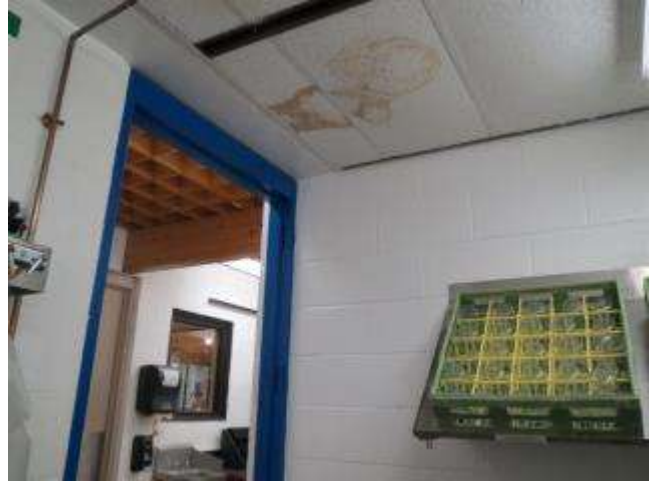
Culinary Arts Ware Washing Area: Perforated ceiling panels have degraded and are non-washable and therefore not code compliant.

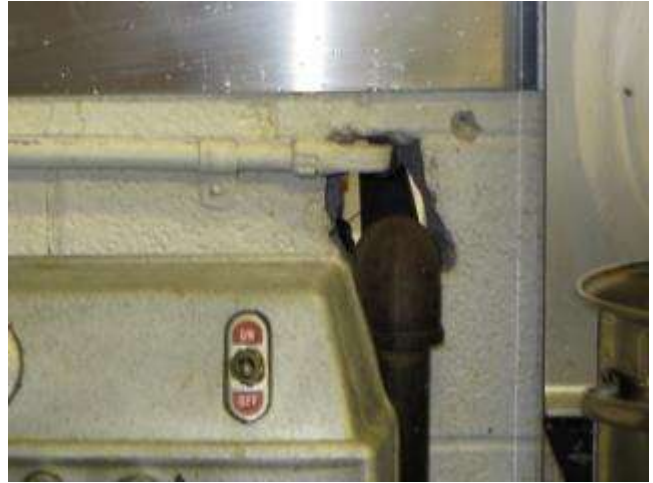
Culinary Arts General Area Conditions: Walls have degraded. There are open gaps in the wall at piping, which is unsanitary.

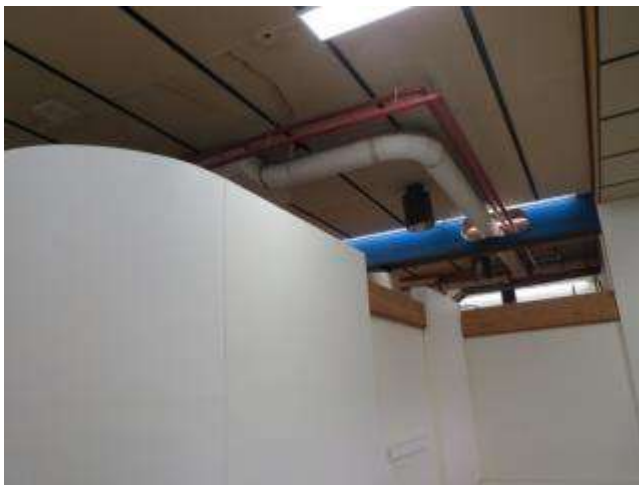
Culinary Arts General Area Conditions: There are unfinished ceilings, exposed piping, electric conduit and duct work render most areas almost impossible to maintain as a sanitary environment.

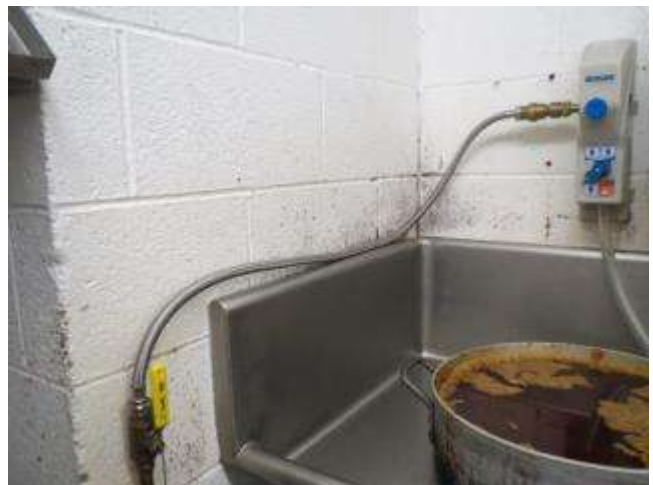
Culinary Arts General Area Conditions: Evidence of mold on the walls, which is a serious health hazard.

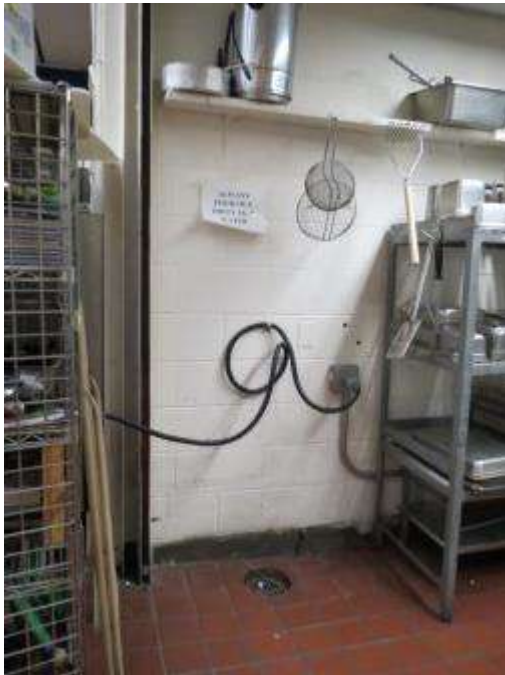
Culinary Arts General Area Conditions: There are an inadequate number of floor drains to enhance housekeeping. Mop buckets are dumped in this floor drain located adjacent to a “clean ware” area, unsanitary.

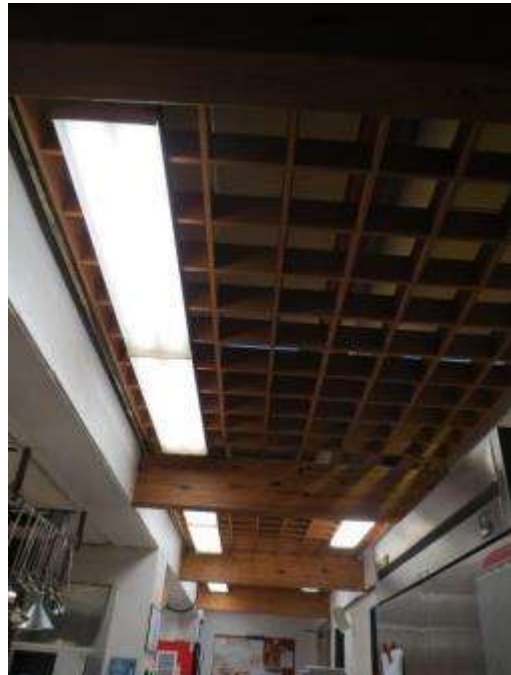
Culinary Arts General Area Conditions: There are unfinished ceilings with exposed piping, electric conduit and duct work above render most areas almost impossible to maintain as a sanitary environment.

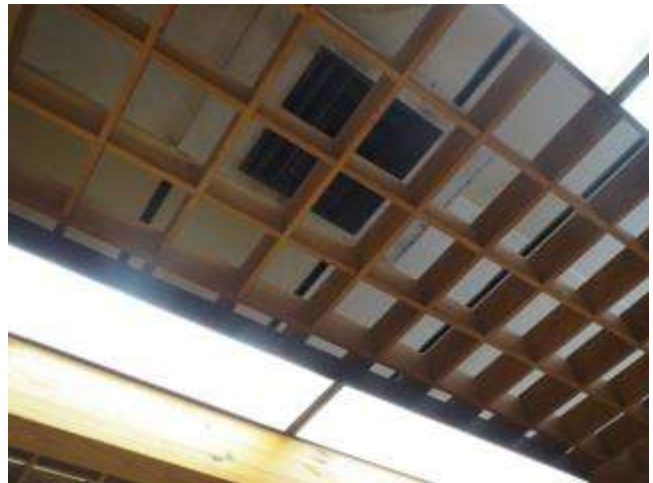
Bakery General Area Conditions: There are unfinished ceilings with exposed piping, electric conduit and duct work above render all areas impossible to maintain as a sanitary environment.

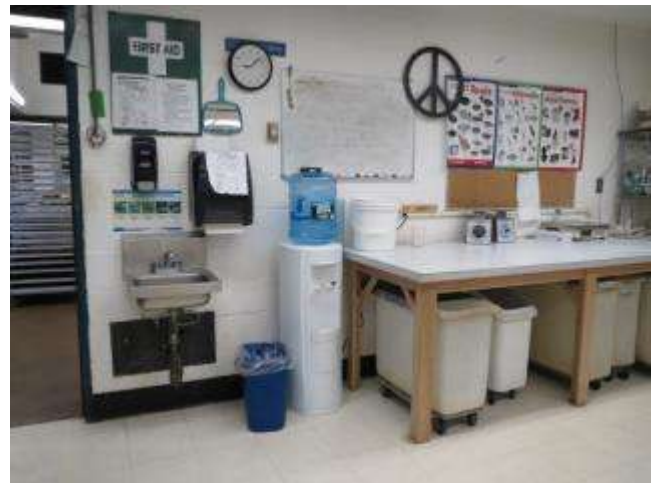
**Preparation:** There is an insufficient quantity of code mandated hand sinks. This is the only hand sink in the entire teaching kitchen.

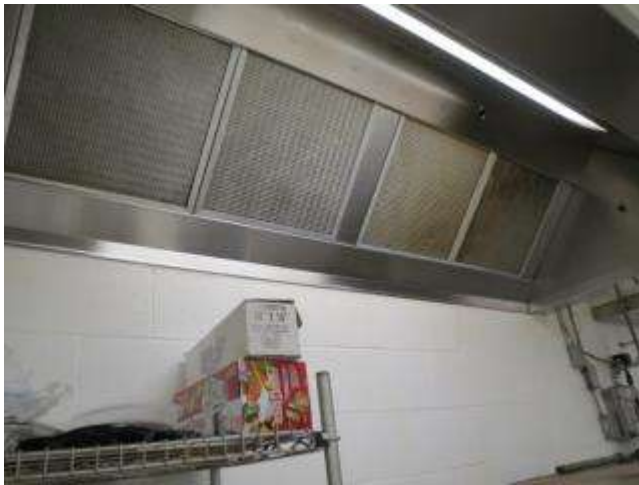
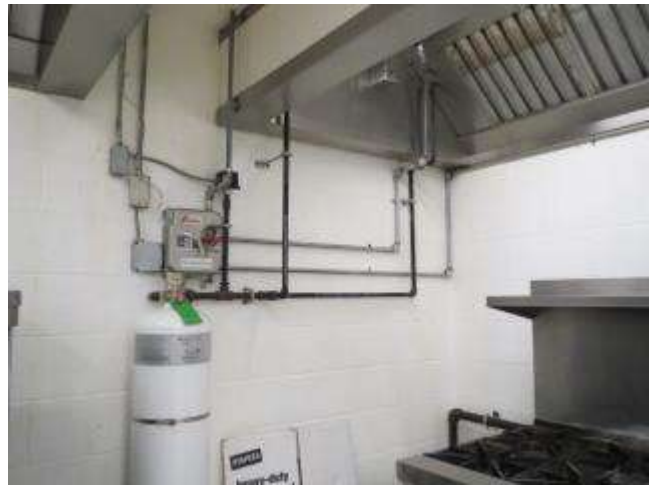
**Exhaust Hoods over Cooking Equipment:**  
Mesh filters located in the plenum chamber are extremely ineffective and accumulate grease rather than filtering the air stream. The grease cannot drain away as there is no “grease capture gutters”.
