758 MARRETT ROAD  
LEXINGTON, MASSACHUSETTS 02421

Michael McKeon  
**Kaestle Boos Associates**  
325 Foxborough Boulevard #100  
Foxborough, Massachusetts 02035  
October 29, 2013

This updated structural evaluation of the Minuteman High School, located at 758 Marrett Road in Lexington, MA, was undertaken at the request of Mr. Michael McKeon, AIA, of Kaestle Boos Associates, Foxborough, Massachusetts.

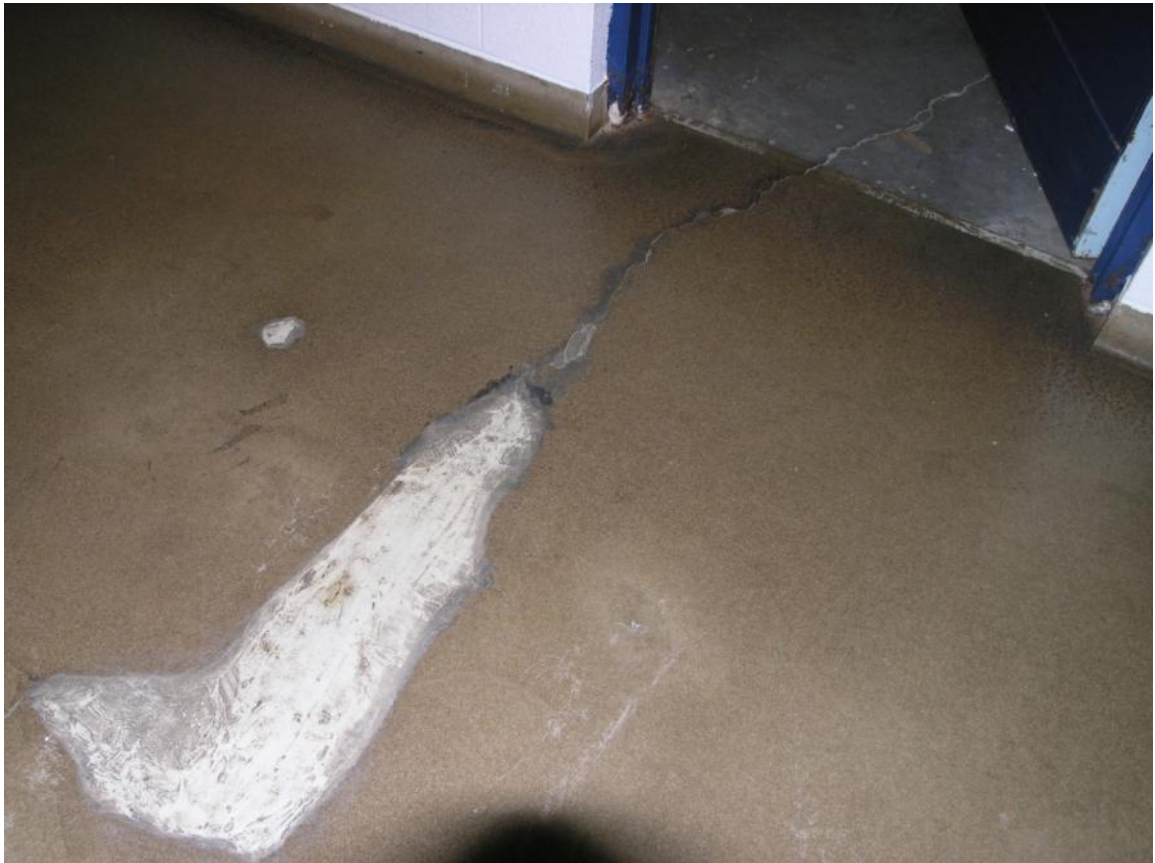
Photo #1

- **Cracks in the concrete floor slab-on-grade throughout the school building:** Numerous cracks were observed in the ground floor concrete slab on grade. **(Photo #1)**

- **COMMENT:** The cracks in the Ground Floor concrete slab on grade appear to be shrinkage cracks caused by improper construction or improper curing of the concrete floor slab. These cracks degrade the usefulness and serviceability of the concrete floor slab, but are not structurally detrimental.

*Photo of one of the many cracks in the ground floor concrete slab on grade found throughout the school building.*

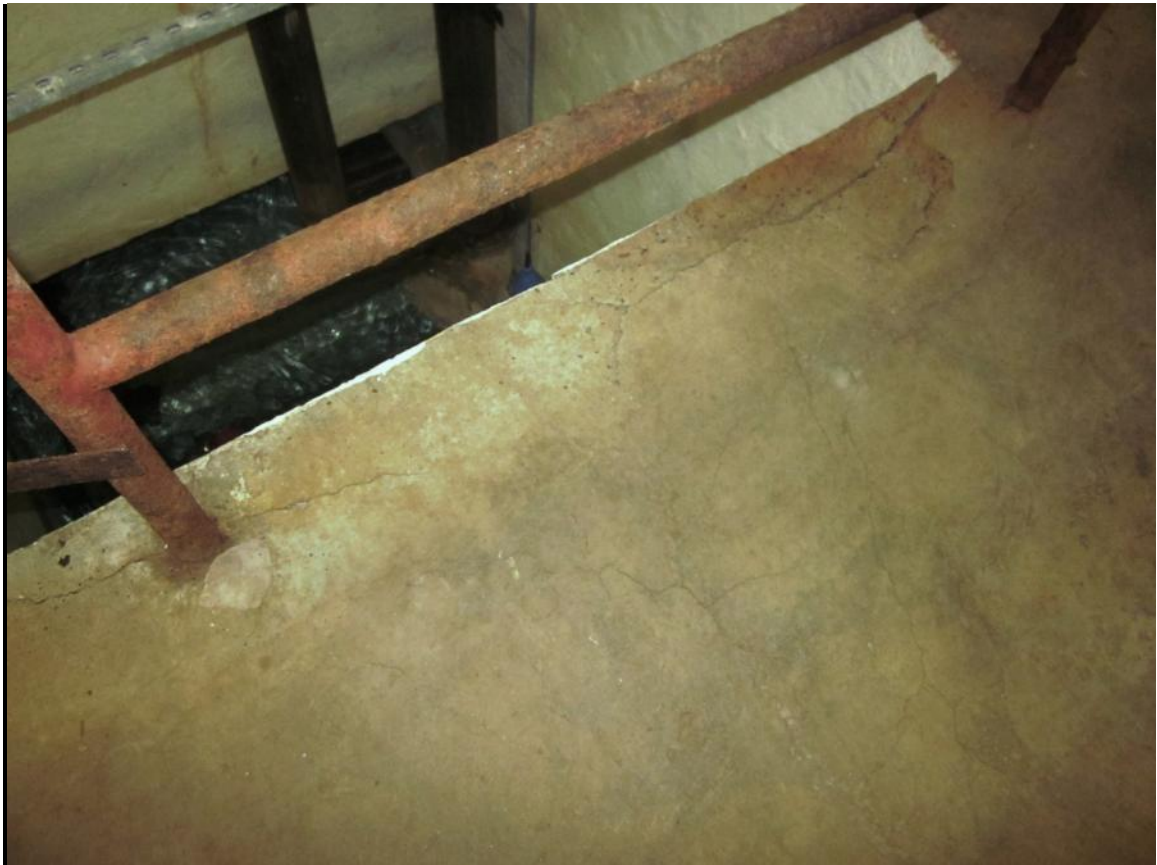
Photo #2

- **Cracks and spalls in the concrete floor slab in the natatorium and abutting pool filter room:** Several cracks and spalls were observed in the concrete apron around the swimming pool and in the floor of the adjacent filter room. **(Photo #2.)**

- **COMMENT:** The cracks and spalls in the apron around the swimming pool and in the pool filter room are likely exacerbated by the corrosive action of the chlorine that is contained both in the water and in the air in these rooms. Preventative actions should be taken to repair these cracks and spalls to arrest further degradation of the floor slabs in these rooms.

*This photo shows some of the cracks and spalls in the natatorium and pool filter room concrete floor slab.*

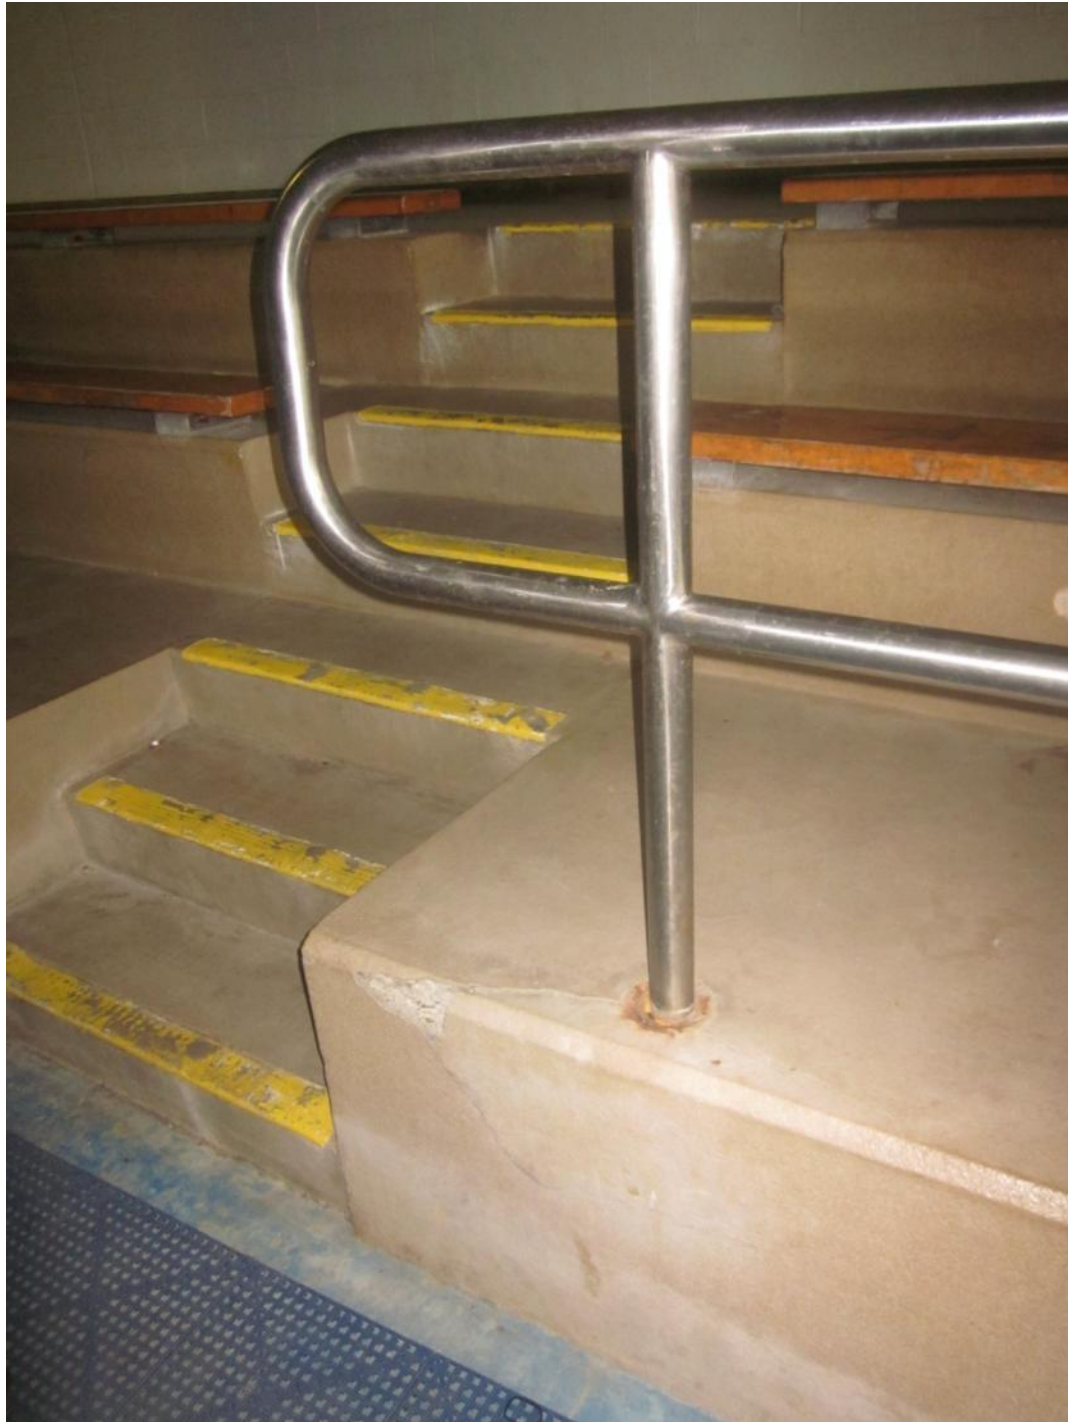
Photo #3

- **Cracks and spalls in the natatorium concrete bleachers at guardrail inserts:** Large cracks and spalls have occurred at several locations in the natatorium where the guardrails for the bleacher seating around the swimming pool are pocketed into the concrete. **(Photos #3 and #4.)**

- **COMMENT:** The cracks and spalls in the concrete where guardrails are pocketed into the concrete bleachers appear to be caused by the expansive corrosion of the steel inserts that secure the ends of stainless steel guardrail posts. Under the current conditions, the guardrails may not be able to resist the thrust for which they were designed. Odeh Engineers recommends that the guardrail steel inserts be replaced with stainless steel inserts and the cracked and spalled concrete be repaired with modern, high-performance concrete repair products.

*This photo shows one of the several locations where cracks and spalls have occurred where the natatorium bleacher seating guardrails are pocketed in the concrete.*

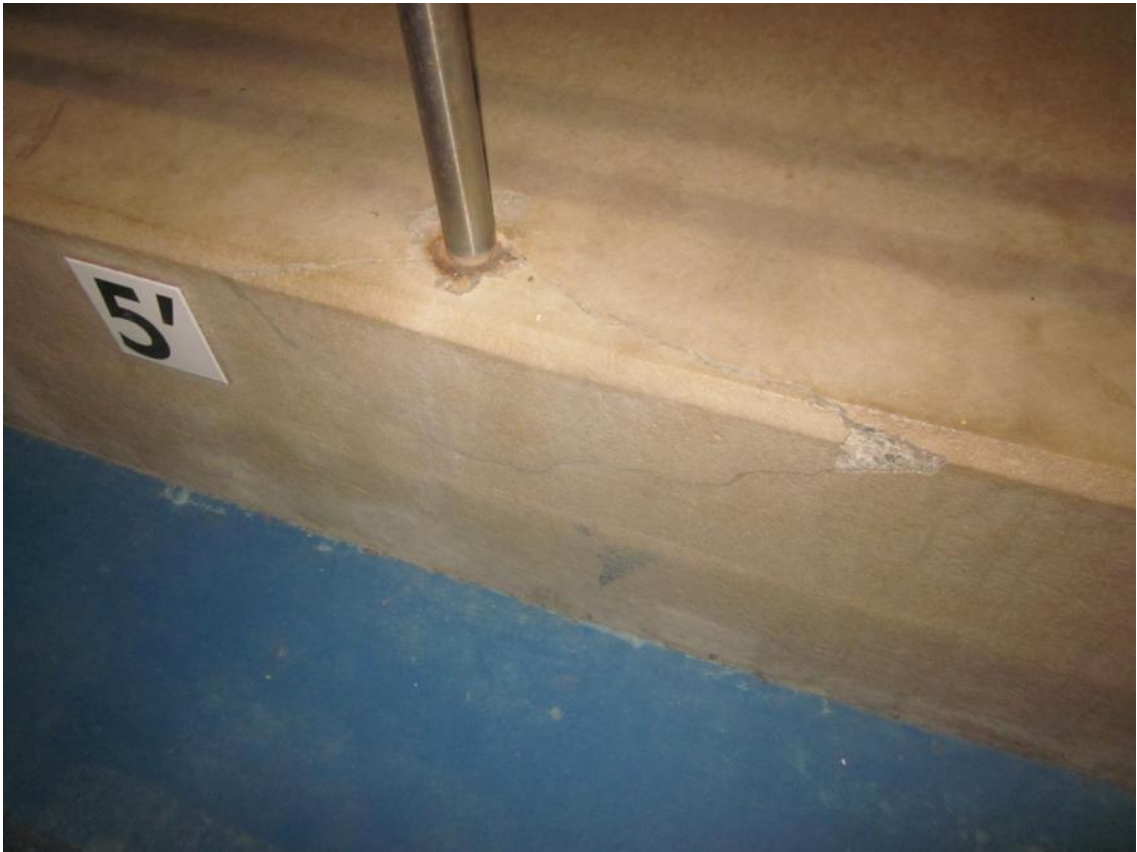
Photo #4

*This photo shows another location where cracking and spalling of the natatorium bleacher seating has occurred where the guardrails are pocketed in the concrete.*

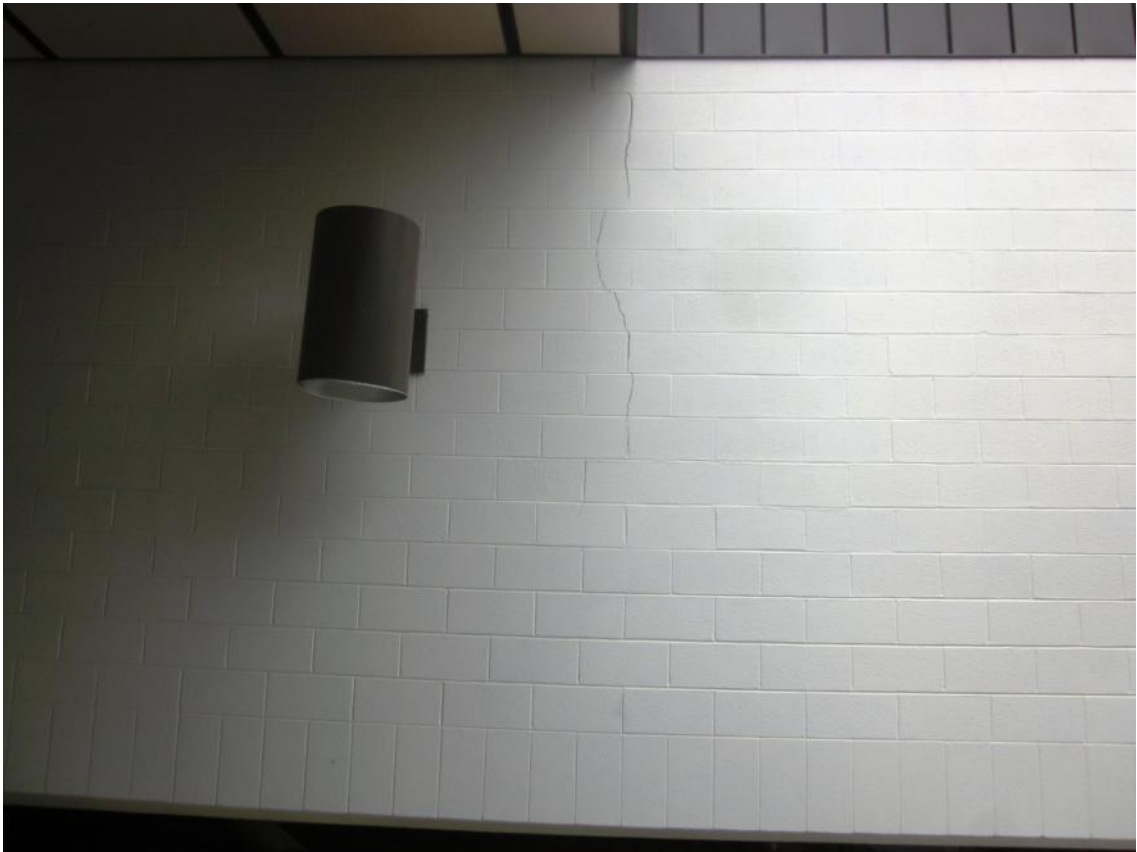
Photo #5

- **Numerous cracks in interior masonry block partition walls:** Throughout the school building, many cracks were observed in the non-bearing concrete masonry block partition walls. The cracks are typically found where the building steel columns are contained within these walls. **(Photos #5 and #6.)**

- **COMMENT:** The cracks in the interior masonry block partition walls appear to have occurred due to two main reasons. Apparently during construction of these walls, there was not sufficient room provided within the wall cavities to accommodate the movement of the building structural frame. Compounding this problem is the fact that weaknesses in the blocks are created by having to notch the masonry block webs and face shells to accommodate the structural members. The movement of the structural frame due to lateral loads and thermal dimensional changes may impinge upon the notched blocks, causing the walls to move and crack. Secondly, there are virtually no control joints in the masonry walls to allow for dimensional changes in the masonry due to temperature and moisture variations. A third possible factor causing the cracks and displacements in the masonry may involve the expansion joints in the multi-story building. This factor will be addressed later in this section of the report. Although the walls are structurally stable in their current condition, the cracks in the masonry block partition walls substantially reduce the strength of these walls to resist lateral movements during severe wind or seismic events. In addition, fragments of masonry block may fall out of these cracks over time and could cause personal injury.

*This photo shows one of the many cracks found in the non-bearing interior masonry block partition walls.*

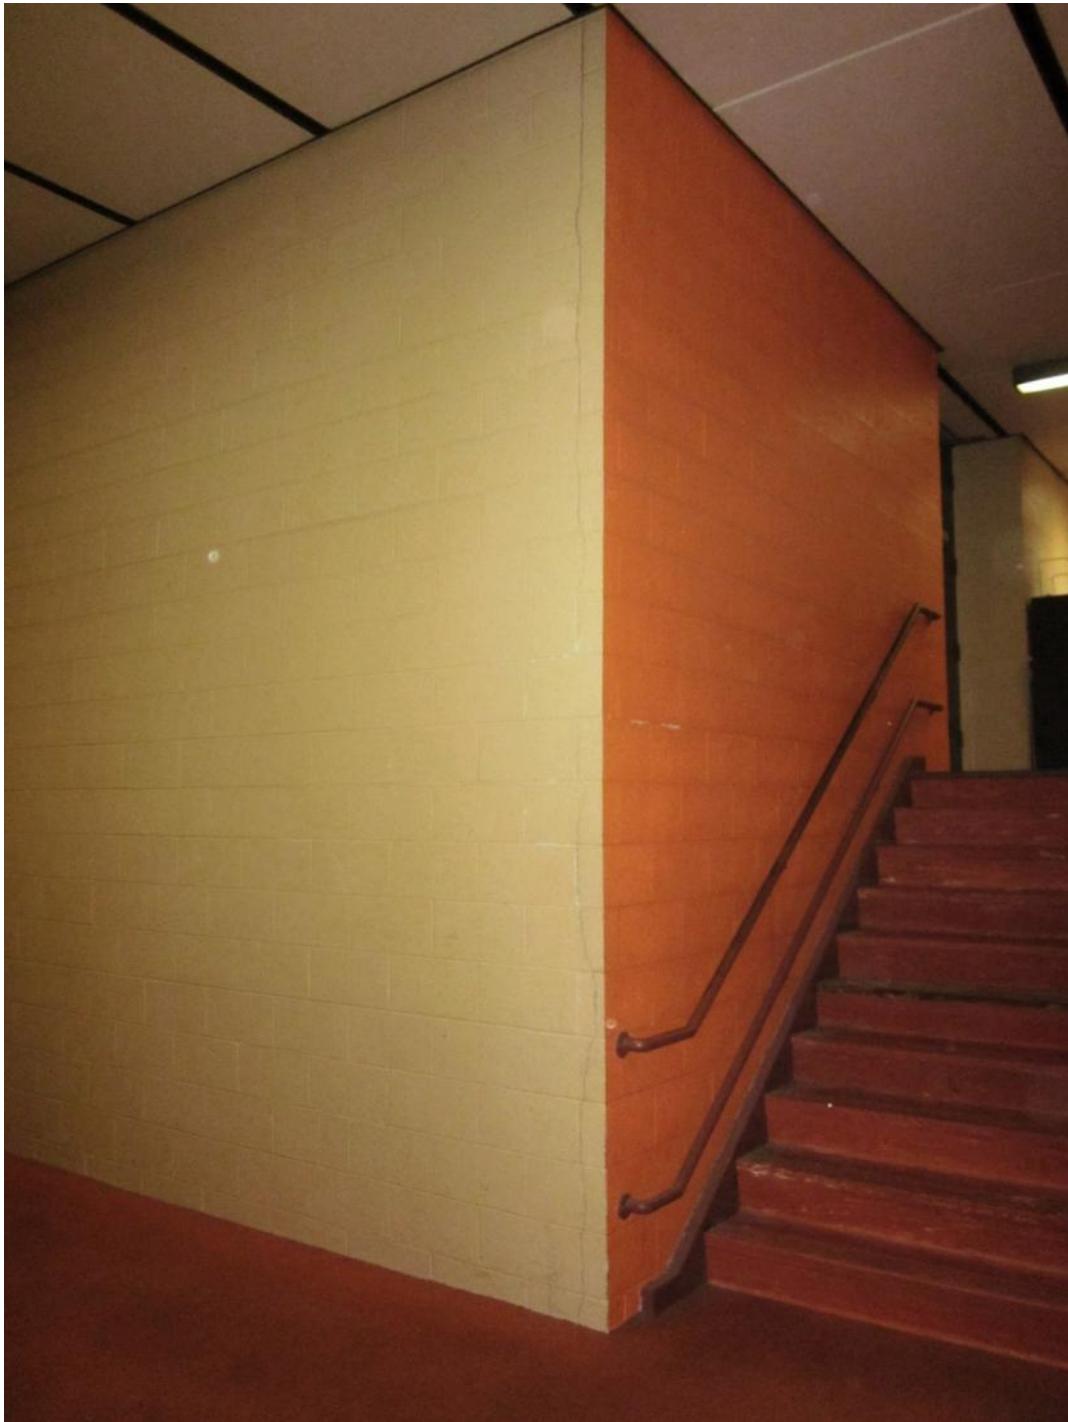
Photo #6

*This photo shows another of the many locations throughout the school building where the interior masonry block partition walls are cracked.*

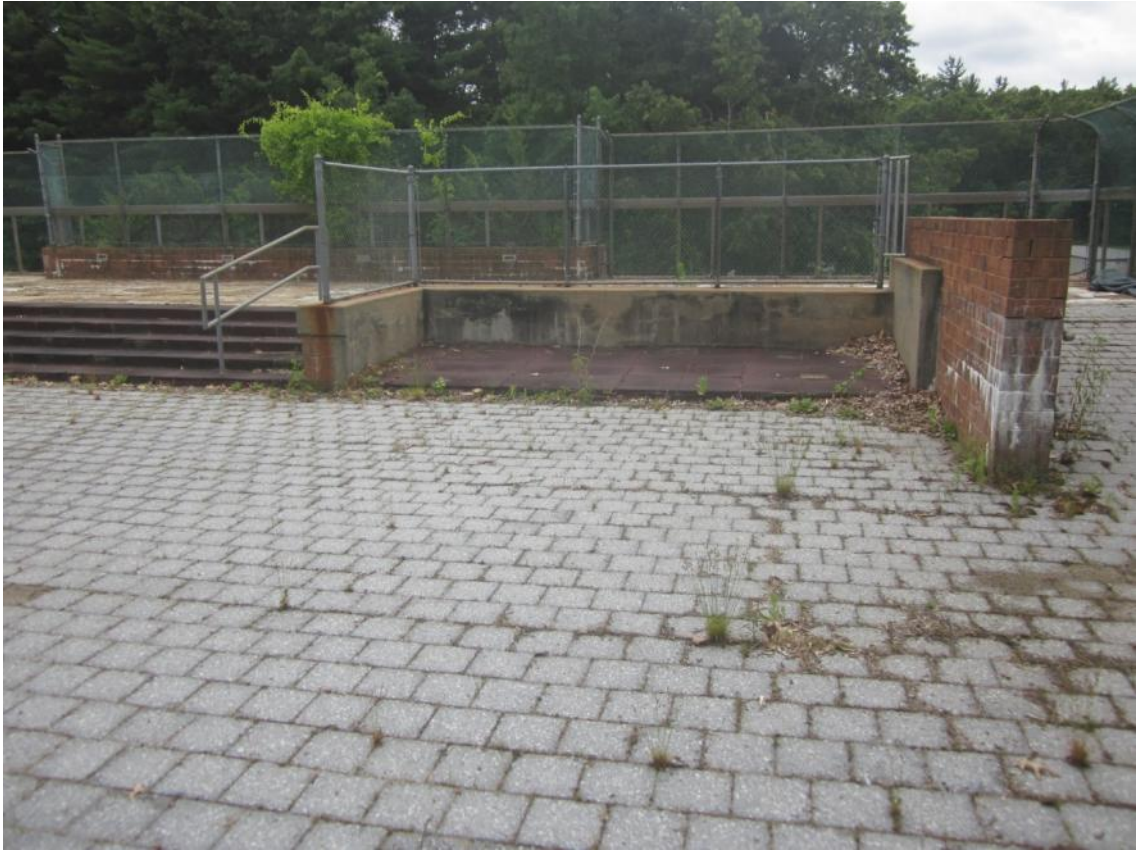
**Photo #7**

**brick walls of the Boiler Room building and the terrace walls and pavers above the Boiler Room building:** Long term water infiltration and the subsequent growth of vegetation has damaged the exterior brick walls of the Boiler Room building and the brick walls and the patio pavers of the terrace above the roof of the Boiler Room building. **(Photos #7 to #11.)**

- **COMMENT:** In addition to damaging the exterior walls of the Boiler Room building, and the terrace walls and pavers above, the water infiltration may be jeopardizing the structural concrete roof slab of the Boiler Room building. It was reported to Odeh Engineers that some minor repairs to the exterior brick veneer walls of the Boiler Room building had been performed since Odeh Engineers previous investigation in 2008. However, no long-term, systematic repairs to these exterior brick walls have been undertaken.

*This photo shows the damage to the brick walls and the patio pavers at the terrace above the roof of the Boiler Room building due to long-term water infiltration and vegetative growth.*

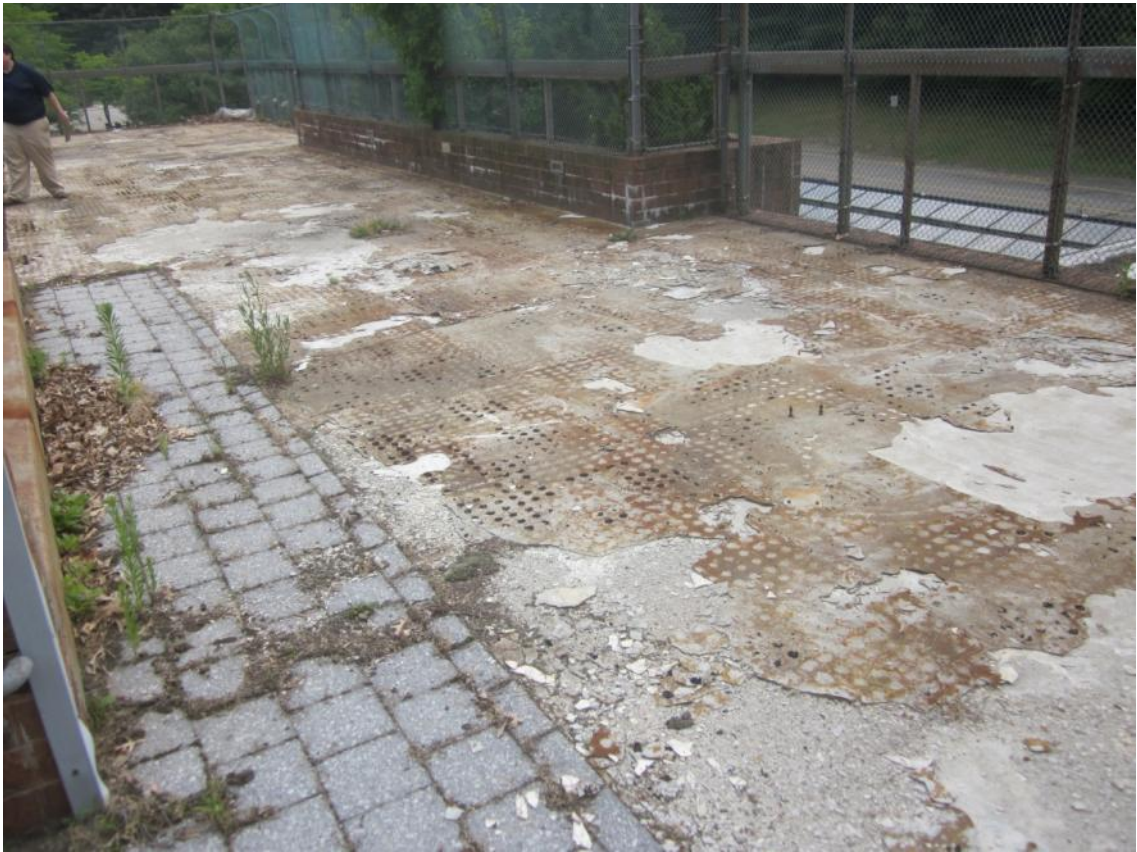
**Photo #8**

*This photo shows another view of the damage done to the terrace above the Boiler Room roof from long-term moisture infiltration and vegetative growth.*

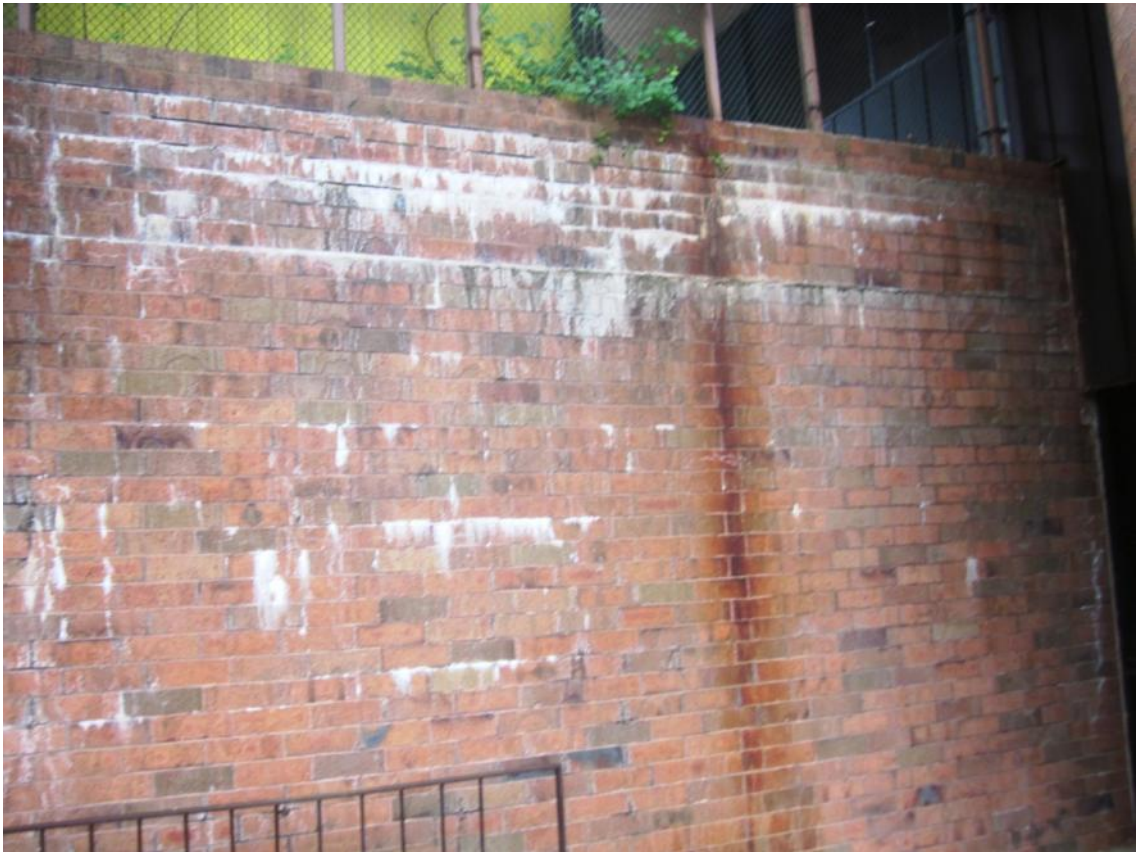
Photo #9

*This photo shows the efflorescence leaching from the exterior brick walls along the east side of the Boiler Room building resulting from water infiltrating these walls from the terrace above.*

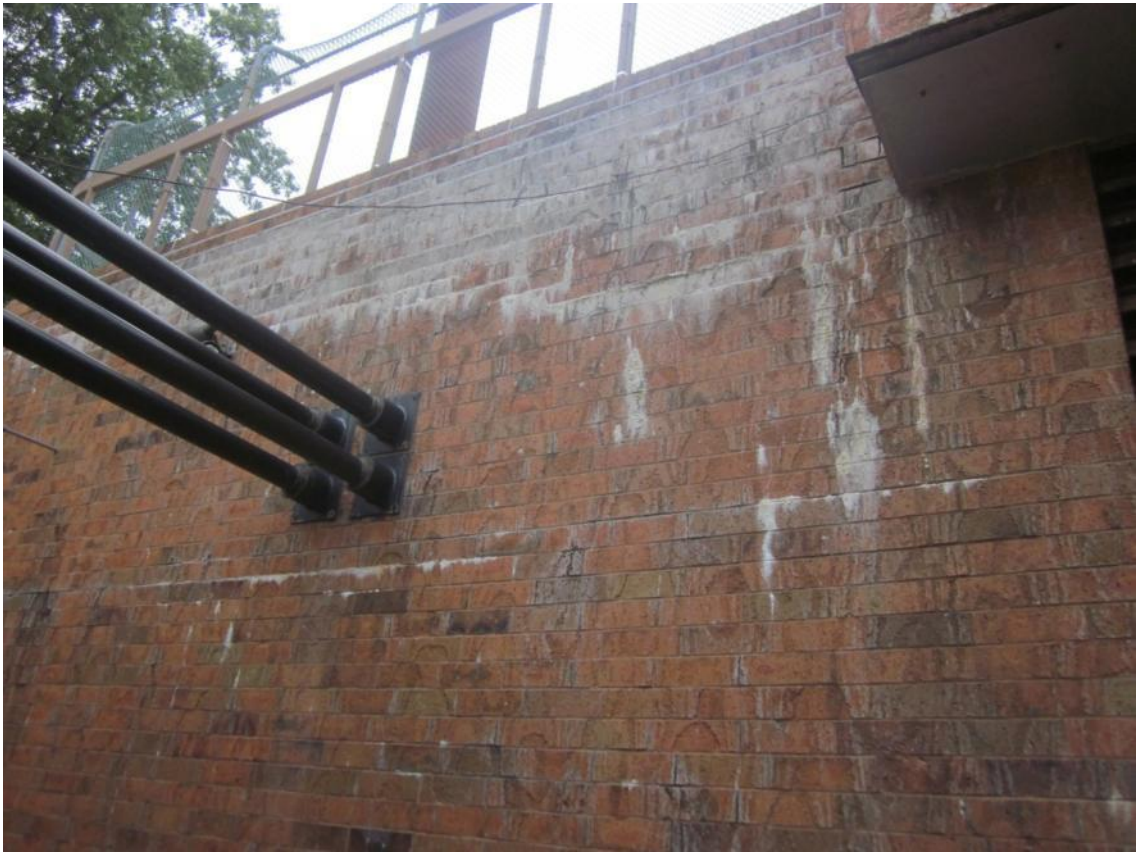
**Photo #10**

*This photo shows another view where water infiltration from the terrace above is damaging the south brick wall of the Boiler Room building.*

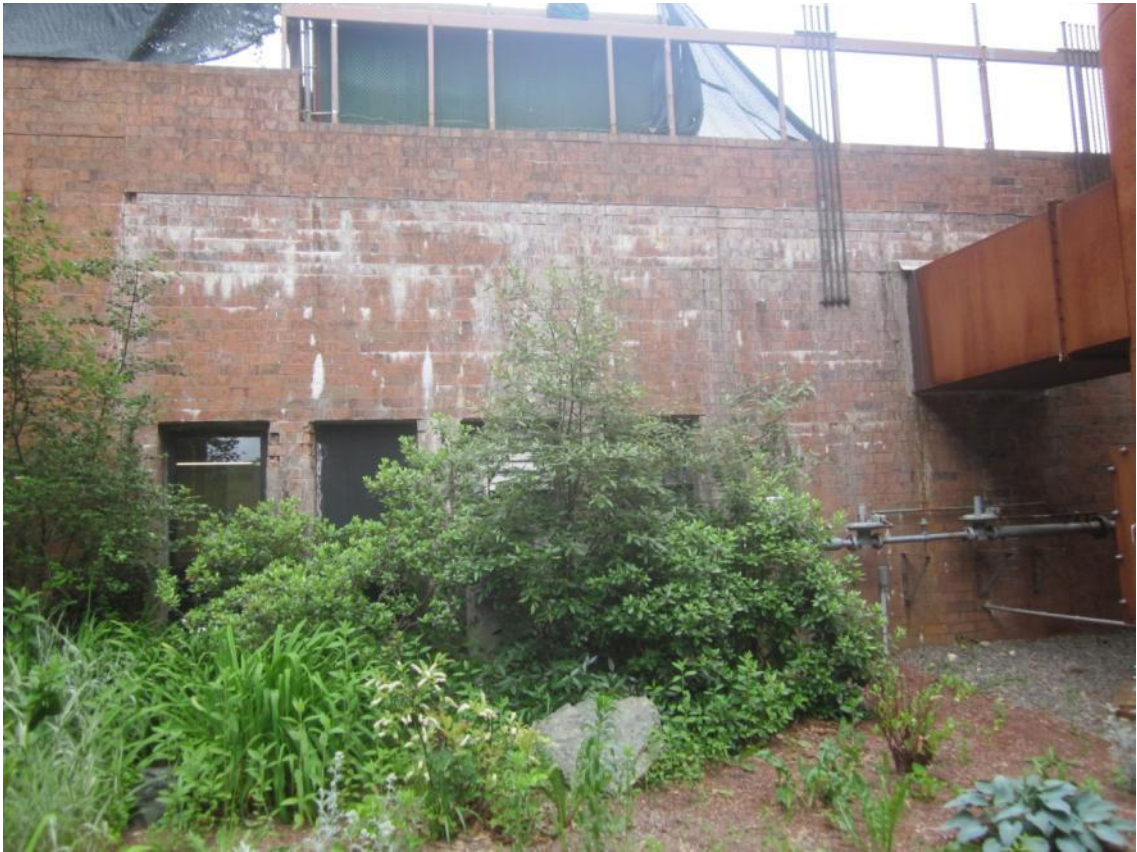
**Photo #11**

*This photo shows the efflorescence leaching from the west exterior wall of the Boiler Room building due to water infiltration from the terrace above.*

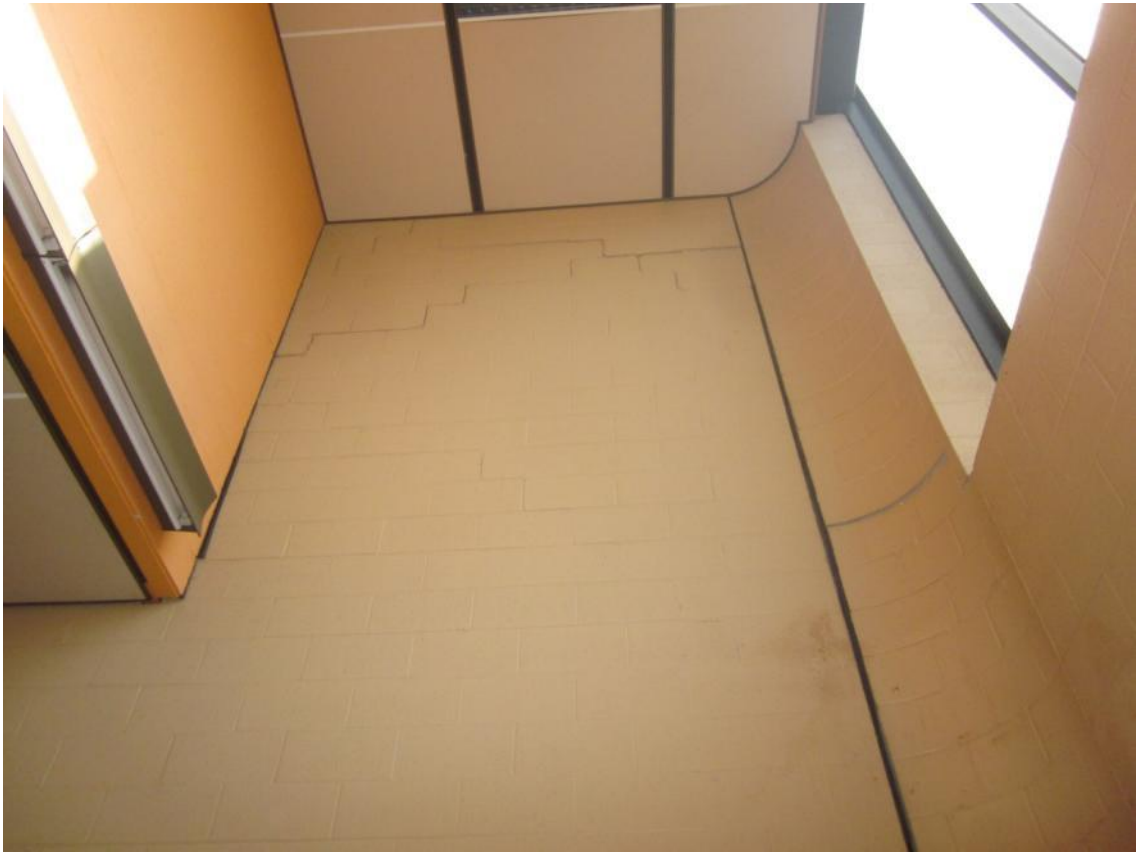
**Photo #12**

- **The load-bearing masonry block walls at the two pairs of stair towers located at the east and west ends of the school building are cracked and displaced:** The masonry block walls at the two pairs of stair towers are cracked and displaced. The most significant cracks occur in the masonry pillars on each side of the window openings just below the high roof framing elevation. **(Photos #12 to #16.)**

- **COMMENT:** Based on our recent examination of these structures, it appears that the cracking and displacements of the load-bearing masonry block walls of these stair towers may be due to the movement of the steel frame of the building from thermal expansion and contraction (see discussion of improperly constructed roof expansion joints below), and/or from lateral wind loads.  
Additionally, the tall slender nature of the masonry pillars (which appear to be unreinforced), make them particularly susceptible to flexural cracking due to lateral movement of the stair tower. At the high roof level, the stair structure is not tied back to the main superstructure and therefore these pillars may be moving excessively under wind loads.  
In order to mitigate additional cracking and deterioration of the masonry stairway walls, Odeh Engineers recommends that the slender “pillars” at the top of each stairwell be removed and reconstructed using solid grouted and reinforced masonry piers.

*This photo shows the typical cracking of the masonry block walls found at each of the multi-story stair towers located at the east and west ends of the school building.*

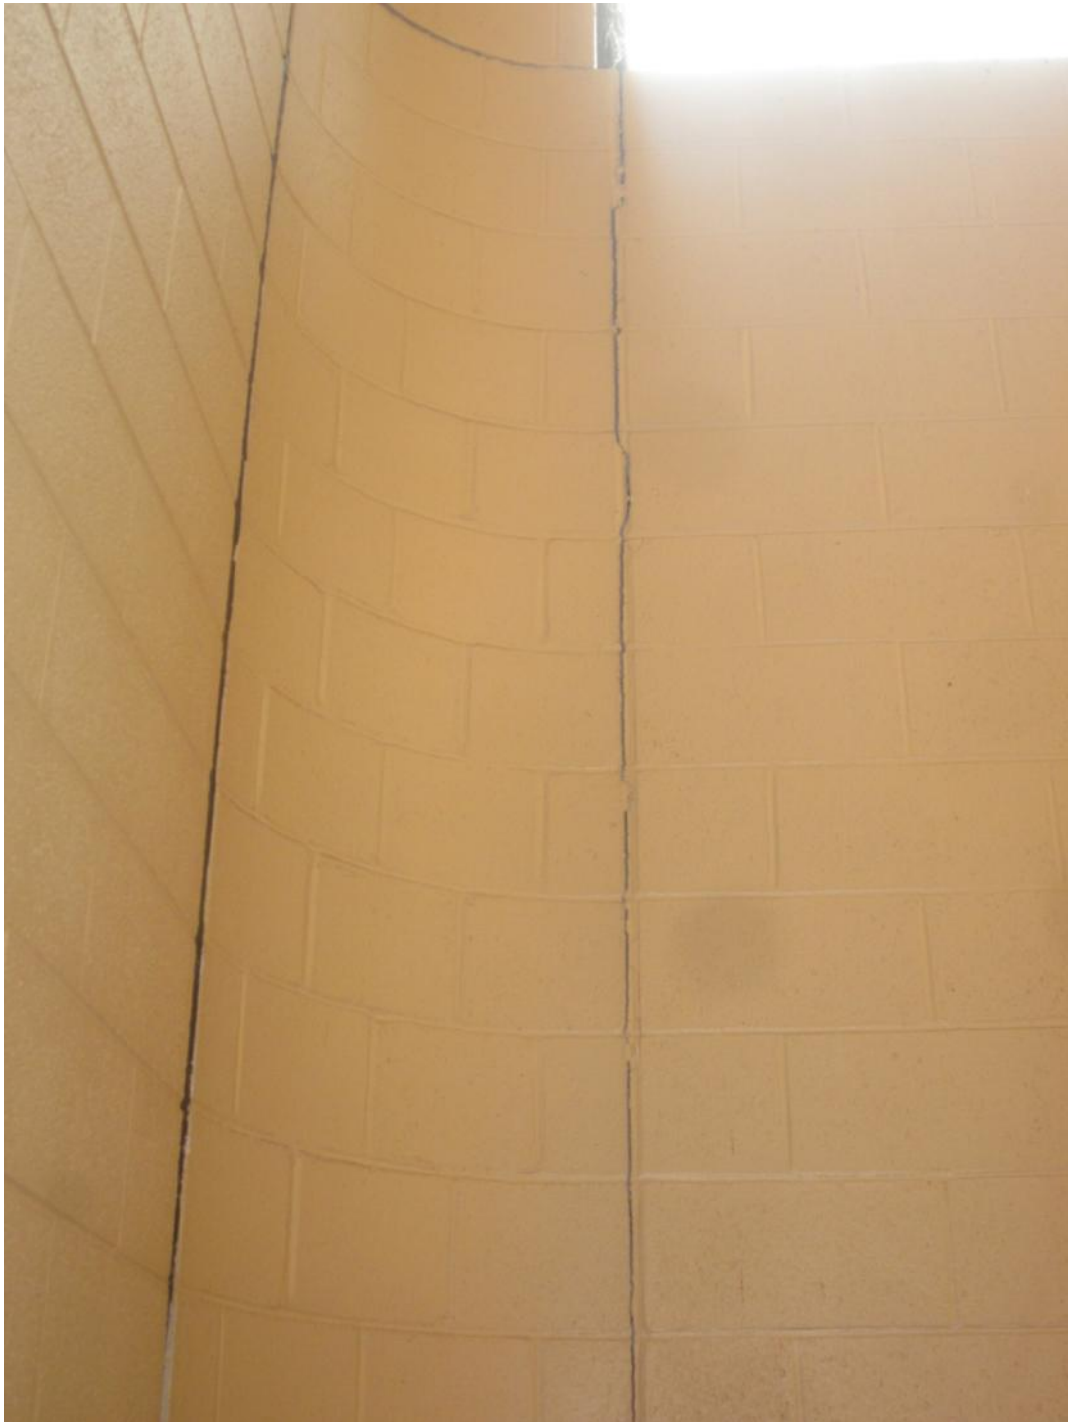
**Photo #13**

*This photo shows the vertical crack in the load-bearing masonry block walls of one of the multi-story stair towers at the east and west ends of the building.*

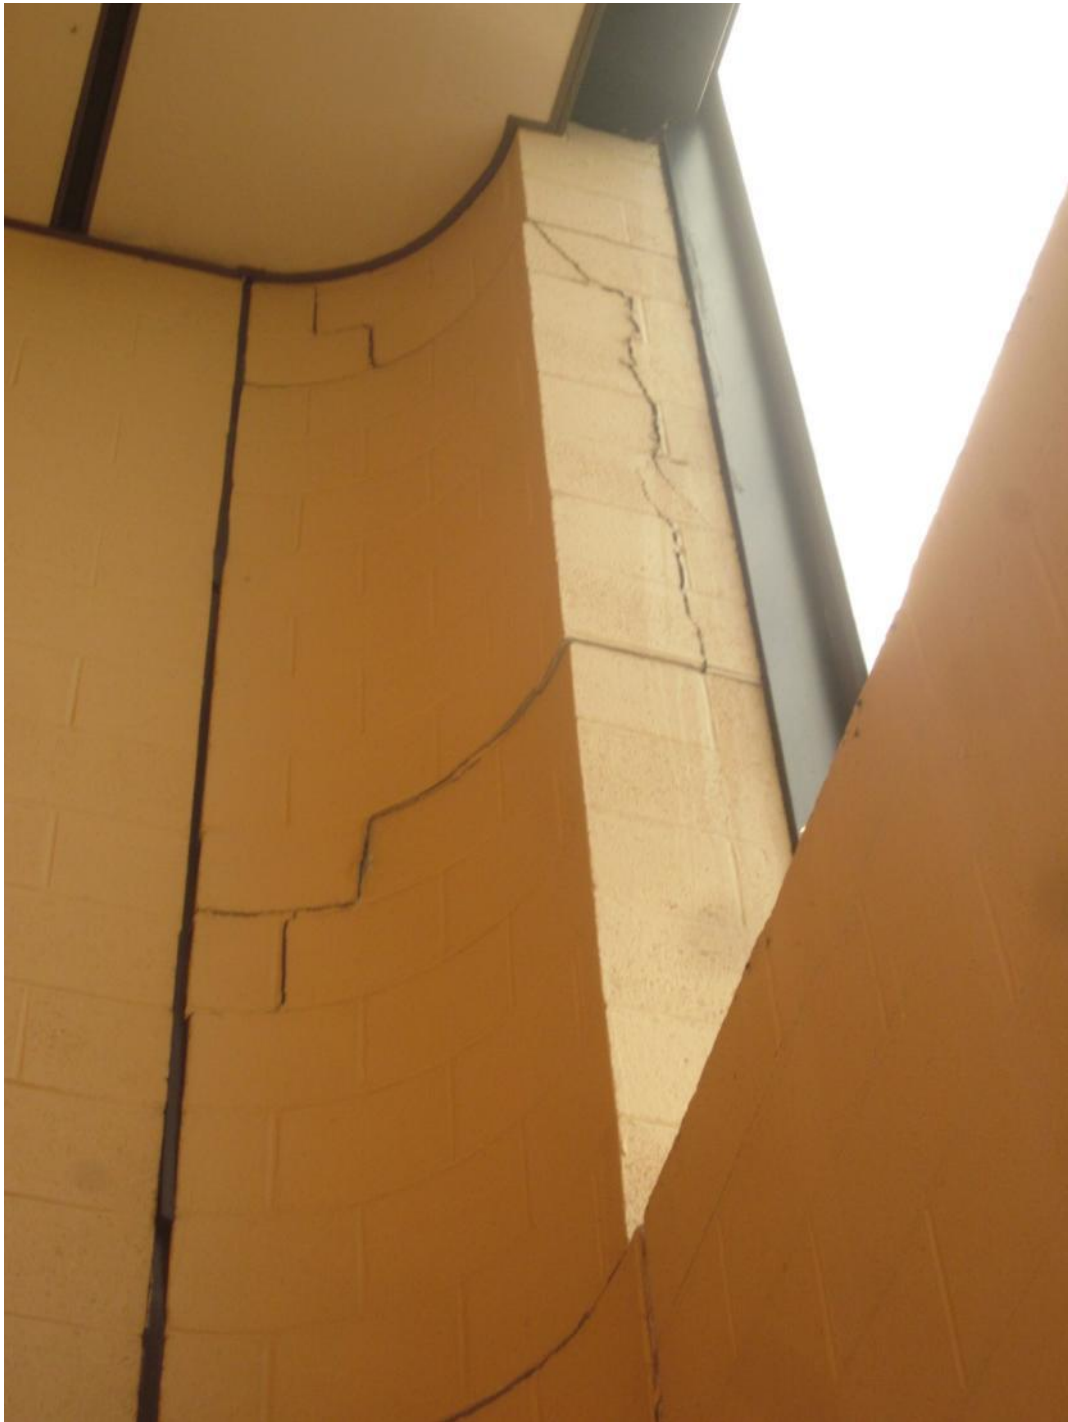
**Photo #14**

*This photo shows the cracking and displacements of the masonry pier along the window of the multi-story stair towers at the east and west ends of the school building.*

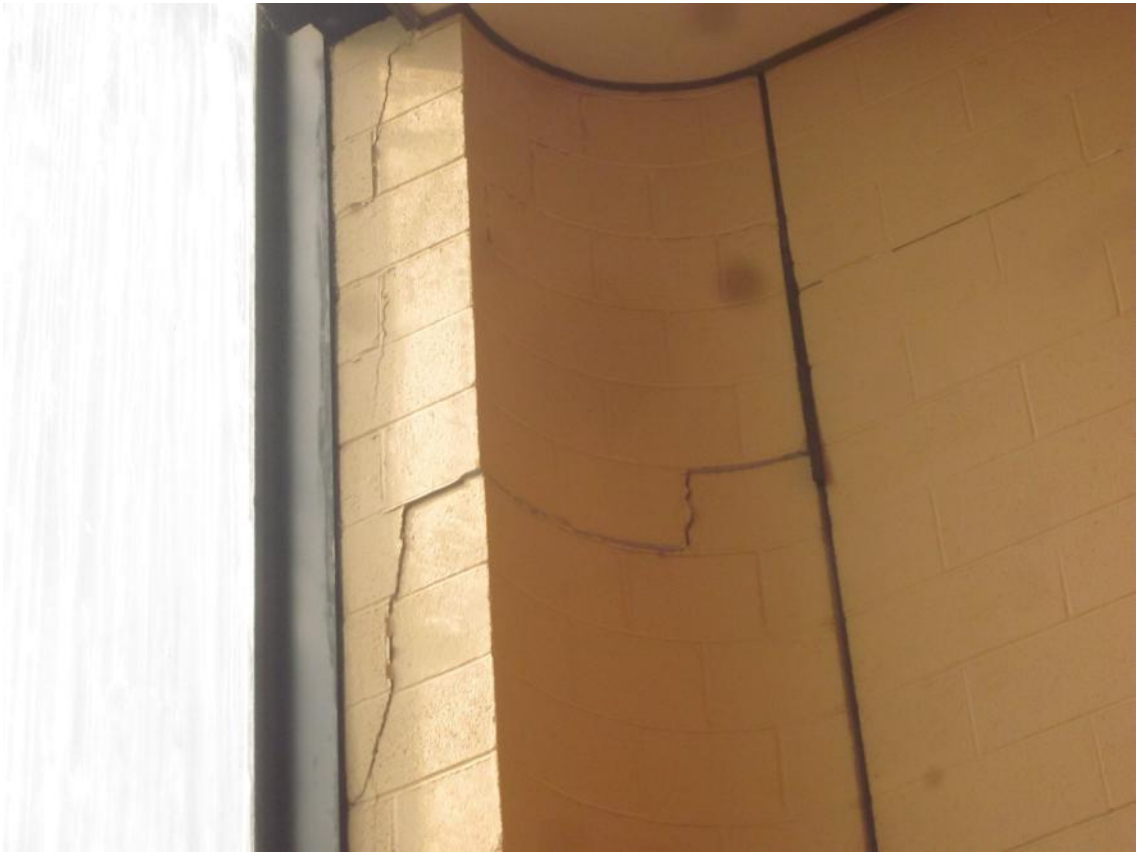
**Photo #15**

***This photo shows the cracking and displacement of another of the concrete block walls in the stair towers at the east and west ends of the school building.***

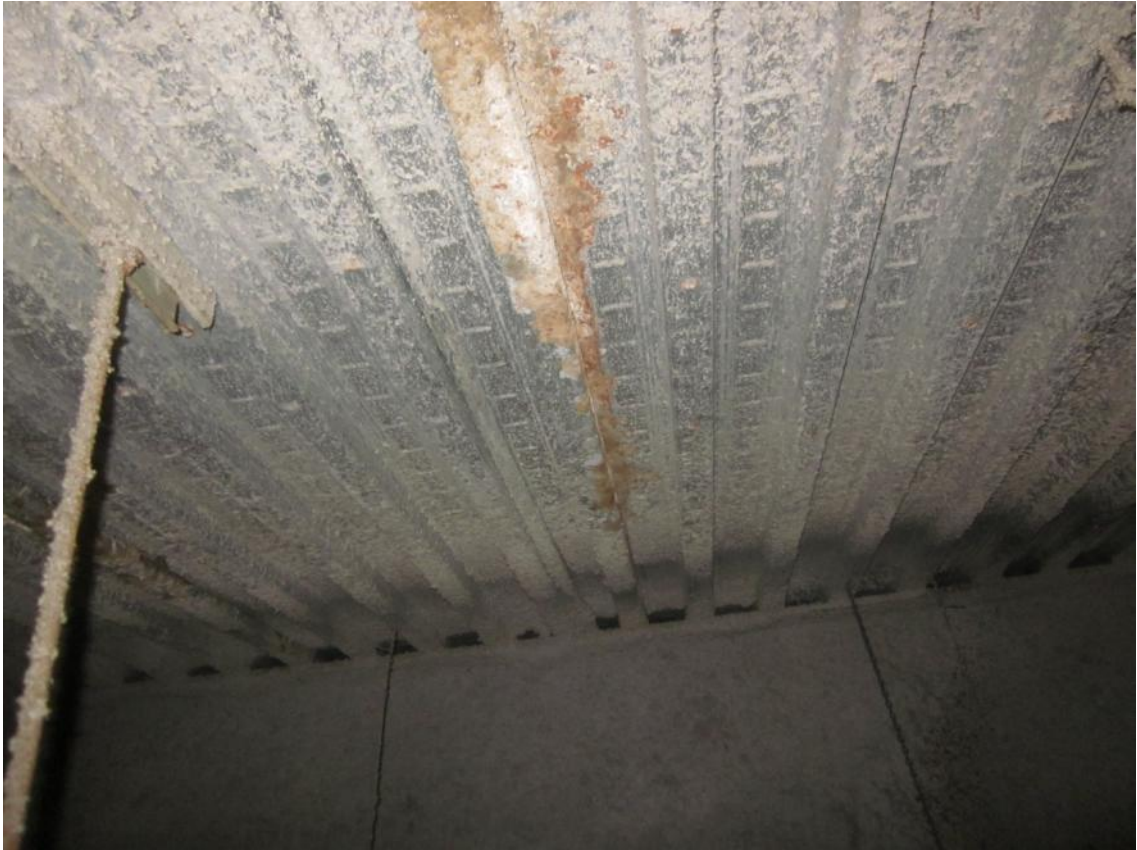
**Photo #18**

- **The roofing system on the school building has reached the end of its useful life:** The rubber roofing membrane on the roof of the building has reportedly been patched many times. The failed roofing system has led to roof leaks into the building. The roof leaks have caused some corrosion and deterioration of the composite metal roof decking. Many of these roof leaks have occurred at, or near the roof drains, and along the two expansion joints in the building. **(Photos #17 to #20.)**

*This photo shows one of the locations where minor corrosion of the composite metal roof deck has occurred apparently from leaks in the roofing membrane.*

- **COMMENT:** The roofing system needs to be replaced as soon as possible. Continuing roof leaks may cause significant deterioration of the composite metal roof decking and the concrete slab. Long-term roof leaks can create serious structural issues if left unattended.

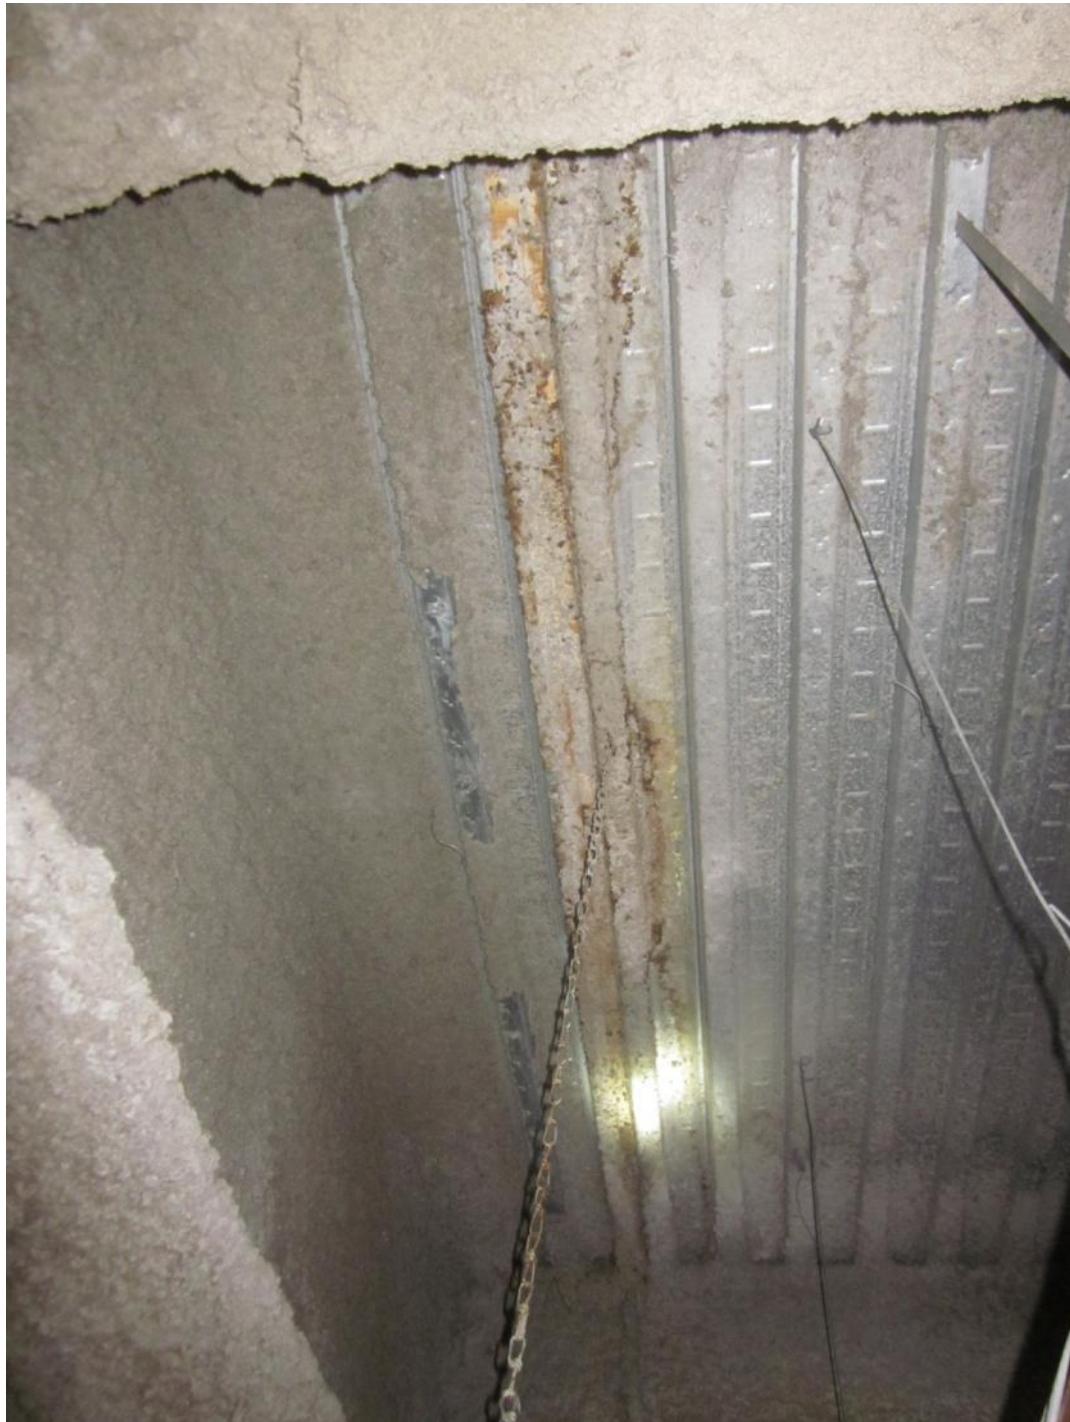
Photo #19

*This photo shows the corrosion of the composite metal roof decking along one of the expansion joints in the roof of the school building.*
