758 MARRETT ROAD  
LEXINGTON, MASSACHUSETTS 02421

Michael McKeon  
**Kaestle Boos Associates**  
325 Foxborough Boulevard #100  
Foxborough, Massachusetts 02035  
October 29, 2013

This updated structural evaluation of the Minuteman High School, located at 758 Marrett Road in Lexington, MA, was undertaken at the request of Mr. Michael McKeon, AIA, of Kaestle Boos Associates, Foxborough, Massachusetts.

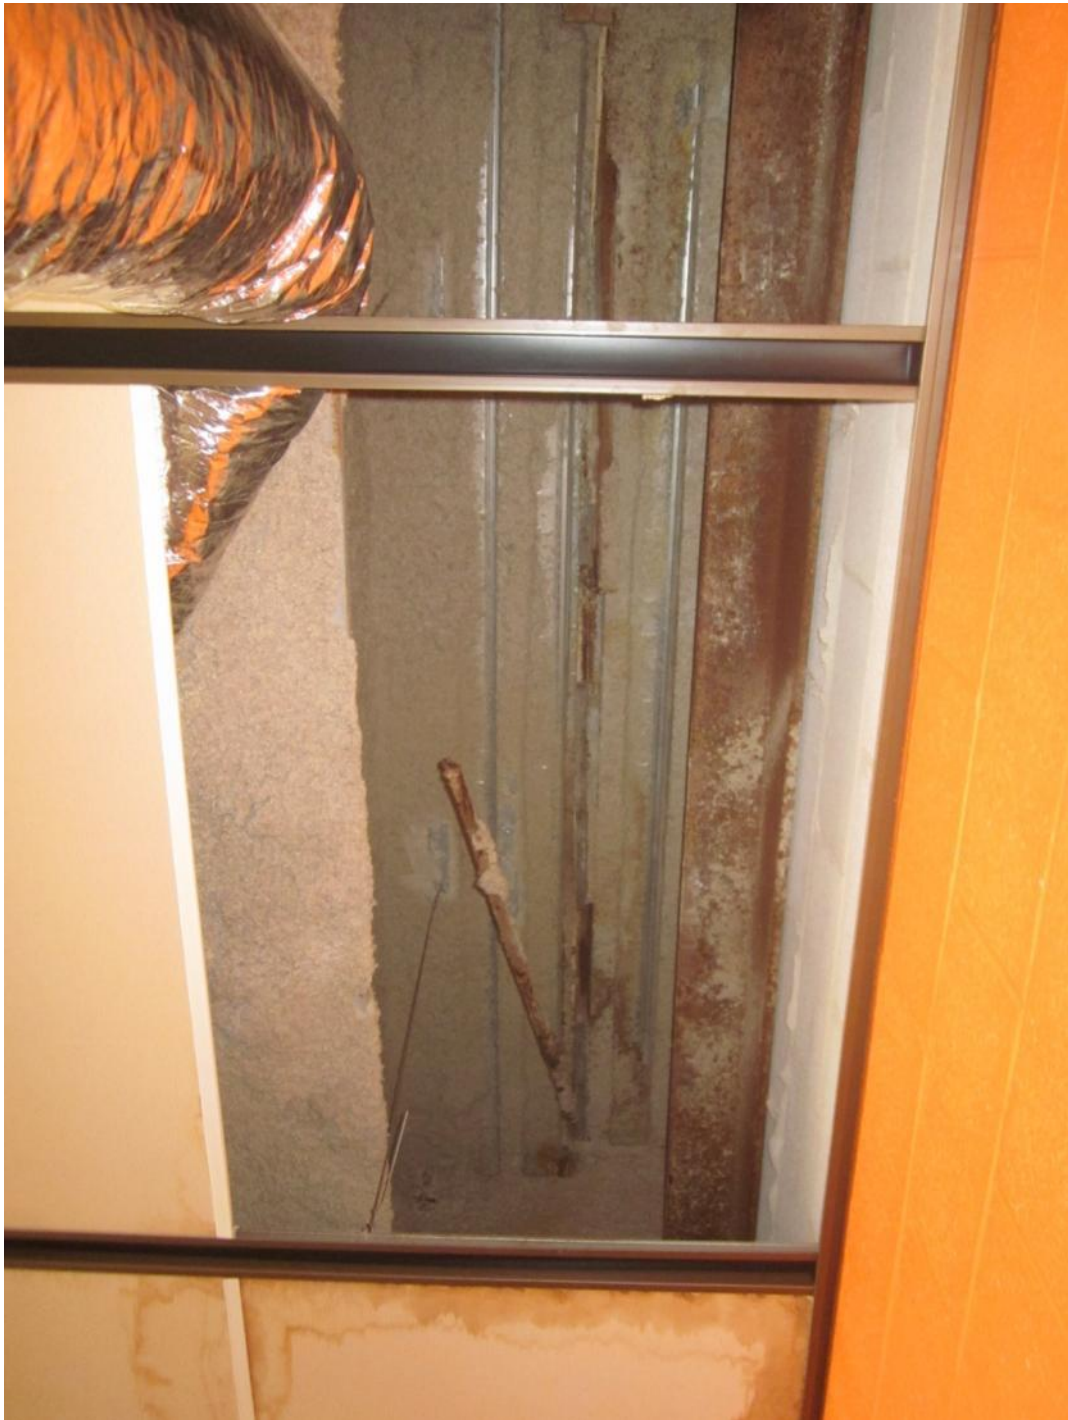
**Photo #20**

- **The roofing system on the school building has reached the end of its useful life:** The rubber roofing membrane on the roof of the building has reportedly been patched many times. The failed roofing system has led to roof leaks into the building. The roof leaks have caused some corrosion and deterioration of the composite metal roof decking. Many of these roof leaks have occurred at, or near the roof drains, and along the two expansion joints in the building. **(Photos #17 to #20.)**

*This photo shows another of the roof leaks that has occurred along the expansion joint adjacent to the Instructional Media Center.*

- **COMMENT:** The roofing system needs to be replaced as soon as possible. Continuing roof leaks may cause significant deterioration of the composite metal roof decking and the concrete slab. Long-term roof leaks can create serious structural issues if left unattended.

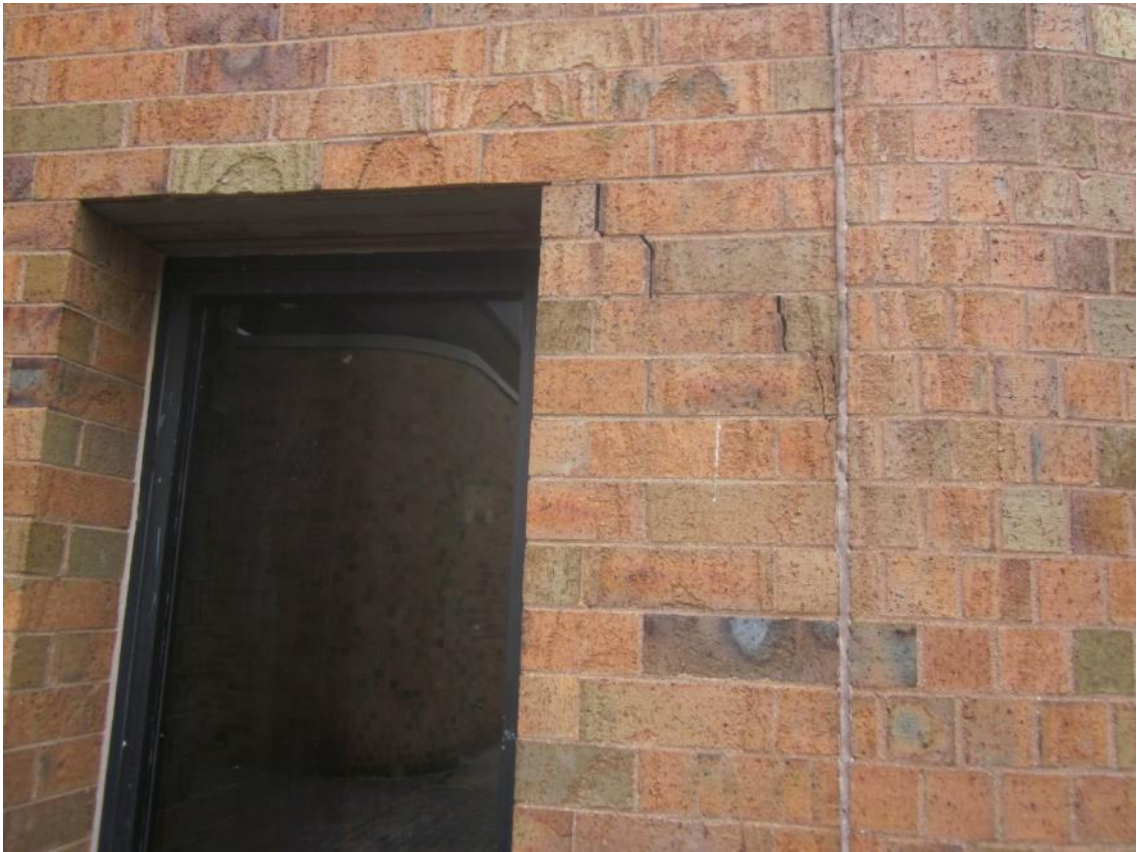
**Photo #21**

- **Minor cracking of the exterior brick walls:** Minor cracking of the exterior brick walls was noted at several locations. **(Photos #21 and #22.)**
  - **COMMENT:** In general, the cracking of the brick veneer appears to be the result of an insufficient number of control joints to allow for the expansion and contraction of the brick. A maintenance program of repairing the bricks and raking and repointing the mortar joints should be established to prevent water from entering the building envelope through these cracks. The creation of additional control joints should be considered.

*This photo shows one of the locations where minor cracking of the exterior brick veneer has occurred.*

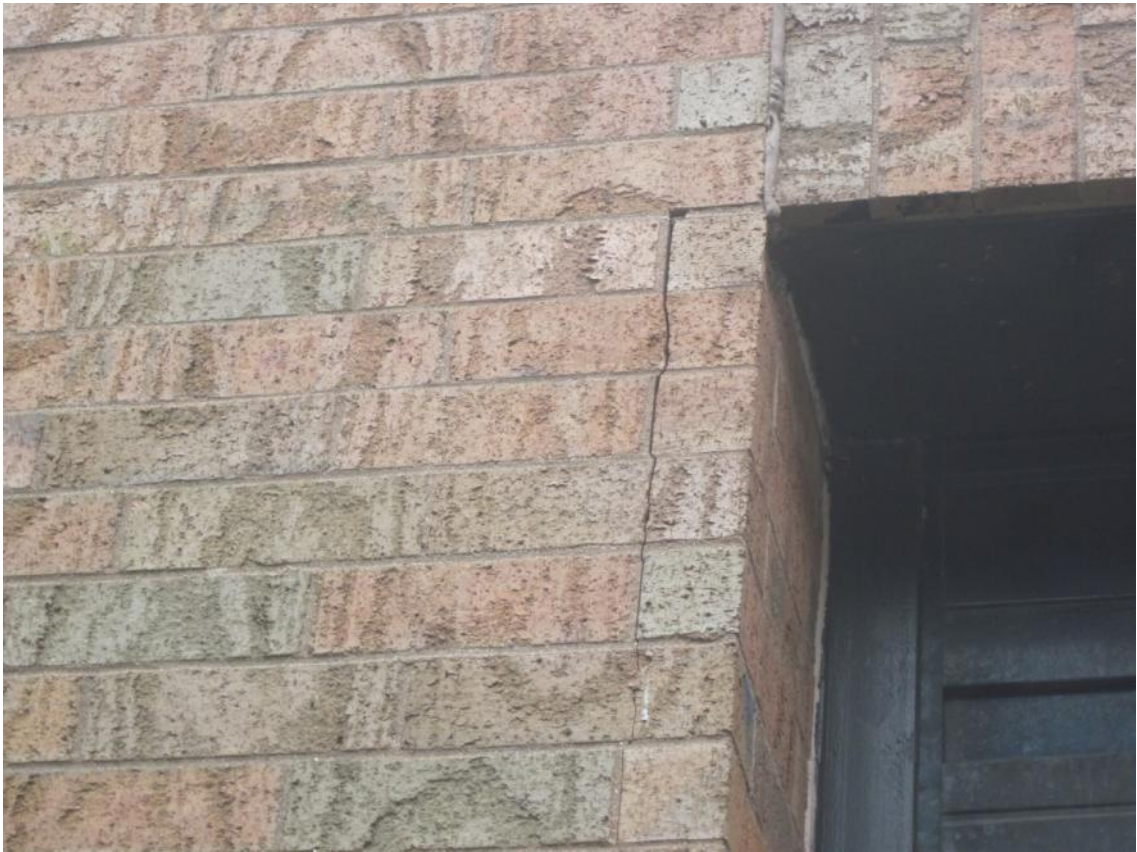
**Photo #22**

*This photo shows another location where cracking of the brick veneer has occurred.*

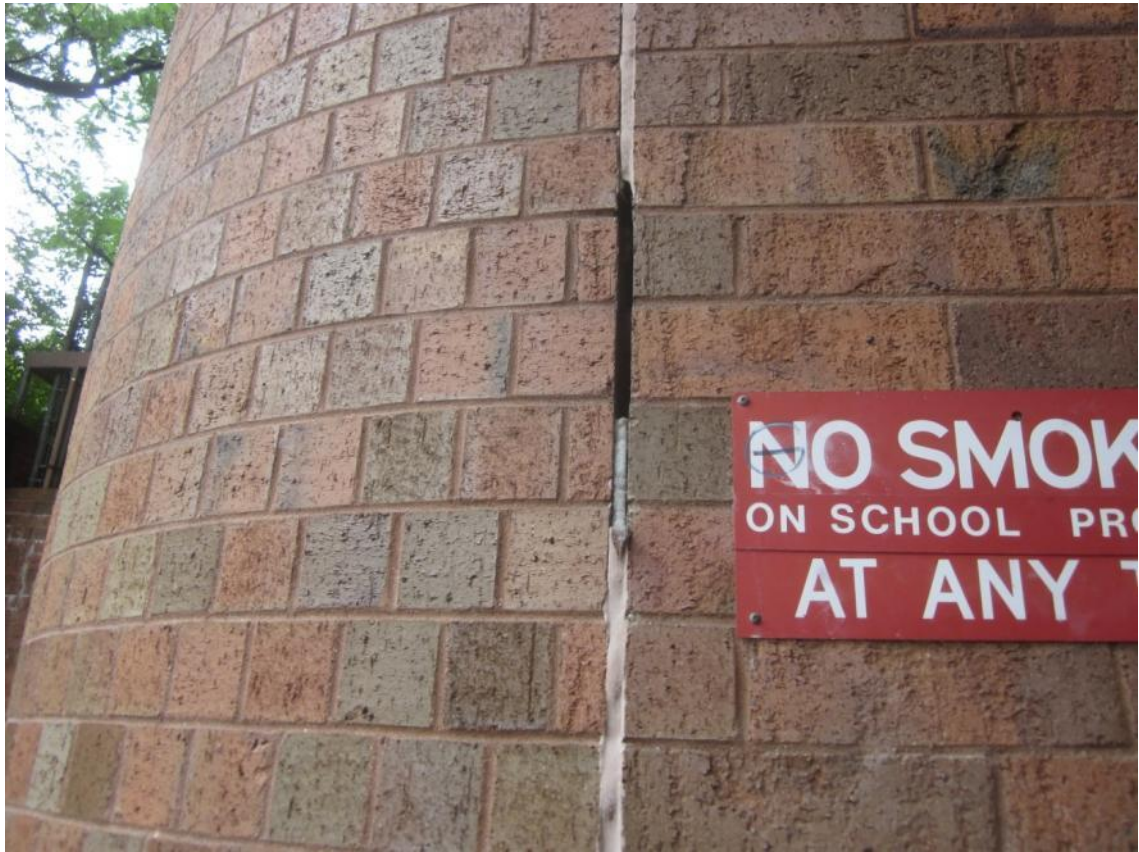
Photo #23

- **Failed or missing joint sealants in the exterior brick walls:** Odeh Engineers noted several locations where the sealants in the existing control joints in the exterior brick walls has failed or is missing. **(Photos #23 to #25.)**

*This photo shows one of the many locations where the joint sealant in the exterior brick wall control joint is partially missing.*

- **COMMENT:** A maintenance program should be established to restore the sealants and the functionality of the control joints to prevent water infiltration and to assure the long-term performance of the brick veneer.

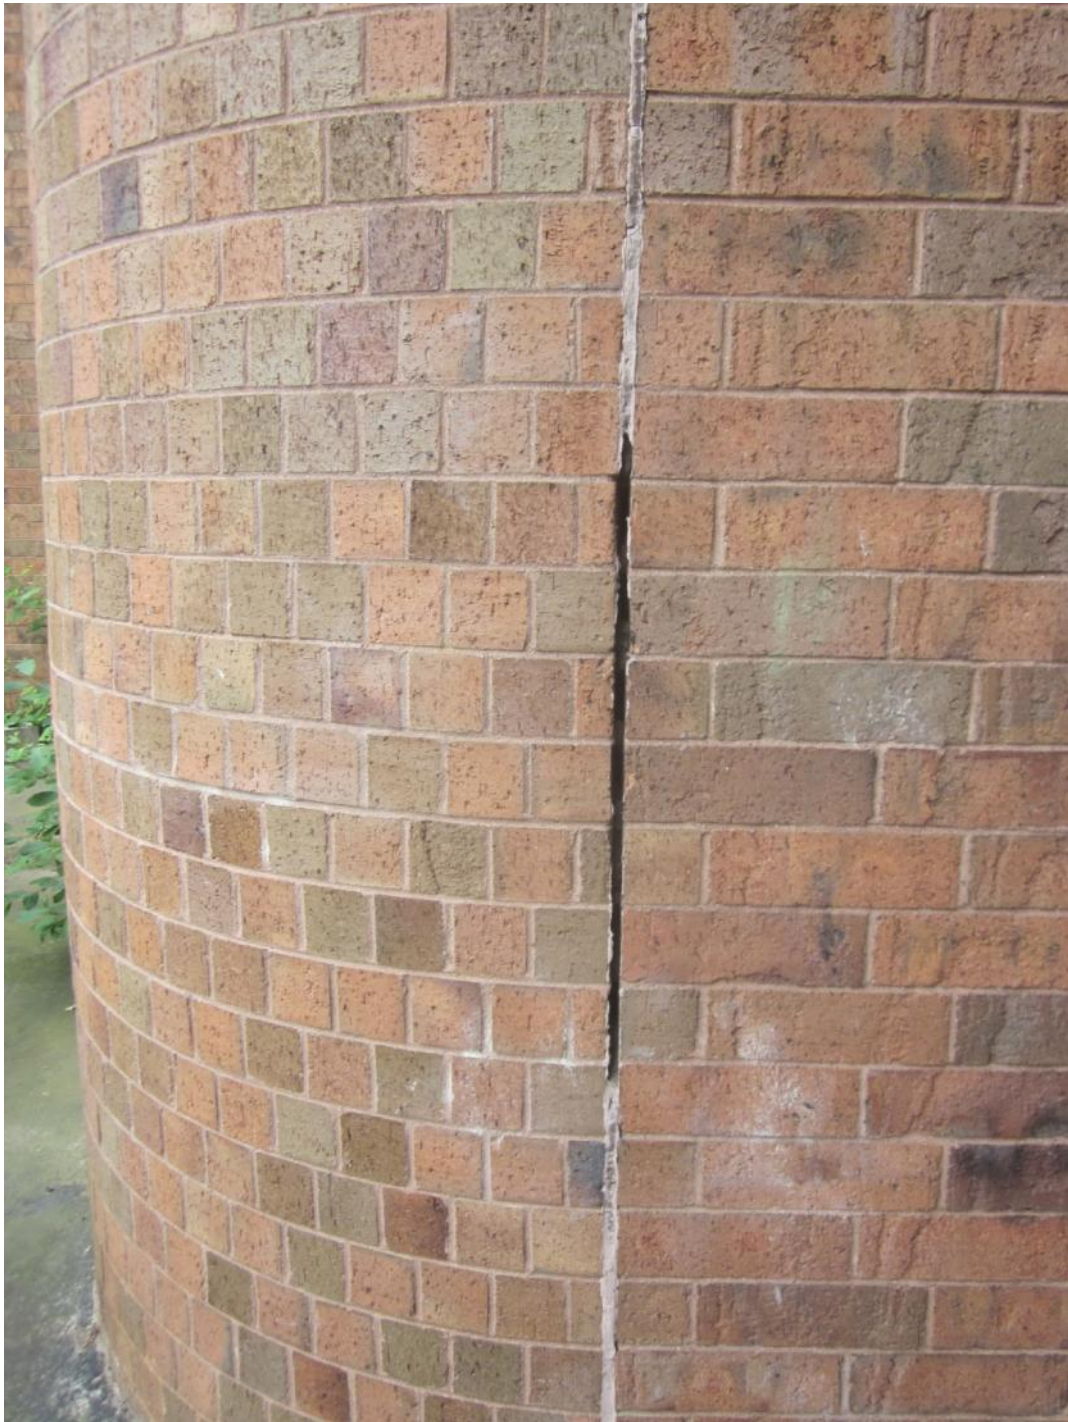
**Photo #24**

***This photo shows another location where the sealant in the exterior brick wall control joint is missing.***

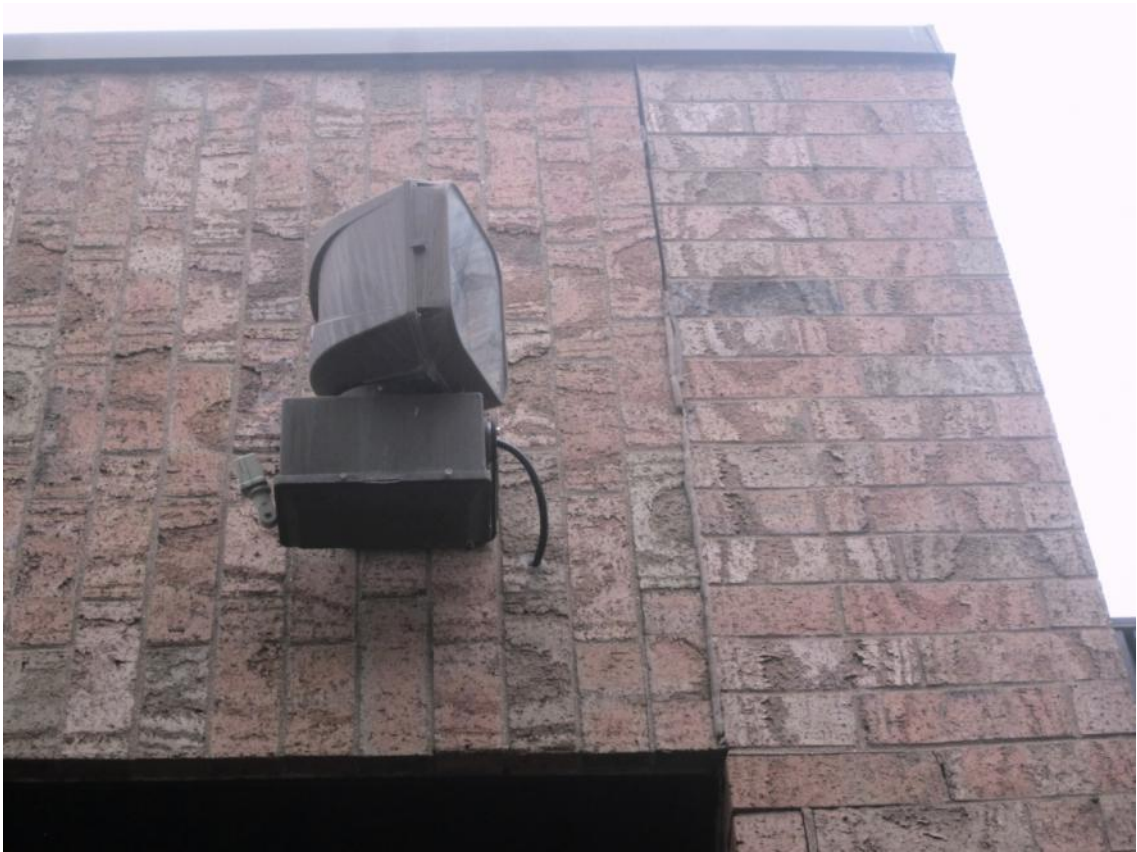
Photo #25

*This photo shows another location where the sealant is missing from the top of the control joint, and the sealant is being squeezed out from the lower portion of the exterior brick veneer control joint.*

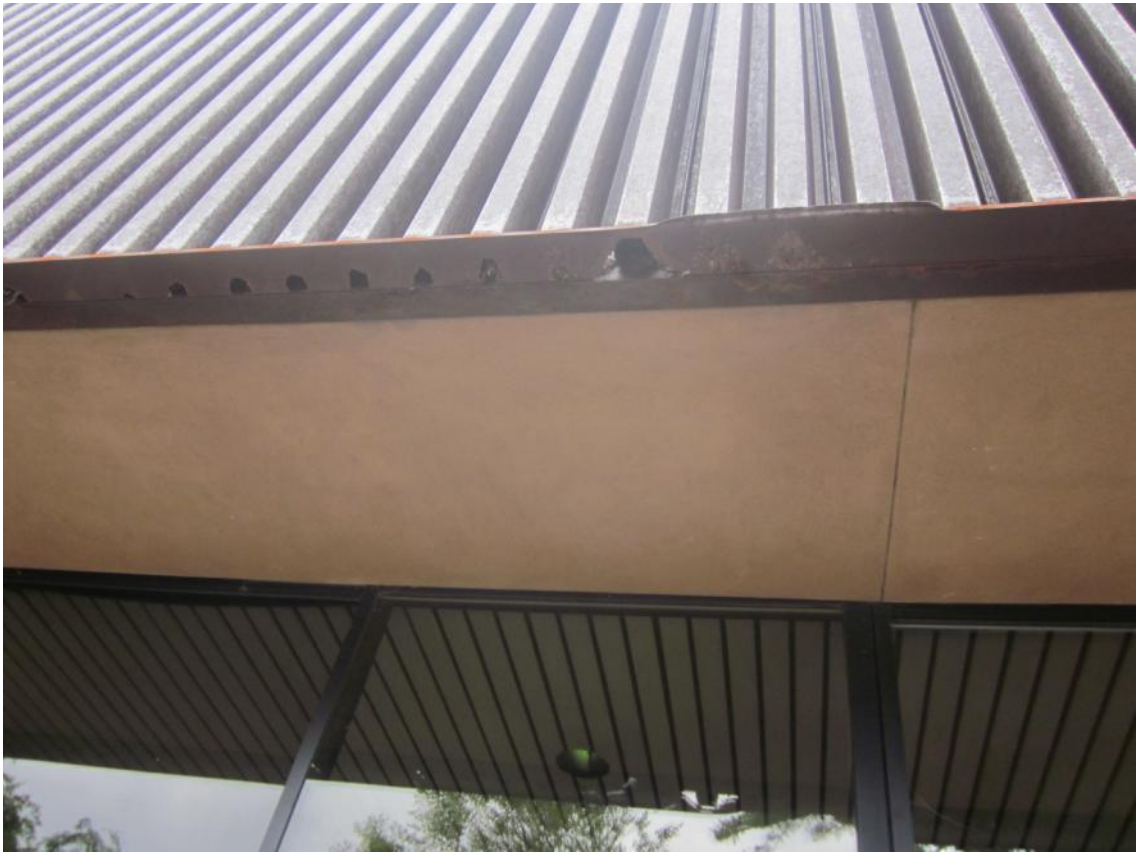
**Photo #26**

- **Deteriorated closure plates on base of Cor-Ten siding:** The closure plates at the base of the exterior wall vertical metal siding panels have deteriorated at many locations around the building. It was reported to Odeh Engineers that the deterioration of some of the bottom closure plates was so severe that the closure plates were removed. Birds and bees are nesting in the voids of the metal siding panels that are exposed by the deteriorated or missing closure plates. **(Photos #26 and #27.)**

*This photo shows the deterioration of the bottom closure plate at the base of the Cor-Ten metal siding on the west side of the school building.*

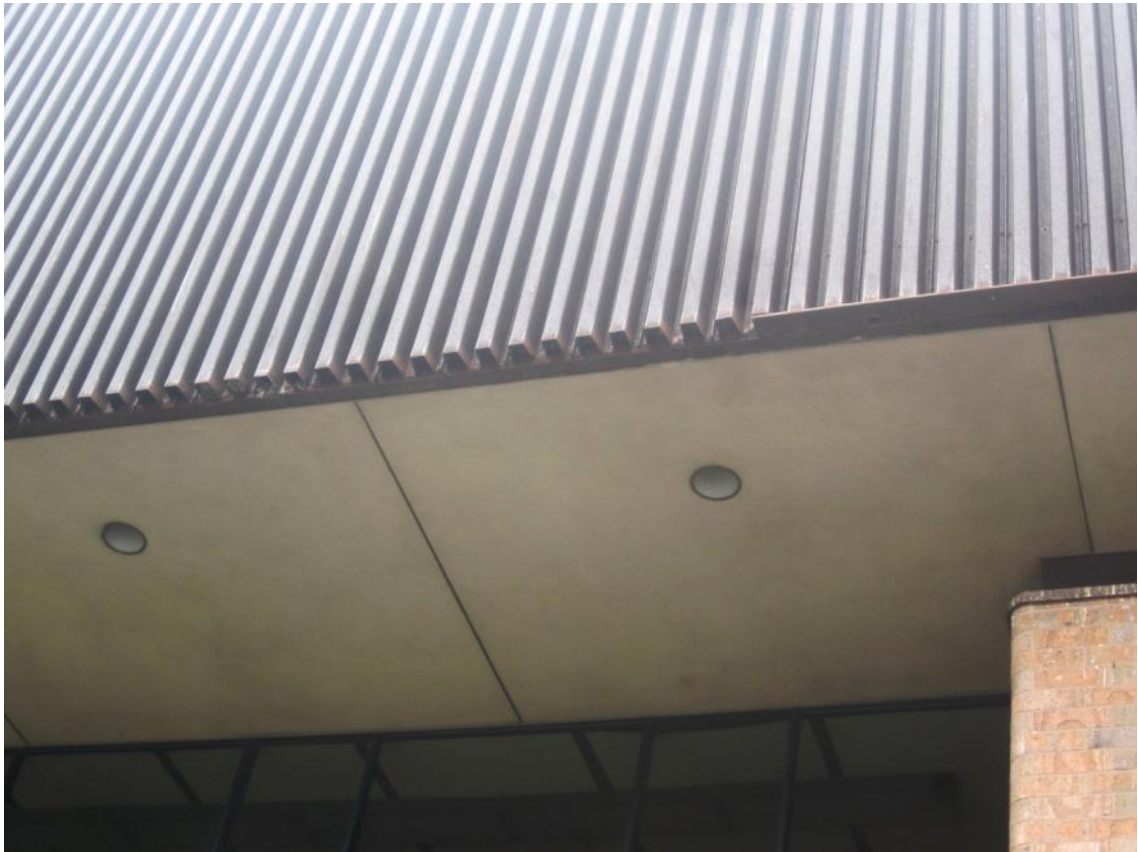
**Photo #27**

*This photo shows a location where the bottom closure plate for the exterior wall metal siding panels was reportedly removed due to significant deterioration of the closure plate.*

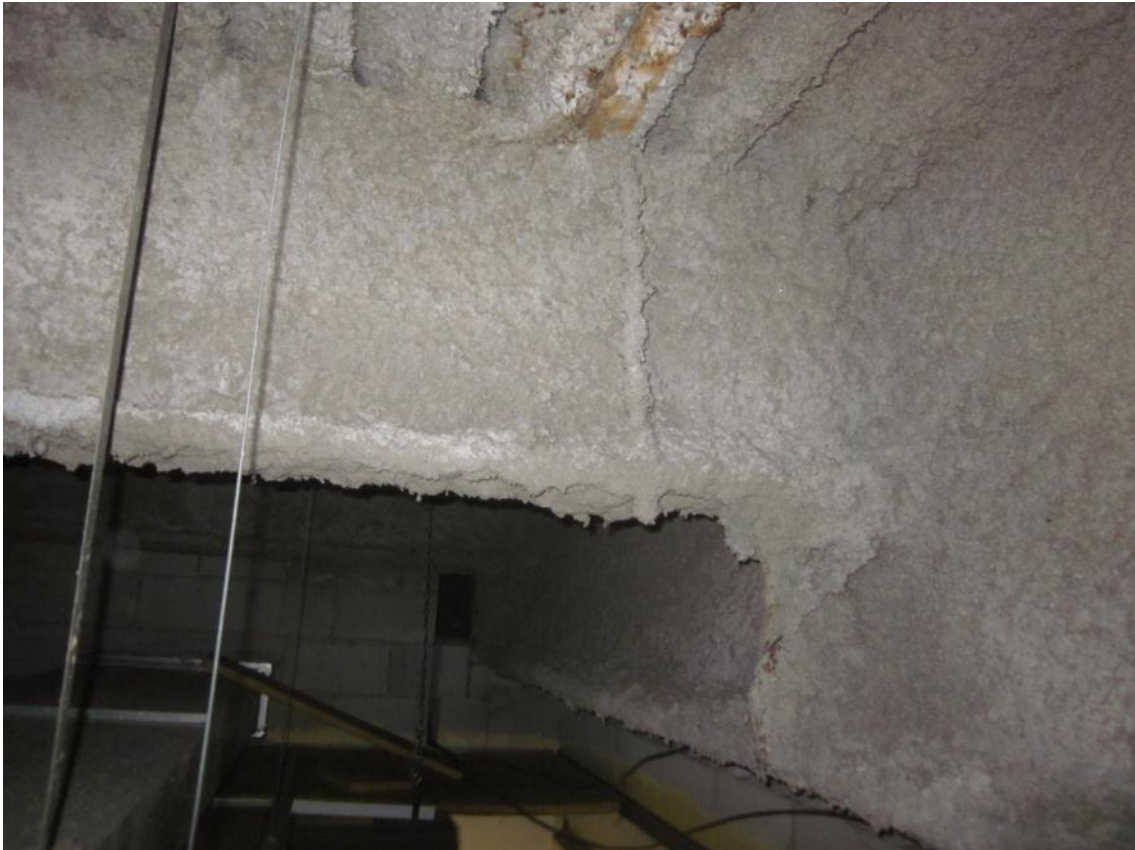
Photo #28

- **COMMENT:** The steel members at the roof level expansion joints typically have the greatest amount of movement due to the changes in temperature from the heat of the sun and the winter cold. The roof framing members at the expansion joints are typically covered with a thick, stiff coating of spray-applied fire resistance material (SFRM). Assuming that the expansion joints were functioning properly, cracks should have developed in the SFRM where the opposing sides of the roof framing structural members at the expansion joints would move relative to each other. No cracks in the SFRM or any other indications of movement of the opposing members on each side of the expansion joints were in evidence.  
In addition, the original structural details of the roof level expansion joints show a bent plate supporting the concrete slab from the adjacent girder to

*This photo shows one of the steel roof beams framing into a steel roof girder along the west expansion joint of the multi-story building. The gray material on the roof beam and girder is the spray-applied fire resistance material (SFRM). The roof beam is seated on a slide-bearing assembly mounted on the roof girder. No visible evidence of cracking of the SFRM or other indications of movement of the steel framing on opposite sides of the expansion joint can be seen.*

As part of any renovation, Odeh Engineers recommends that the expansion joints be reviewed and perhaps repaired to allow for improved movement in the steel frame. Odeh Engineers will also address concerns related to seismic loading through these joints in a separate report on seismic deficiencies in the building.

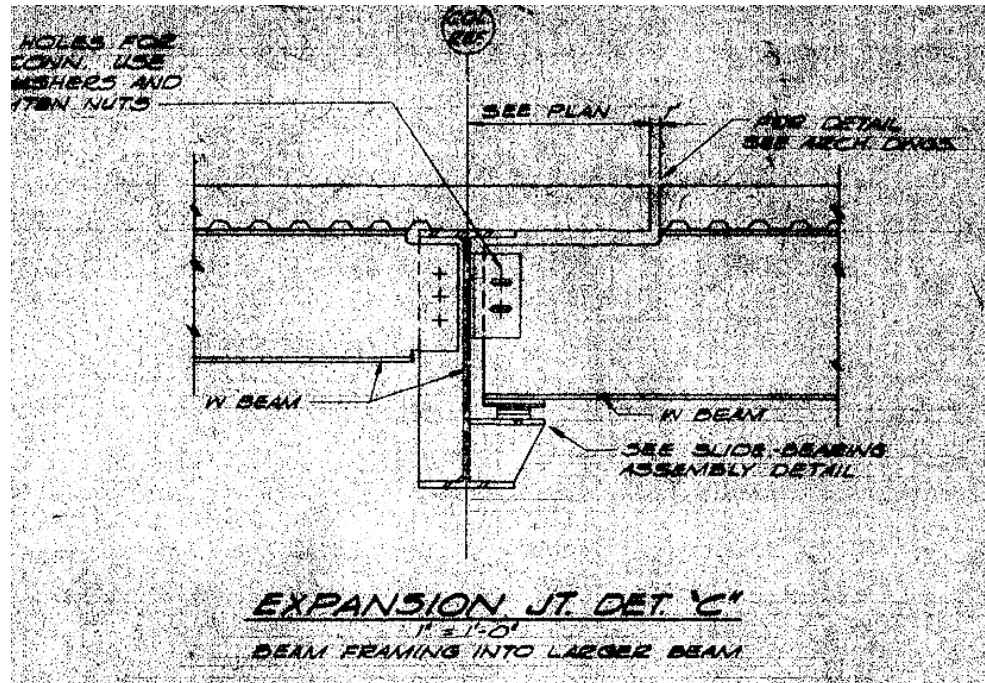
**Figure 8: Typical roof framing level expansion joint detail from the original structural design drawings.**

expansion joints were not constructed in conformance with the structural details on the original structural design drawings, see Figure 8 below. Instead of providing for a sliding joint in the roof plane (as indicated in the drawings), we observed that the joint in fact appears to be rigidly connected and unable to displace independently on each side as originally intended in the design (see photographs #10 and #11).

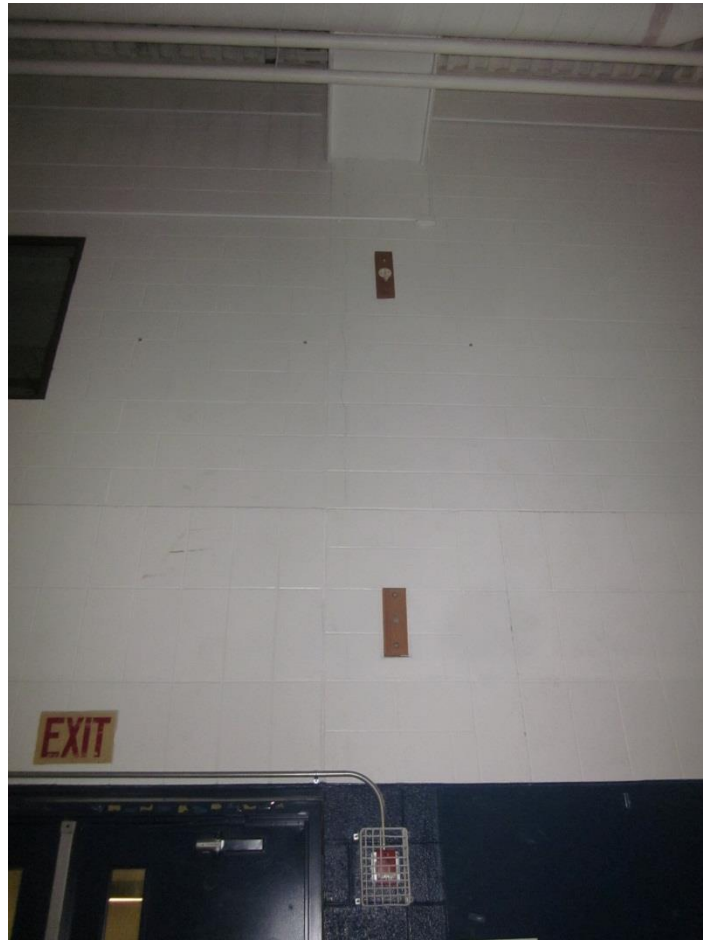
**Photo #1**

*This photo shows a presumed location of a steel moment frame column within the gymnasium north wall. Vertical cracks are present possibly due to the lateral movement of the column, which cannot be accommodated by the masonry infill wall.*

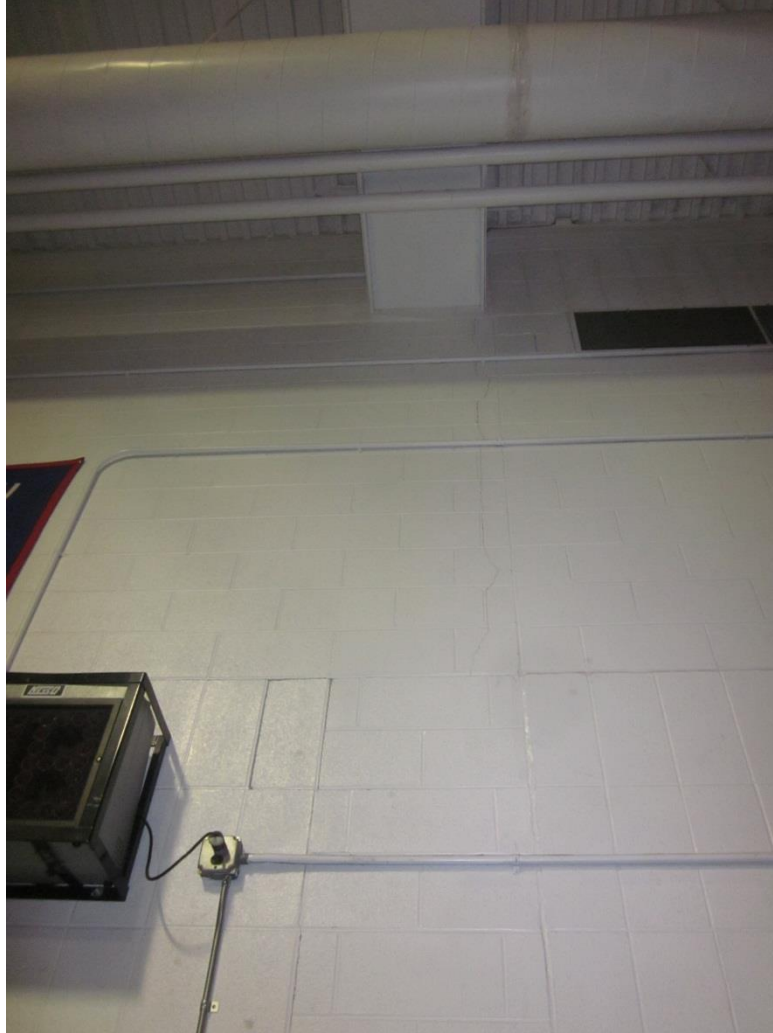
**Photo #2**

*This photo shows another area of cracked masonry infill wall within a moment frame in the gymnasium north wall.*

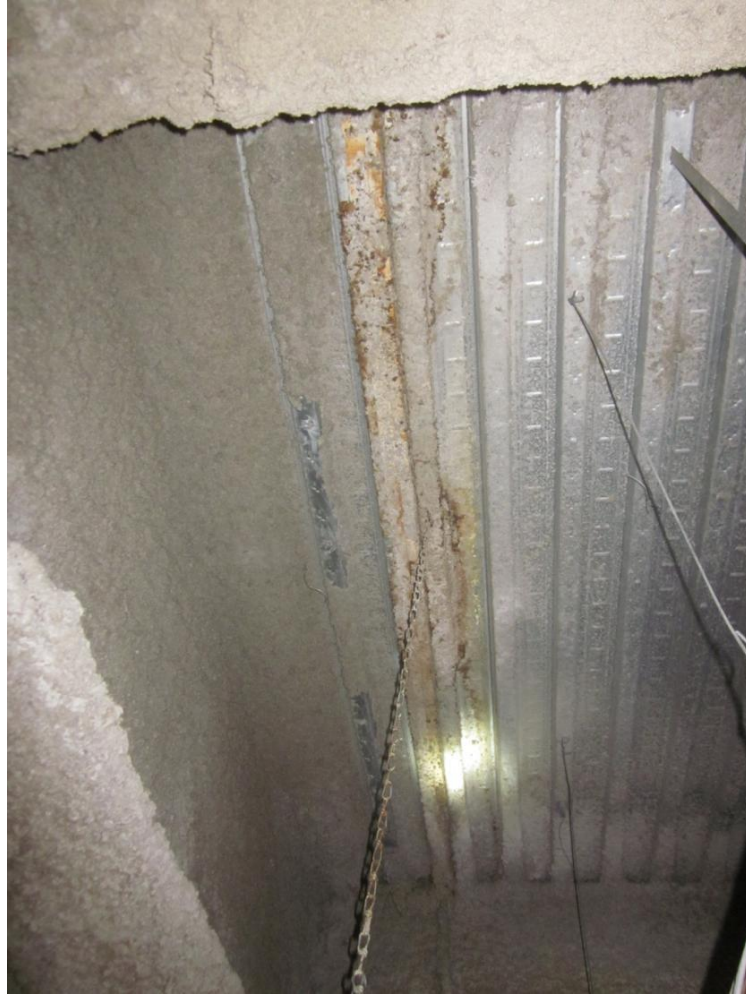
**Photo #3**

*This photo shows the corrosion of the composite metal roof decking along one of the expansion joints in the roof of the school building.*

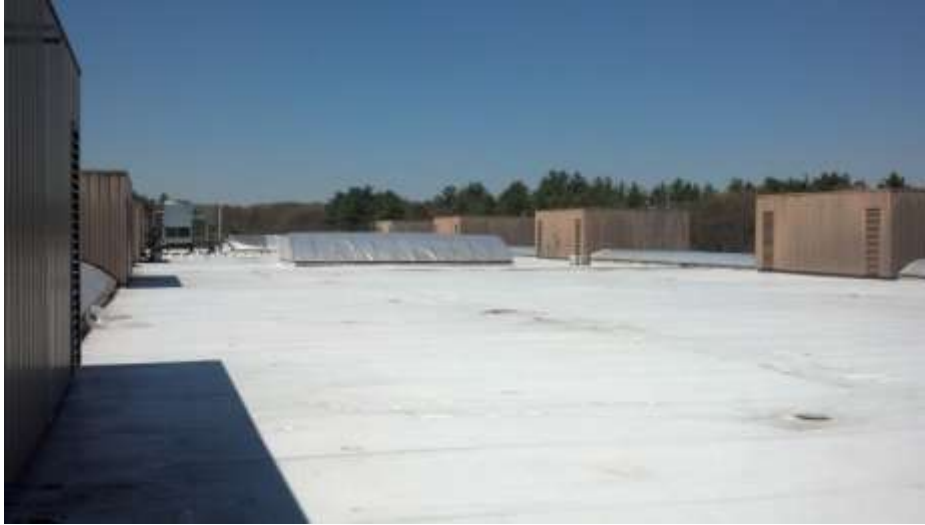
The louvers appear to have been modified in the field and were not supported adequately allowing the louver blades to be unsupported vertically at each side of the door. The fresh air intake and the relief air connections to the louvers did not meet adequate design standards allowing the effective free area of the louvers to be minimized due to the very short connection of sheet metal. The outside air intake ductwork was insulated with rigid fiberglass insulation, much of which has surface damage. The supply air and return air ductwork is not insulated. The air-handling units are in poor condition and generally have reached their maximum serviceable life.

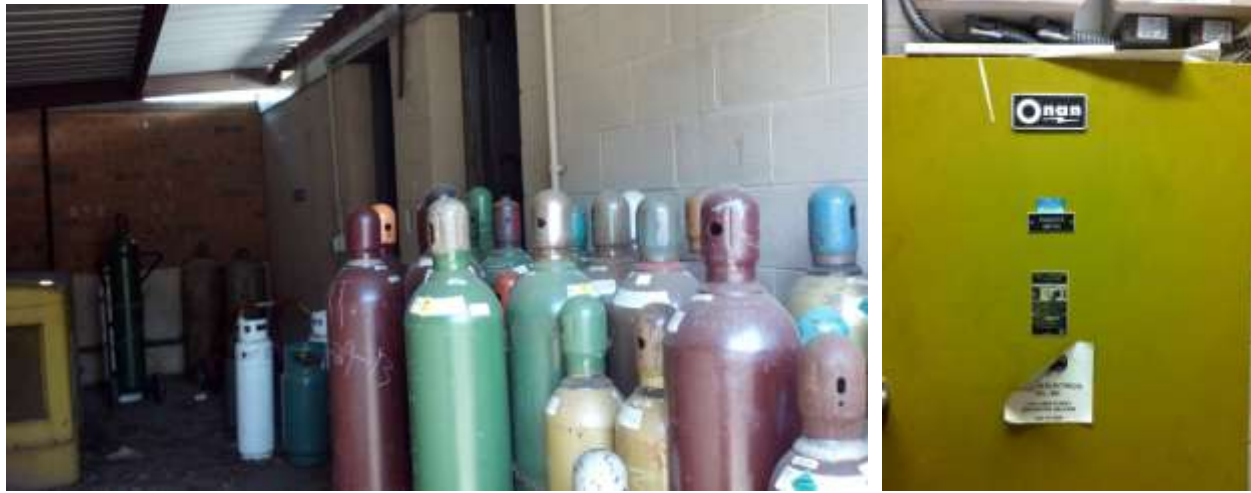
The emergency system is in violation of current codes as it does not maintain separation of emergency and standby loads. The equipment including the automatic transfer switch and panelboards are not housed within dedicated spaces with properly rated assemblies.
