To: Mr. Kevin Mahoney	Date: August 11, 2014	Gale Job No. 828170 P03
Minuteman Regional High School 758 Marret Road Lexington, MA 02421	Re: Boiler Roof Replacement and Skylight Repairs Minuteman Regional Vocational Technical High School Lexington, MA	
<b>RE: Stair Materials</b>

Minuteman Roof Replacement Site Visit 8/11/2014

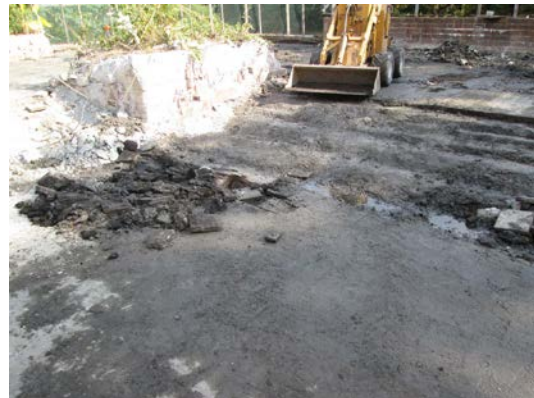
Photo B

1. At the request of Capeway, Gale travel to the site to observe the stair demolition work. Of specific concern was the stairway components that were located around the middle roof area.
2. Upon Gale’s arrival, Capeway’s demolition crew had removed that majority of the upper overburden components and had exposed the stairways that lead to the center portion of the roof; refer to photograph A.
3. Gale observed that the concrete material in this location appeared to be structural grade concrete that had been densely vibrated. Gale requested that Capeway’s demolition crew remove a section of the over burden at the lower limits of the stairway, which confirmed that the waterproofing system appears to extend under the stair system; refer to photograph B for location.

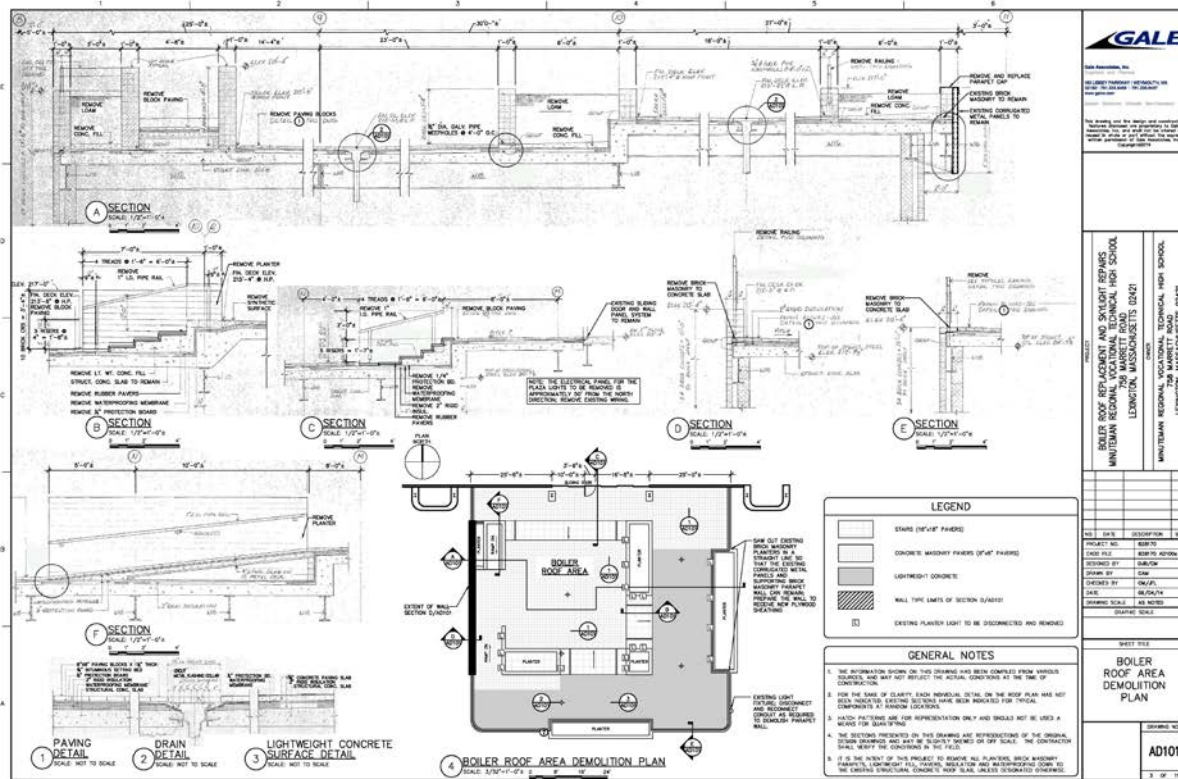
- All parties discussed the concrete material, and that the original detail drawings which were used as the basis of Gale's design indicated that the stair material was light weight concrete fill; refer to Image C which is Gale's Sheet AD101, which includes scans of the original design drawing presented as Image D.

Image C – Gale’s Design Drawing which incorporates excerpts of the original design drawings.

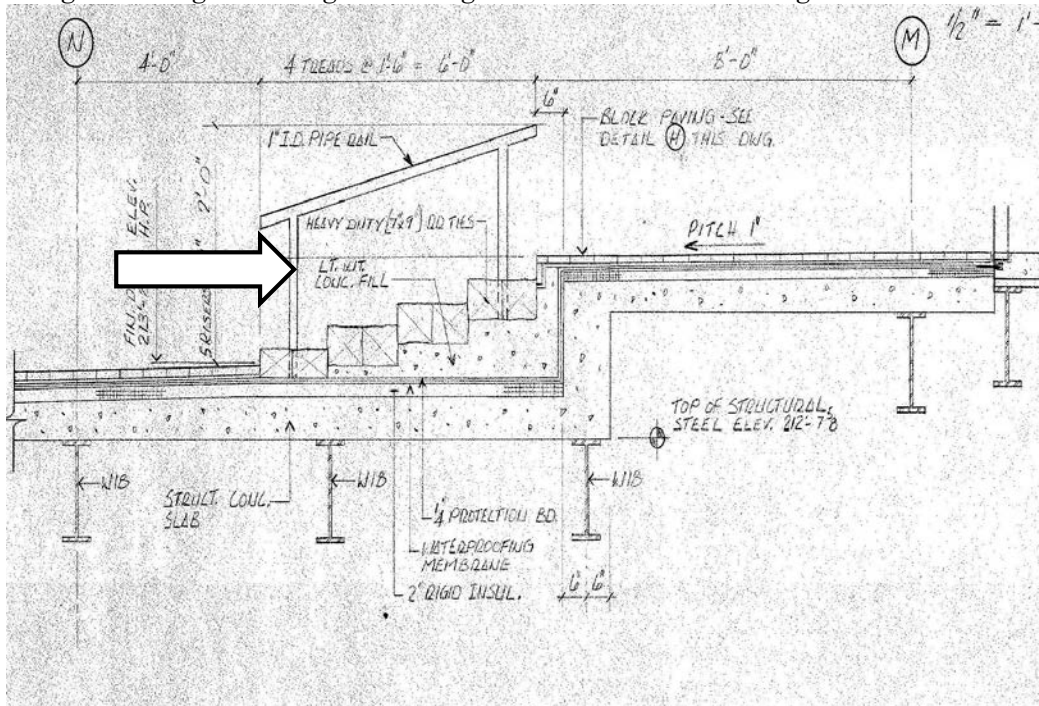
Image E – excerpt of the original building drawing, Section N, which references “Lt. Wt. Conc. Fill”.

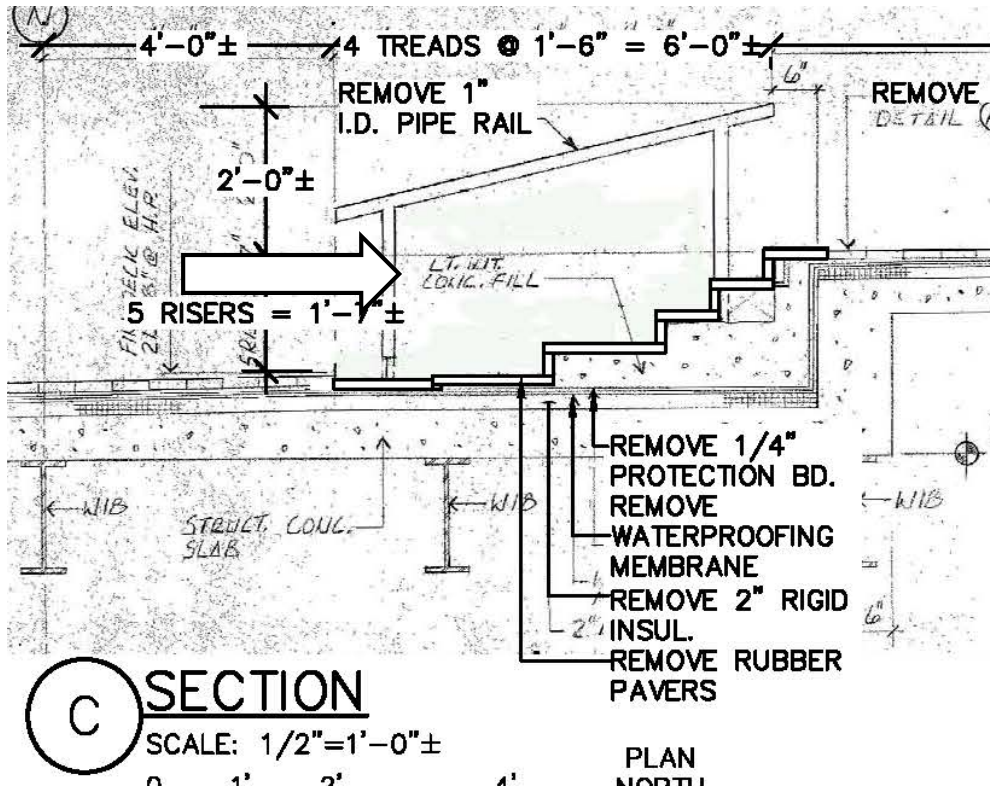
- Gale’s drawing was modified to include the original design details, but incorporated the overburden substrates that were found on the existing roof system; refer to Image F.
- As the existing waterproofing and insulation system extended below the structural concrete stair system, these stairs needed to be removed, or trapped moisture would be present within the new roof system, which would result in moisture drive/condensation which would affect the bonding adhesives used for the roof components.
- Gale discussed the conditions with Minuteman via telephone, and discussed that the structural concrete material needed to be removed to prevent potential future delamination of the roof system.

Image F – Gale’s Section C which reflects the original design drawings “Lt. Wt. Conc. Fill”

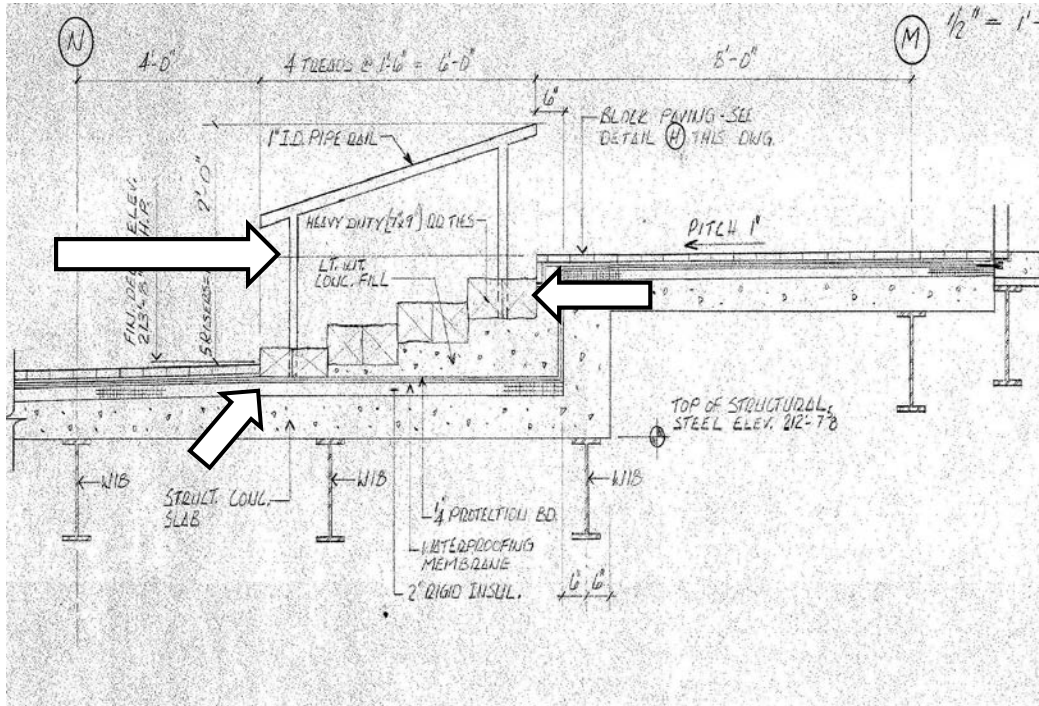
4. Capeway's demolition crew indicated that the hole was a result of the stairway railings extending down, through the waterproofing system, and being secured to the structural concrete slab. This detail is different from that which was shown on the original building drawings, which indicates that the railing was set in light weight concrete fill, above the waterproofing system; refer to Image C for an excerpt of the original building drawing which was used as a basis for the design.

Image C – excerpt of the original building design drawings which show the stair railings being set in “Lt. Wt. Conc. Fill”.

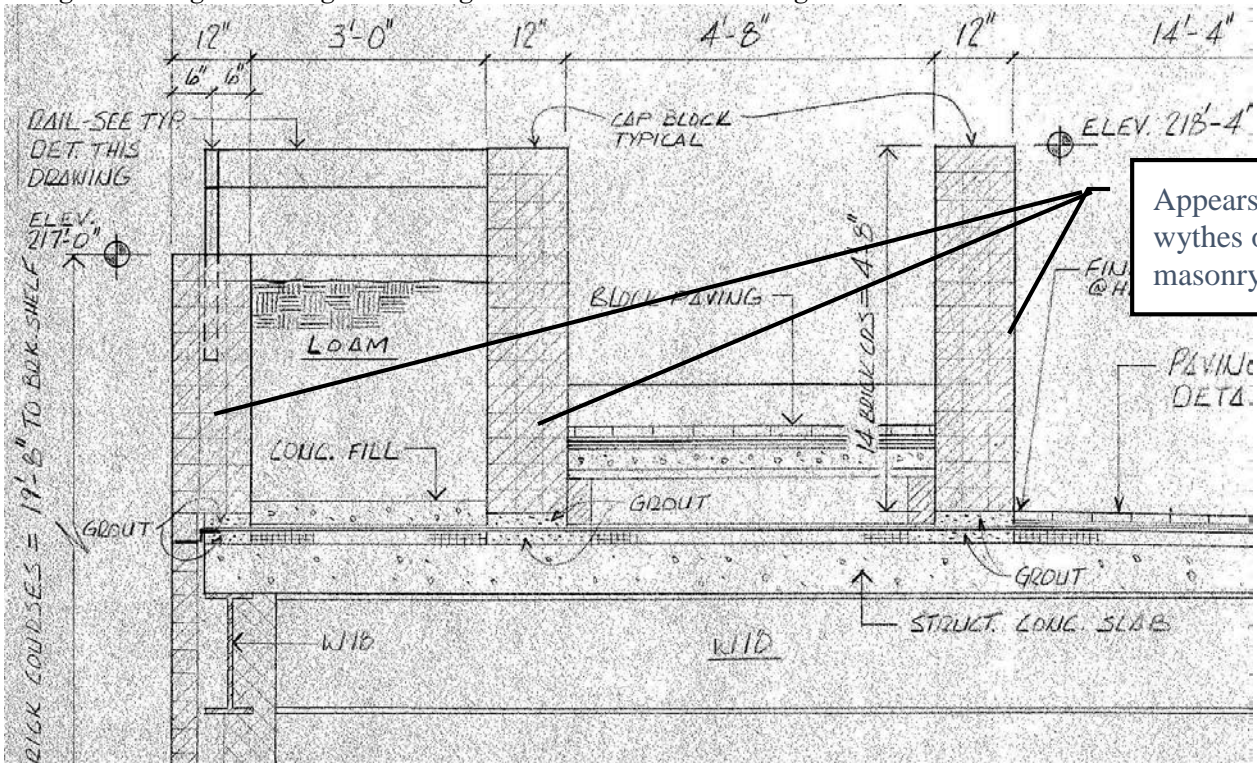
6. Both Images E and F represent close-ups of the original design sections presented in Image D. Each of the planter walls which extend up, above the plaza deck surface are depicted with the industry standard slanted hatch, which represents brick masonry units which are set atop a layer of grout on the structural concrete deck. The planter walls also represent that there are three wythes of masonry, which is consistent with the dimensions that were presented on the original design drawings, and were used as the basis for the design.

Image E – original design drawing with industry standard brick masonry unit hatching within the planter walls.

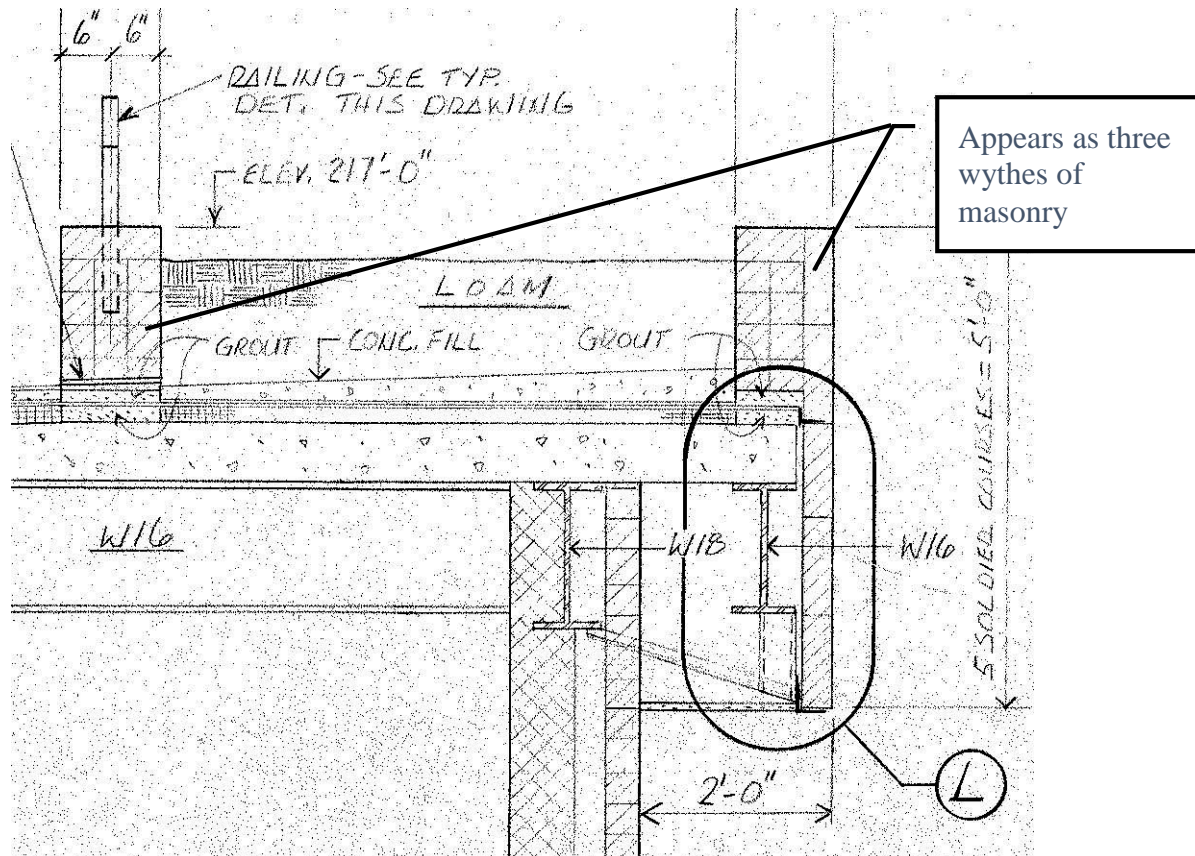
Image F – original design drawing with industry standard brick masonry unit hatching within the planter walls.

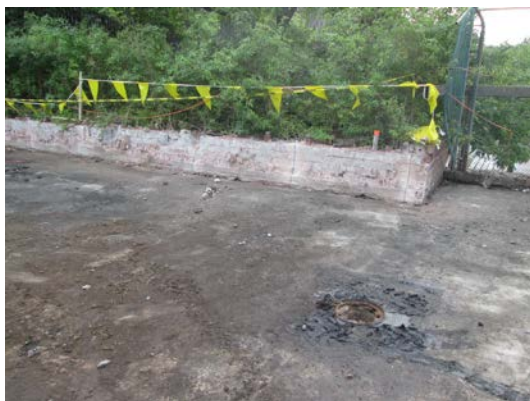
Photo G

- Capeway indicated that upon removal of the top horizontal course of brick masonry, and the exterior wythe which was exposed to the typical walking areas of the plaza deck, a structural concrete curb was in place at each of the planter locations. Refer to photographs G and H.

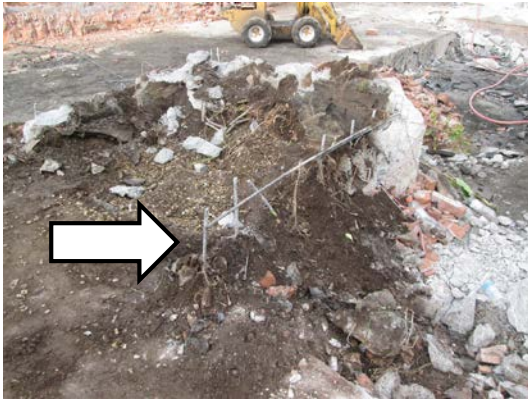
Photo I

9. Capeway's demolition crew used a 90 pound jack hammer on these walls, and found that a significant amount of structural reinforcement bars were placed within these concrete curbs; refer to photographs I and J.

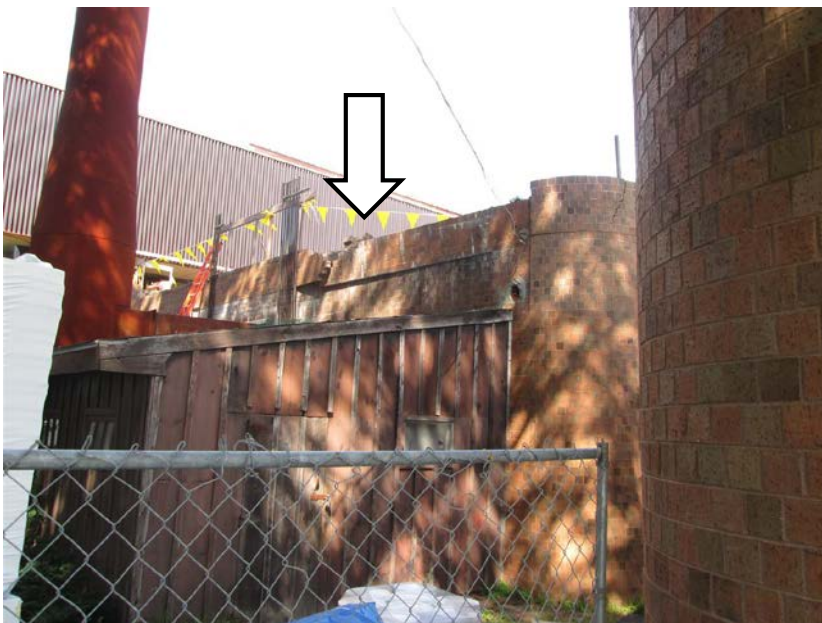
Photo A

1. Gale received a phone call from Capeway which indicated that the existing brick masonry wall around the perimeter of the roof system had become displaced in sections, and did not appear to be laterally supported to the backup wall. This condition was uncovered as the existing steel perimeter rails were being removed. Photograph A shows the initial wall that was the original area of concern.

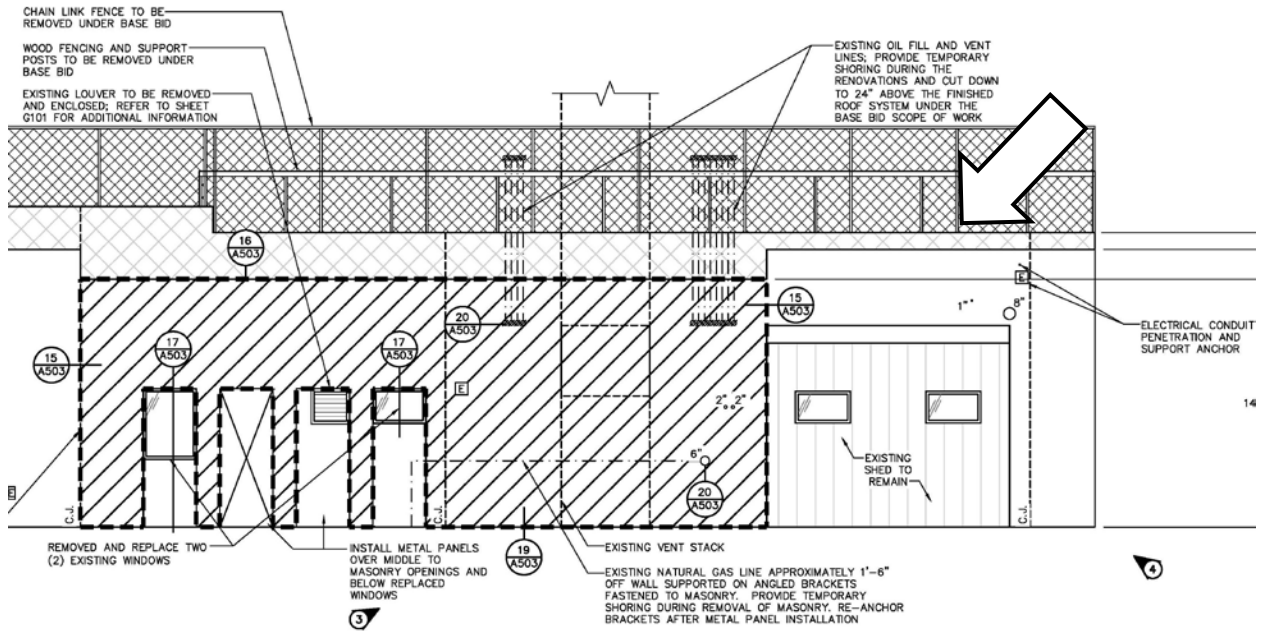
2. A portion of the brick masonry in this location is originally scheduled to be removed as part of the scope of work, and shown in Image B, which is an excerpt of Gale's original design drawing, Sheet A201. The masonry was to be taken down to just below the existing concrete roof deck, as to allow the new roof system to be installed, and the mortar below the removed areas were to be repointed to stabilize the wall.

Image B – West elevation. The net hatch references the area to be demolished to complete the roof replacement project; the arrow represents the initial area of concern.

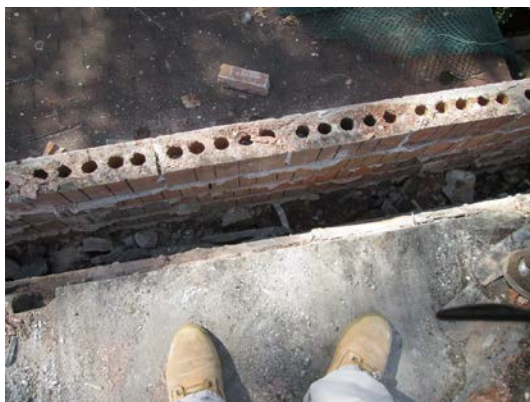
Photo C

3. Capeway's demolition crew removed the upper limits of the brick masonry down to the designated elevation and found that the majority of the masonry wall in this section was displaced by approximately three inches; photograph C. One section of wall had extended beyond the face of the masonry which had already become displaced; photograph D.

4. This displacement reportedly occurred as a result of the perimeter rail removal. As can be seen in photograph C, there are some corrugated metal ties which were originally attached to the backup wall, but they are not consistently spaced at 16" on center. The units which were observed in this location had either disengaged from the brick or the backup wall, or were rusted. Please note that corrugated ties are only recommended for interior construction.

5. As portions of this area were designated to be removed as part of the project, and the demolition work which was being performed adjacent to this area was vibrating the masonry wall, Gale directed Capeway's demolition crew to remove these components prior to their departure, as they were a potential fall hazard onto the structure and gas conduit lines below this area.

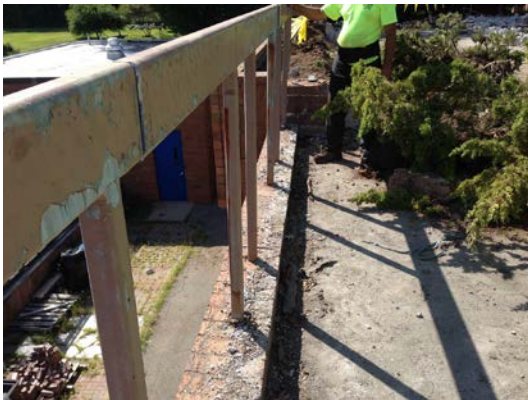
Photo E

6. While on site, Capeway's demolition crew indicated that similar conditions were encountered on the plan south and east walls, which were not designated to be demolished. Capeway's demolition crew had field cut the top rails of the units in an attempt to make the units more manageable for the removal operations. They indicated that once the units were cut, the rail could be pulled laterally by approximately 1-1/2" in both directions relative to the plane of the wall; refer to photograph E, which shows the rail in the background in plane with the adjacent rail, and photograph F, which shows the movement.

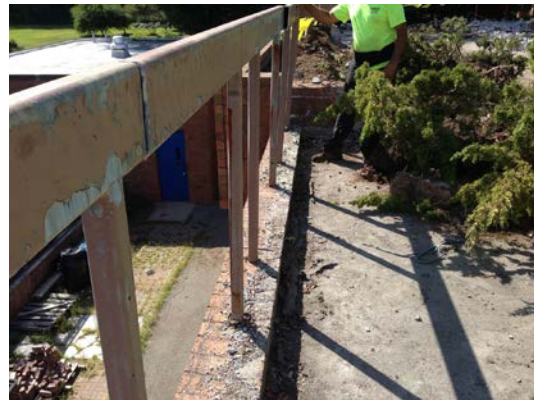
Photo F

7. This movement was reportedly a result of the concrete roof deck slab being cast around the railing on three sides, and either a lack of fastening, or fasteners that had been rusted out. Photograph G shows an area where the concrete roof deck has a notch where the railing had been placed.
8. Capeway's demolition crew indicated that the brick masonry roof edge/parapet cap was easily removed from the top of the wall, as there was no evidence of fasteners into the concrete deck to secure the masonry from lateral movement.
9. Capeway's demolition crew stated that a fabric coated copper flashing was placed intermittently between the concrete deck, and the brick masonry grout layer, which allowed the masonry to be removed easily in these locations; photograph H shows a section of flashing that had been partially removed from the wall.

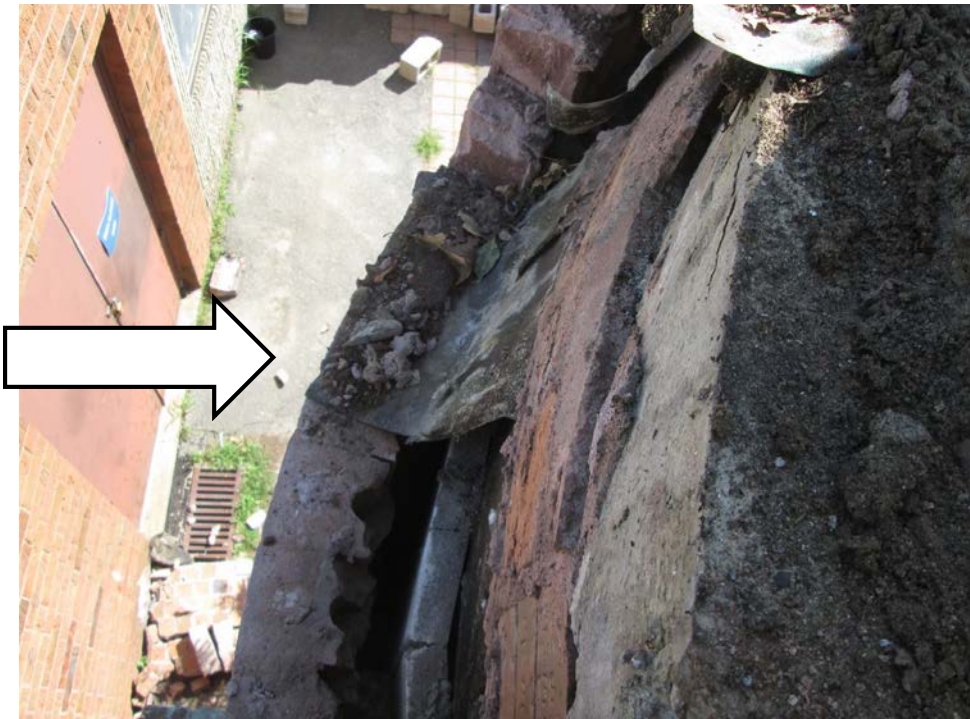
10. Gale noted that a fabric coated copper flashing was terminated within the masonry wall at approximately six (6) courses down from the roof deck slab location, and was buried within the brick masonry wall. However, this flashing did not extend out through the face of the masonry. Refer to photograph I. Capeway's demolition crew indicated that the flashing was not consistent or sealed, and there were some holes in the product.

Photo I – fabric coated copper throughwall flashing found approximately six courses below the concrete roof deck elevation.

11. Gale reminded Capeway's demolition crew that as the masonry was pulling away from the wall, that they would be required to provide temporary protection of the throughwall penetrations (conduit, vents, electrical lines, etc.) until a decision was made as to the remainder of the masonry around the perimeter of the building.

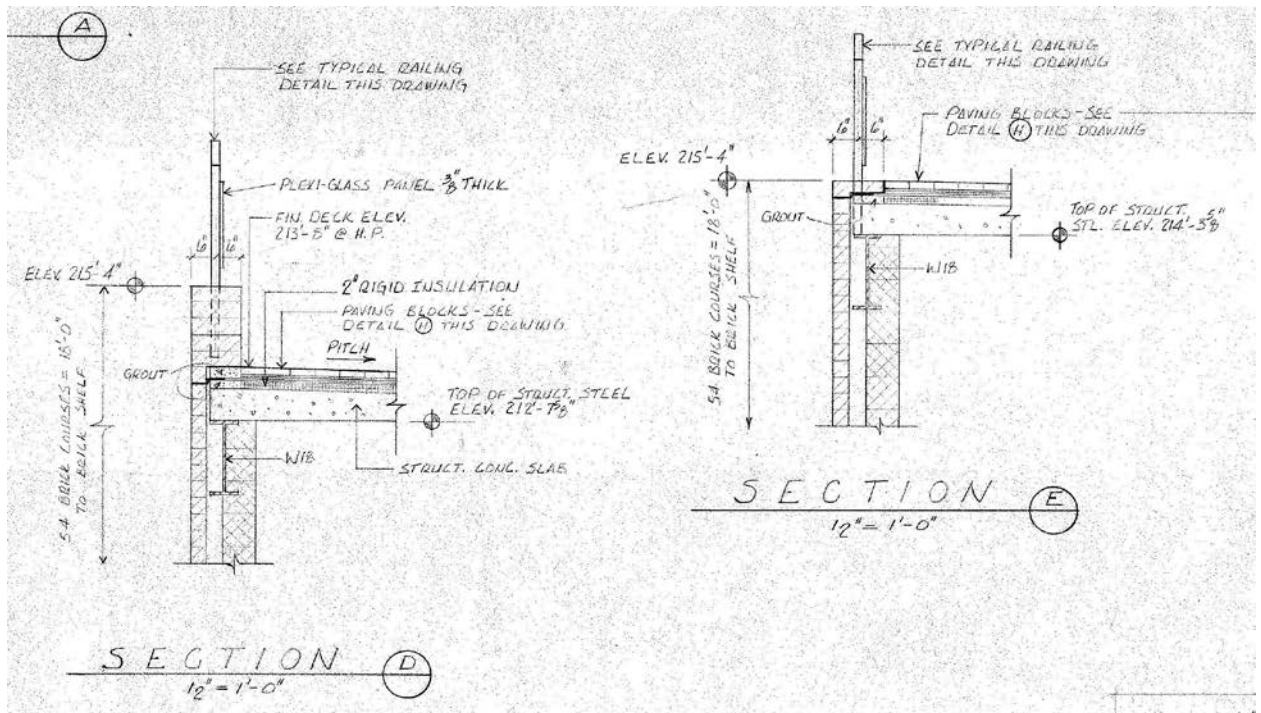
12. Gale reviewed the original building drawings, an excerpt is shown in Image J related to the perimeter walls. The exterior wall does show a “darker” line, which could be considered a throughwall flashing just above the roof deck location and under the brick masonry cap units, however, it is not called out or referenced in this, or other drawings provided to Gale for review. Note however, that a darker line from the backup wall, to the exterior masonry wythes had not been shown at the approximate sixth course down, presenting no indication that a throughwall flashing had been present. Please note that the masonry above this dark line was scheduled to be removed as part of this project to allow for the new roof details to be installed.

Image J – excerpts of the building’s original design drawings; a throughwall flashing within the wall system was not evident.

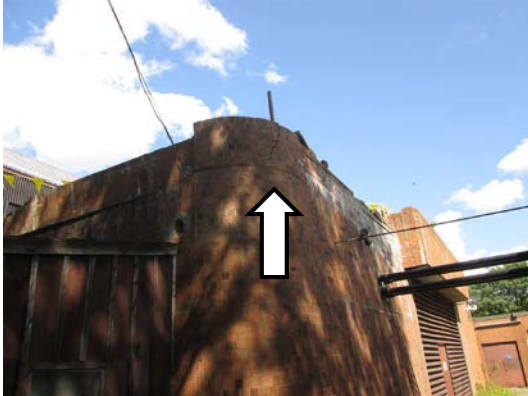
Photo K

13. As indicated in photograph K, the throughwall flashing that was encountered within the wall system cannot be visibly seen from the exterior.
14. Capeway had a delivery of roof membrane and insulation delivered to the site, which is currently being stored within their fenced in area; photograph L.
15. Gale discussed the conditions with Minuteman, and forwarded an electronic mail briefly outlining the findings at the site.

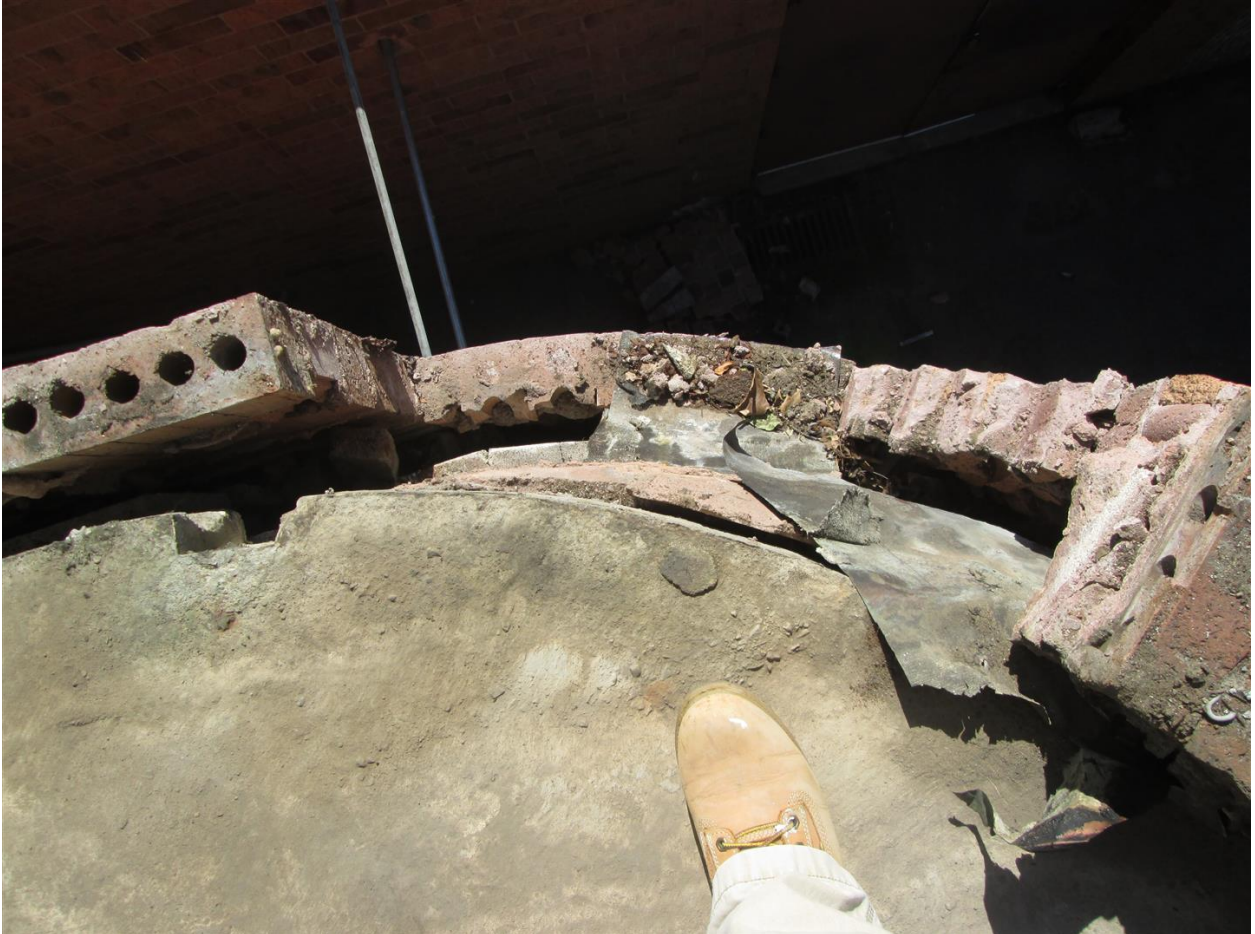
3. Gale discussed the throughwall flashing which was encountered at the roof deck level, as well as within the masonry wall approximately six courses below the edge; photograph C.

Photo C – throughwall flashings found at the plan south east corner of the building.

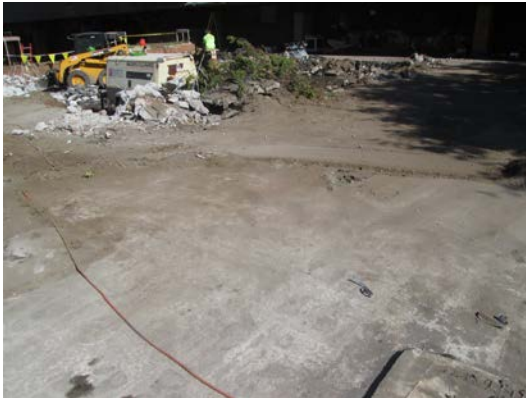
Photo D

4. The structural concrete curbs which were found in the planter were discussed; the removal operations were on going at the time of the visit as indicated in photographs D and E.
5. The lateral masonry anchor conditions that had been observed to date were discussed, and the potential concerns for the wall systems below.
6. Minuteman/Superintendent directed Capeway to have the brick masonry around the perimeter of the roof system removed down to the existing throughwall flashing which had been buried in the wall.
7. Minuteman requested that Capeway have four test cuts performed in the lower level brick masonry wall sections to confirm the spacing of the lateral anchor ties. As the anchors should have been spaced at 16” on center both horizontally and vertically to meet the building code installation requirements at the time of construction, Gale

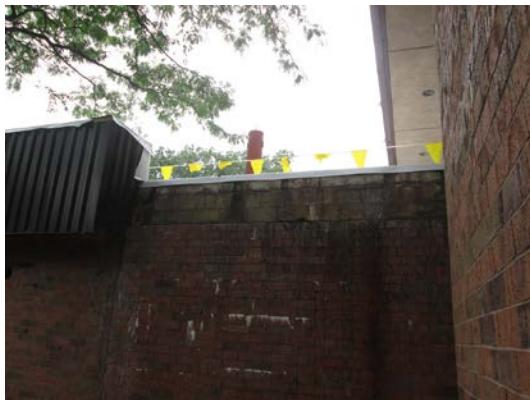
Photo A

1. As directed by Minuteman, Capeway had removed the upper limits of brick masonry around the perimeter of the roof edge, down to the existing throughwall flashing that had been encountered, on the plan east and south elevations (photographs A and B respectfully).

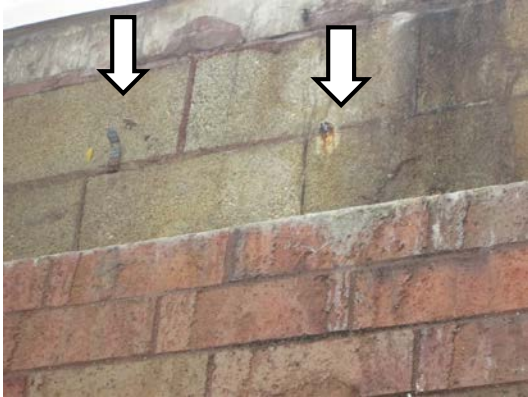
3. The corrugated ties were reportedly rusted where they met the concrete masonry unit backup wall. The adjustable ties were reportedly rusted, or the pintles not in place at several locations; refer to photographs E and F.

Photo E – corrugated ties in place with rust near the limits of the concrete masonry unit wall

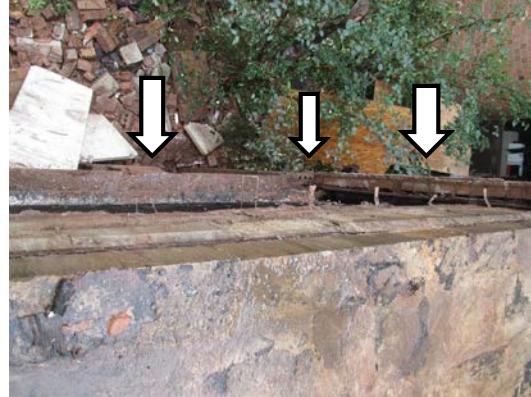
Photo F – corrugated tie at the upper limits, and adjustable ties at the lower limits.

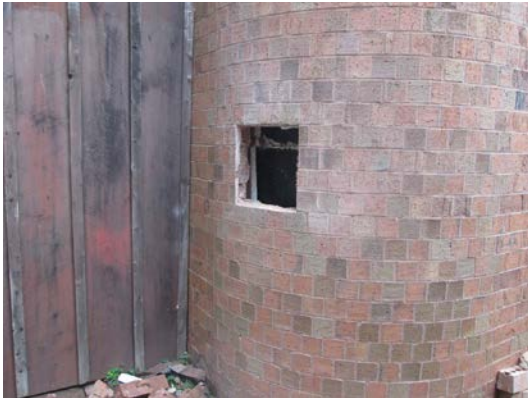
Photo G

4. Gale reviewed the four test cut locations, two of which are shown in photographs G (west elevation wall) and H (south elevation wall).
5. It appears that the lower elevation walls are constructed differently from the upper elevations, in that the concrete masonry unit backup wall has been coated with an asphaltic dampproofing, a layer of 1-1/2" expanded polystyrene insulation, an air cavity, and then the brick masonry veneer.
6. An electrical conduit was noted within the cavity wall directly behind the south wall test cut, as can be seen in photograph H.

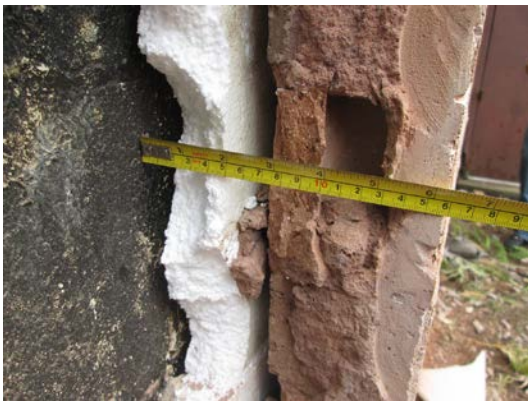
Photo I

7. The plane of the brick masonry varies with respect to the backup wall, and ranges from approximately 6-1/2" to 8-1/2"; refer to photographs I and J.

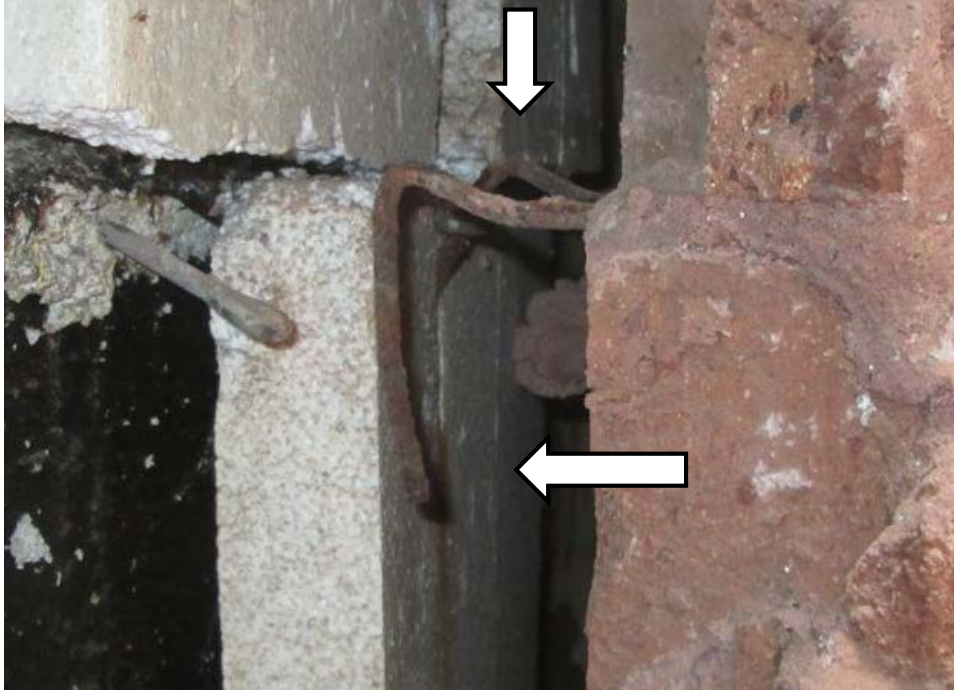
8. The test cuts revealed multiple different conditions related to the adjustable ties, which ranged from partially engaged pintles, missing pintles, and rusted eyehooks. Refer to photographs J, K, L, M and N.

Photo J – West elevation; Note that the pintle in the foreground is not engaged in the eyehook, and that the pintle in the back ground is engaged, but both the eyehook and pintle are bent which can allow horizontal movement.

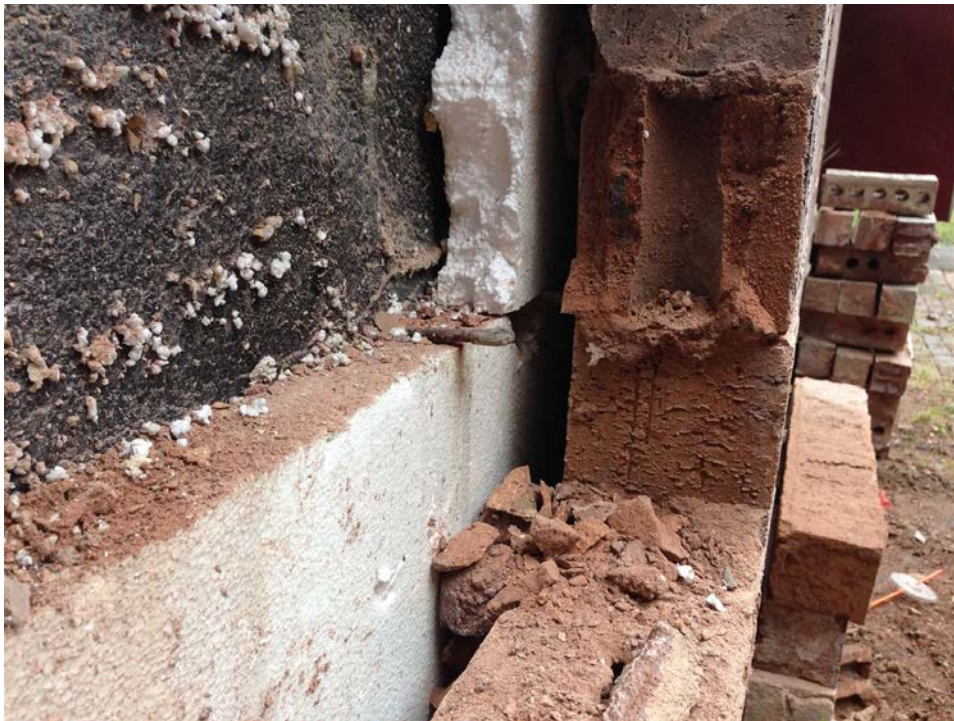
Photo K – South elevation; location one – east side of test cut; the eyehooks of the adjustable ties were in place in the backup wall, but the pintle was not installed. Note that the mortar joint is continuous in this location, and not disturbed, indicating that the wall anchor was not in place.

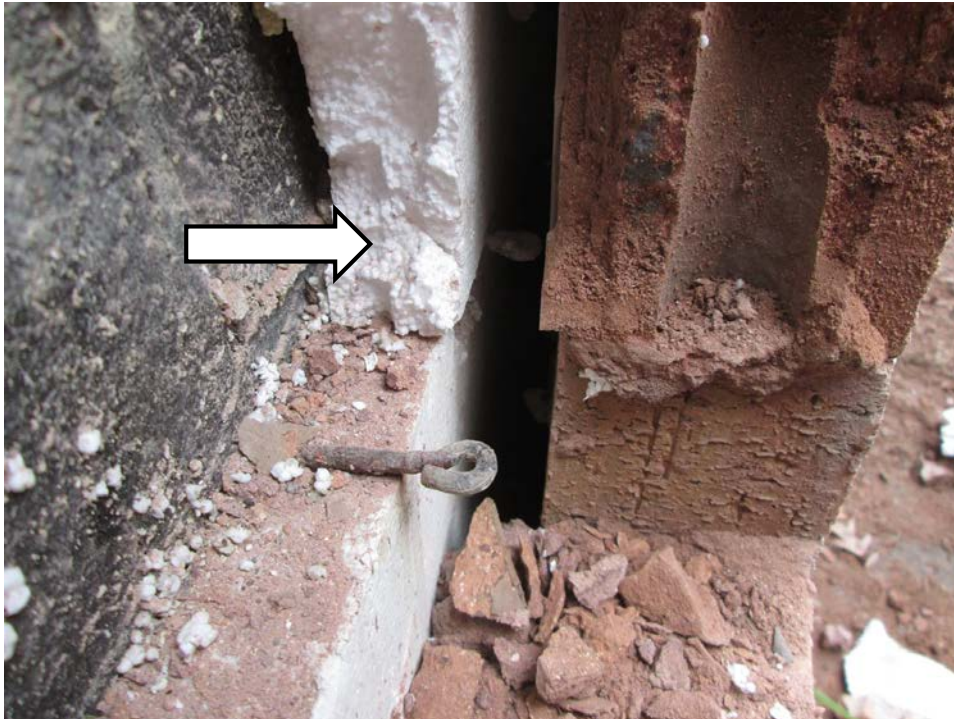
Photo L – South elevation; location one – east side of test cut; view showing the eyehook beyond without the pintle.

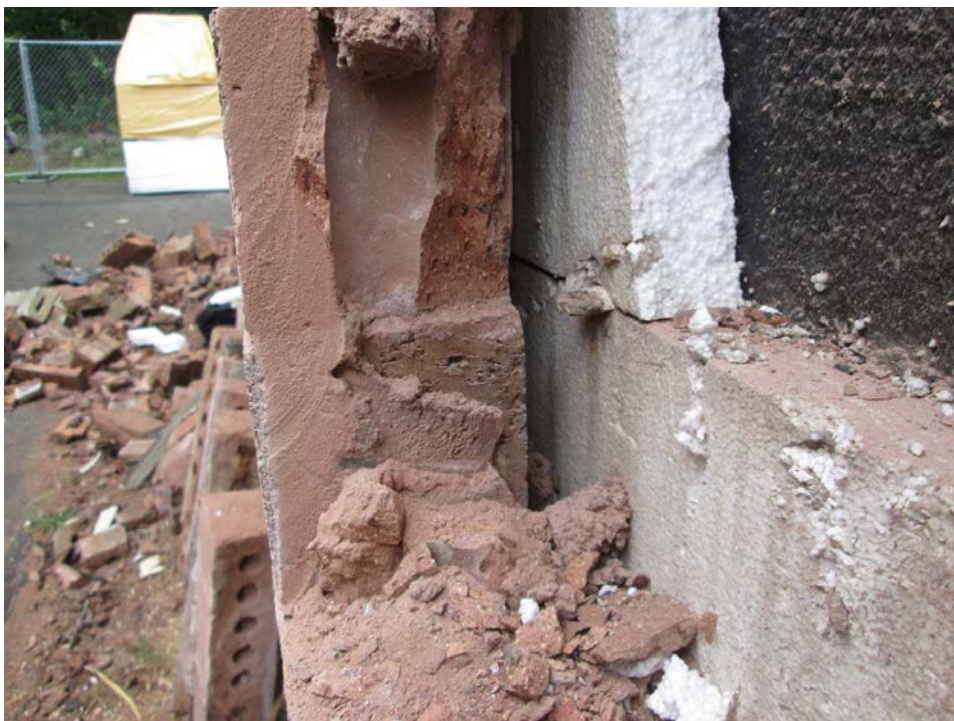
Photo M – South elevation; location one – west side of test cut; the eyehooks of the adjustable ties were in place in the backup wall, but the pintle was not installed. Note that the mortar joint is continuous in this location, and not disturbed, indicating that the wall anchor was not in place.

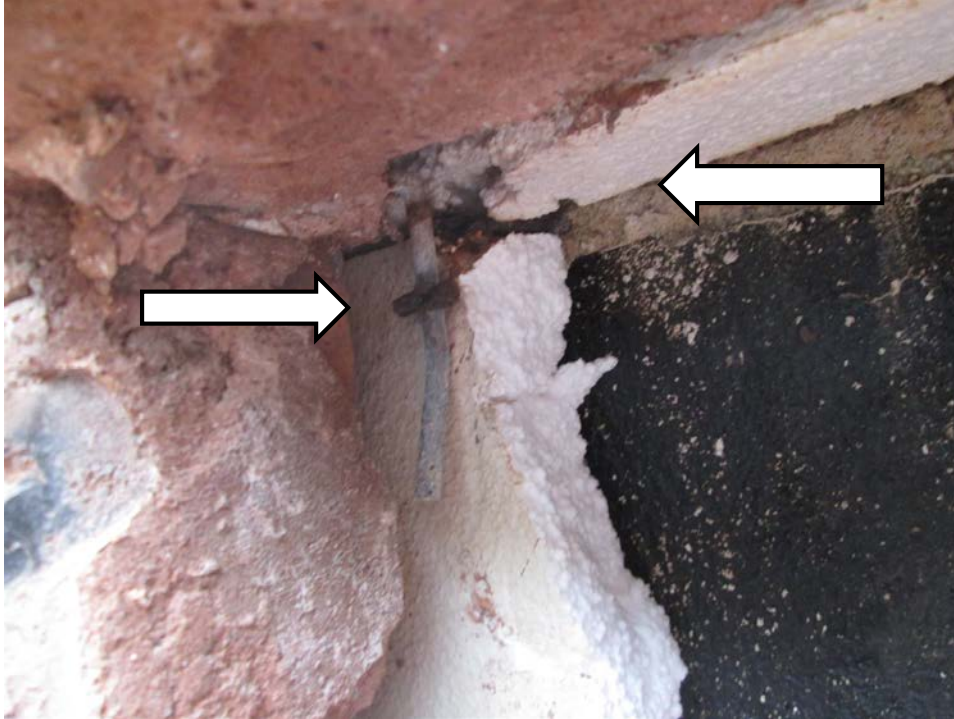
Photo N – South elevation; location two; the pintle extended into the eyehook, but the eyehook was rusted, and no longer engaged to the backup wall. The arrow on the right indicates the location where the shank of the eyehook is, versus the arrow on the left, which is where the “eye” is.

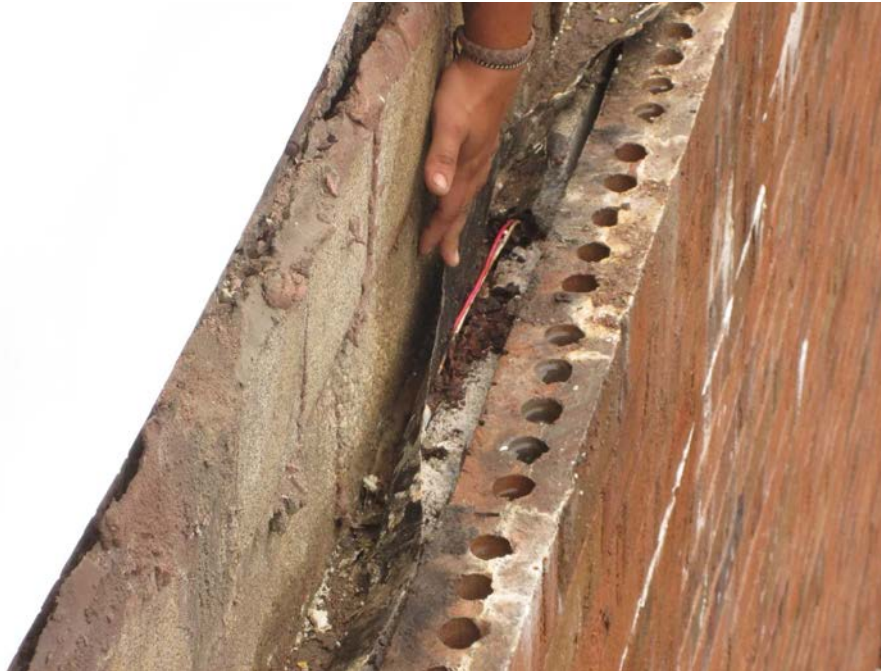
Photo Q – rusted conduit exposing the electrical wires within the cavity wall.

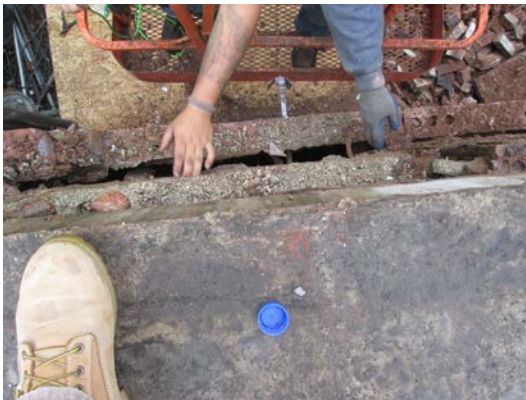
Photo R

11. Capeway’s demolition crew was in the process of removing the designated brick masonry components from the west elevation wall as part of the contract work, and noted that the concrete masonry units at the upper elevations were severely deteriorated due to repeat water infiltration into the structure; photographs R and S.

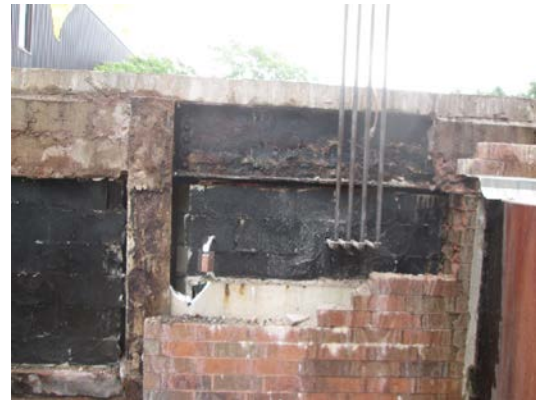
Photo S – area where CMU was removed

12. The area where the concrete masonry units were removed (shown in photograph S), exposed the structural steel beam used to support the concrete slab. Rust and exfoliation was observed in this location, likely a result of the repeat water infiltration which had been experienced over the years. It is anticipated that the exfoliation will be scraped and coated with a zinc rich primer prior to the installation of the new wall system.
13. It was noticed that the penetrations through the masonry walls had not been sealed to prevent air/moisture movement through the wall system; refer to photograph T.
14. Capeway is in the process of installing the roof system on the upper roof area, and will continue with the installation in the days that follow; refer to photograph U.

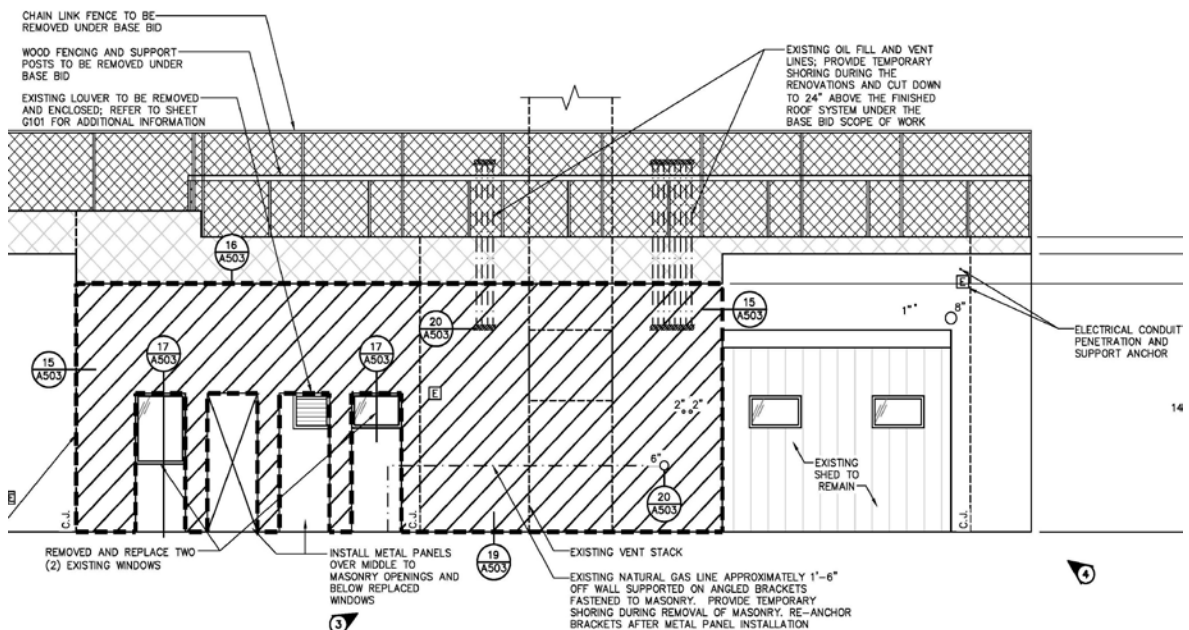
Image A

1. Earlier in the week, the Capeway demolition crew started the removal of the existing exterior wall as designated on the contract drawings; refer to image A for the approximate location. The intent of the removal operations was a result of the severe damage to the exterior brick masonry units, which appeared to be caused by water infiltration around the perimeter of the roof system above; refer to photographs B and C for a file photograph of the wall system prior to the removal operations.

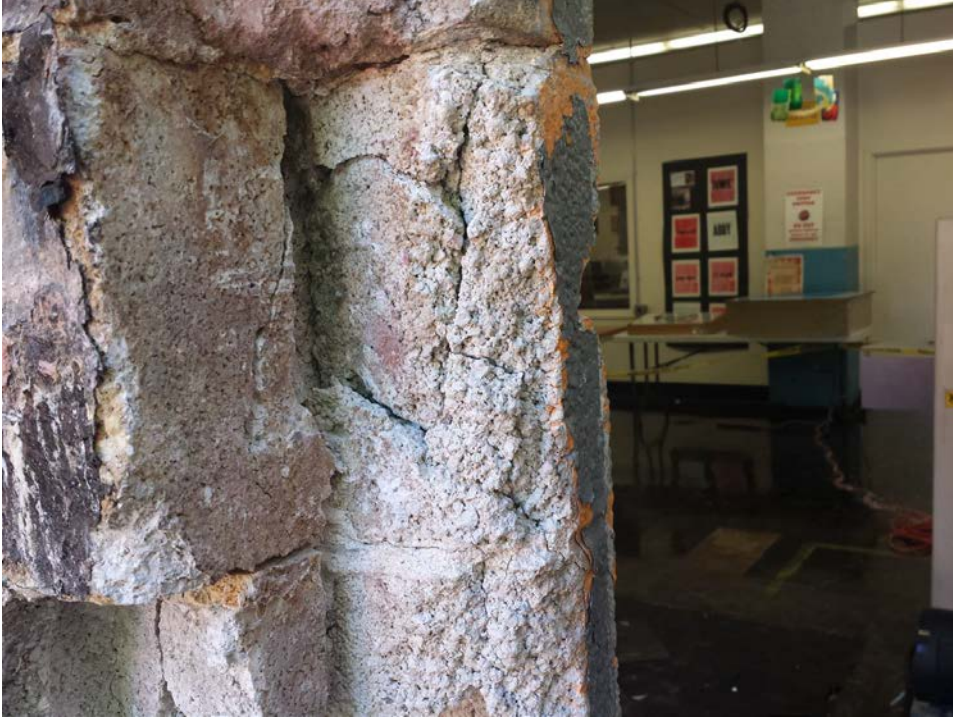
3. The inner and exterior CMU wythes were found to be in distress, with cracks and deterioration noted; refer to photograph C, which was an image taken by Capeway.

Photo C – deteriorated CMU

7. As the entire wall would be opened when the existing CMU columns were removed, it was determined that the installation of replacement CMU block would provide a solid substrate for the new wall cladding system, as well as maintain the appearance of the existing interior CMU wall. Capeway's masons are proceeding with the CMU installation, providing reinforcement bars at approximately four feet on center, to support the wall; refer to photographs F and G.
