To: Mr. Kevin Mahoney	Date: August 11, 2014	Gale Job No. 828170 P03
Minuteman Regional High School 758 Marret Road Lexington, MA 02421	Re: Boiler Roof Replacement and Skylight Repairs Minuteman Regional Vocational Technical High School Lexington, MA	
<b>RE: Stair Materials</b>

Minuteman Roof Replacement Site Visit 8/11/2014

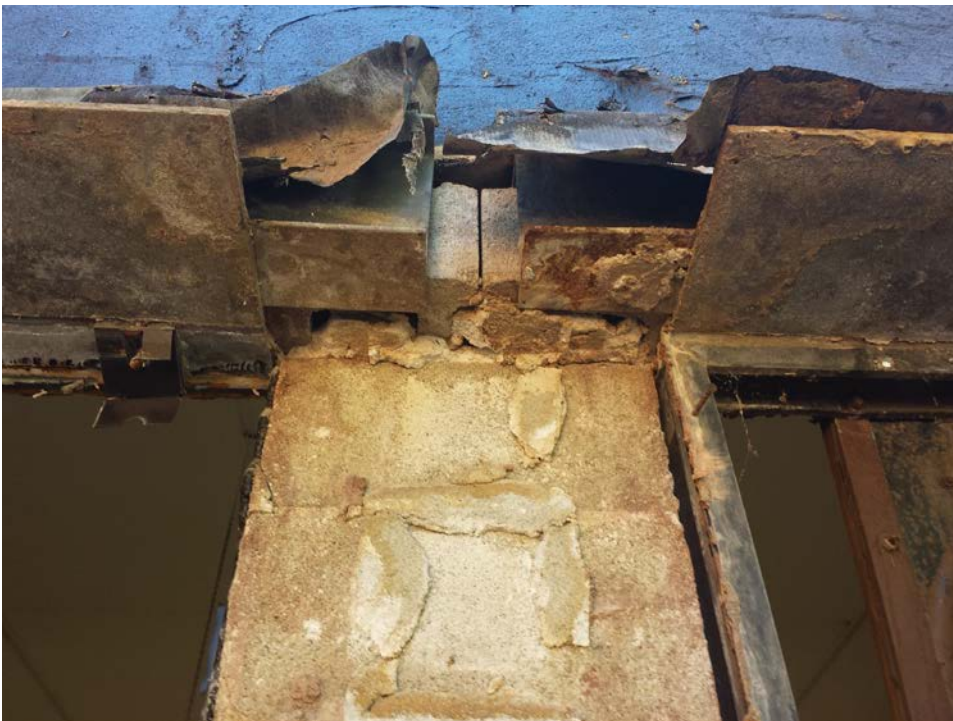
4. The existing steel lintels which supported the window and louver frame openings are set on these columns, are not continuous, and could not be easily supported if the individual CMU were to be removed and replaced; refer to photograph D, which was an image taken by Capeway.

Photo D – lintels are not continuous, and rest on the CMU

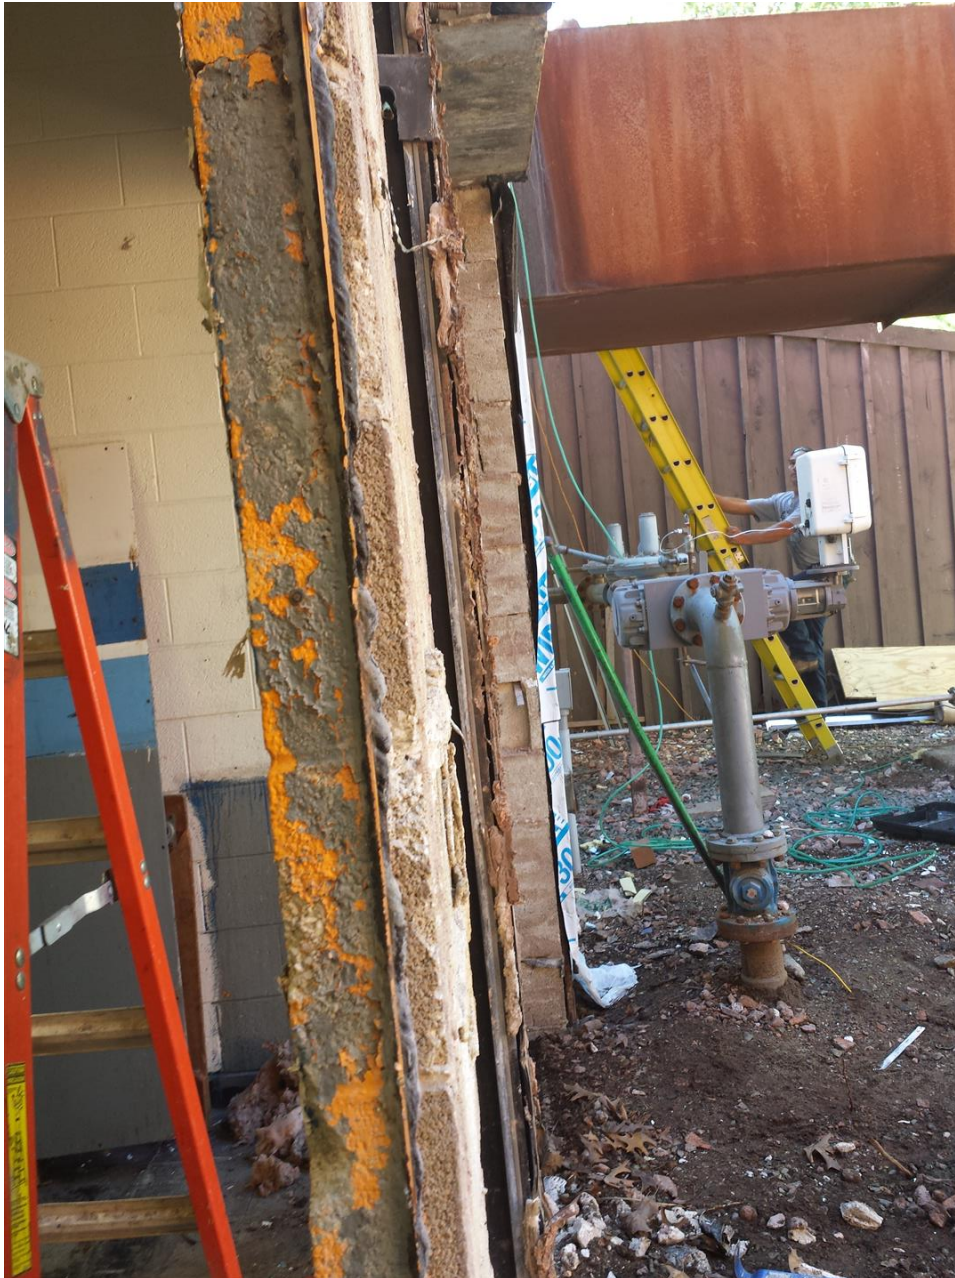
5. Based on information provided by Capeway, Capeway's demolition crew, and observed by Minuteman, it appeared that the concrete columns could be pushed approximately one (1) inch, indicating that it was not properly secured, or set in friction against the structural beam above. Photograph E was taken by Capeway and presents the slight lean into the building's interior.

Photo E – existing column leans inward, towards the building.

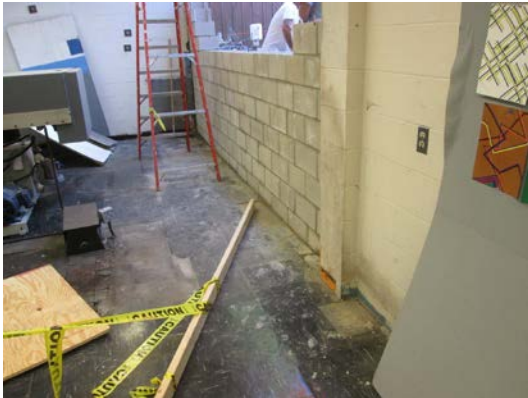
Photo F – wall being rebuilt.

7. As the entire wall would be opened when the existing CMU columns were removed, it was determined that the installation of replacement CMU block would provide a solid substrate for the new wall cladding system, as well as maintain the appearance of the existing interior CMU wall. Capeway's masons are proceeding with the CMU installation, providing reinforcement bars at approximately four feet on center, to support the wall; refer to photographs F and G.

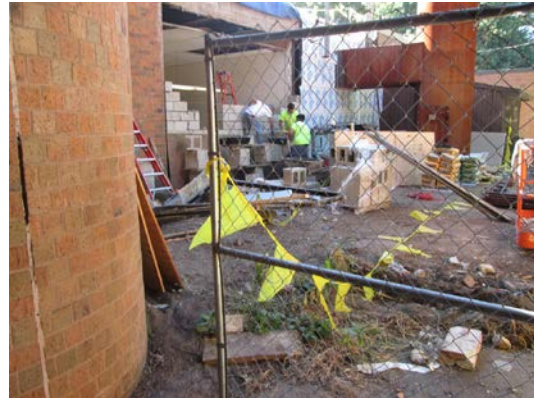
Photo G – wall being rebuilt.
