To: Mr. Kevin Mahoney	Date: August 11, 2014	Gale Job No. 828170 P03
Minuteman Regional High School 758 Marret Road Lexington, MA 02421	Re: Boiler Roof Replacement and Skylight Repairs Minuteman Regional Vocational Technical High School Lexington, MA	
RE: Stair Materials

Minuteman Roof Replacement Site Visit 8/11/2014

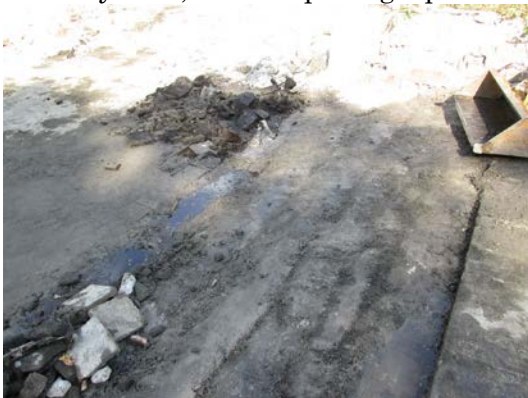
Photo A

1. At the request of Capeway, Gale travel to the site to observe the stair demolition work. Of specific concern was the stairway components that were located around the middle roof area.
2. Upon Gale’s arrival, Capeway’s demolition crew had removed that majority of the upper overburden components and had exposed the stairways that lead to the center portion of the roof; refer to photograph A.
3. Gale observed that the concrete material in this location appeared to be structural grade concrete that had been densely vibrated. Gale requested that Capeway’s demolition crew remove a section of the over burden at the lower limits of the stairway, which confirmed that the waterproofing system appears to extend under the stair system; refer to photograph B for location.

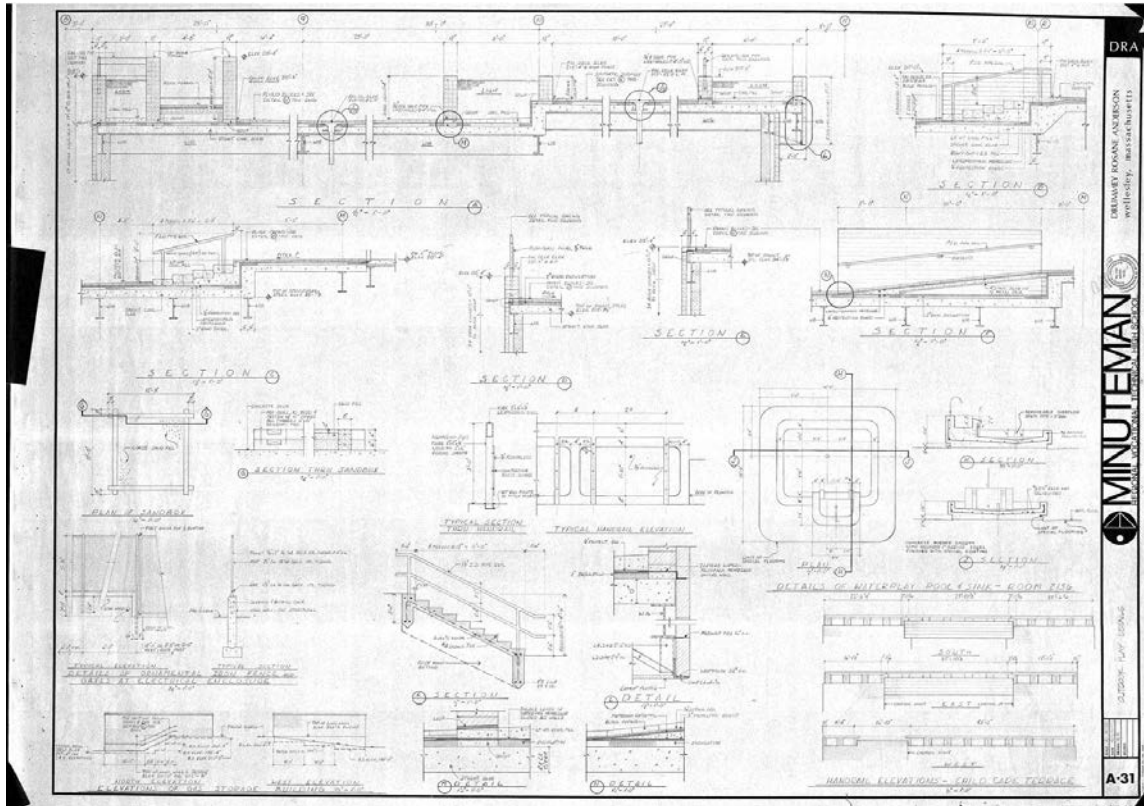
Image D – original design drawing used as a basis for design.

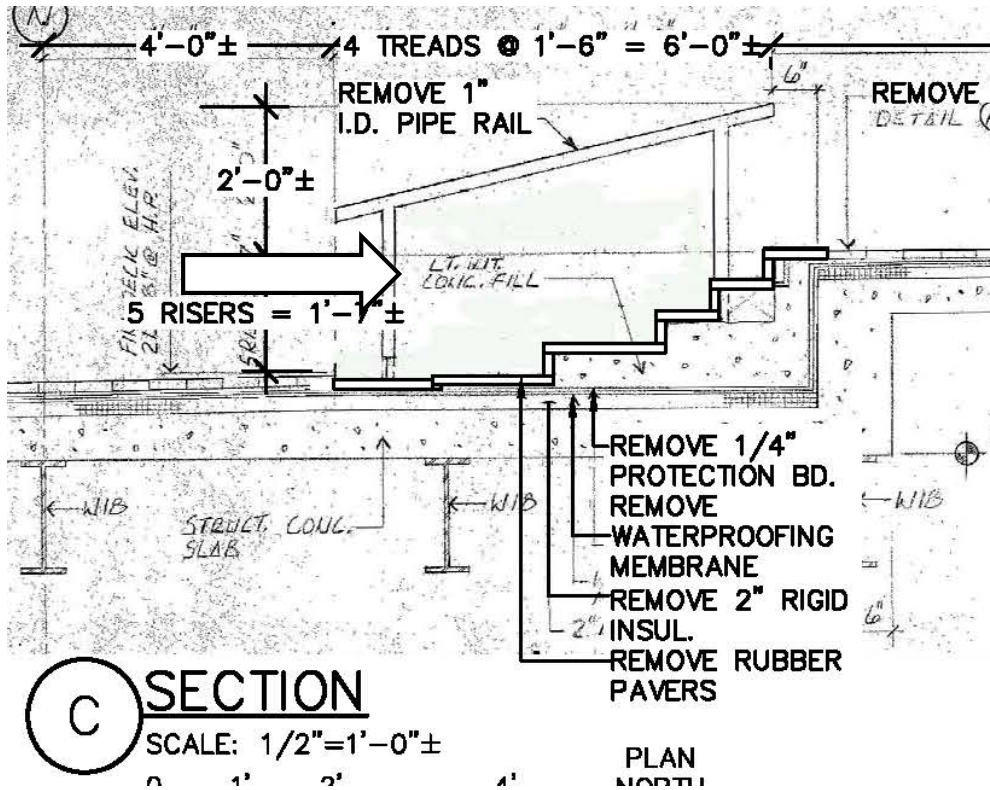
- Gale’s drawing was modified to include the original design details, but incorporated the overburden substrates that were found on the existing roof system; refer to Image F.
- As the existing waterproofing and insulation system extended below the structural concrete stair system, these stairs needed to be removed, or trapped moisture would be present within the new roof system, which would result in moisture drive/condensation which would affect the bonding adhesives used for the roof components.
- Gale discussed the conditions with Minuteman via telephone, and discussed that the structural concrete material needed to be removed to prevent potential future delamination of the roof system.

Image F – Gale’s Section C which reflects the original design drawings “Lt. Wt. Conc. Fill”
