Raleigh Hills K-5 School

Facility Condition Assessment Summary

Assessment Date: 6/4/19

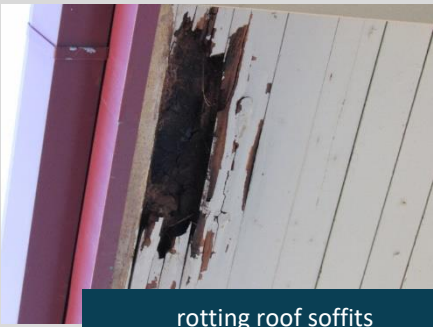
- Roof is in very poor condition, significant moss growth, soft spots, metal is warped, and soffits have rot and damage in many areas due to leaks.

rotting roof soffits

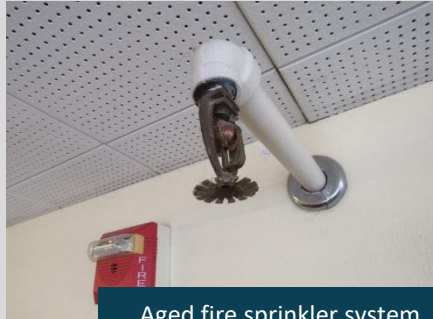
- Fire sprinkler system components are obsolete and only provides partial coverage.
- No surveillance present

Aged fire sprinkler system

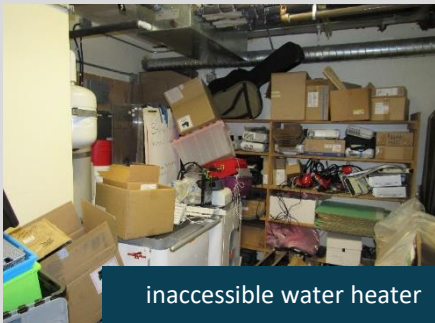
- Water heaters are at or exceed expected useful life and water heater located in LL18 is inaccessible due to clutter in the closet. Closet should be cleared of storage items, so a code required clearance is available for the water heater (notified maintenance).

inaccessible water heater

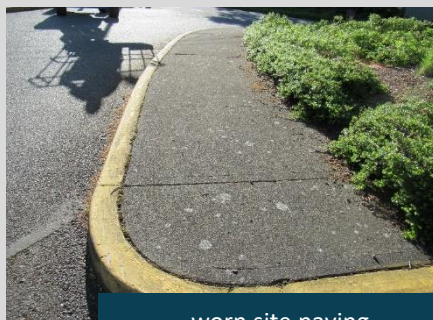
- Parking lot is alligating

worn site paving
