# Beaverton High School

## Facility Condition Assessment Summary

**School:** Beaverton High School  
**Age:** 1915/1938  
**Size (SF):** 264,016  
**Area:** 26.23 acres  
**Assessment Date:** 6/19/19  
**Student Population:** 1,469

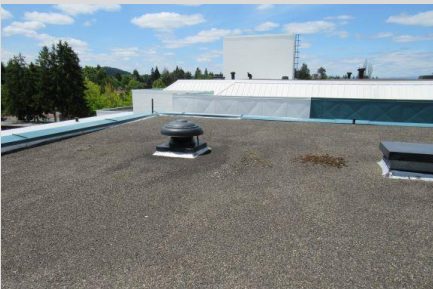
moss build up and drainage issues

- Moss build-up, exposed seams, and partially clogged drains on rooftop  
Recommend moss removal, seal, and drain cleaning

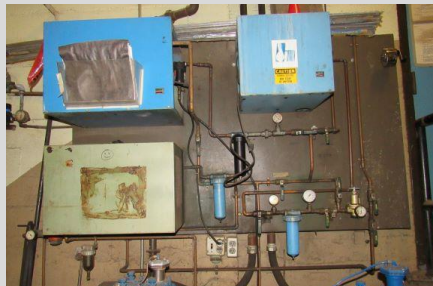
pneumatic controls

- Restrooms reported to be ventilated poorly; recommend study to determine adequate additional exhaust
- Exhaust fans for locker rooms do not operate
- West side of the building's control system is pneumatic and obsolete
- Science rooms should be considered for increased ventilation
- Recommend additional ventilation for Annex Building due to change in space use
- Boilers have maintenance issues with tripping breakers and chemical balance
- Building needs a complete rebalancing (Existing Building Commissioning) project

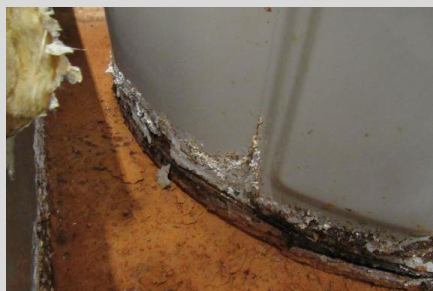
corroded water heater

- In cafeteria, water heaters have corrosion at the base and are leaking (notified maintenance already); causing damage to wallboard
- Mixing station for domestic hot water of the east side of campus is heavily corroded and leaking (district has been notified)

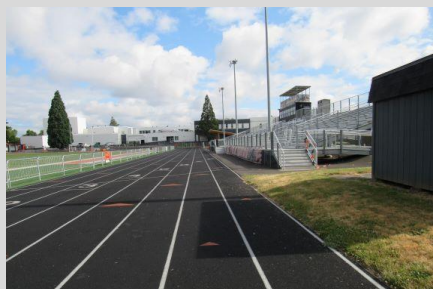
worn out track

- Synthetic track has many patches and rubber is showing a lot of deterioration
- Tennis court surface is warped, and fence needs repair
