FEASIBILITY STUDY

Carroll County Public Schools | May 15, 2019

East Middle School

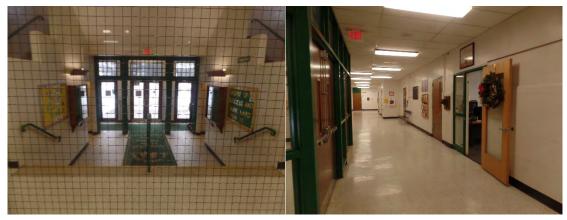
Main Entry Lobby

Entry to the building is on the West side via a lobby located a half story below the main level of the building. A secure vestibule is located here but with limited visibility from the administration office located a half story above this area. This makes it difficult for the administrative staff to supervise the main entry and for visitors to understand where to go upon entry to the building. There is no accessible route into the building from the main entrance. There is no elevator in the building.

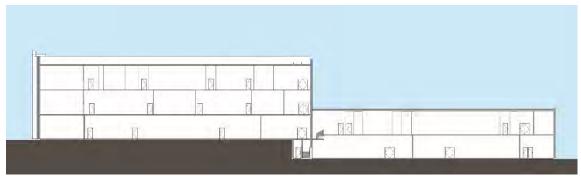
Building Section between 1936 Building on Left and 1950 2-story addition on right.

The building floor levels are not ADA accessible. Entry to the building is via a half-flight of stairs to get to the main level of the building. Access between floors is only possible via stairs – there is no elevator in the building. The levels of the 2-story addition do no align with the floors of the original building and require circulation via stairs in the corridors to access between levels. Also, the 'U' shaped configuration of the building makes circulation from the end of one wing to another cumbersome. Often students take a shortcut through the media center, however this causes disruption to media center instruction.

Note that levels do not align between section of the building.

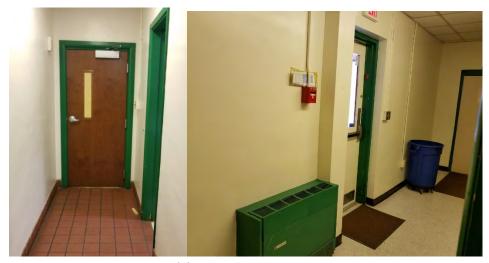
Receiving Area

Receiving: Receiving corridor is very tight and has a 3'-0" door. Deliveries must maneuver around several turns and doors before getting into the Kitchen proper. Recommend that a more direct passage to the kitchen is created and install a fly fan at the 42-inch wide receiving door.

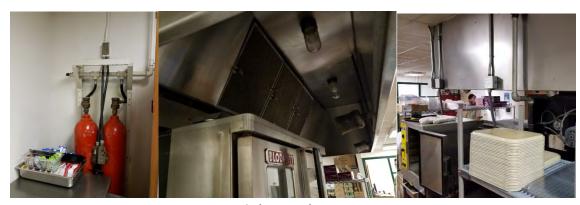
Kitchen Hood

Kitchen: Production space appears to be adequately sized. Area is poorly ventilated and extremely hot during warmer months, cold during winter months, adding to worker stress and fatigue. Additional cooking equipment is needed to properly prepare current menu items. The kitchen is dimly lit and promotes a depressing atmosphere. The kitchen lacks the necessary quantity of pass-thru heated or refrigerated cabinets to back-up the serving line. The exhaust hood has no dedicated make-up air and is outdated and must be replaced to comply with latest Mechanical Code. There is an insufficient quantity of hand washing sinks.

Exhaust Hood: Made of stainless steel with baffle- type filters. Insufficient light levels. No make-up air.
