# SCOPE STUDY

**Carroll County Career &  
Technology Center**

**Board of Education of Carroll County  
Westminster, MD**

**August 23, 2006**

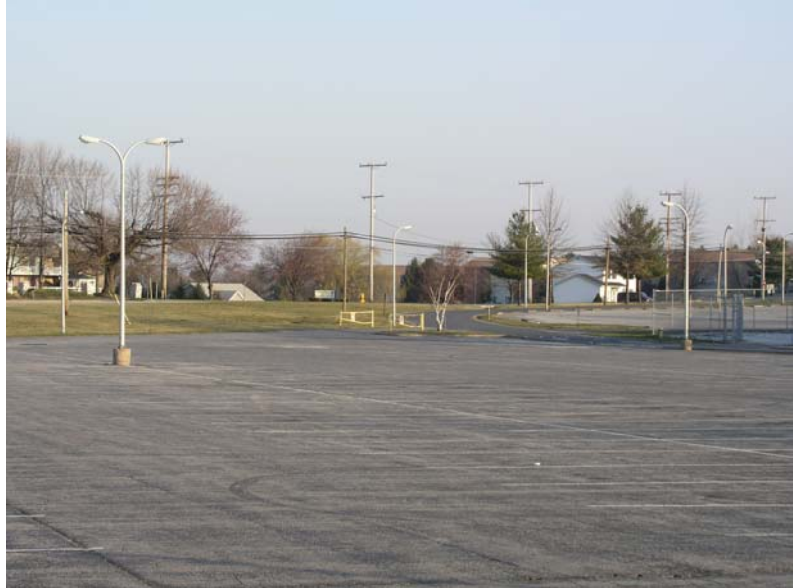
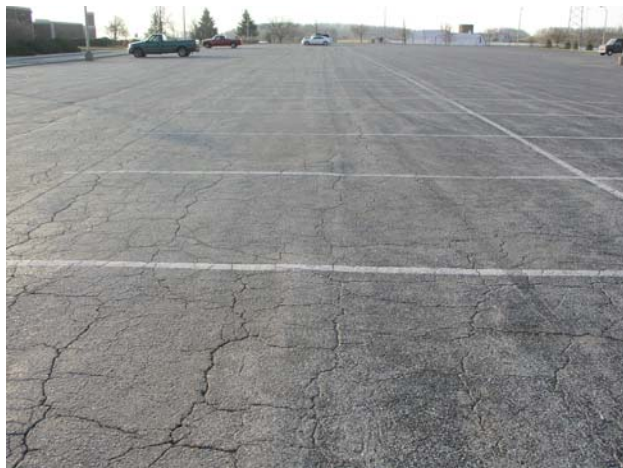
Generally, the existing parking lot is in need of serious repairs. The photo on the previous page shows how the wearing surface has completely dried and demonstrates the impacts of UV rays over the years. The visible cracking will require a major expenditure to bring the surface up to a usable condition. Obviously the surface course is in the worst condition; however it is not known if the subsequent courses reflect the same type and quantity of cracking.

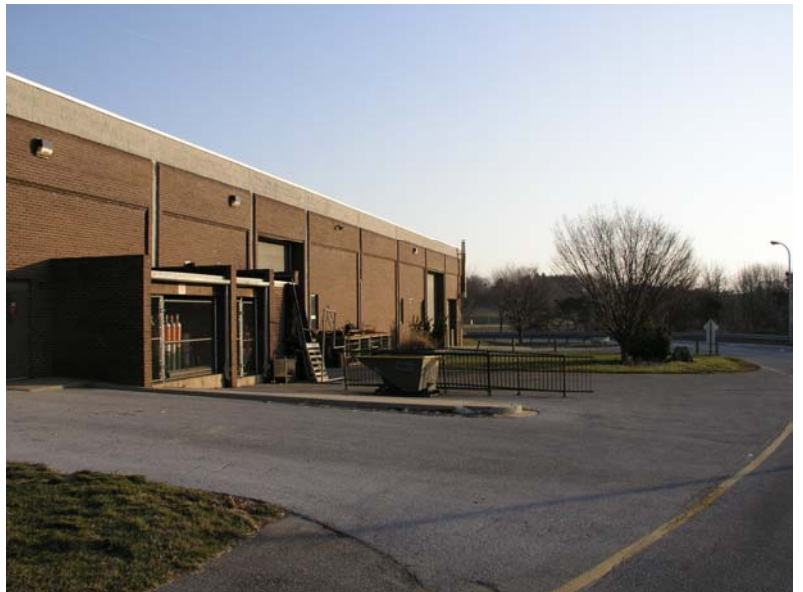
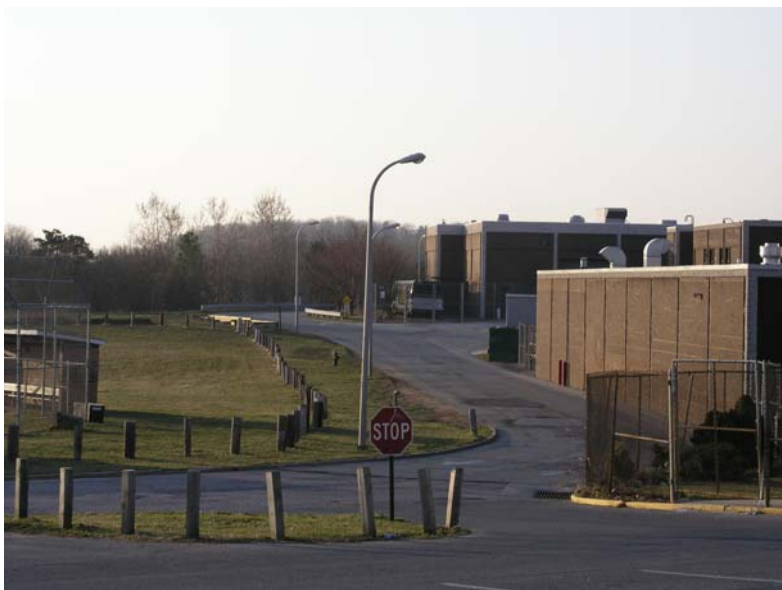
The terminus of the two way operation for the perimeter drive occurs at the parking lot adjacent to the greenhouses along the east side of the building. Once again, the perimeter drive contains multiple locations where services and building entries must occur as apparent in the photo to the left. Upon closer inspection, it appears

that the condition of the service drive is almost as bad as the parking lot in the front of the building.

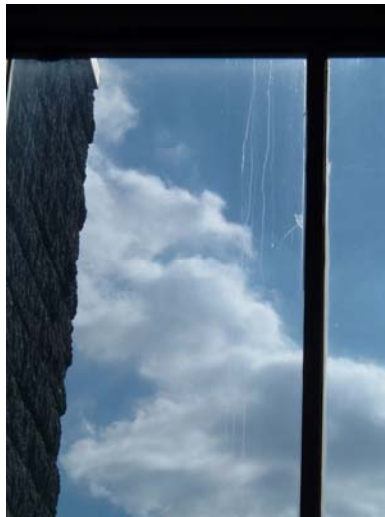
*Figure 1*

The building skin is comprised of brown brick masonry veneer and some striated concrete block veneer with concrete block back-up. The brick bond is a standard running bond. The autobody building contains the original brick veneer on the north, east, and west sides and was repointed during the renovation. The south side was covered with a new metal panel system to help mitigate leakage through the masonry. The windows on the 1970 section are aluminum with single pane glazing and are not thermally broken. Leaks at many of these windows have been noted by school maintenance personnel (see figure 1). The 1986 addition contains thermally broken aluminum windows with insulated glazing units. The window sills are sloped brick on both sections of the building.

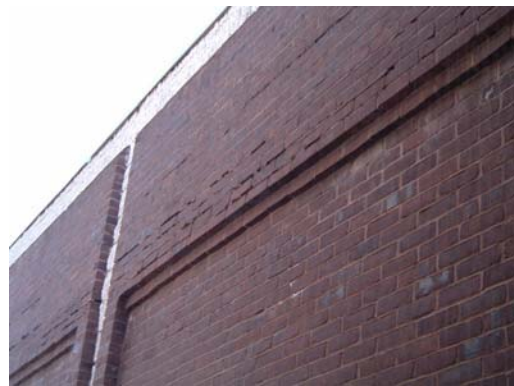
*Figure 2*

The mortar joints of the brick veneer appear to be in poor condition (see figure 2). Numerous leaks in the building have been occurring as a result of the failed mortar (see figures 3 & 4). This has caused damage inside the building. Select areas of mortar have been repointed at areas where leaks are active. Efflorescence is present in numerous locations, indicating heavy water penetration inside the masonry cavity. The entire building should be repointed or the brick veneer removed and replaced as part of a major renovation. The windows in the original building should be replaced with aluminum, thermally broken windows.

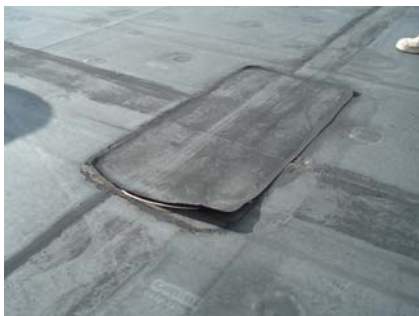
Figure 5

Evidence of ponding was observed throughout the entire roof area. The parapet flashings on the 1970 building are blistered in numerous areas (see figure 8). According to school maintenance personnel, the parapet flashings leak constantly. Some sections of the parapet flashing were replaced in 2005. Roof drains leaked previously but were all patched in recent years. The main roof areas have numerous fans, vents, flues, and other mechanical penetrations. Base flashings are peeling and in generally poor condition (see figures 5 and 6). Edge metal at the parapet walls is in good condition, however the joint sealant has failed in many locations and needs to be recaulked (see figure 7).

The entire roof system should be replaced in the next 1 to 3 years. All copings should be sealed as soon as possible. A second roof drainage system (overflow) will need to be incorporated. This can be via scuppers cut through the existing parapet wall or additional roof drains installed adjacent to the primary roof drains. A combination of both types may be required to meet the code requirements. All flashings at parapet walls and at all roof penetrations should be replaced as part of the total roof replacement program.

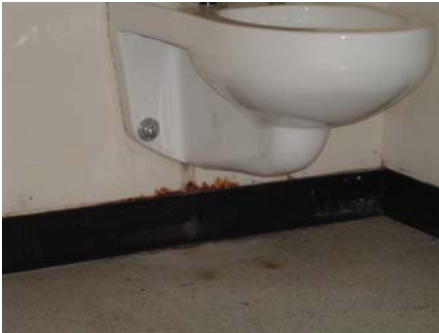
Figure 9

No toilet rooms meet current ADA requirements. Leaking of fixtures was noted and the quantity of fixtures does not meet current code requirements (see figure 9).

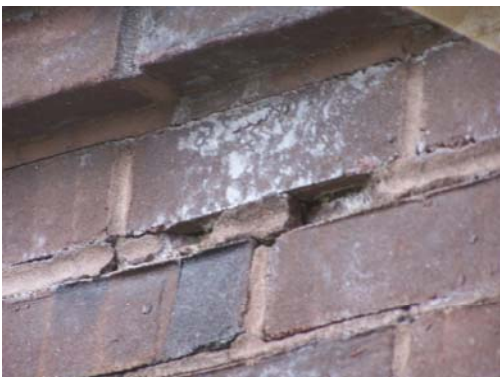
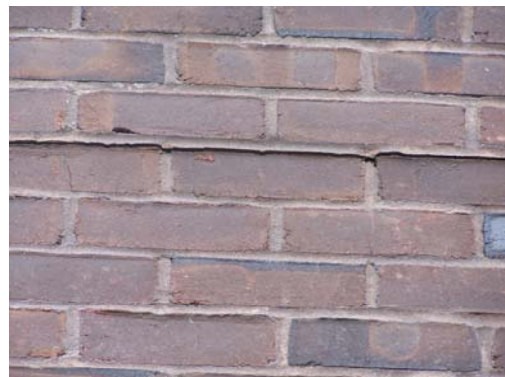
There were a few maintenance items, that although they are not a problem now, could develop into one if left as is. In a few locations, there is evidence of failing mortar joints. Continued exposure to freeze/thaw cycles will cause these joints to leak, allowing moisture into the building. We recommend these be re-pointed.

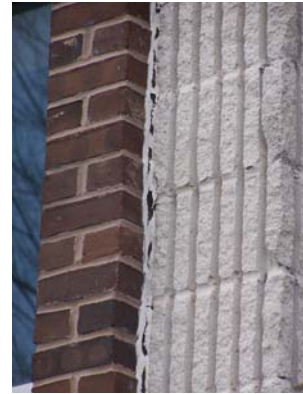
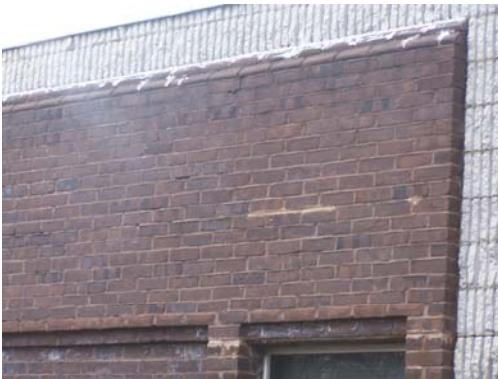
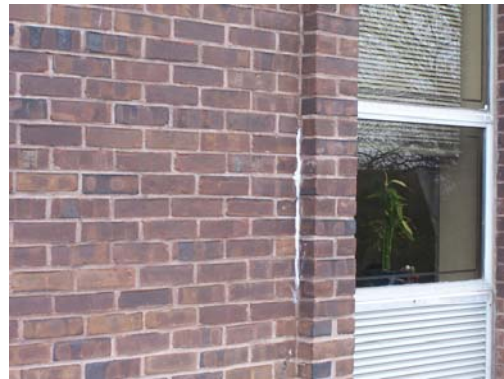
Similarly, it appears as if some of the caulk joints are also failing and need to be cleaned and re-caulked to prevent moisture getting in to the building.

Additionally, there are joints that have already been re-pointed and repaired with caulk joints that appear to be leaching in isolated locations around the exterior of the building. Although none of these are a structural issue in and of themselves, left un-repaired, they can lead to structural problems in the future.

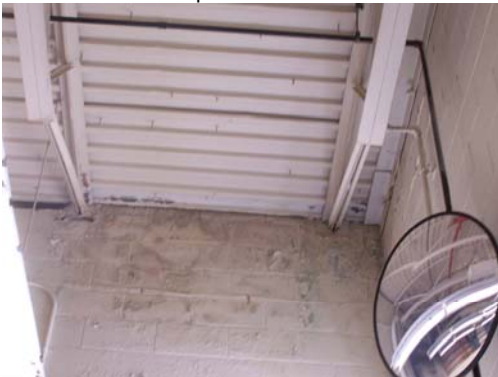
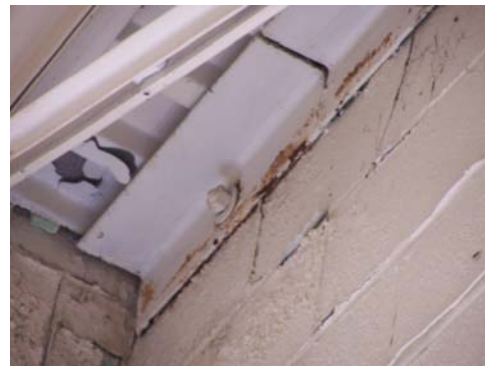
There was also evidence of moisture in one of the welding bays. It appears as if the roof joint may be leaking, causing the paint on the masonry wall to blister and peel. The deck support angle is beginning to rust. This should be cleaned and re-painted, and the roof leak repaired.

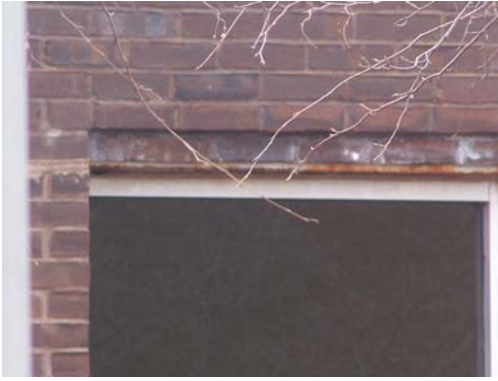
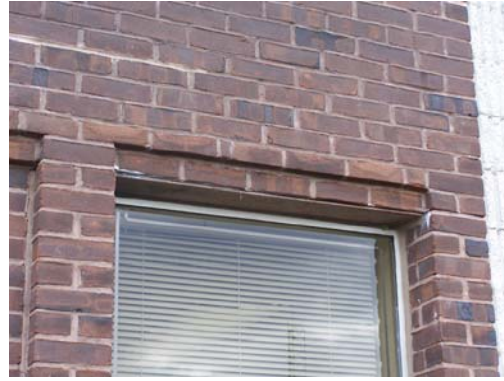
The moisture problems identified above also extended to the steel angle lintels supporting the brick veneer over windows. Many of the lintels showed signs of some corrosion. These should be wire brush cleaned and repainted.

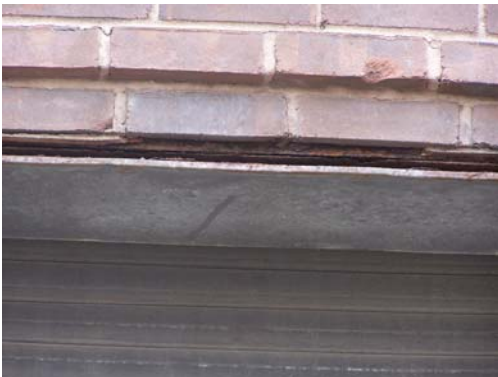
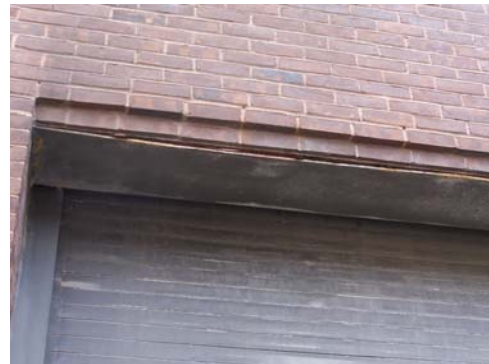
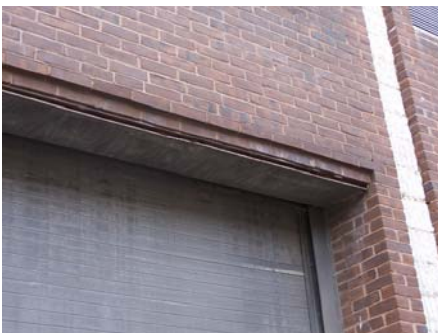
The most significant issue, structurally, was the condition of the hung plates supporting the brick veneer over the overhead doors into all the shops in the 1986 addition. These were severely corroded, and the expansion of the steel as it rusted has caused the plates to warp. In some locations, it appears the steel may have started to laminate. The hung plates are supported from W16 steel lintel beams over the door openings. These beams are within the wall and not visible for observation. However, given the extent of the corrosion of the plates, we recommend the walls be opened up to verify the integrity of these beams. A worst case scenario would be that the walls would need to be temporarily shored, the lintels would need to be replaced, and the walls partially rebuilt.
