PROPERTY CONDITION ASSESSMENT Long Lots Elementary School

PREPARED BY:
Colliers Project Leaders USA NE,
LLC
12/16/21

PREPARED FOR:
Westport Public
Schools,
Town of Westport CT.
Long Lots Elementary
School

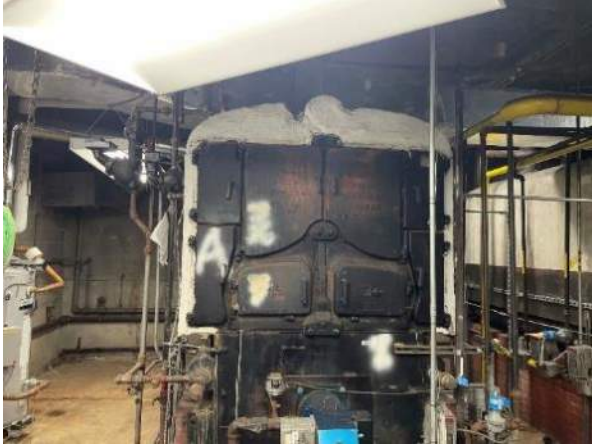
Figure 3: Steam boilers original to the building (cr 1953).

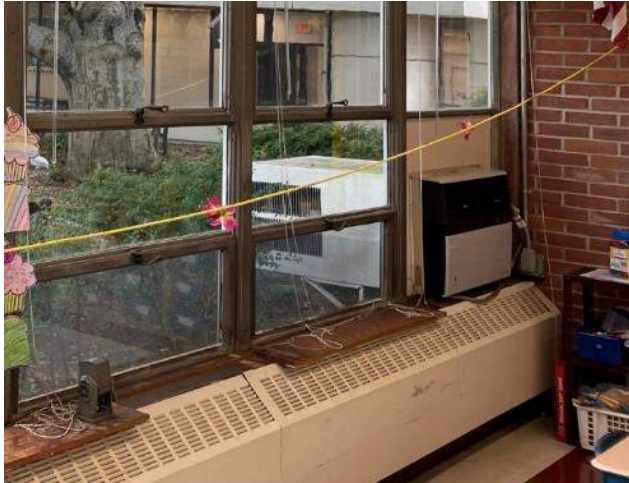
Figure 7: Steam radiation and window AC unit in the original building

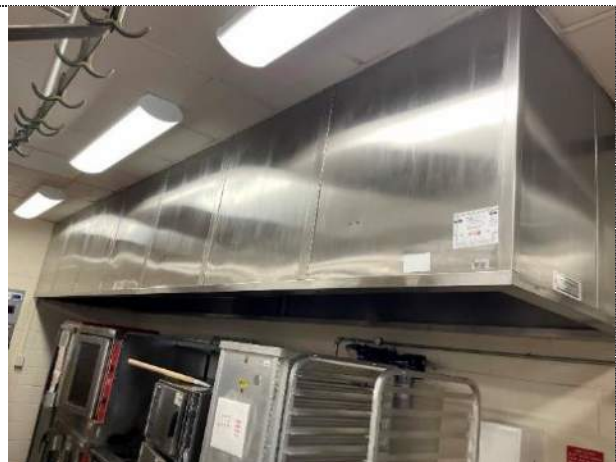
Figure 11: Kitchen exhaust hood.

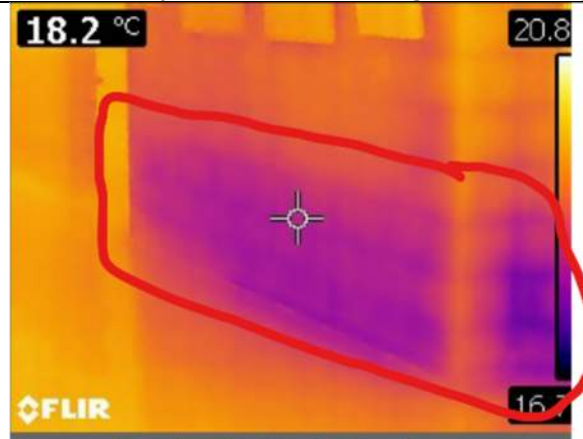
Thermal patterns show cooler temperatures at the foundation wall. This thermal pattern is consistent with missing foundation insulation, wet block, condensation.

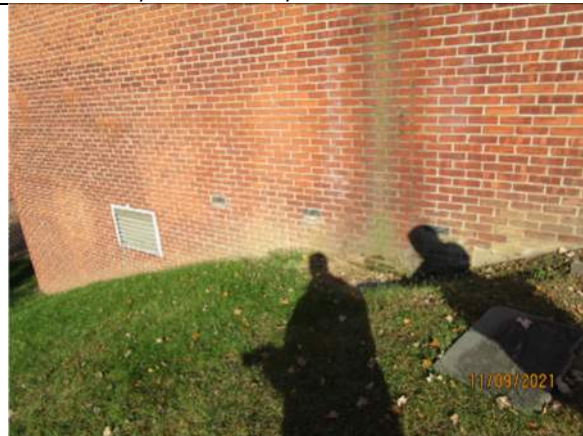
The masonry wall extends below grade with no apparent foundation or waterproofing membrane.

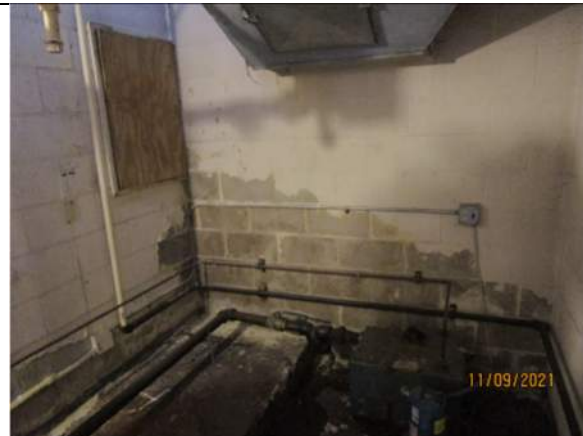
Evidence of hydraulic water pressure against the below grade wall and water infiltration into the building.

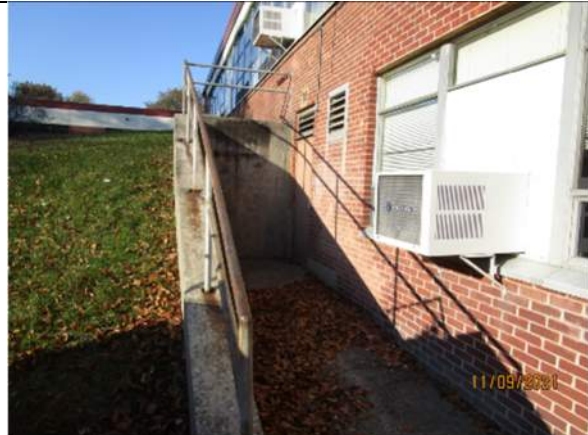
Access to room 19 with a door into the utility tunnels under the building.

Suspect insulation materials on pipes are deteriorating so the tunnels were not investigated.

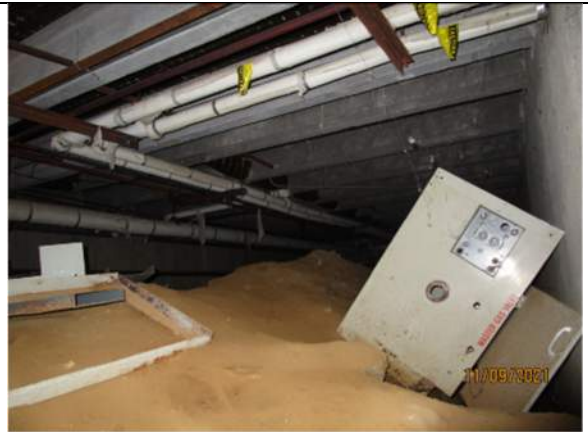
Soils with no vapor barrier allow moisture vapor from the ground into the building.

Observed the unexcavated soil condition through the room 9 hatch.

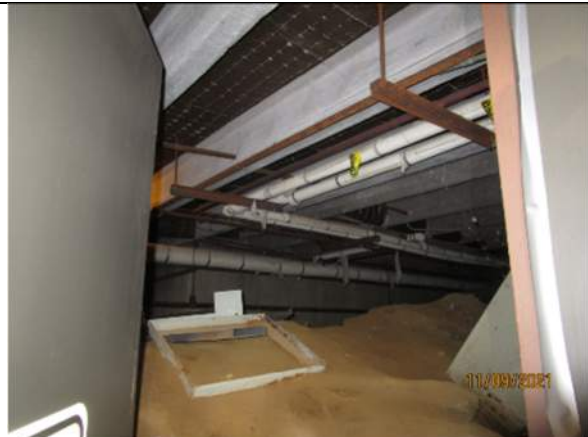
Sandbags observed in place to prevent surface water from infiltration the building. Site grading changes will be needed to correct water infiltration plus the addition of area drains.

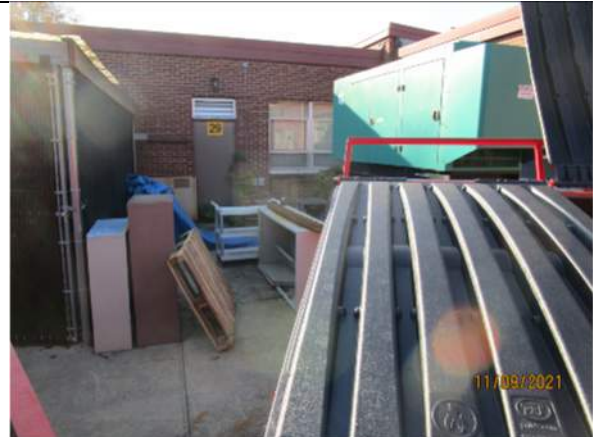
It was reported when the diesel generator is operating the diesel smell is evident in the kitchen. This is a sign of a failed building enclosure and improper balancing of the ventilating system allowing outside air to be pulled into the kitchen. It is reported that the kitchen exhaust hood has no control link between the cooking line hood and makeup air. The kitchen exhaust is likely causing negative air pressure in the kitchen and the poor building enclosure construction is likely allowing these fumes to be drawn into the building through the walls, windows, gaps around the doors and the window air conditioning unit.

The generator exhaust stack should be extended and directed above the roof level. The windows, doors and exterior wall system should be replaced with an airtight building enclosure.

A makeup air unit should be provided to correct the negative air balancing issue in the kitchen.

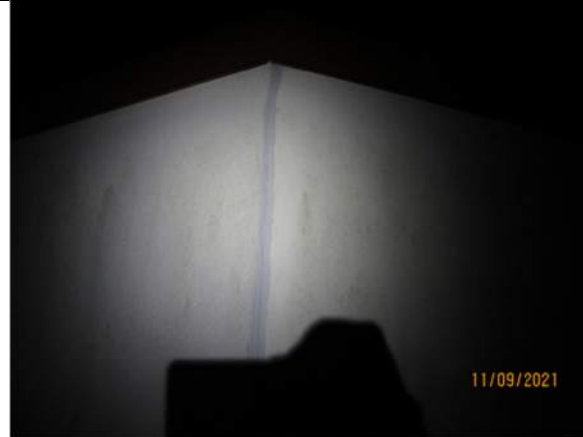
The roof is very fragile. The blister spots are easy to damage if walked on especially in the colder temperatures in addition the bitumen is getting cracked and brittle.

The life expectancy of this roof is 10 - 20 years and it is showing signs of wear.

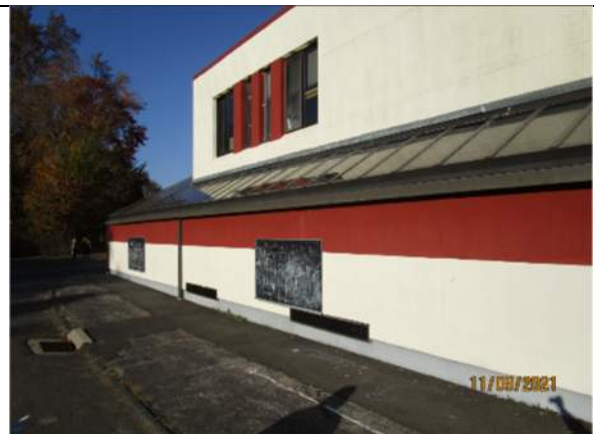
On-going issue with the skylights. Water infiltration issue has been on-going, and several attempts have been made to mitigate the water leaks. Sealant has been applied to the skylight joints. Solar heat gain issue – the skylight has been whited out to try to reduce the amount of solar heat gain in the space.

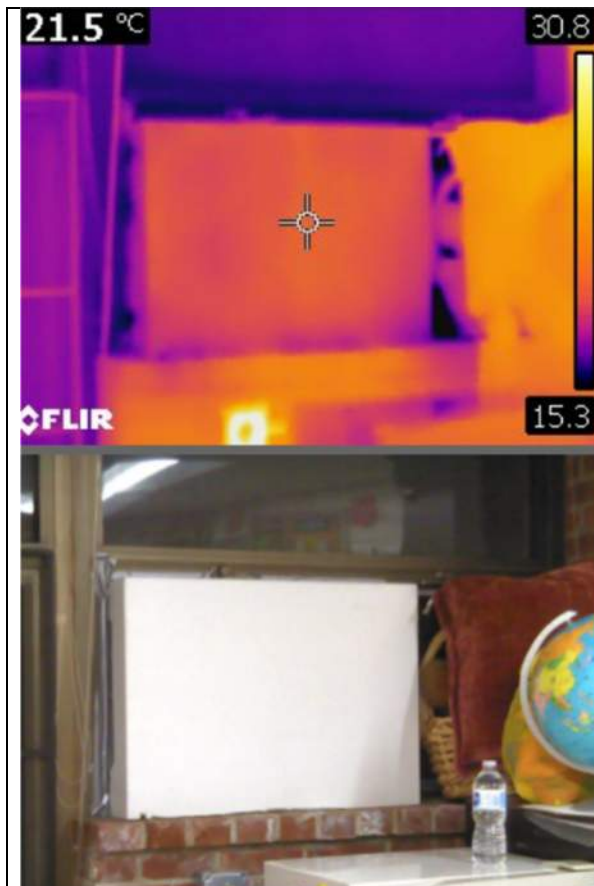
The dark colors around the air conditioner cover are a thermal image of cold air entering the building. Duct tape is being used to try to mitigate this air infiltration.

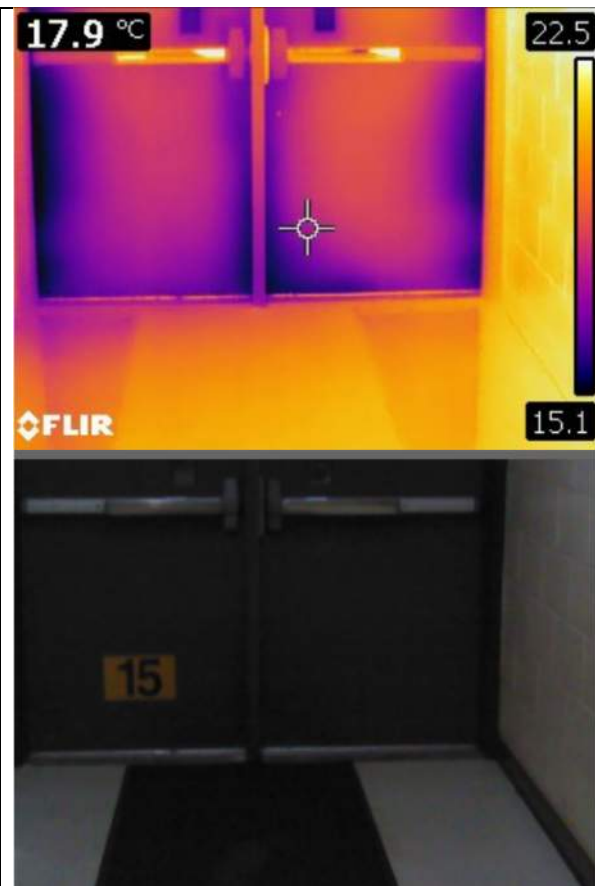
The dark wispy pattern around the perimeter of the entry doors is cold air drafts around the entire perimeter of the pair of doors.

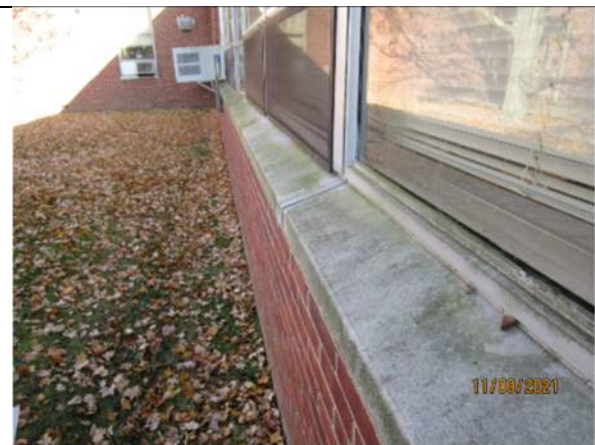
Original single pane window system 1950's vintage.
The windows have had extensive caulking applied to try to address some of the water and air infiltration issues.

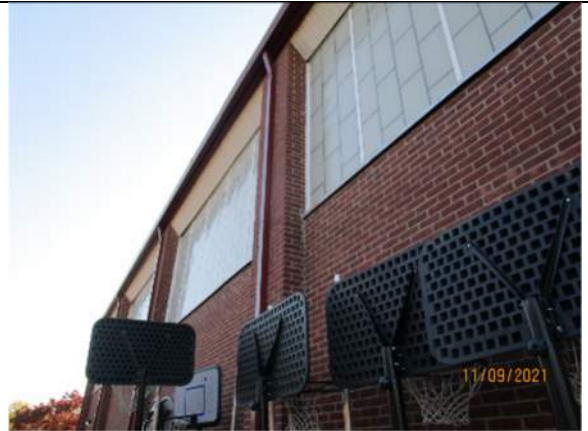
Kalwall System observed in the thermal scans to have air leakage at the perimeter and thermal bridging between the panels.

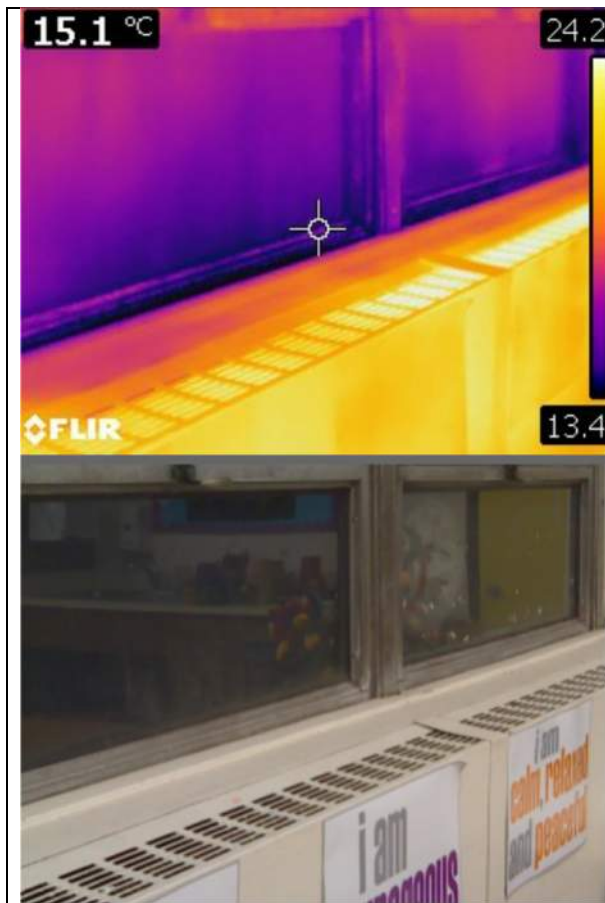
the bright colors are the warm surfaces, and the dark wispy colors are the cold air infiltration drafts. Normally these surfaces would be a consistent color. There is a significant amount of thermal bridging heat loss through the window frames and significant air infiltration.

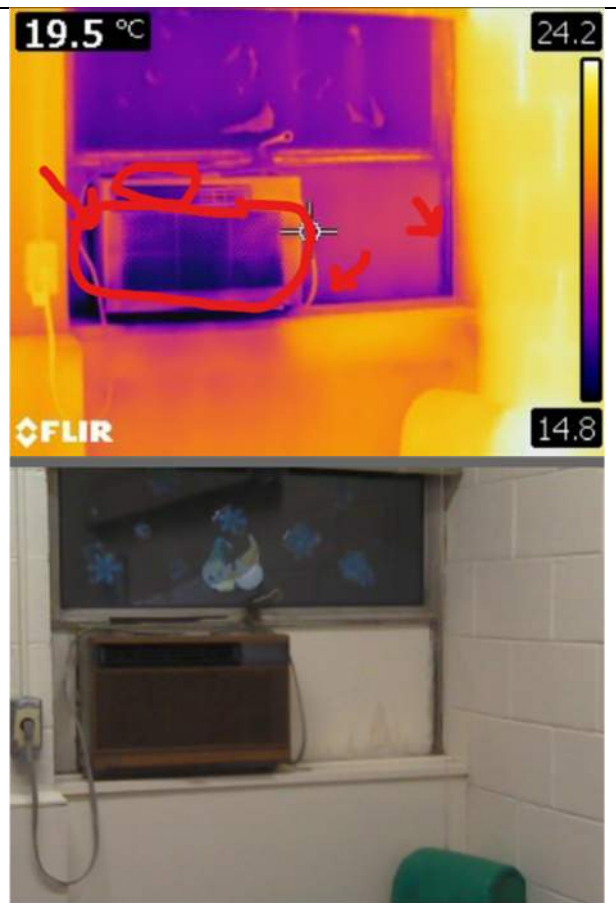
Heat loss can be seen both through the air conditioner and around the air conditioner.

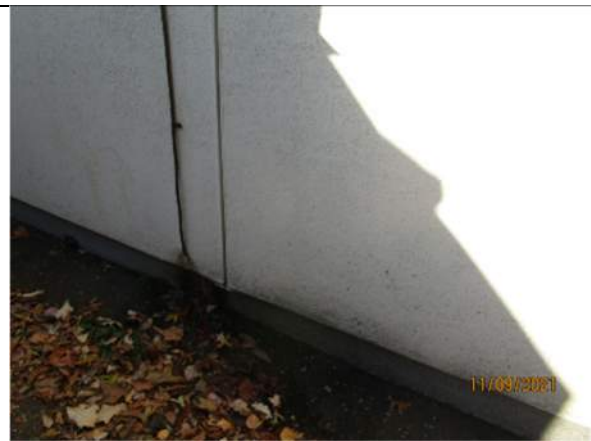
All the base trim and control joints appear to have expansion damage from water exfiltrating the system and expanding when leaving the system.

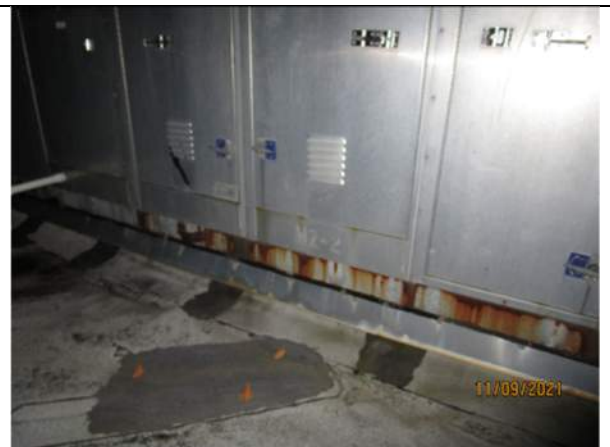
The rooftop units have been reported to have corroded pans that have rusted through and caused leaks into the building. The housing itself does not leak but the internal collection pans for condensation have failed.

The RTU pans have been re-gasketed and caused extensive water infiltration into the auditorium. This resulted in a major project to mitigate the mold caused by this water infiltration into the auditorium.
