Zsafia Pasztor

TREE RETENTION DECEMBER 2018

On November 19-20th, 2018, at your request, I performed a complete tree evaluation at the address of the Talus Middle School in Issaquah WA.

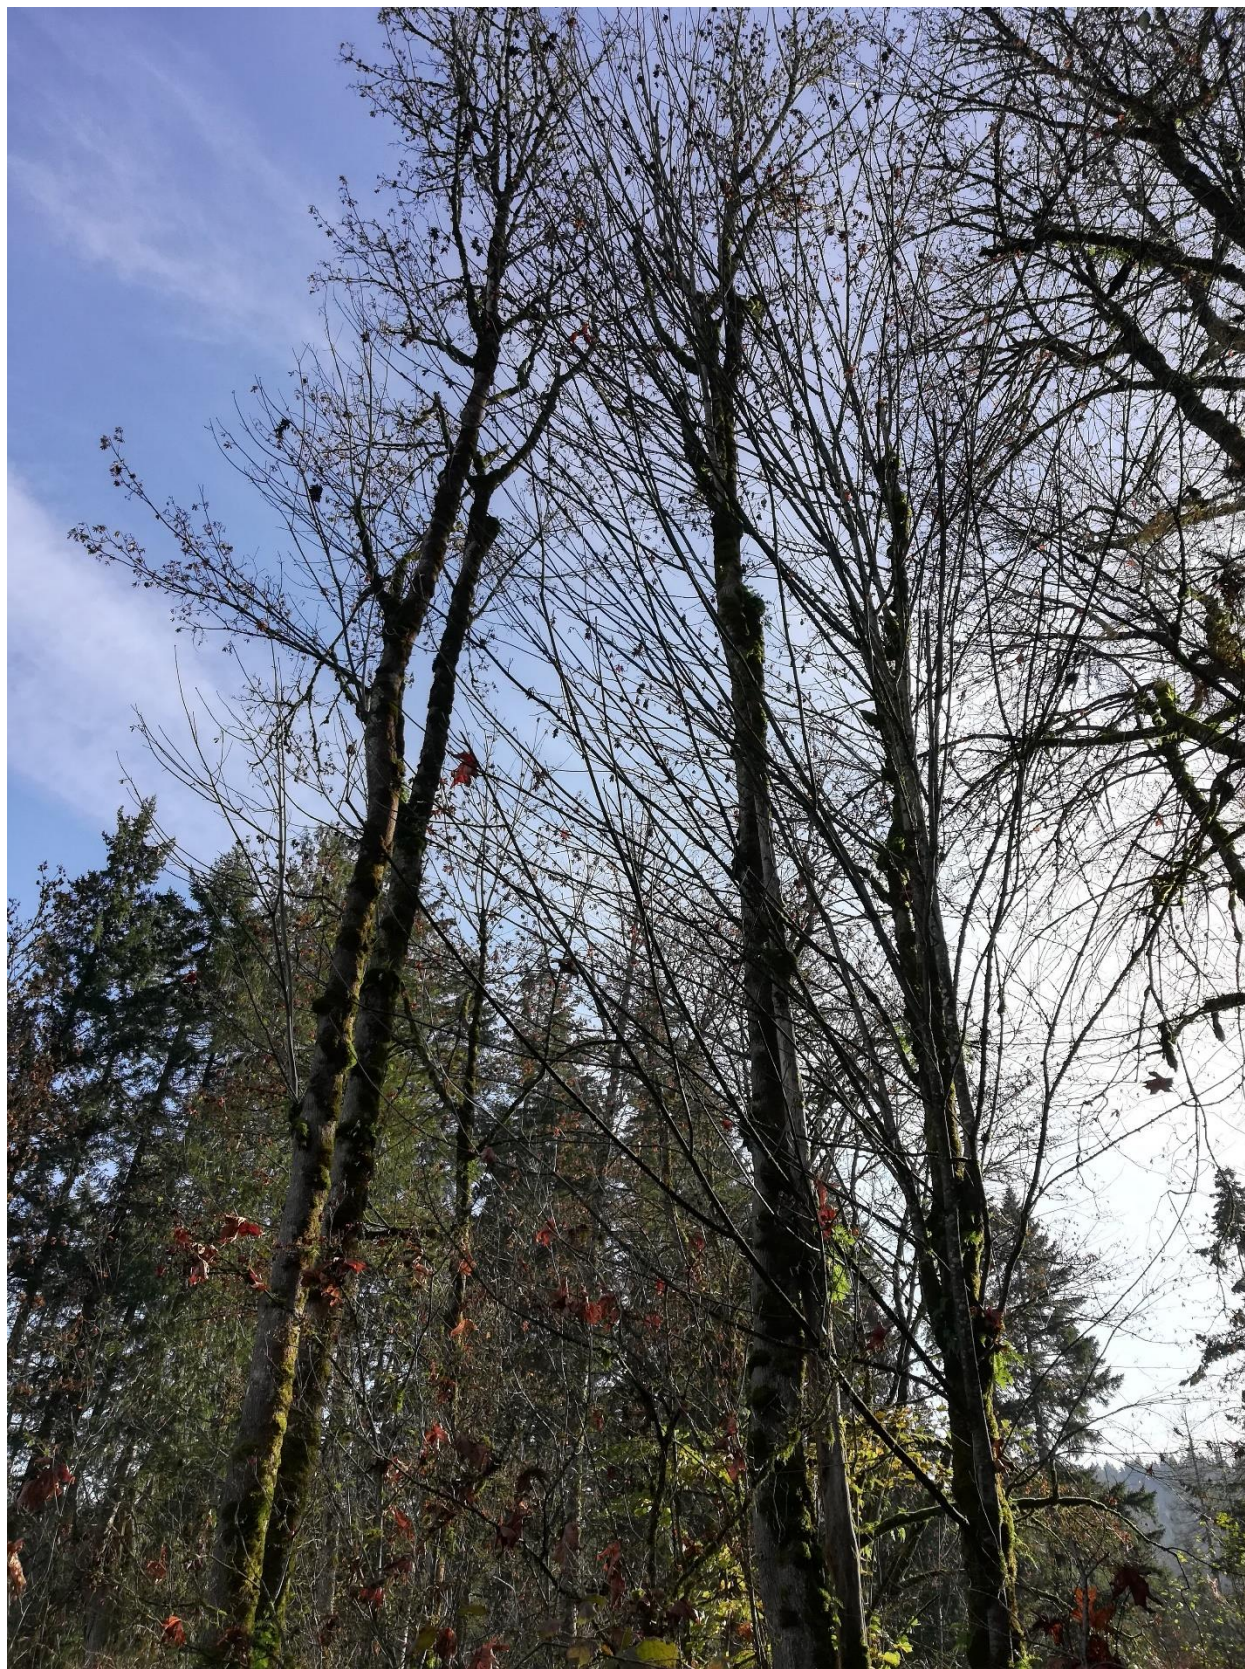
Trees near #14/18/7133

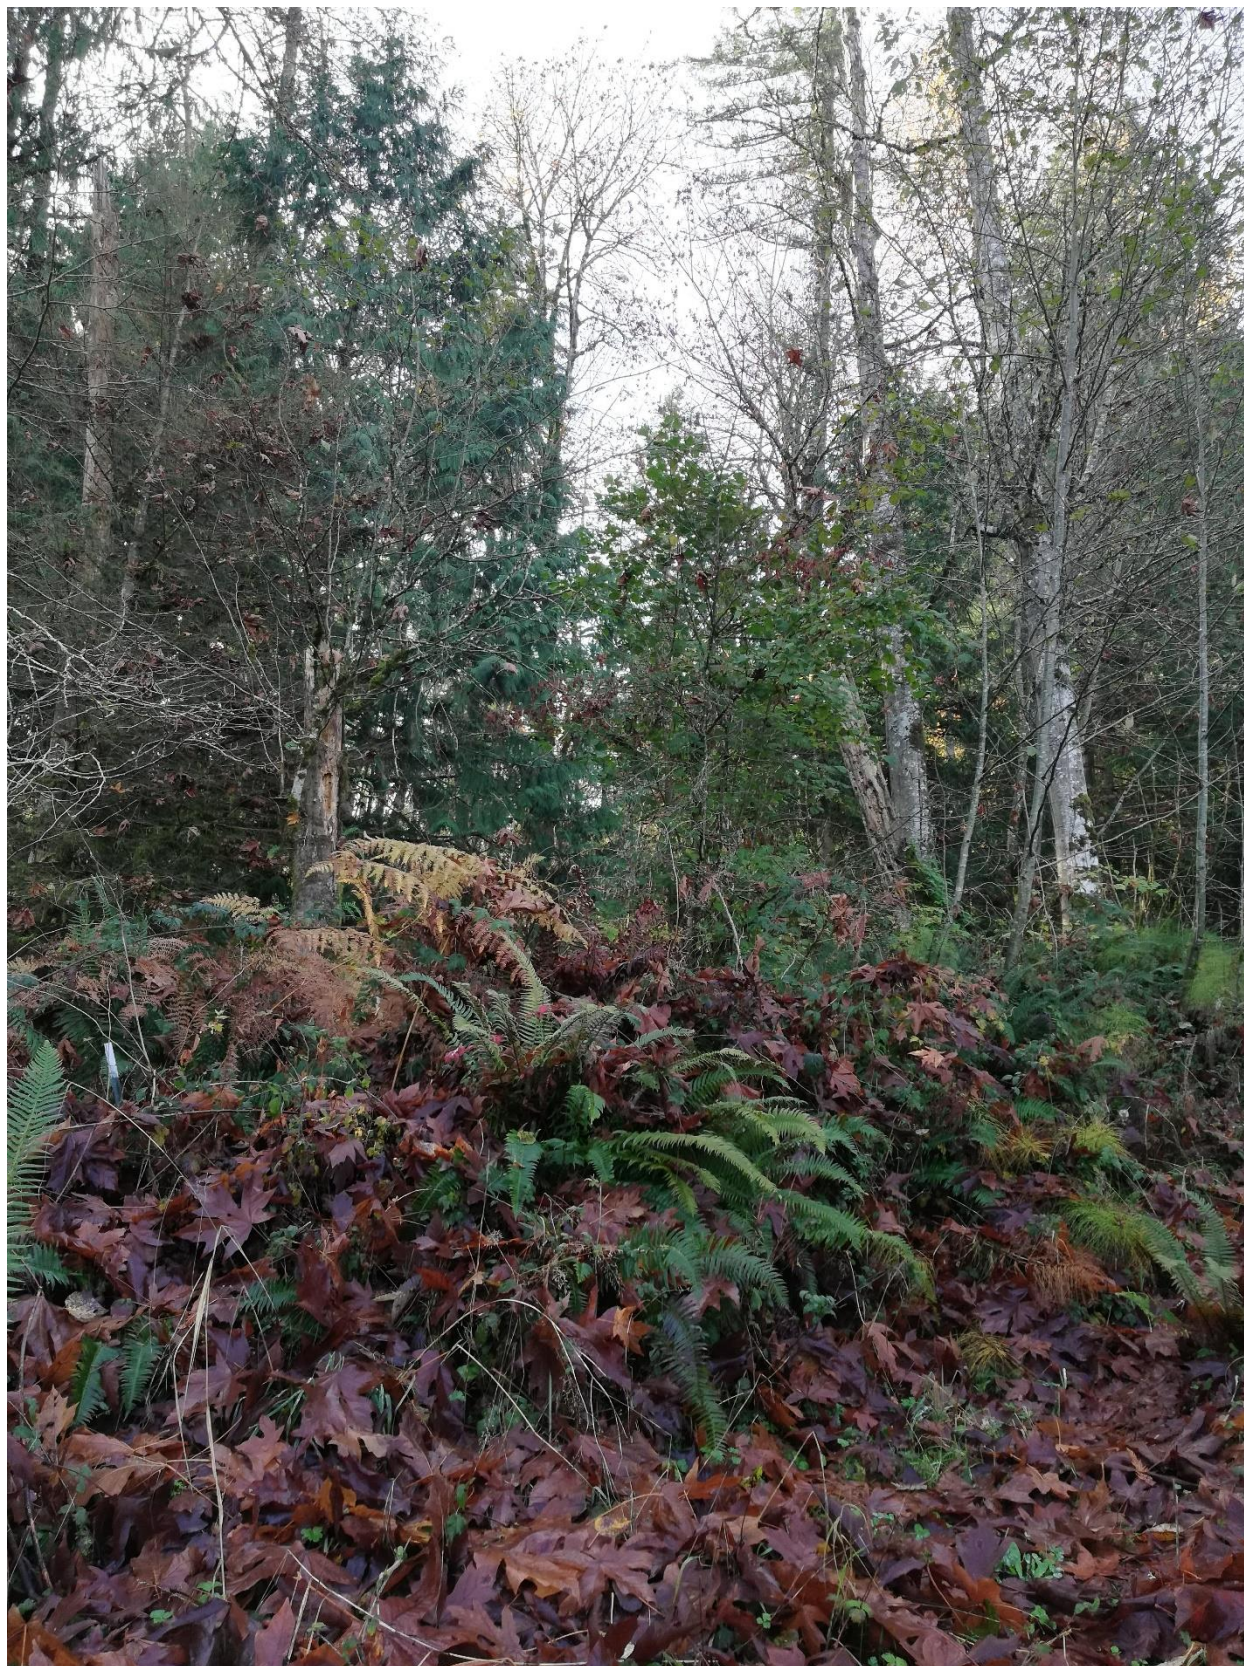
The forest edge on the neighboring property around 7154

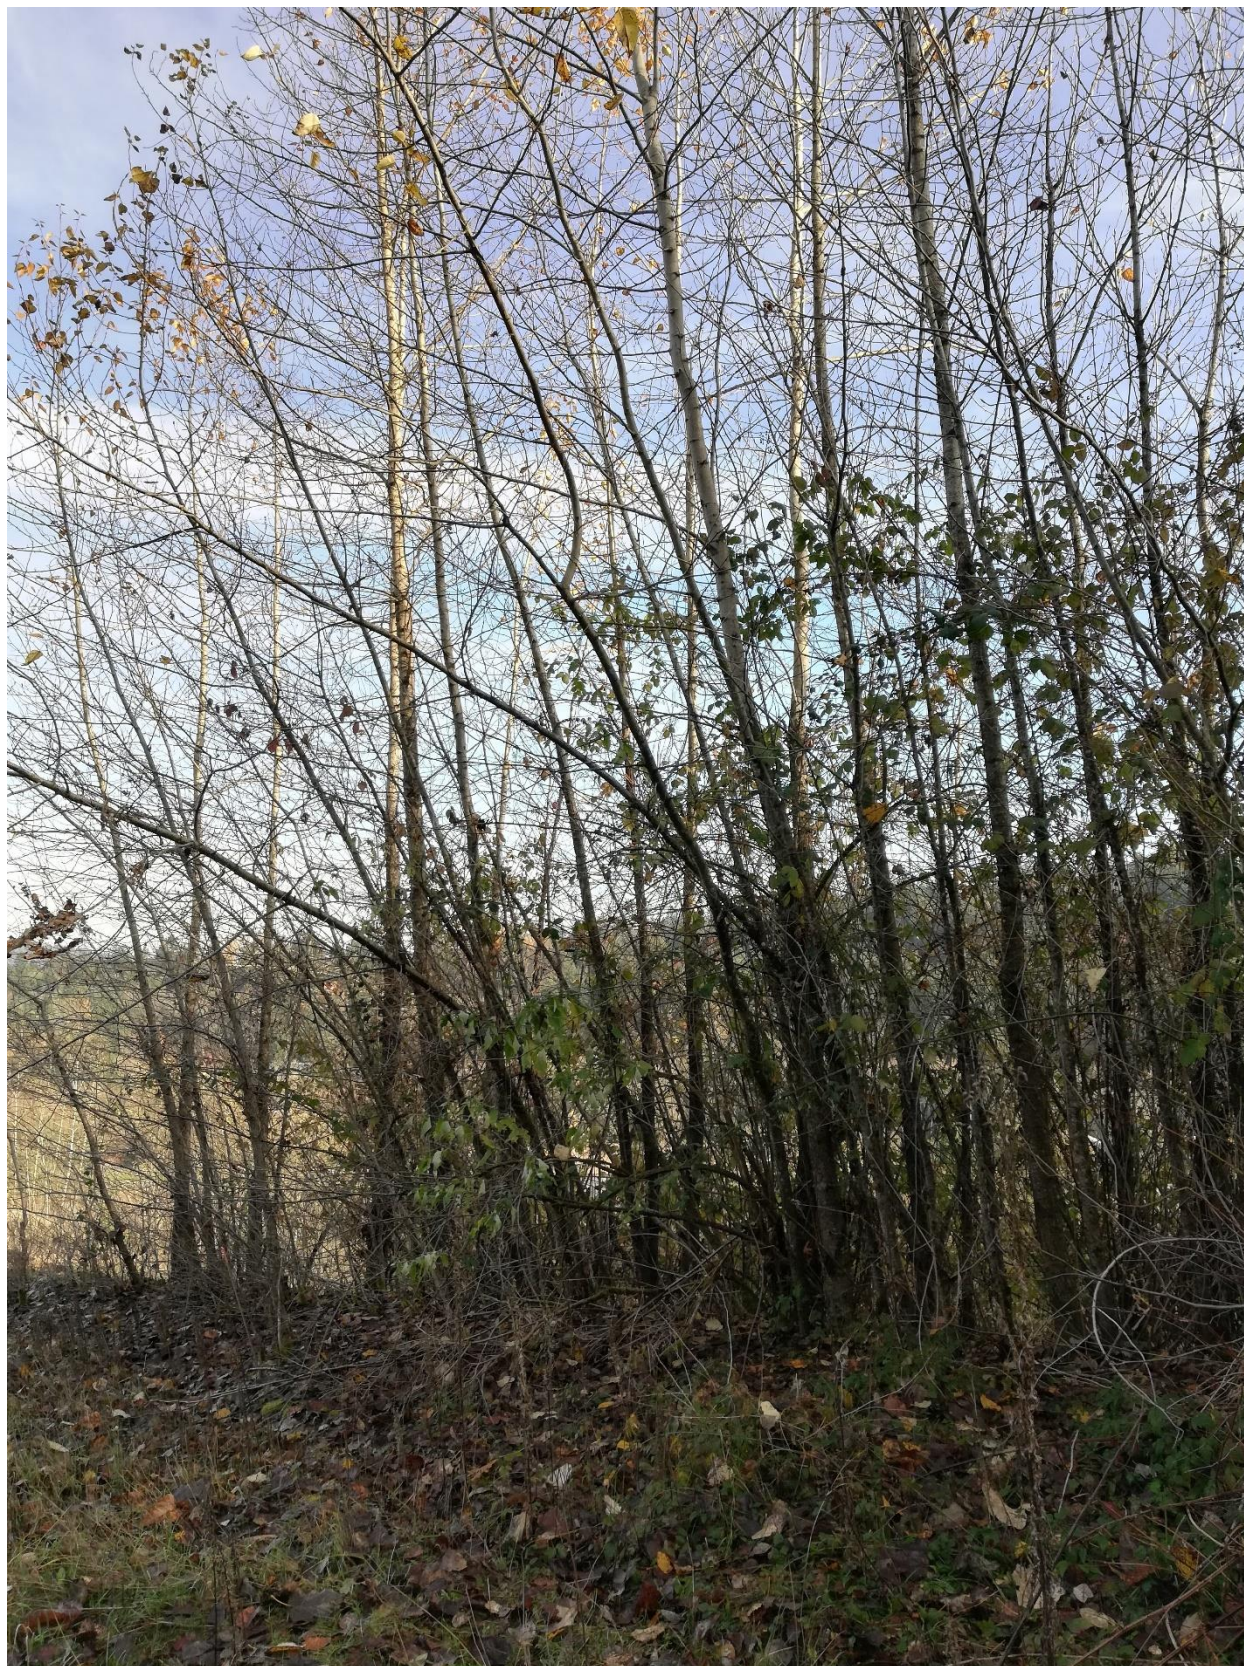
The cluster around #12 and 11

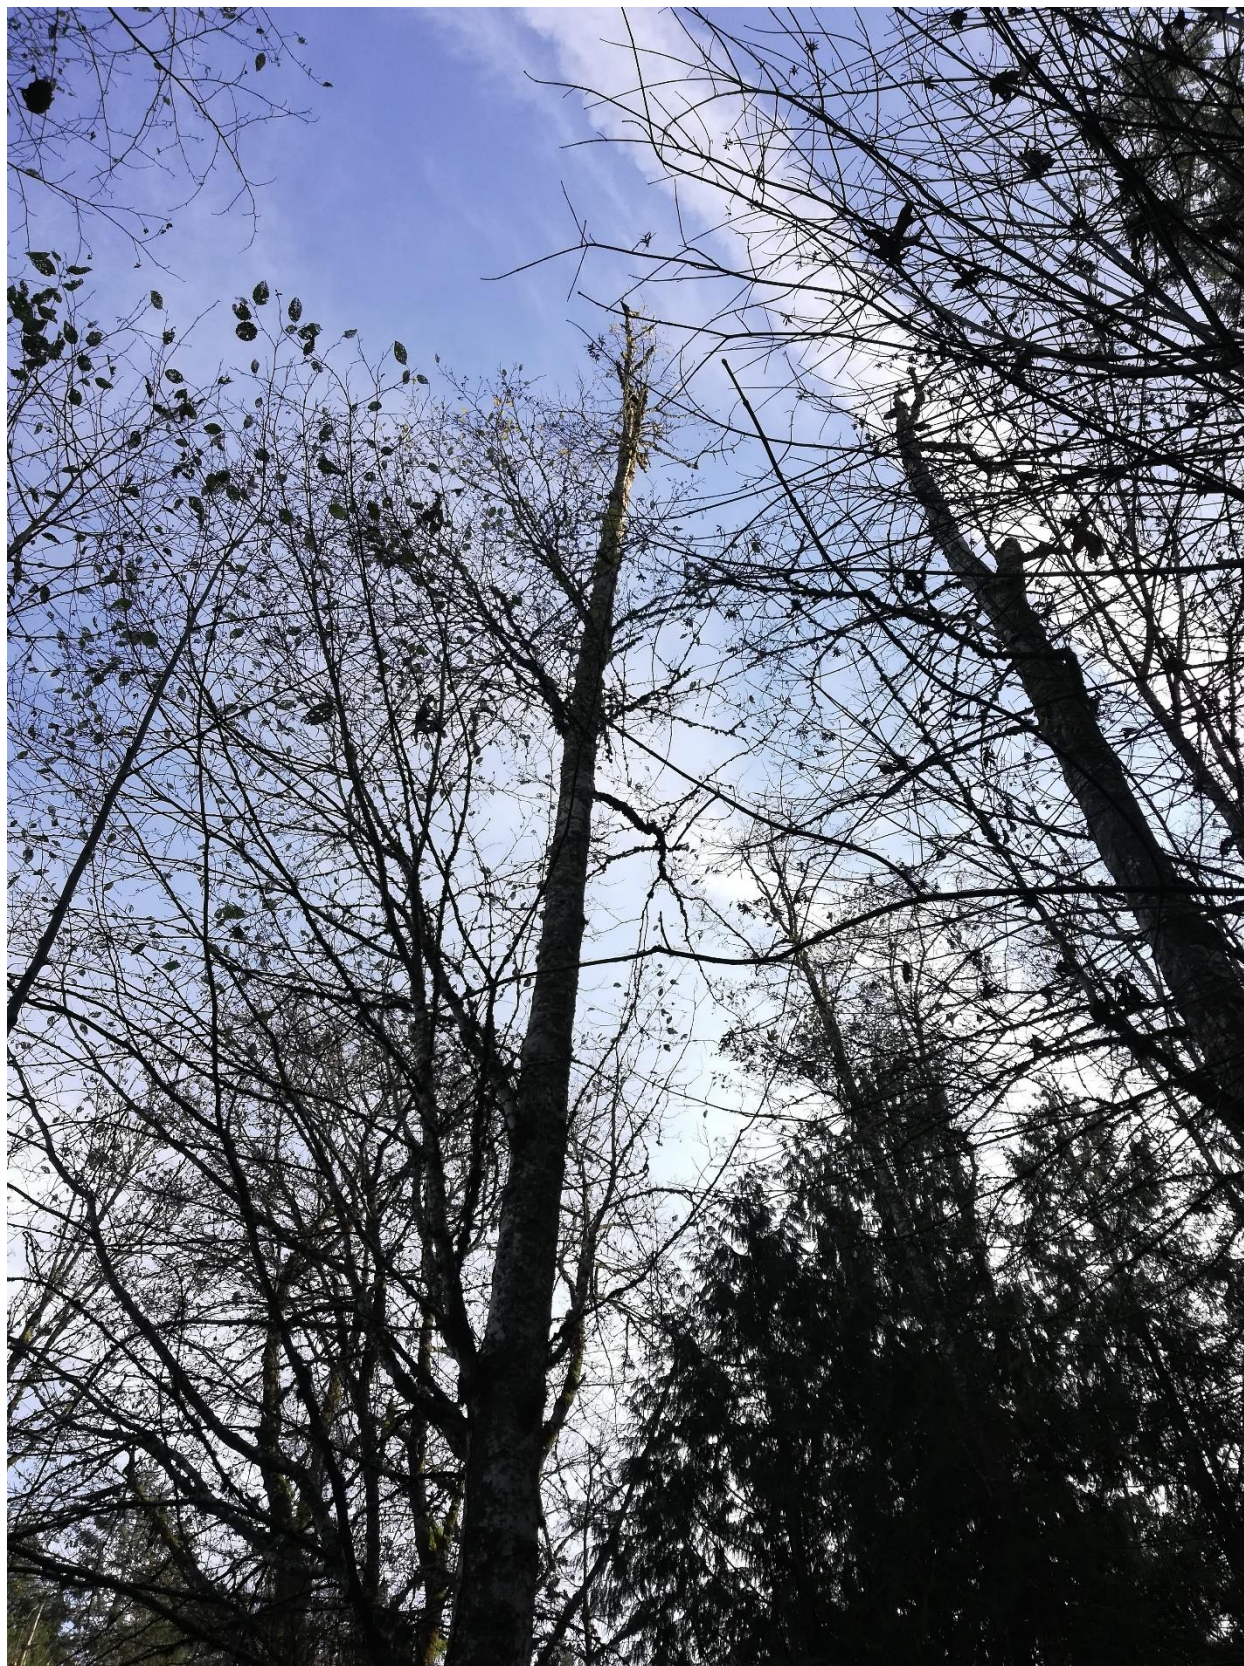
Most of the alders and cottonwoods have their tops missing, large limbs are broken

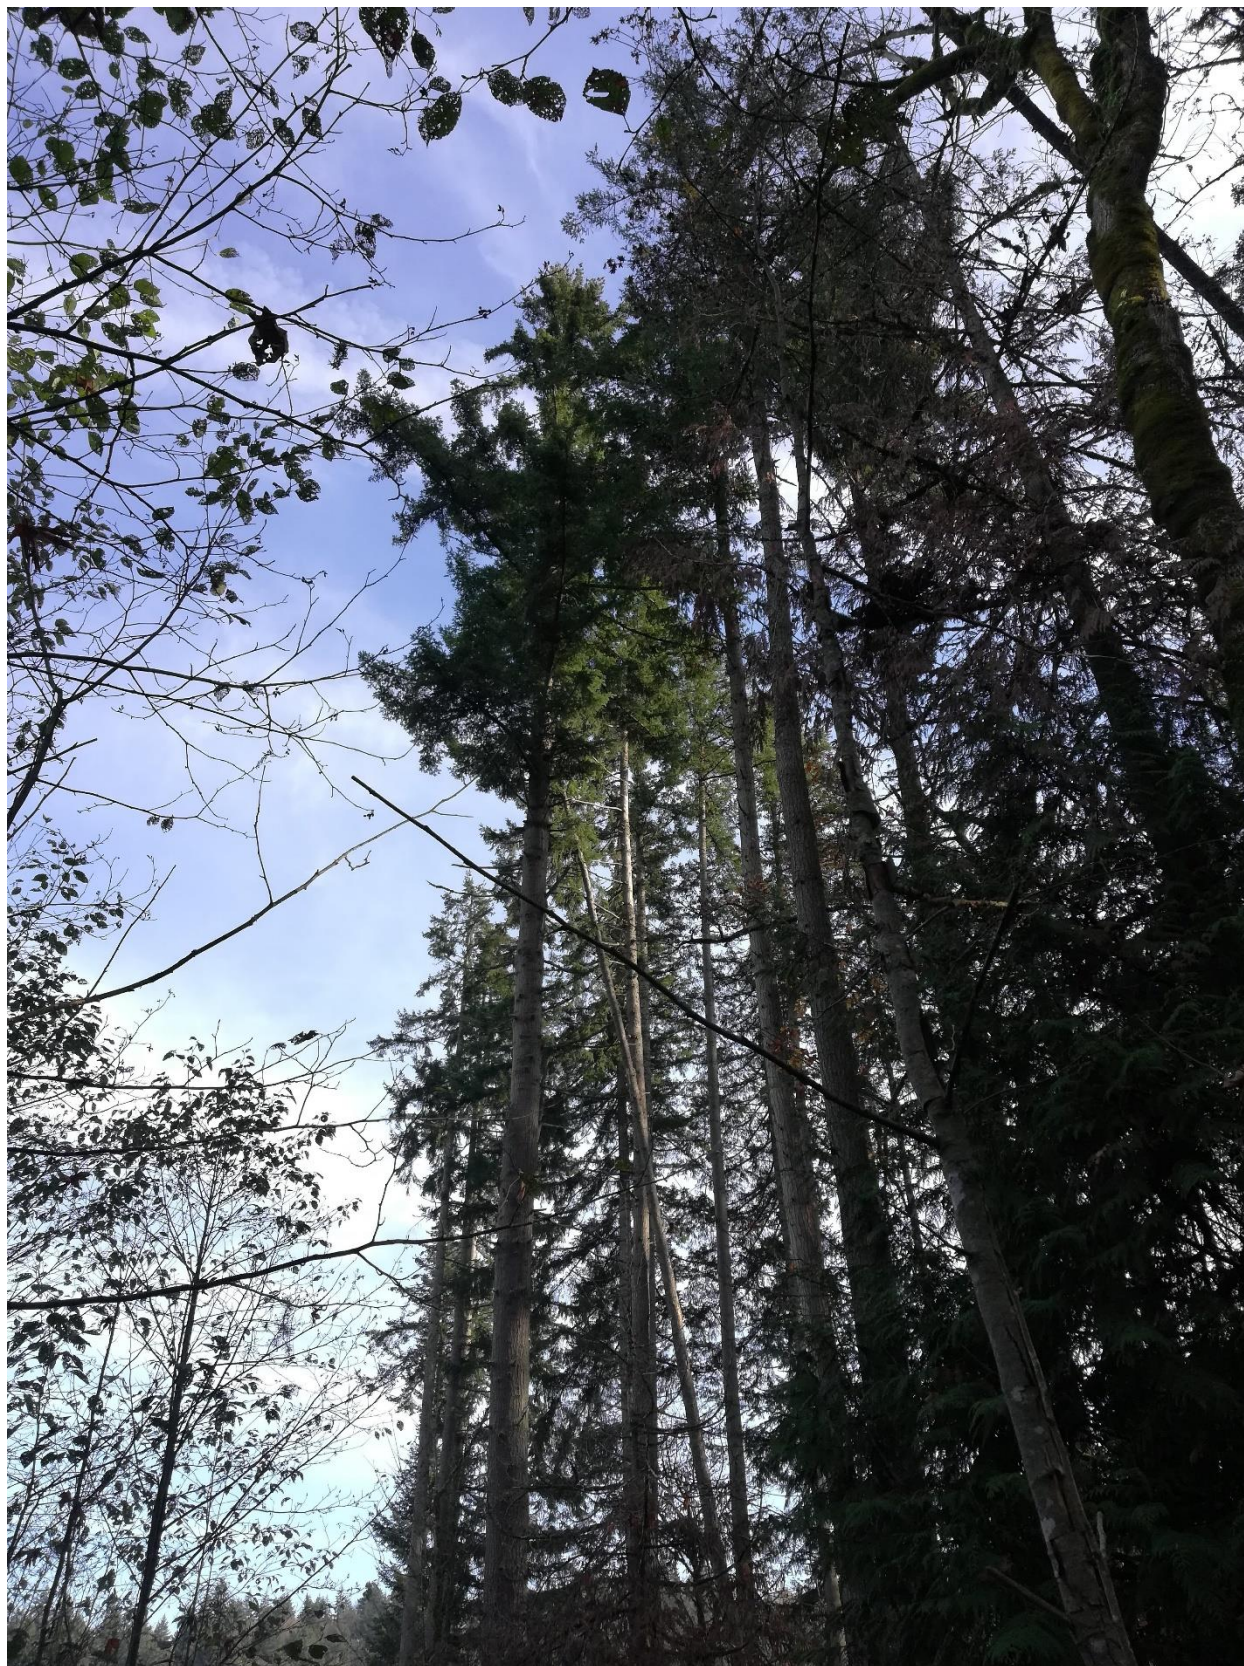
The trees on the neighboring property were tagged by the surveyor company assessing the neighbor's site. These trees are in generally poor health. The trees are on the edge of a forested area and they all show moderate to severe wind damage. Many of the trees within the forest are leaning, about to fall or already fell. Some are dying, others are dead. Roots are exposed on almost all of the trees growing on the edges. The trees need to be protected and a fence as described above need to be placed for the duration of the construction. The fence should be placed at a minimum of 70% of the tree root zone as it is listed above for each tree. Most trees can cope with 30% root loss therefore encroachment up to 30% is acceptable usually.

The neighboring lot is forested with trees damaged and falling over

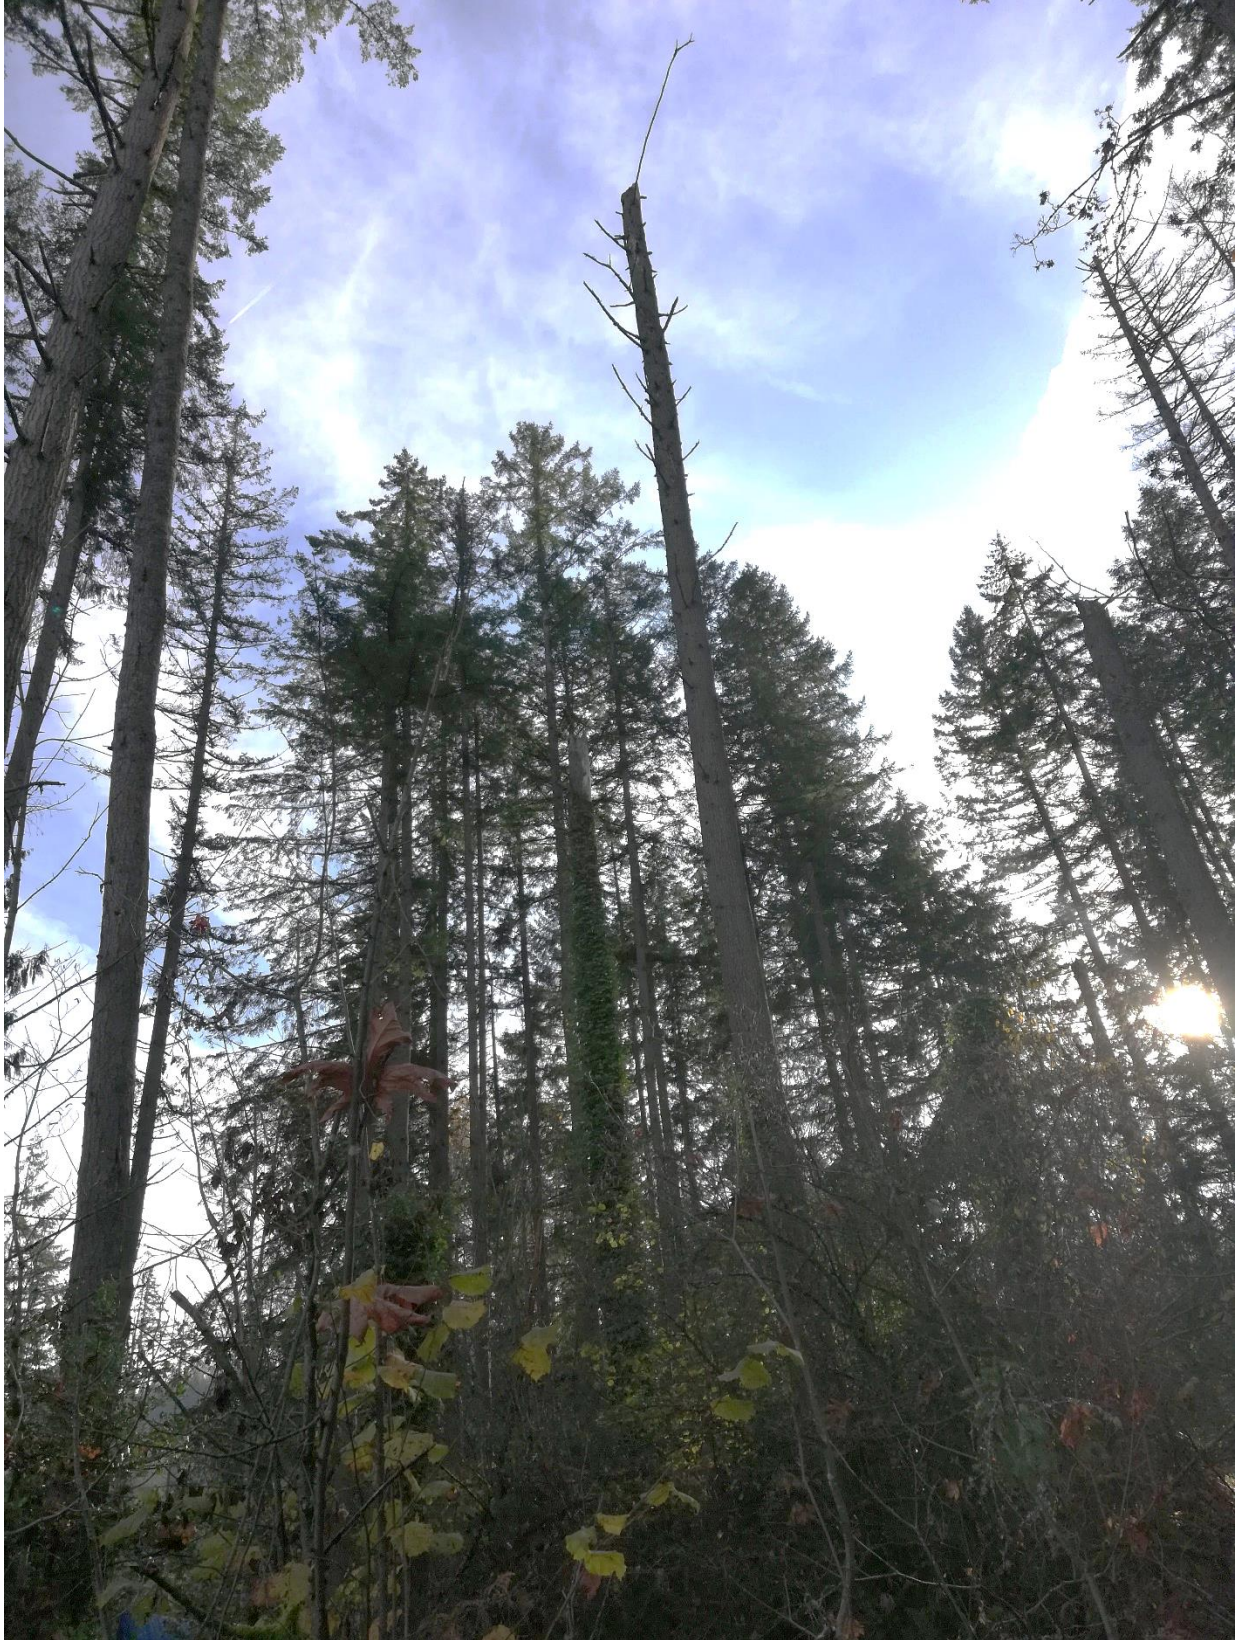
Trees in the neighboring forested lot are showing severe structural defects, they are dying, dead, broken and leaning

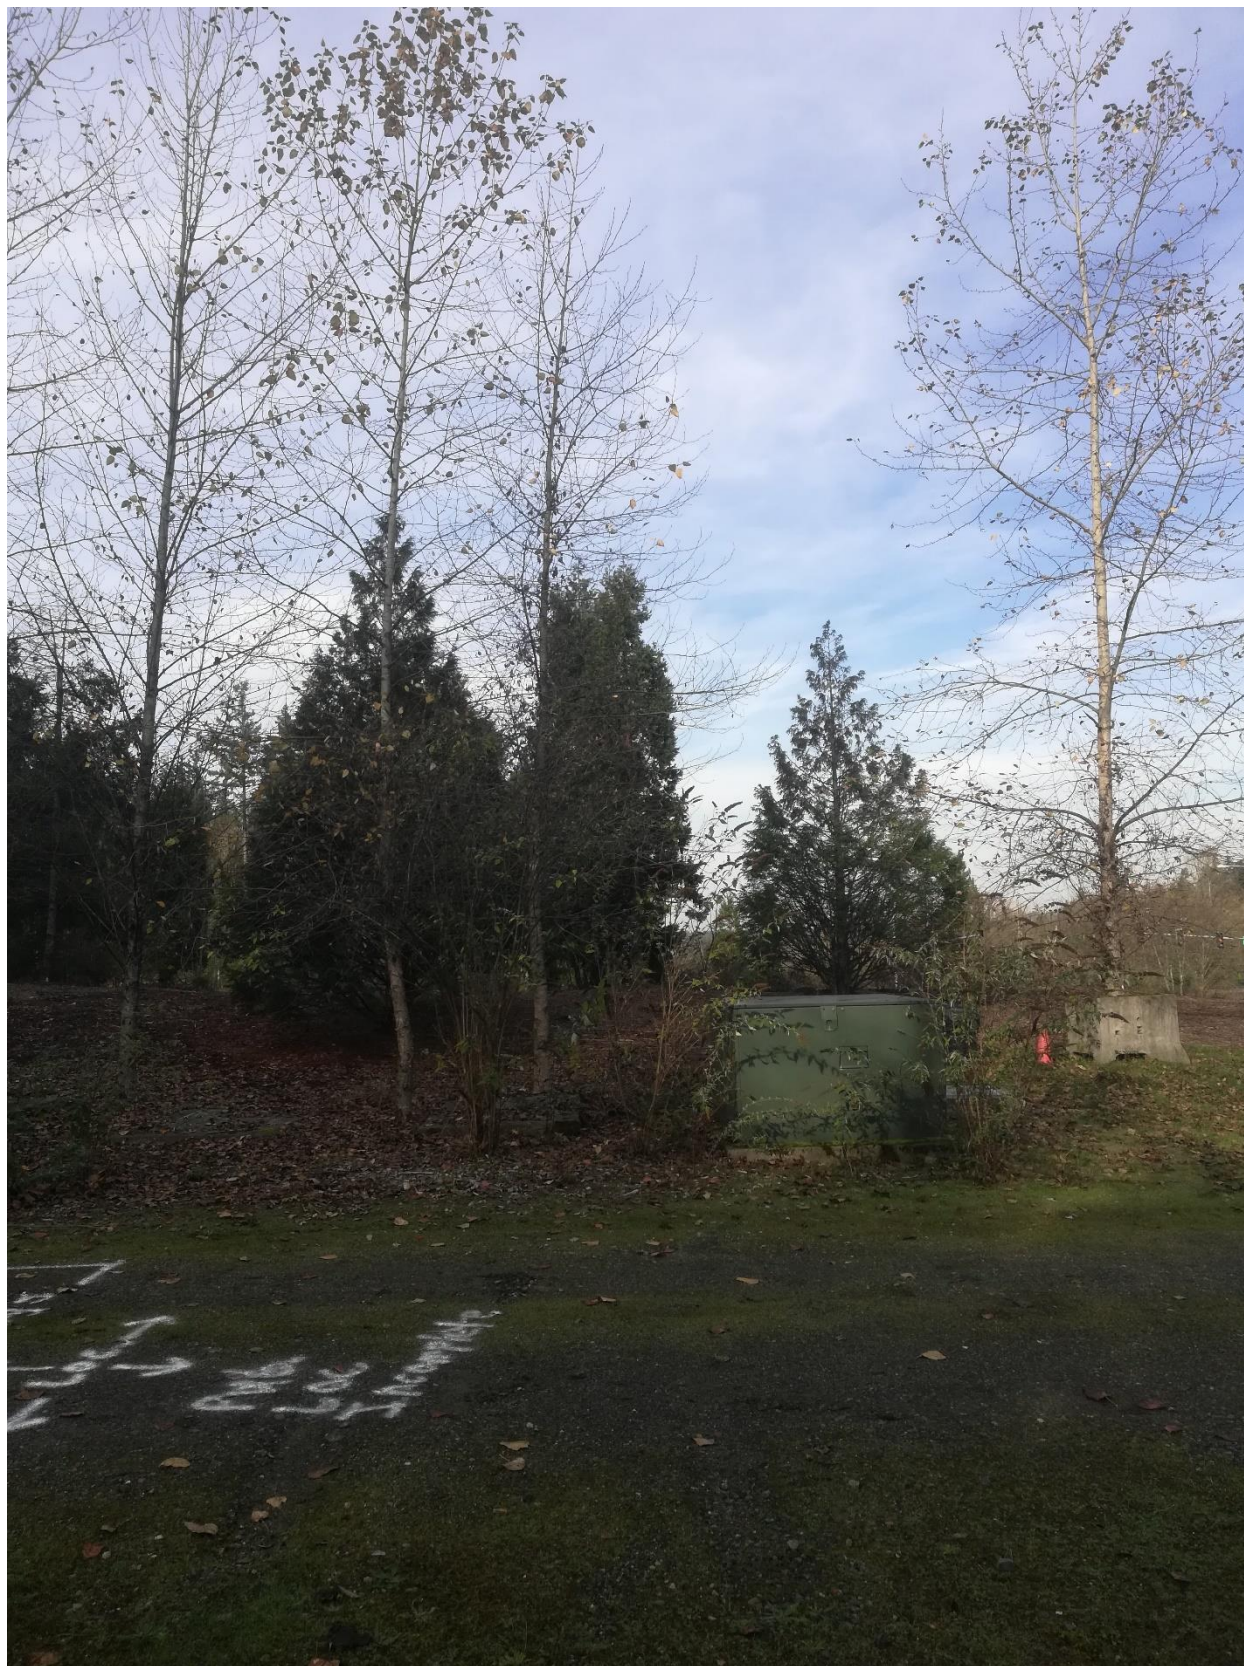
The utility area

I also recommend restorative pruning for the trees near the utility boxes and the easement area. These are crowded, but preservable, especially if correct pruning practices are applied in their care.

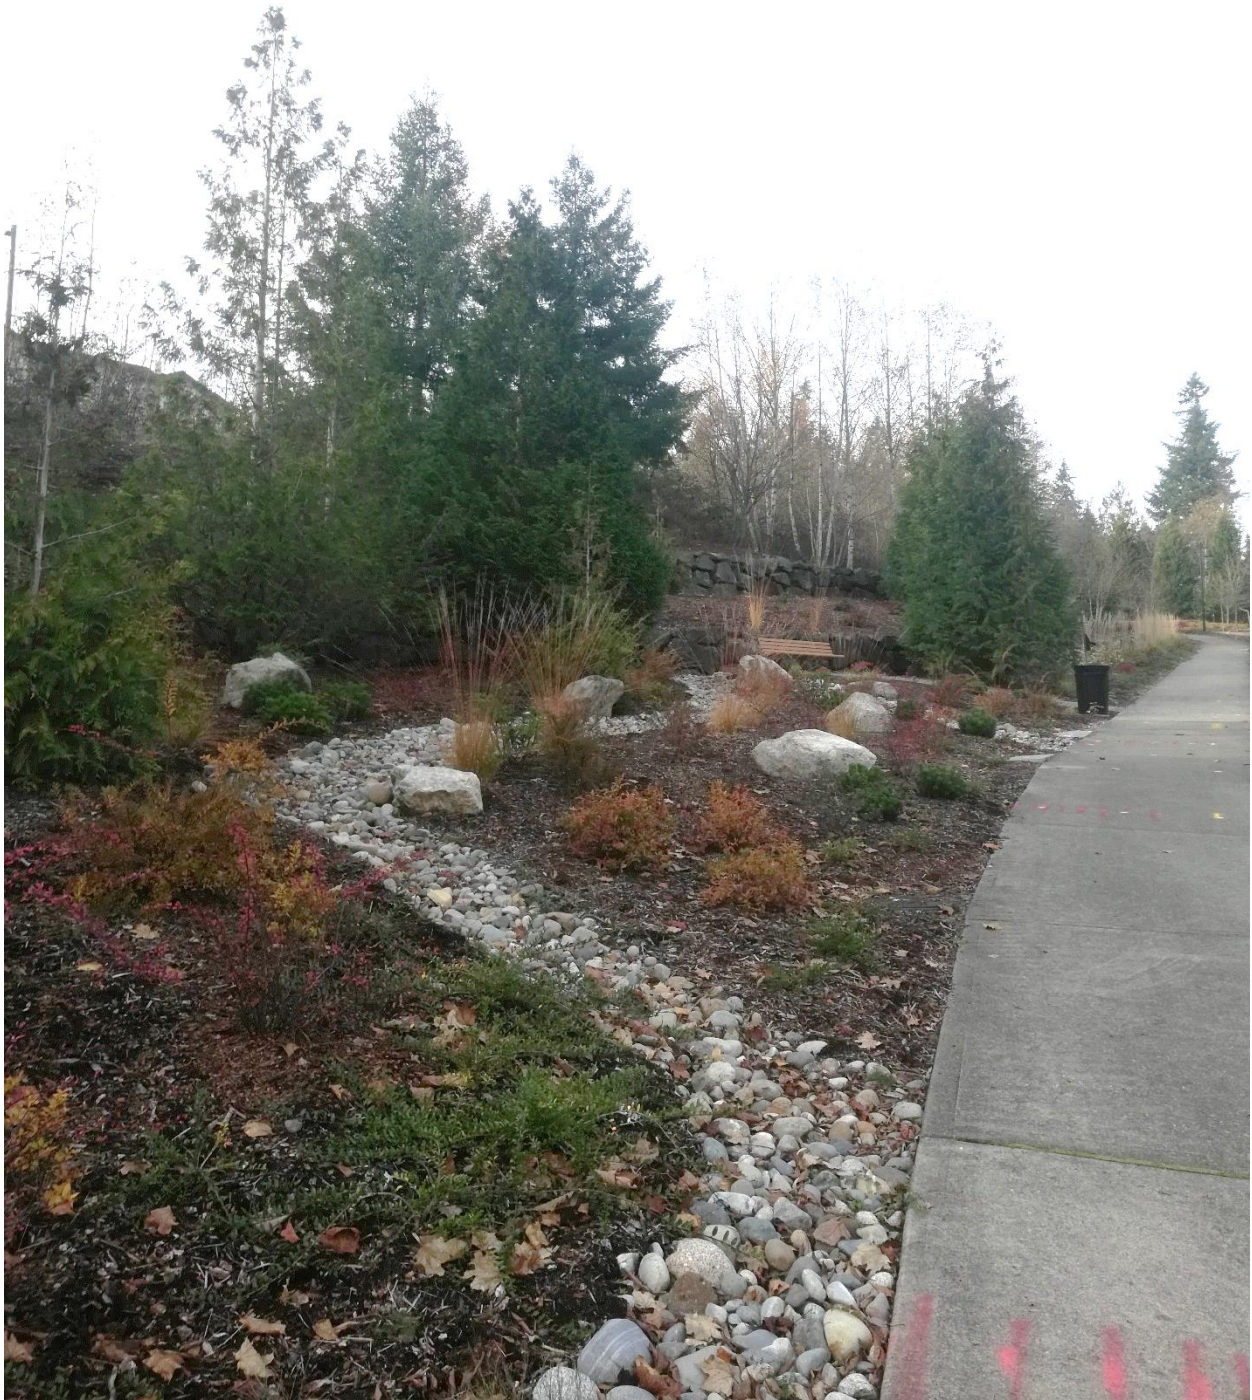
A nice little area by the existing retaining walls

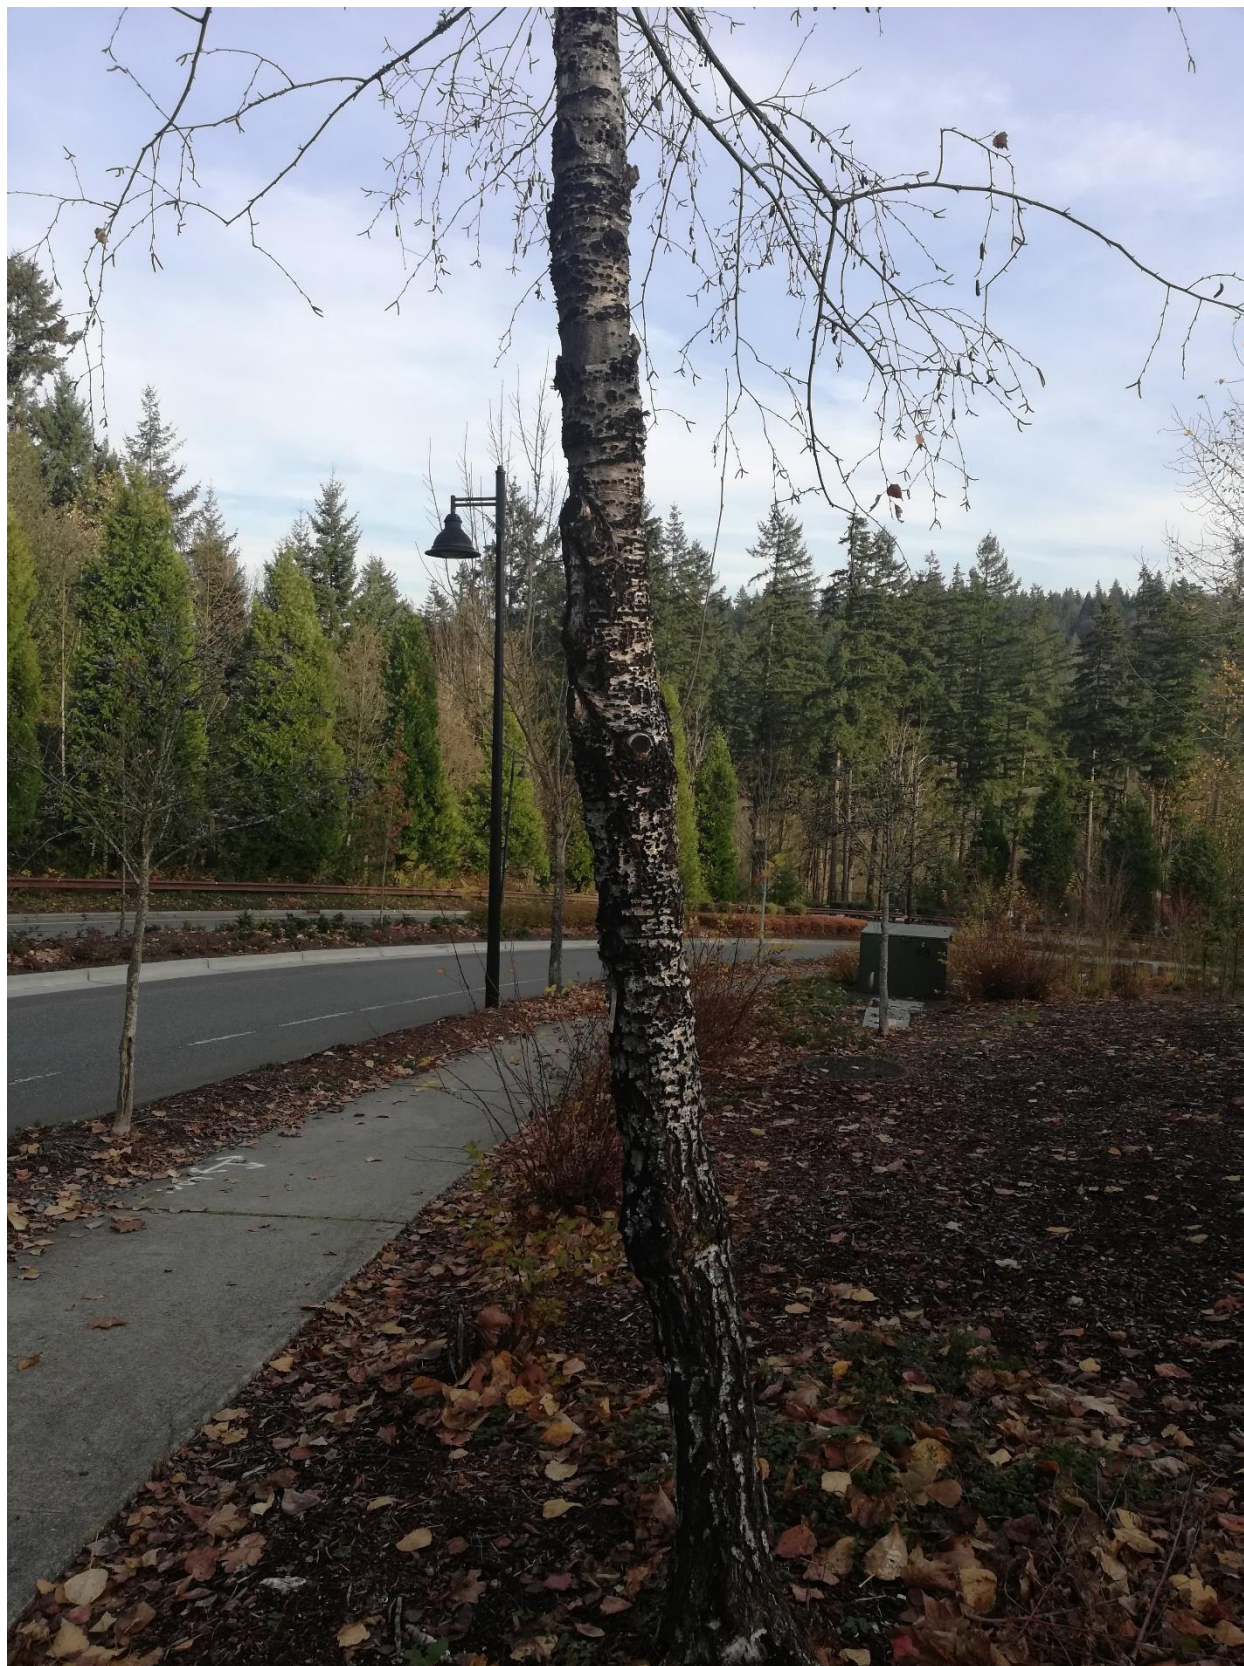
Bronze birch borer damage

I recommend not to use any birch trees since the bronze birch borer is a real threat to our birch trees and is already in the area and is on the site. Sitka spruces can be used in the more wet areas, but other spruces should be planted only if they will be the only tree in a large open spot with well-draining soil and will receive full sun.

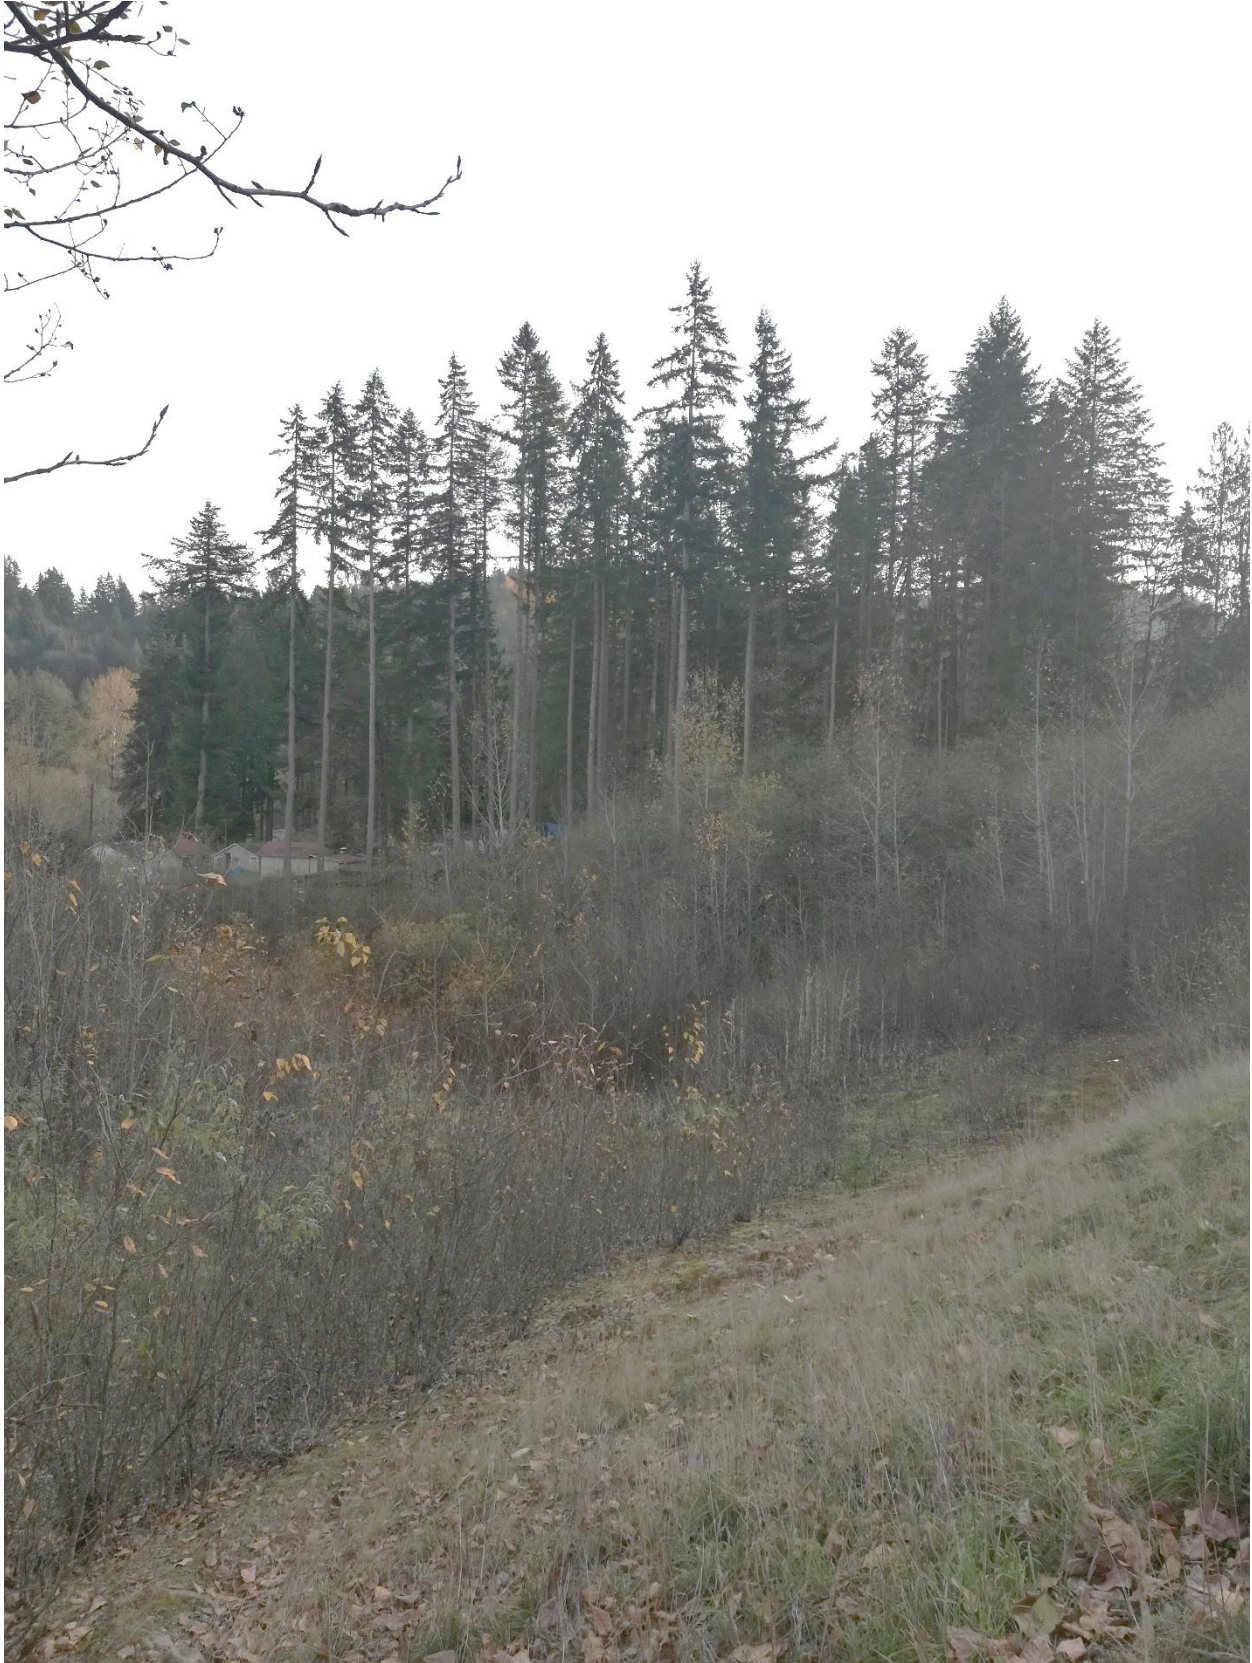
A total of 38 significant trees (alders and cottonwoods for the most part) are needing to be removed because of the construction. None of them are on good health. The site has been logged before and the soil is very poor. The alders and cottonwoods are self-seeded trees naturally growing as the pioneer species moving into a disturbed area with very poor soil health.

Sprouted seedling alders and cottonwood trees growing on the site currently
