Greenwich Central Middle School Systems Evaluation

DTC Project No. 17501.B07

**SUBJECT: GREENWICH CENTRAL MIDDLE SCHOOL SYSTEMS EVALUATION
DTC PROJECT NO. 17501**

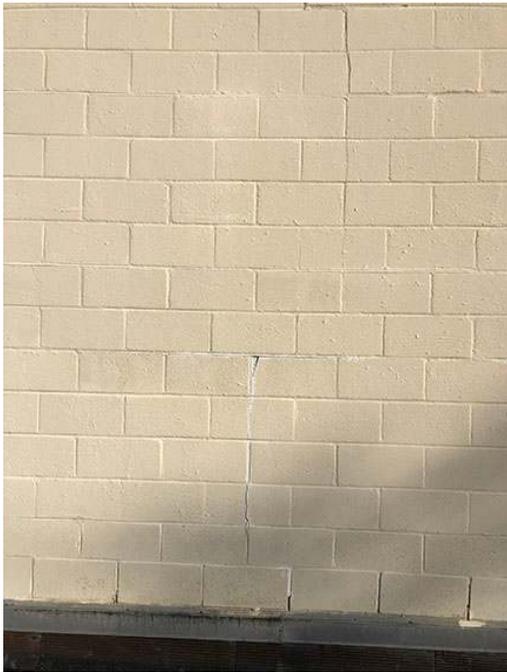
Photo 21. Cracks in CMU Auditorium wall

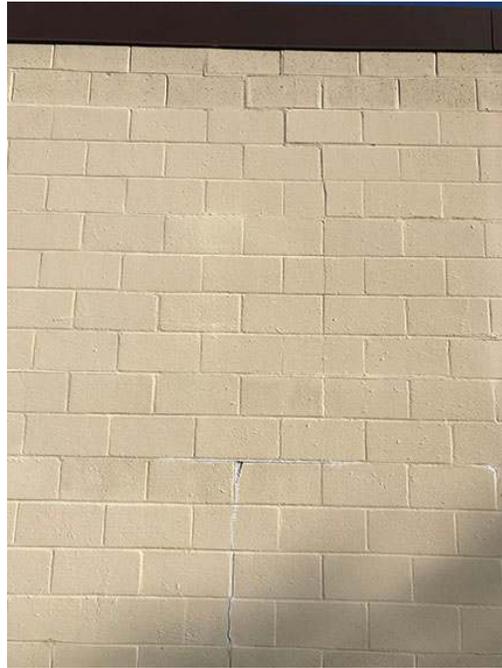
Photo 22. Crack in CMU Auditorium wall

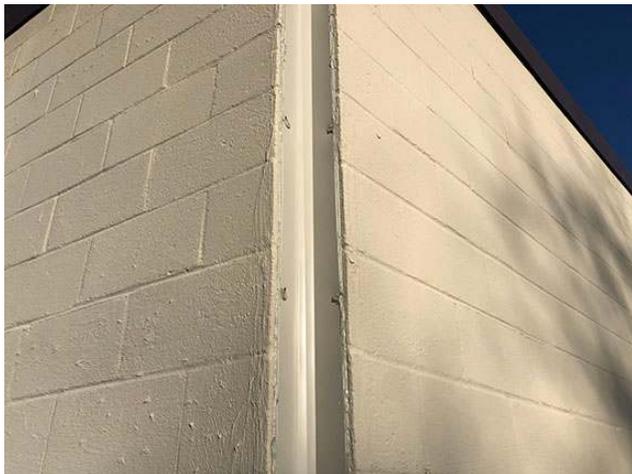
Photo 23. Corner detail in Auditorium wall with cover plate added

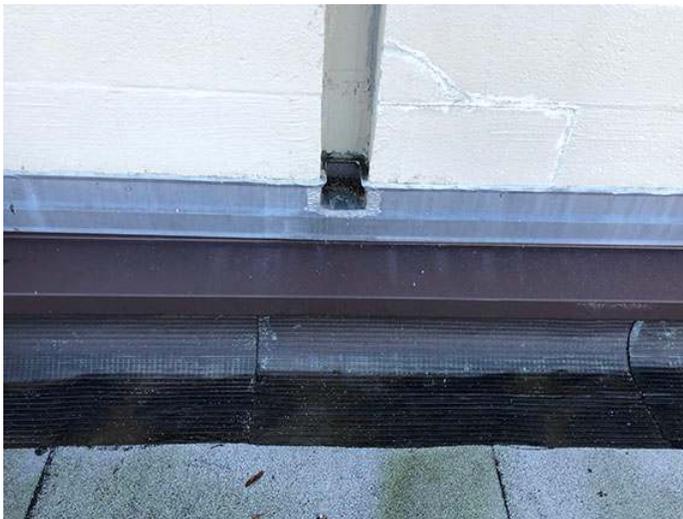
Photo 27. Cracked masonry along recess in Auditorium wall

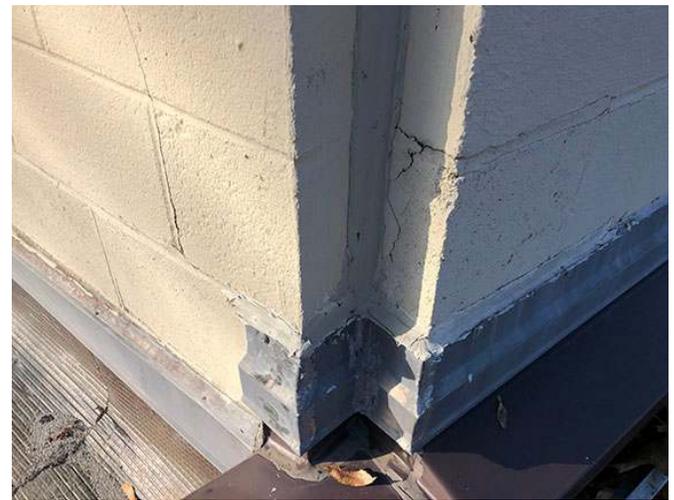
Photo 28. Spalled masonry at corner of Auditorium wall along expansion joint

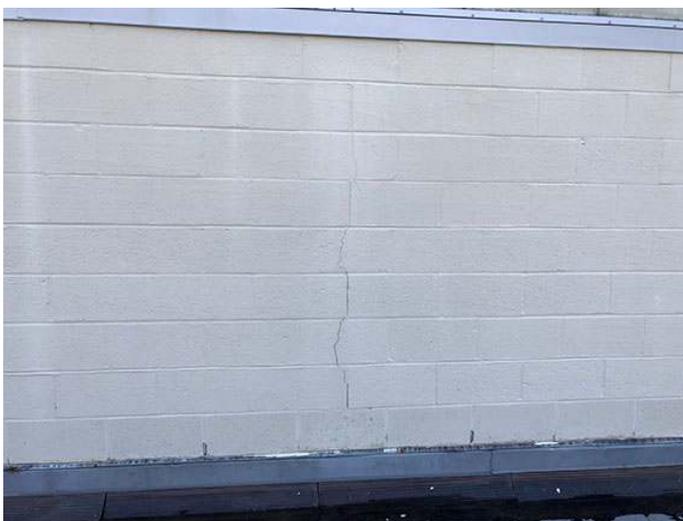
Photo 29. Crack in CMU gymnasium wall

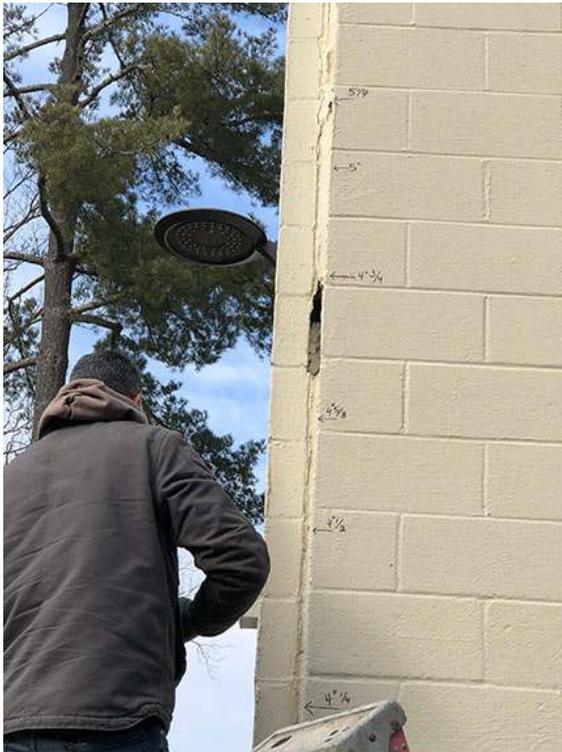
Photo 30. Patch at corner of Gymnasium wall - markers showing bow in masonry wall

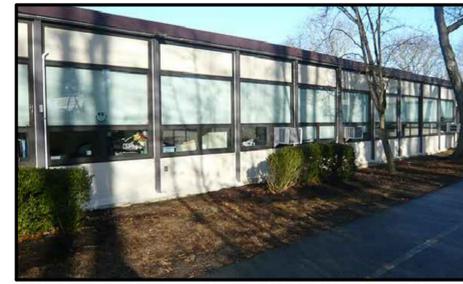
PHOTO 2: TYPICAL FENESTRATION SHOWING EXPOSED STEEL COLUMNS WITH INFILL OF WINDOW WALL SYSTEM AND CONCRETE MASONRY UNITS.

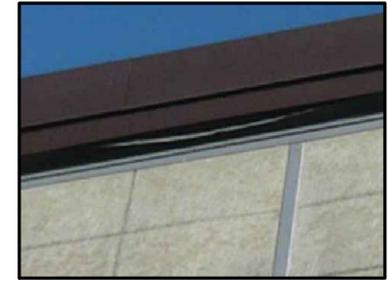
PHOTO 6: EXAMPLE OF TYPICAL METAL EDGE FACIA MATERIAL IN NEED OF REPAIR.

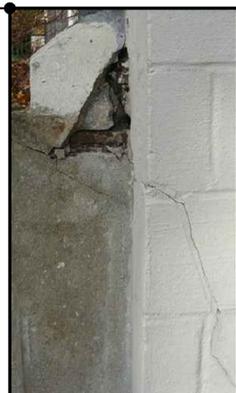
PHOTO 7: TYPICAL DETERIORATION OF CONCRETE AT BASE OF PERIMETER STEEL COLUMNS ALLOWING FOR WATER INFILTRATION WHICH IN TURN PERMITS RUSTING OF STEEL COLUMN BASE PLATE AND CRACKING OF CMU.

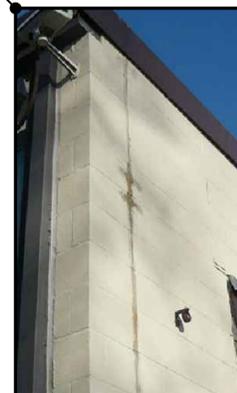
PHOTO 8: VERTICAL CRACK IN CMU WALL. NOTE EVIDENCE OF MOISTURE PENETRATION.

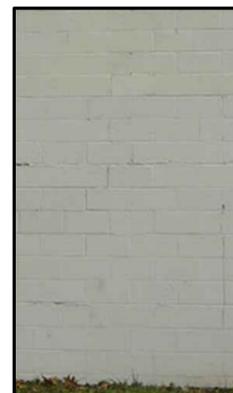
PHOTO 9: TYPICAL HAIR LINE CRACKS IN MASONRY. OBSERVATION INDICATES SEVERAL COATS OF PAINT HAVE BEEN APPLIED OVER EXISTING CRACKS.

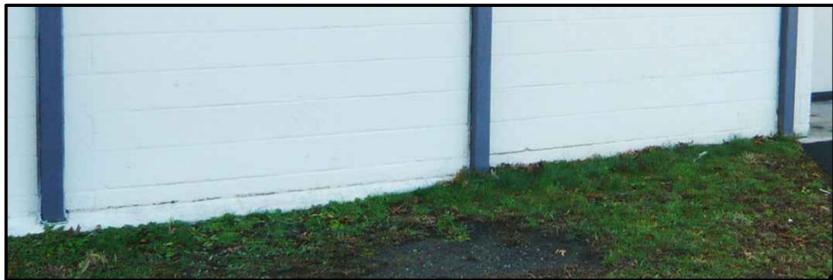
PHOTO 10: EXPOSED TYPICAL CRACK WHERE BASE OF MASONRY WALL MEETS CONCRETE FLOOR SLAB.

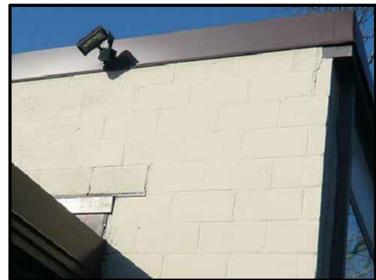
PHOTO 11: TYPICAL INCORRECT FLASHING DETAIL WHERE ROOF MEETS MASONRY WALL. EDGE OF FLASHING EXPOSED WITH OPEN LAPS DUE TO LACK OF TERMINATION BAR. NOTE TYPICAL CRACK AT BUILDING CORNER WHERE STEEL STRUCTURE, MASONRY AND ROOF INTERSECT.

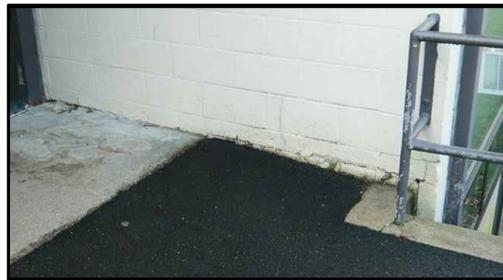
PHOTO 12: BASE OF MASONRY WALL AND ADJACENT SURFACES SHOW EVIDENCE OF SETTLEMENT OF RETAINING WALL AND LANDING.

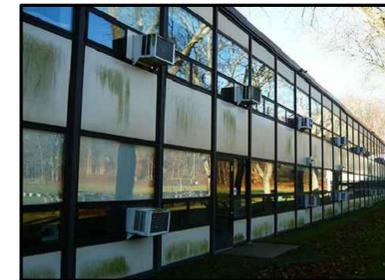
PHOTO 14: THERE ARE LARGE AREAS OF STAINING - PARTICULARLY AT THE NORTHERN FACADES AS SHOWN IN PHOTO.

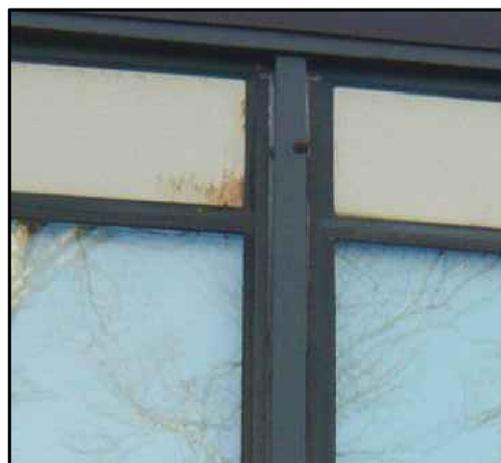
PHOTO 15: NOTE INDICATION OF RUSTING AT METAL PANELS. (TYPICAL).

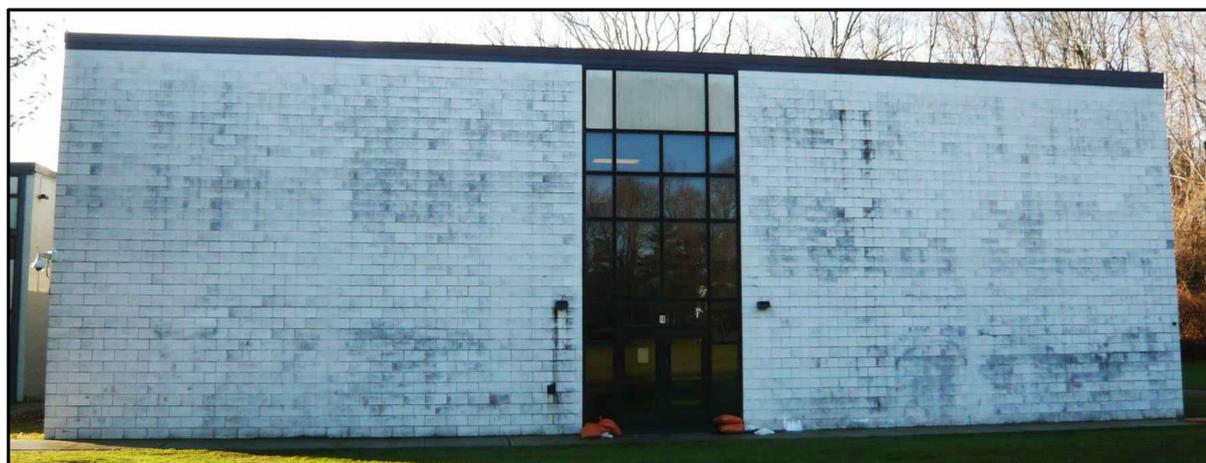
PHOTO 16: LARGE AREAS OF MASONRY STAINING AT MEDIA/COMPUTER WING. STAINING COULD BE EVIDENCE OF IMPROPER OR DEFECTIVE COATING.

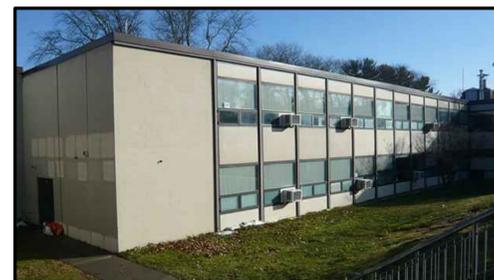
PHOTO 19: EARTH SLOPES TOWARDS SIDE OF BUILDING. POSSIBLE WATER INFILTRATION.

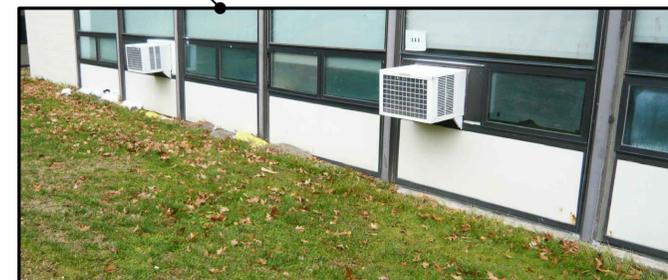
PHOTO 20: SANDBAGS CURRENTLY USED TO PREVENT WATER INFILTRATION. TYPICALLY ONLY A BEAD OF CAULK PREVENTS WATER INFILTRATION AROUND PERIMETER OF BUILDING.

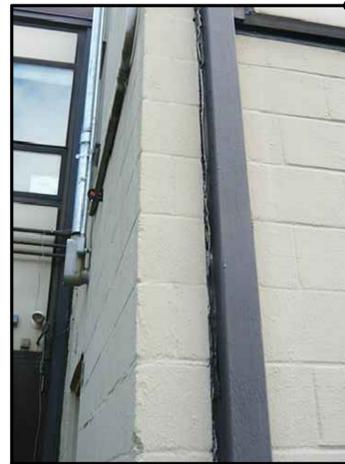
PHOTO 21: TYPICAL DETERIORATION OF JOINT BETWEEN MASONRY AND STRUCTURAL STEEL.

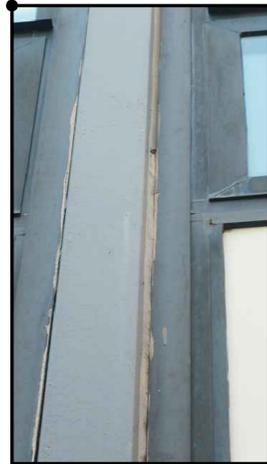
PHOTO 22: TYPICAL DETERIORATION OF JOINT BETWEEN WINDOW WALL SYSTEM AND STRUCTURAL STEEL.

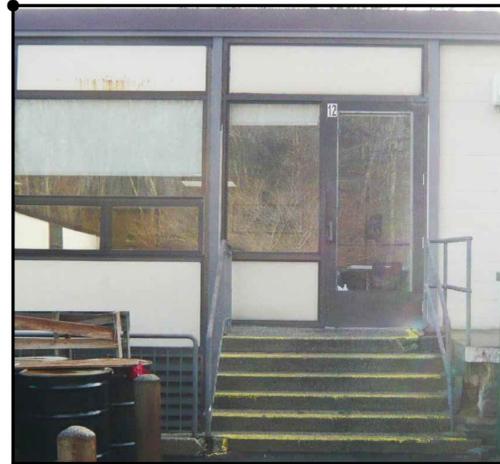
PHOTO 24: DETERIORATION OF STONWORK, CONCRETE, RAILINGS, ETC. ARE EXAMPLES OF TYPICAL CONDITIONS FOR APPURTENANCES ON STRUCTURE.

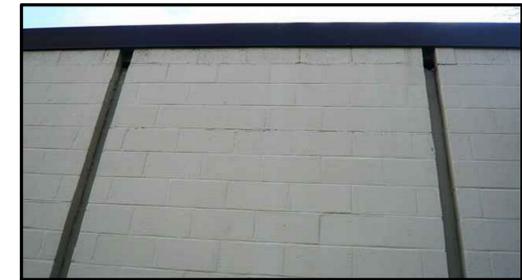
PHOTO 25: GROUT DISPLACEMENT OVER LARGE AREAS TYPICAL INDICATION OF MOVEMENT IN MASONRY.

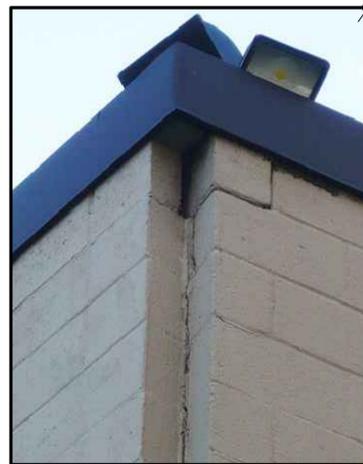
PHOTO 26: VERTICAL CRACK TYPICAL OF ALL BUILDING CORNERS ARE A RESULT OF MOVEMENT IN MASONRY AND IS AN EXAMPLE OF POOR DETAILING OF ORIGINAL BUILDING. MANY OPEN CRACKS (AS SHOWN IN PHOTO) HAVE BEEN AND CONTINUE TO BE REPAIRED AS NEEDED.

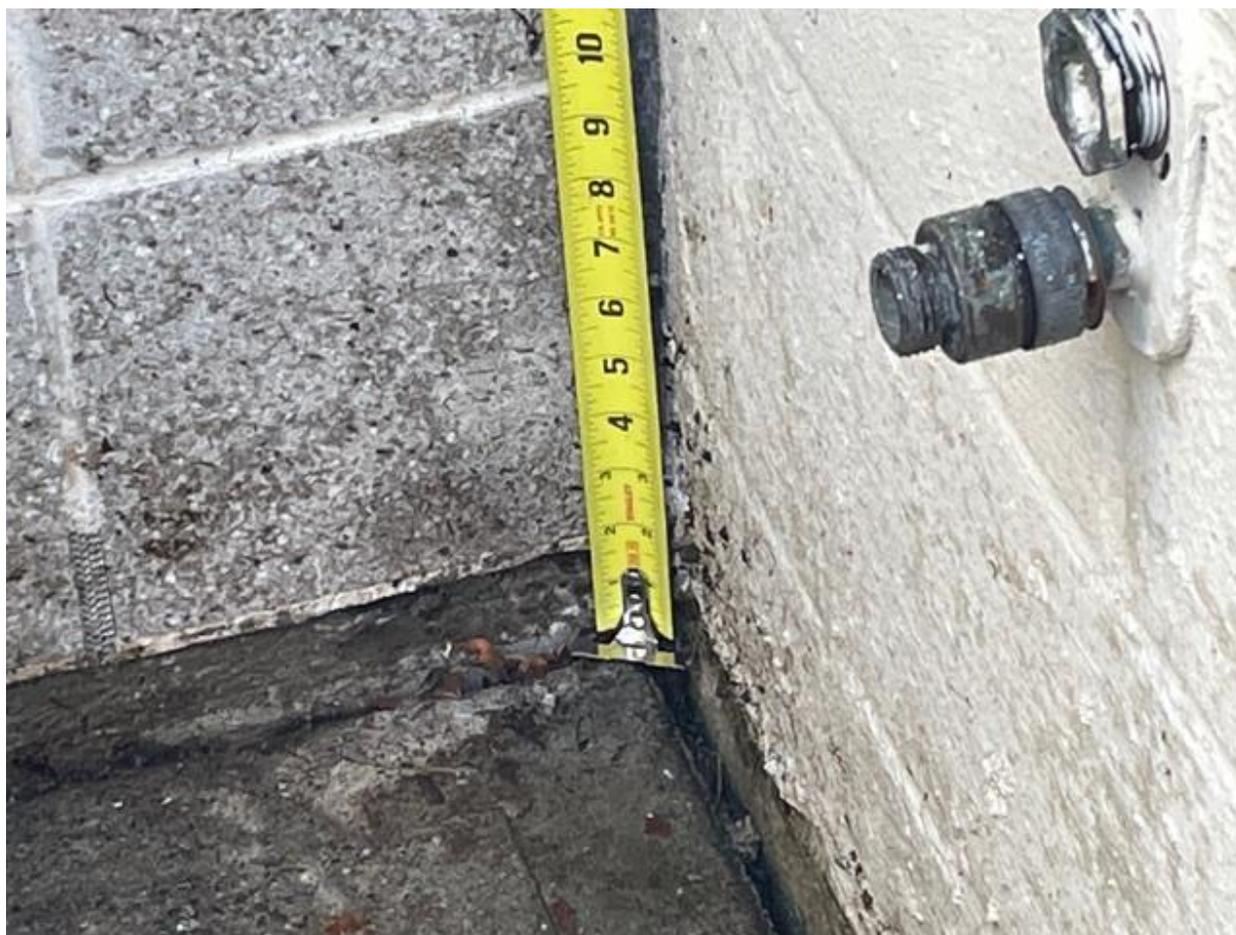
Figure 1 - Concrete sidewalk has sunken approximately 1-3/4" throughout this area due to loss of fines which is the result of repeated flooding due to inadequacy in the storm drainage system.

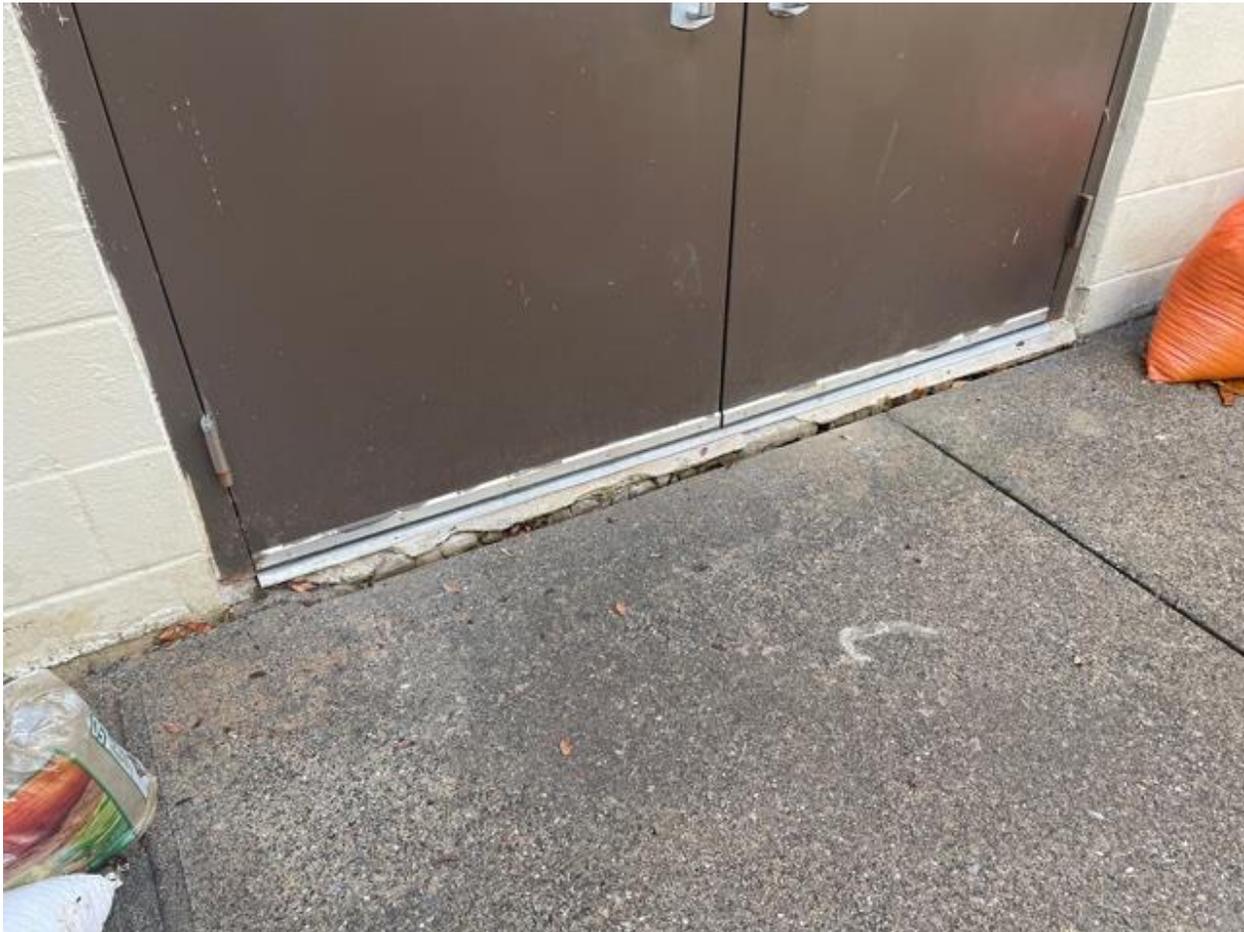
Figure 2 - View of door threshold where the slab has sunken due to loss of fines.

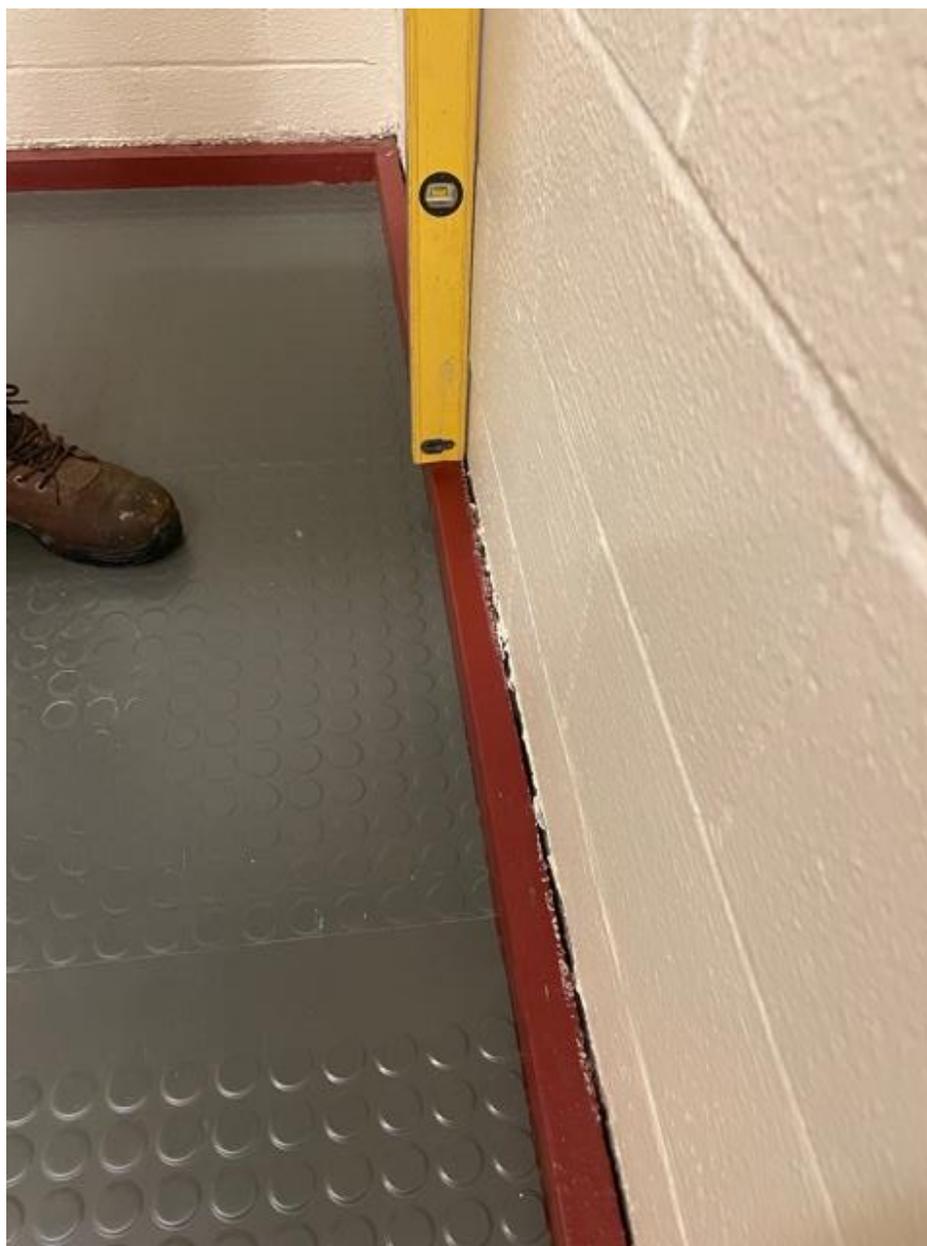
Figure 3 - Exterior wall above the doorway in Figure 2 is leaning away from the building evidenced by the batter of the wall and opening between steel deck at stairwell.

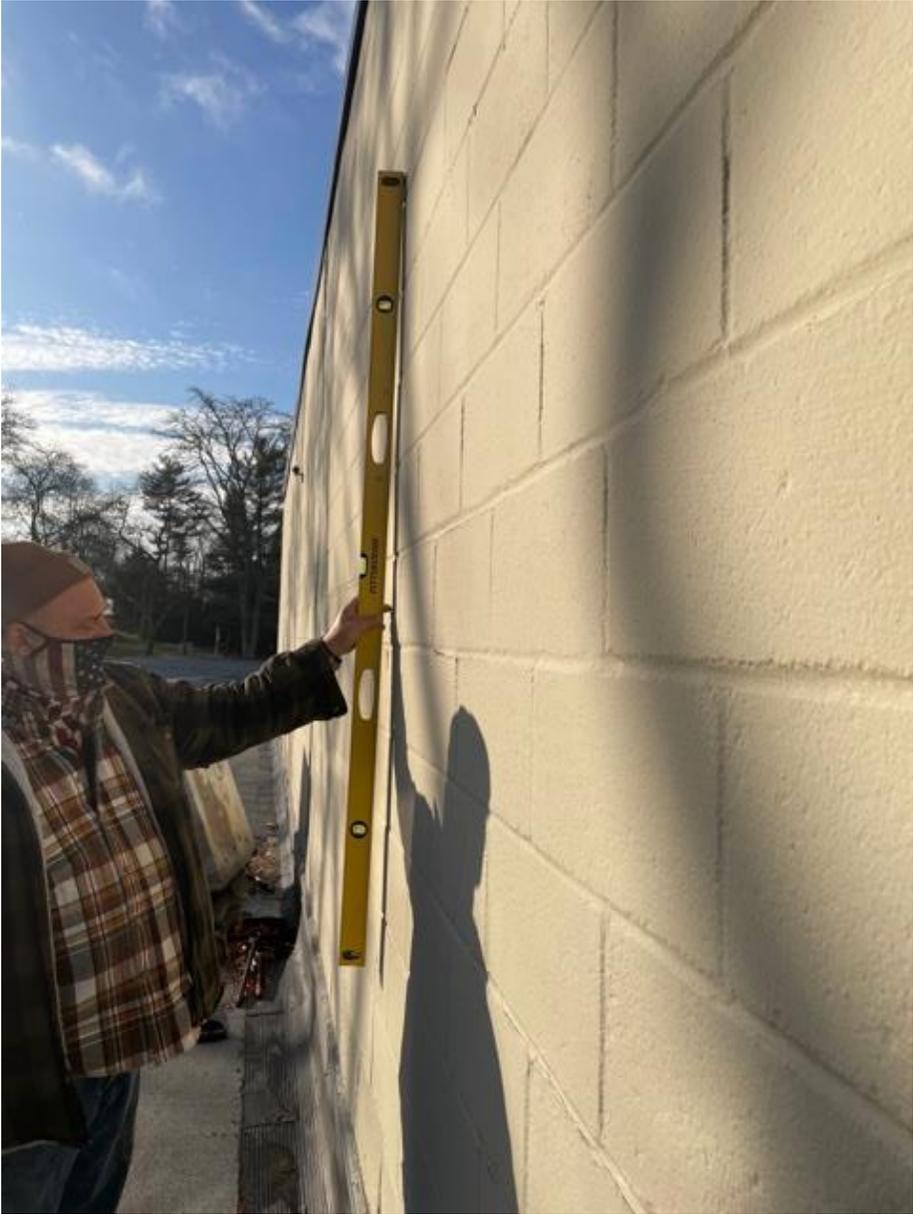
Figure 4 - Facade leaning outward from building evidenced by the level.

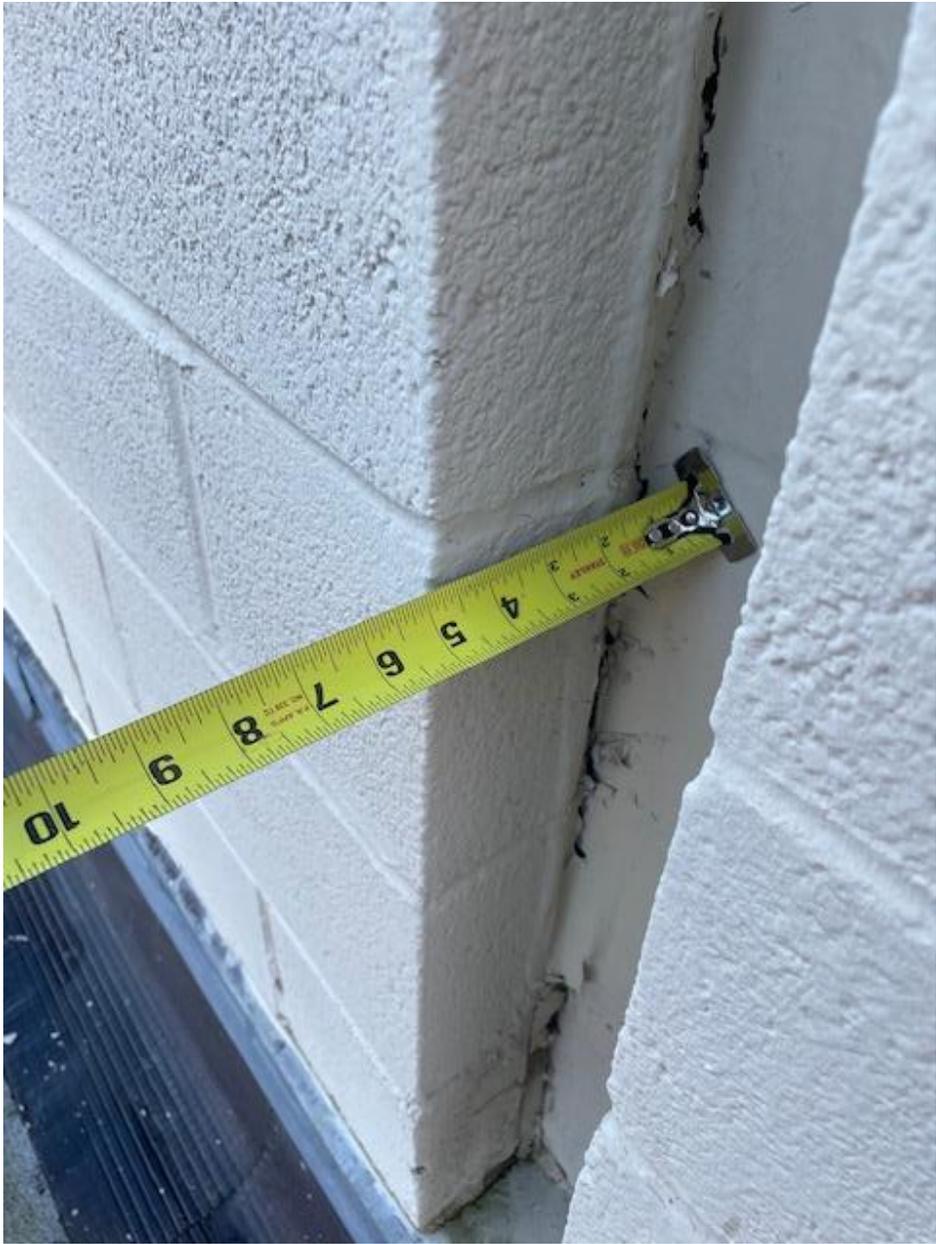
Figure 5 - The base of the facade projects 4" from the CMU wall where in this location the facade is leaning out 4-3/4" from the face of the CMU block.

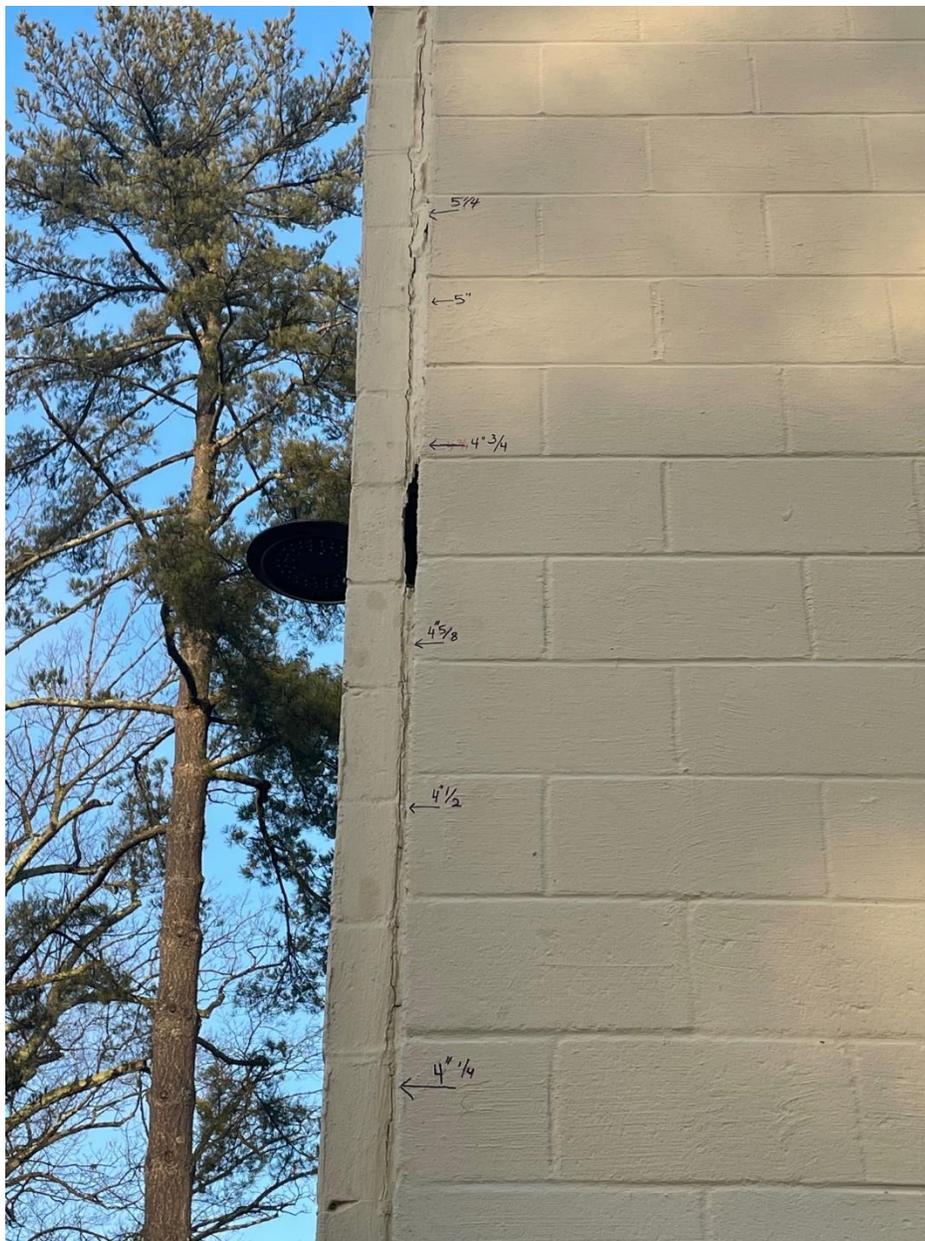
Figure 6 - We marked the degree of batter at the corner of the gymnasium, where the batter away from the building ranges from 4" at the base to 5-1/2" measured roughly 12' from the base of the wall.

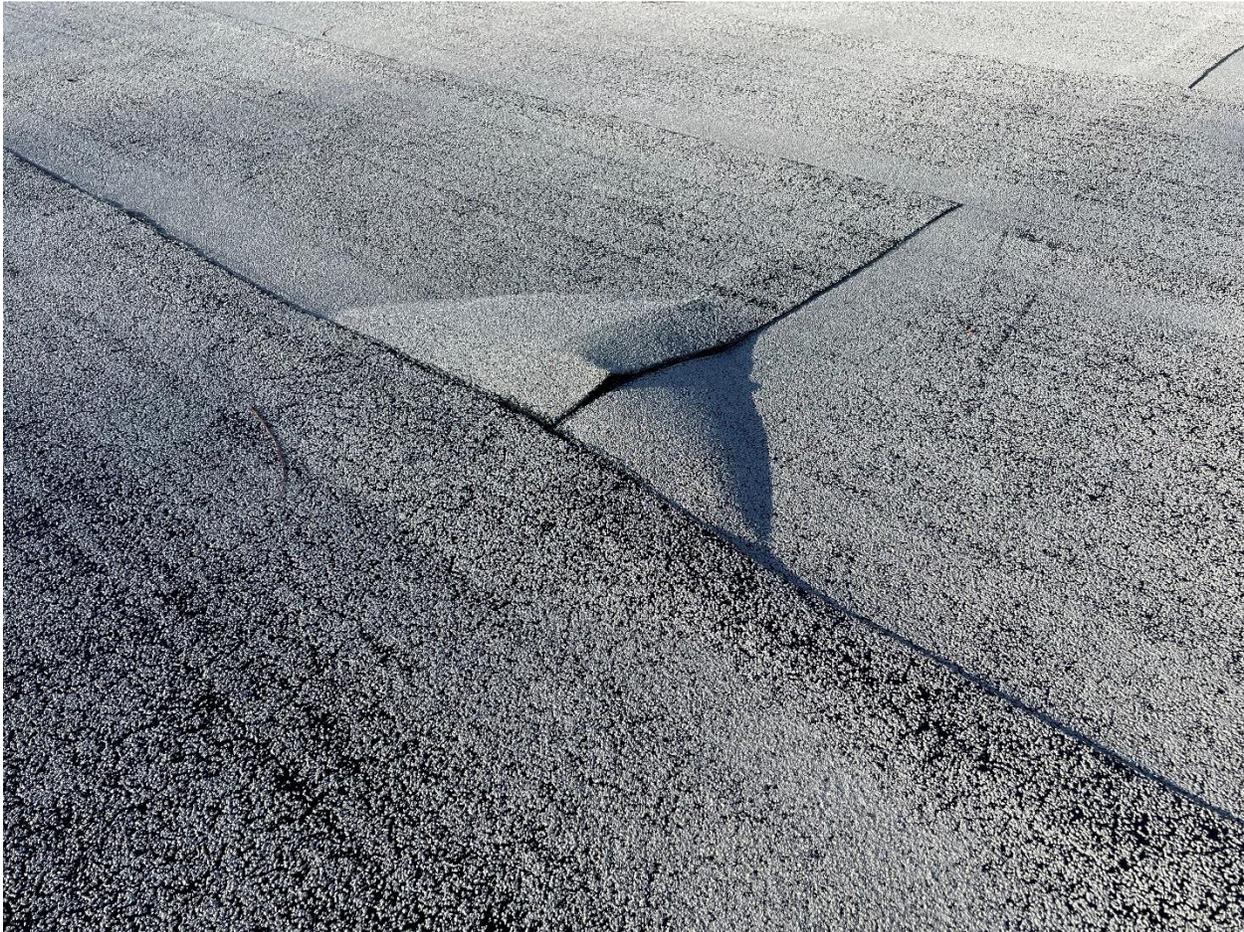
Figure 7 - Blistering was observed throughout the building, with a significant number of bird bath puddles throughout the roof.

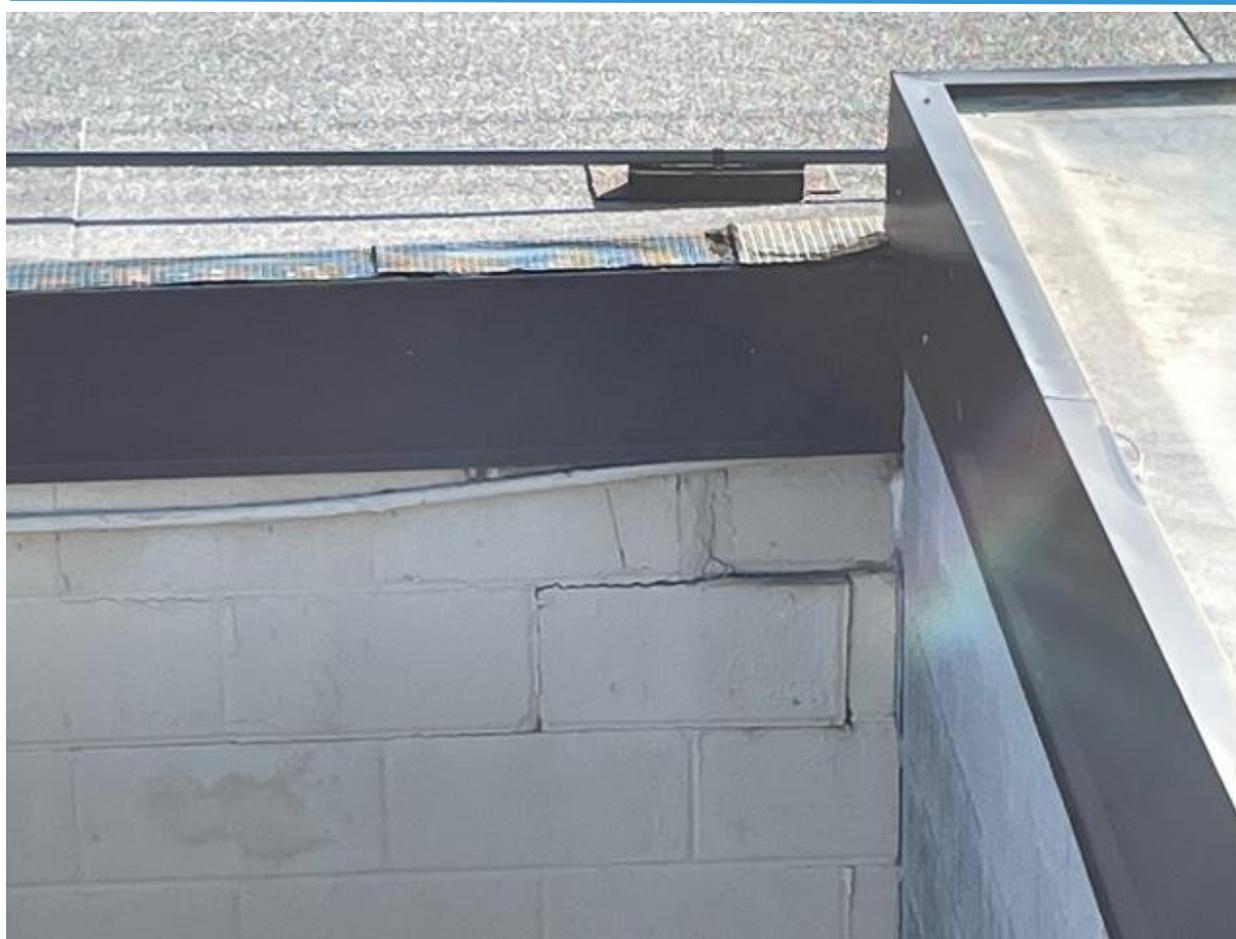
Figure 8 - Flashing details are not sufficiently flexible or waterproof to prevent water infiltration and ice and water damage to upper courses of the facade.

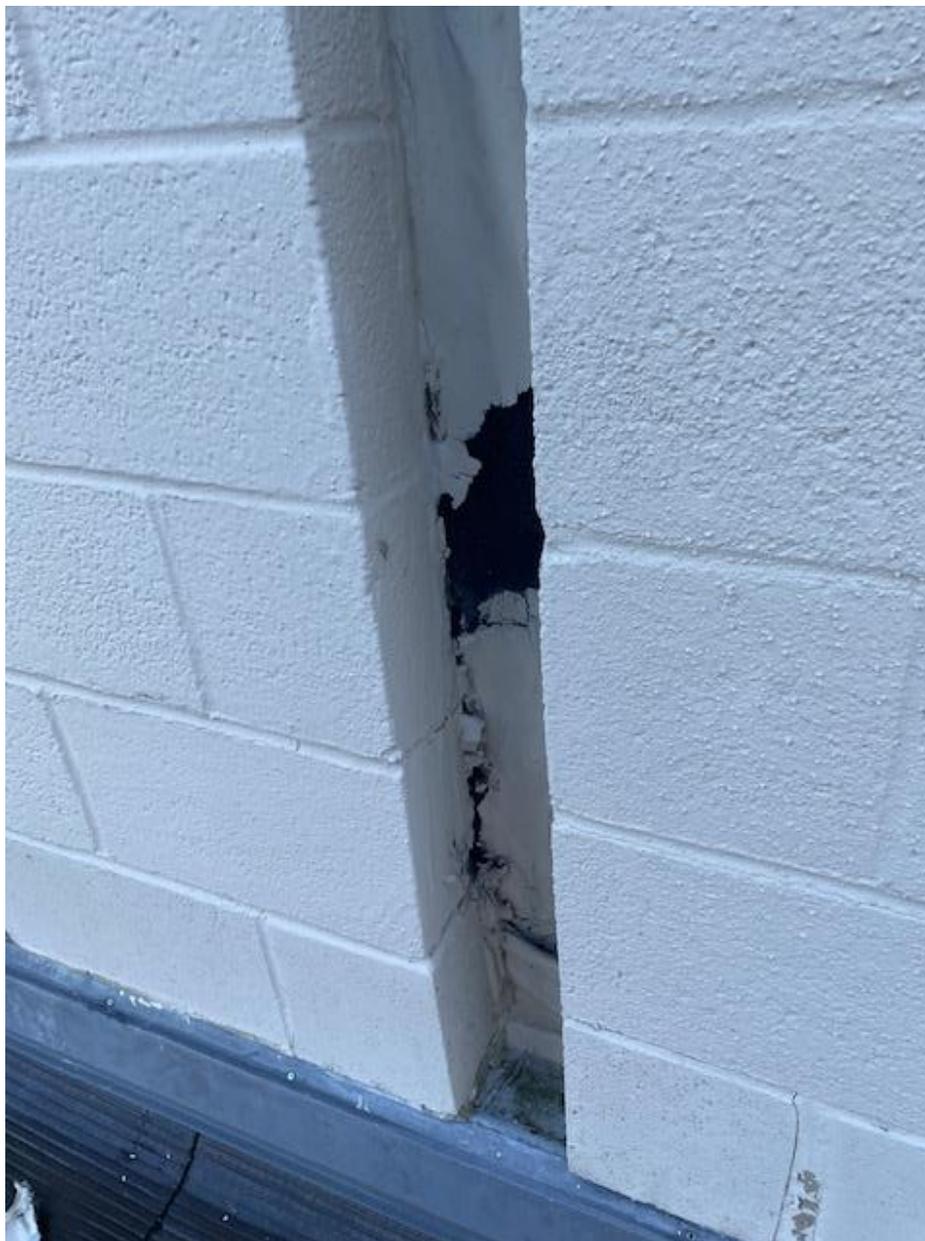
Figure 9 - A combination of design details, flashing, and water proof membrane result in water damage to architectural features. We observed repeated efforts to repair these conditions throughout the original building.

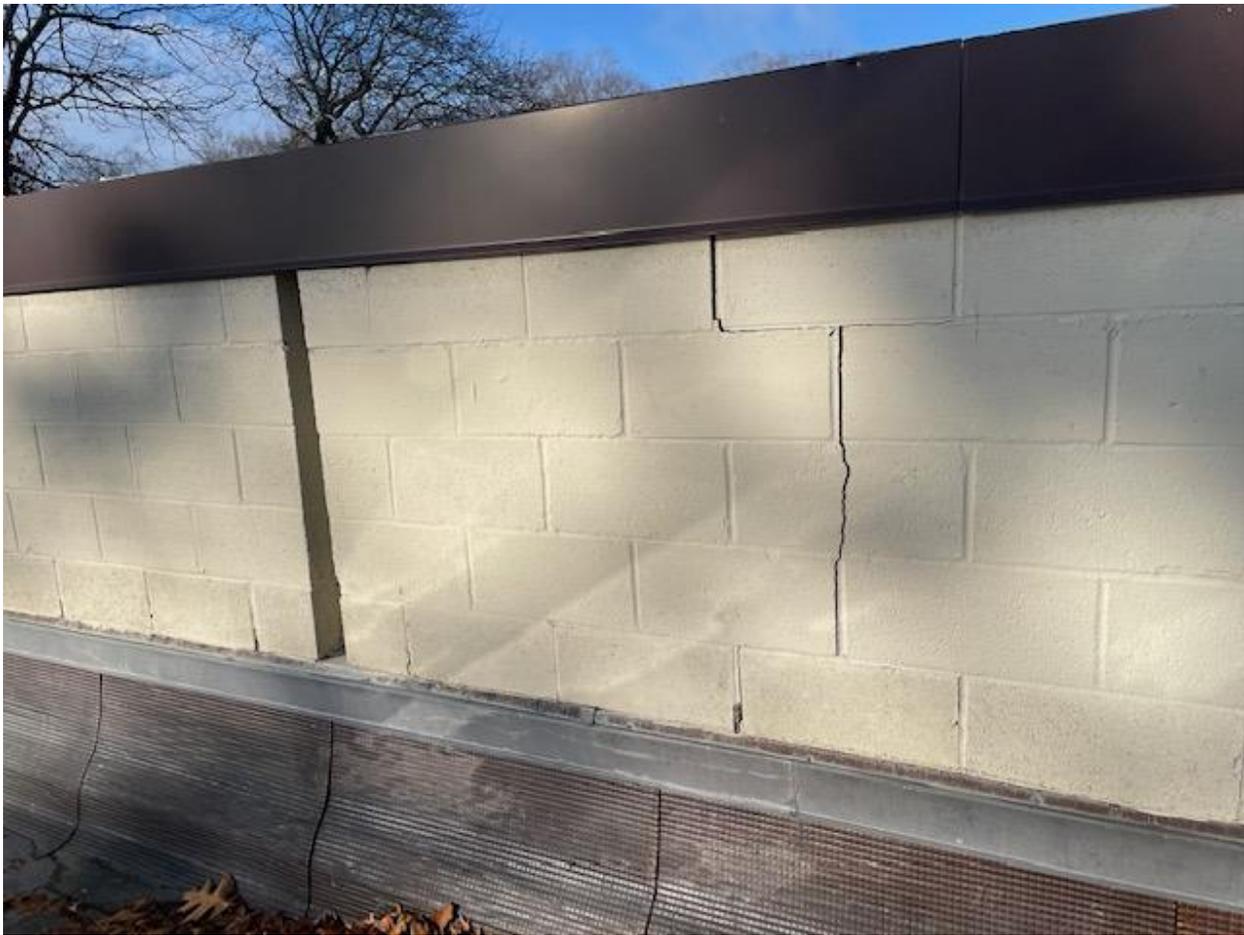
Figure 10 - Severe cracking in the facade due to water and ice damaged. We observed repeated efforts to patch repair these conditions throughout the original building.

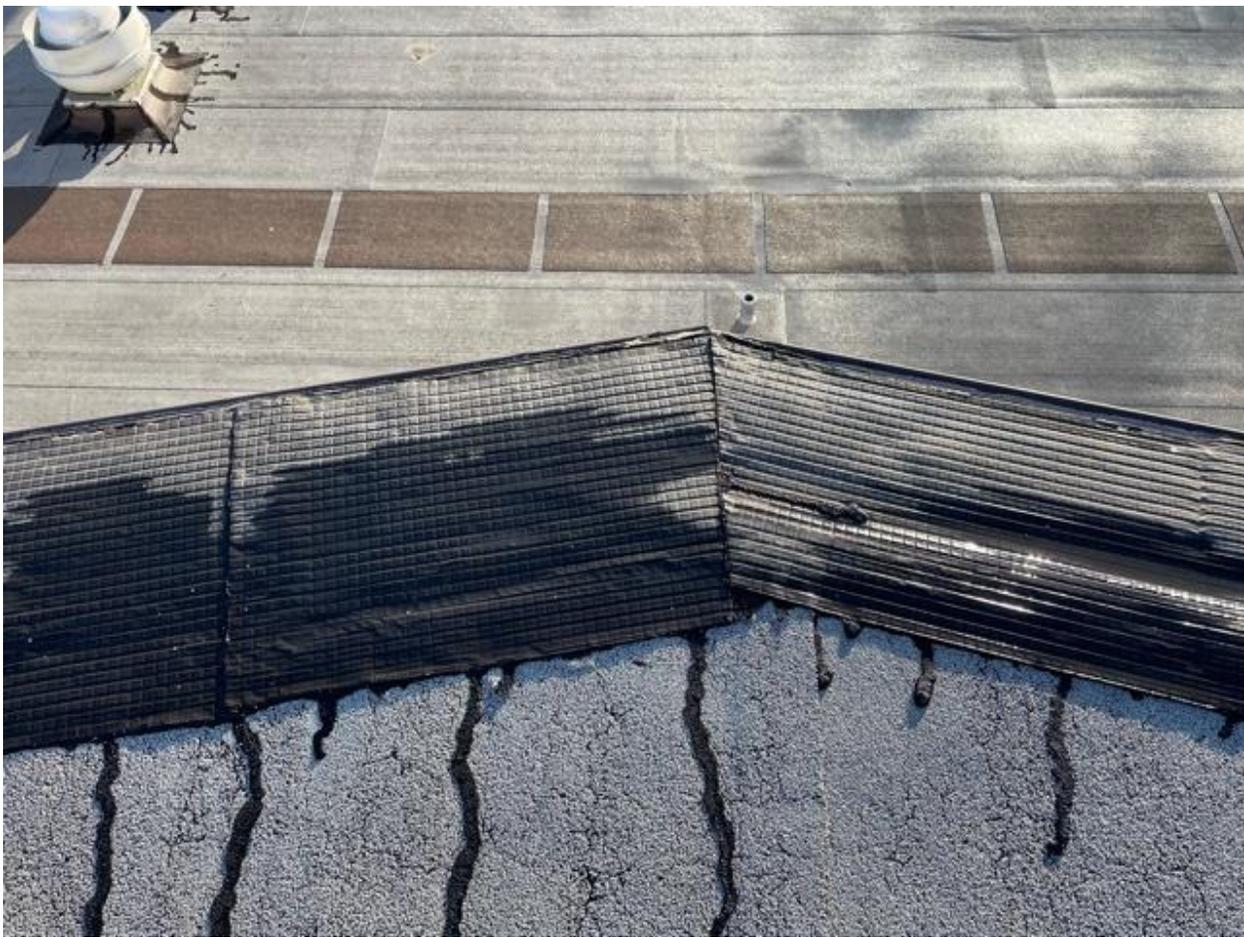
Figure 11 - The roof membrane flashing details are not suitable for protection of the facades from ice and water damage, where this mopped down bituminous membrane and flashing systems are not sufficiently flexible for the design of exterior walls.

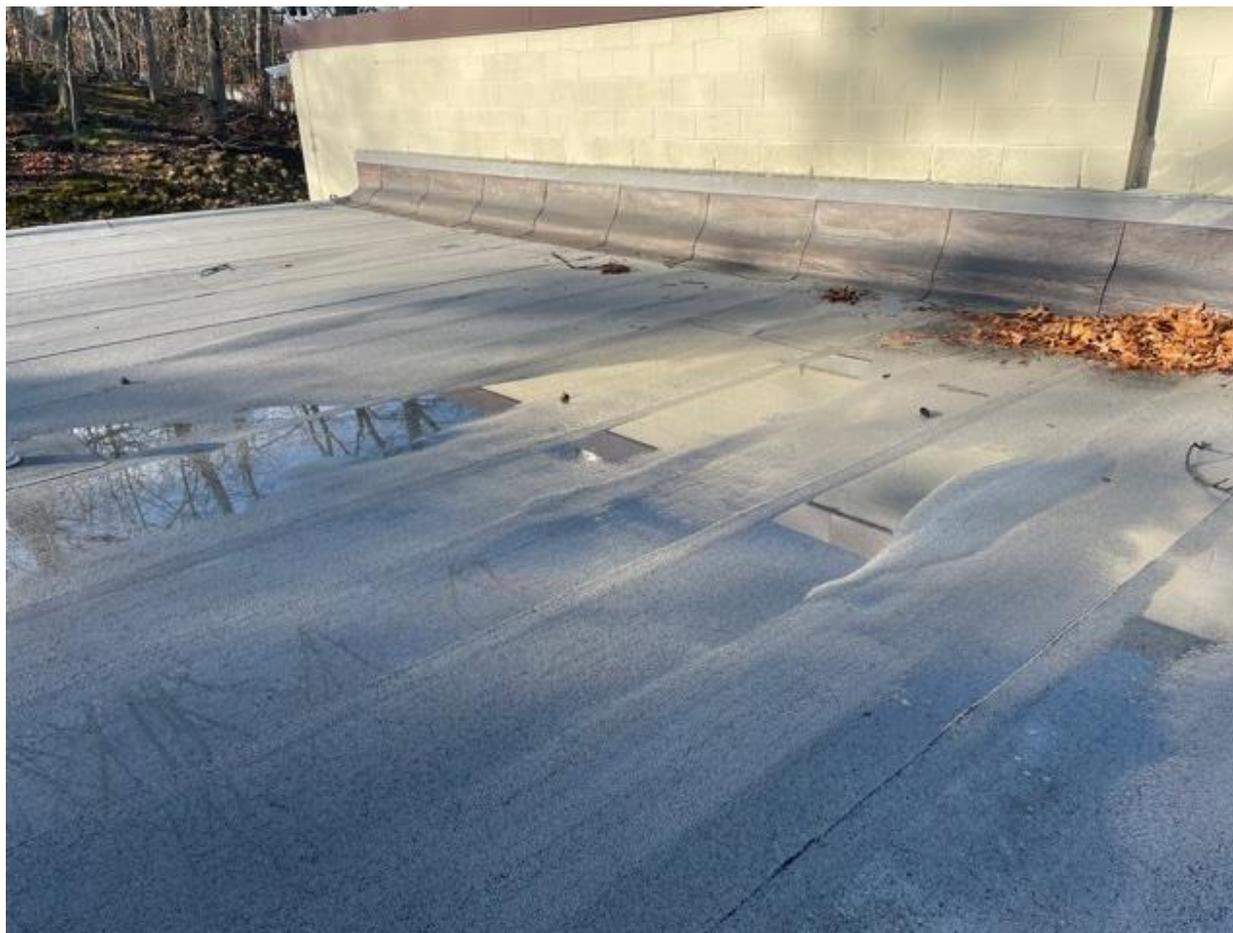
Figure 12 - Bid bath puddles and blister are systemic throughout the existing roof membrane protecting the original building. This indicates that the roof membrane is reaching or has pasted its service life.

- 1) We recommend complete replacement of the roofing system at all locations down to the original deck and installation of a new fully-adhered EPDM (ethylene-propylene-diene-monomer) over a tapered rigid insulation system with all new flashing and sheet metal. We recommend the use of lead coated copper for all sheet metal, including expansion joints and fascias.

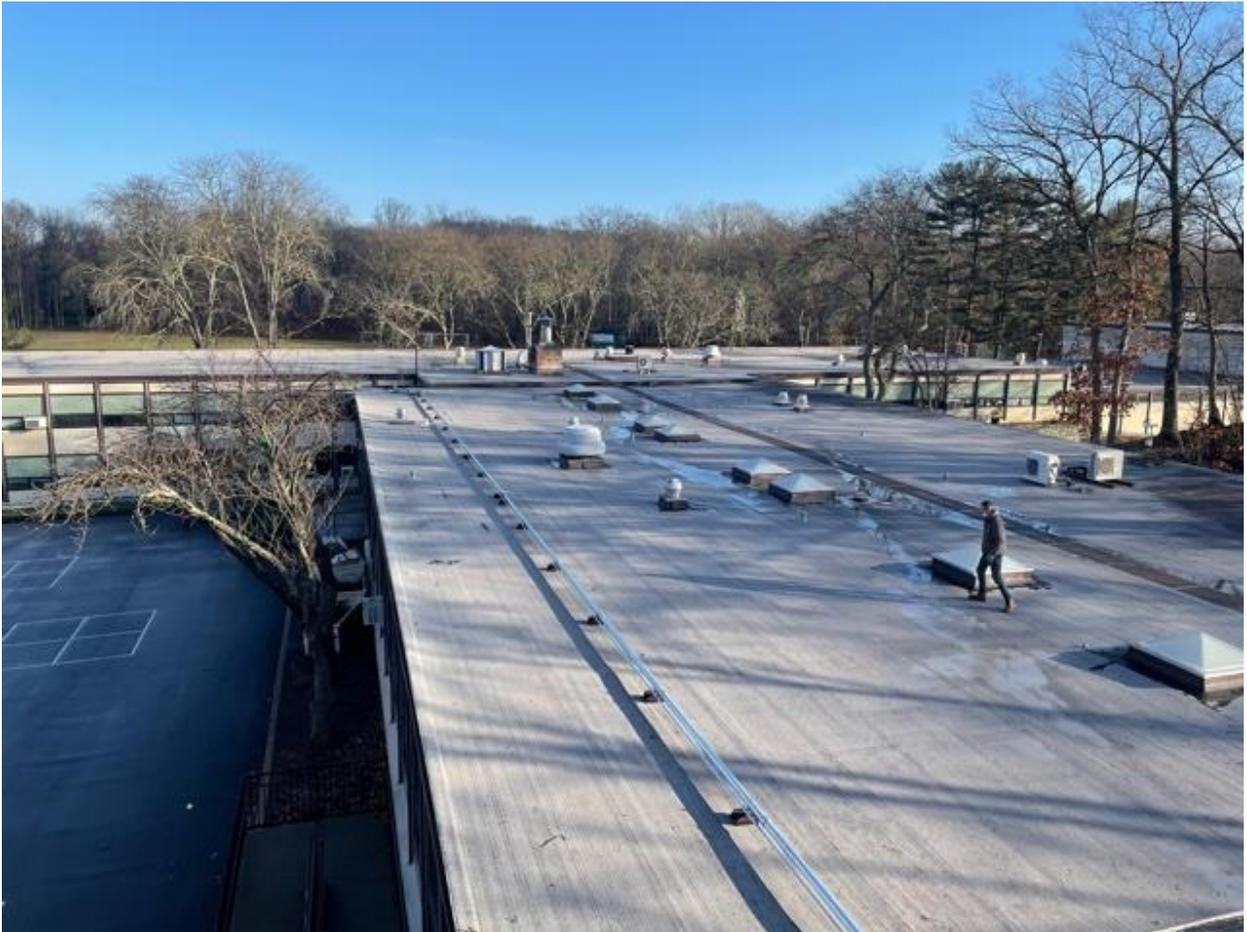
Figure 13 - Panoramic view of the roof membrane over the original building. Bird path puddles and blistering are systemic throughout the roof.

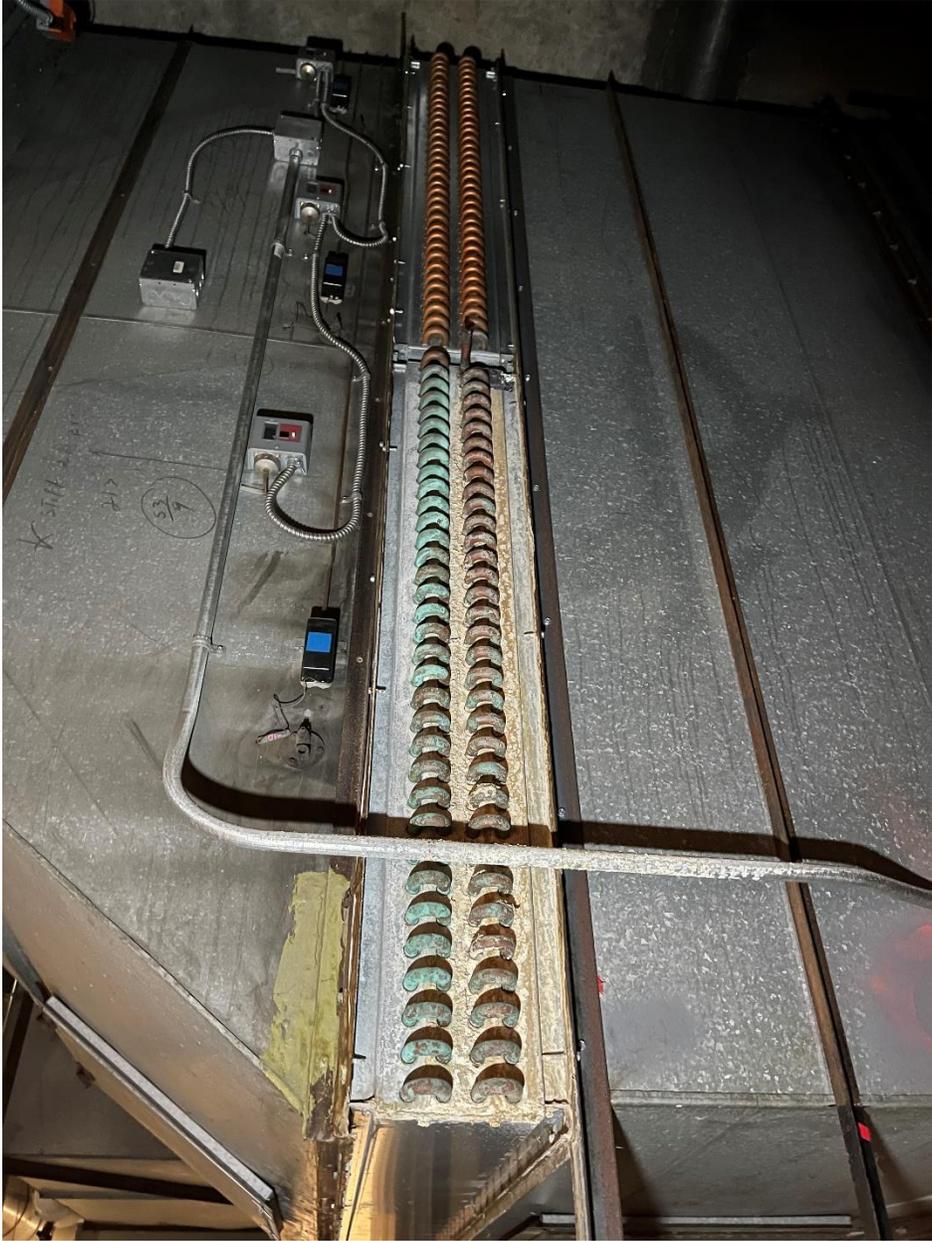
Duct mounted hot-water heating coil in need of replacement directly below recently replace coil section.
