Greenwich Central Middle School Systems Evaluation

DTC Project No. 17501.B07

**SUBJECT: GREENWICH CENTRAL MIDDLE SCHOOL SYSTEMS EVALUATION
DTC PROJECT NO. 17501**

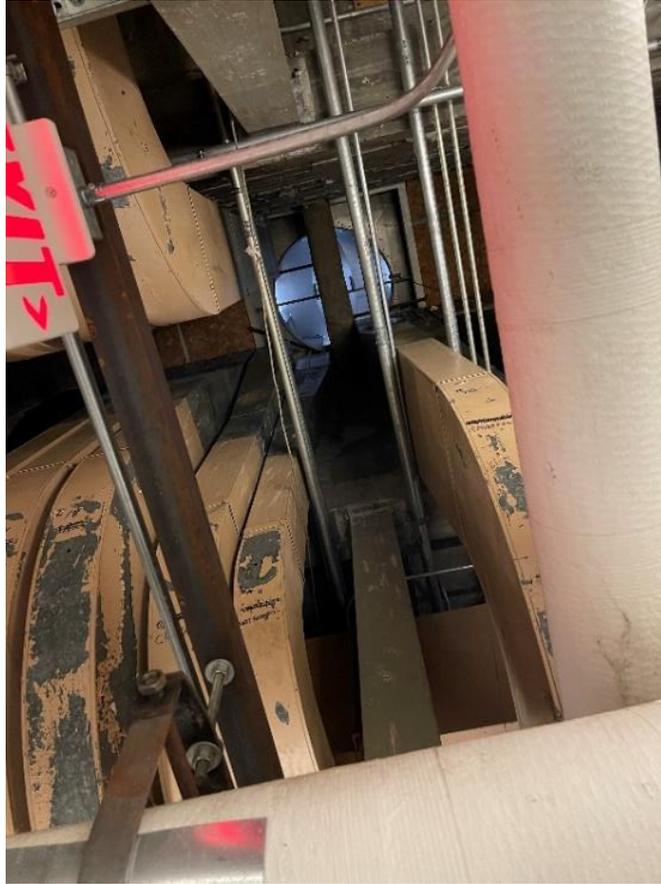
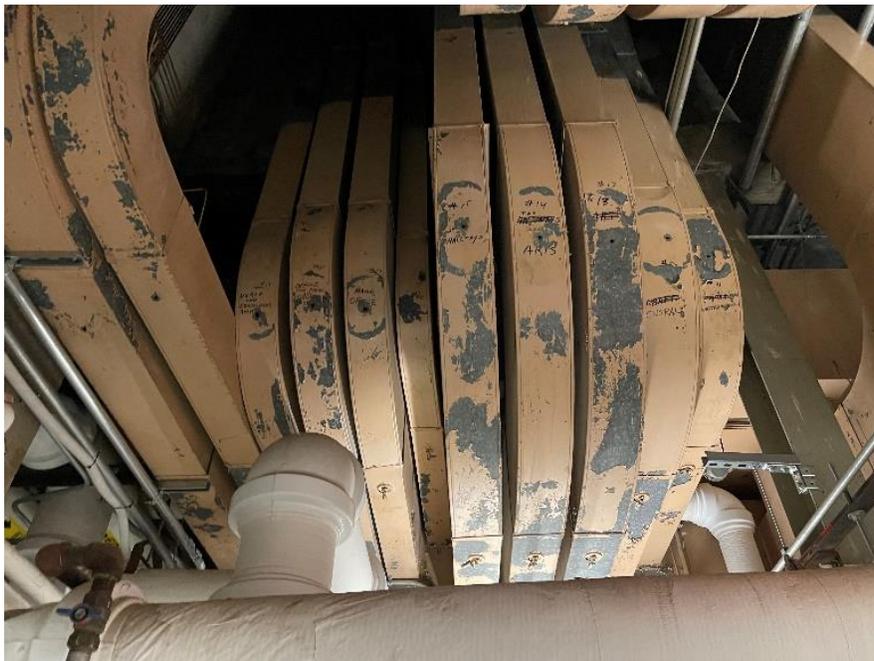
Individual uninsulated zone ductwork up from central station air handling units

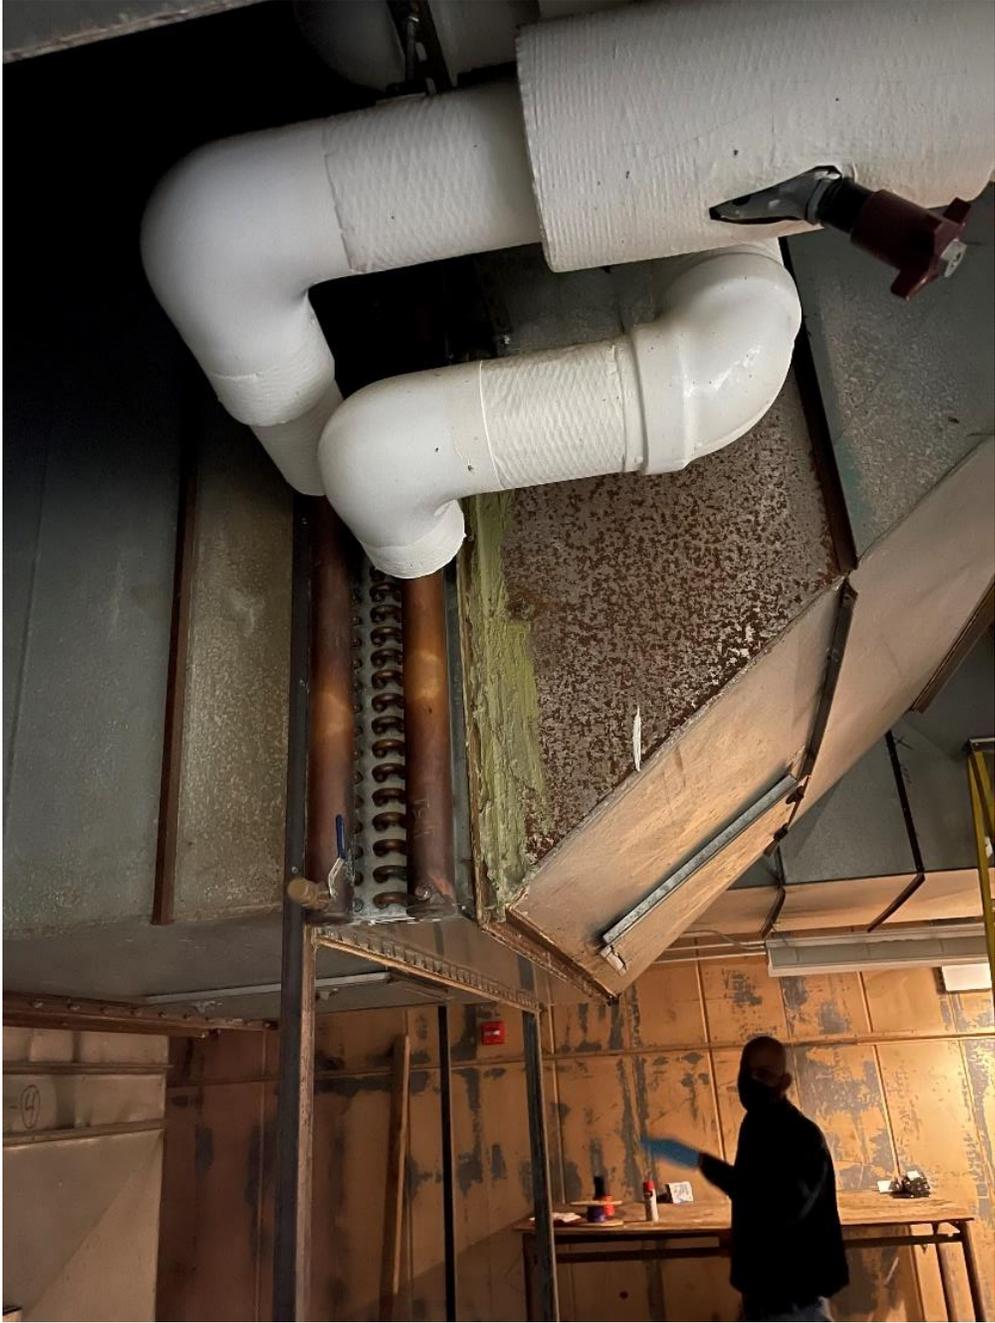
Rust downstream of heating coils
