MEMORANDUM

RE: Tree Preservation for Nebraska Avenue Heritage Trees
WSSI #31089.01

DATE: February 4, 2022

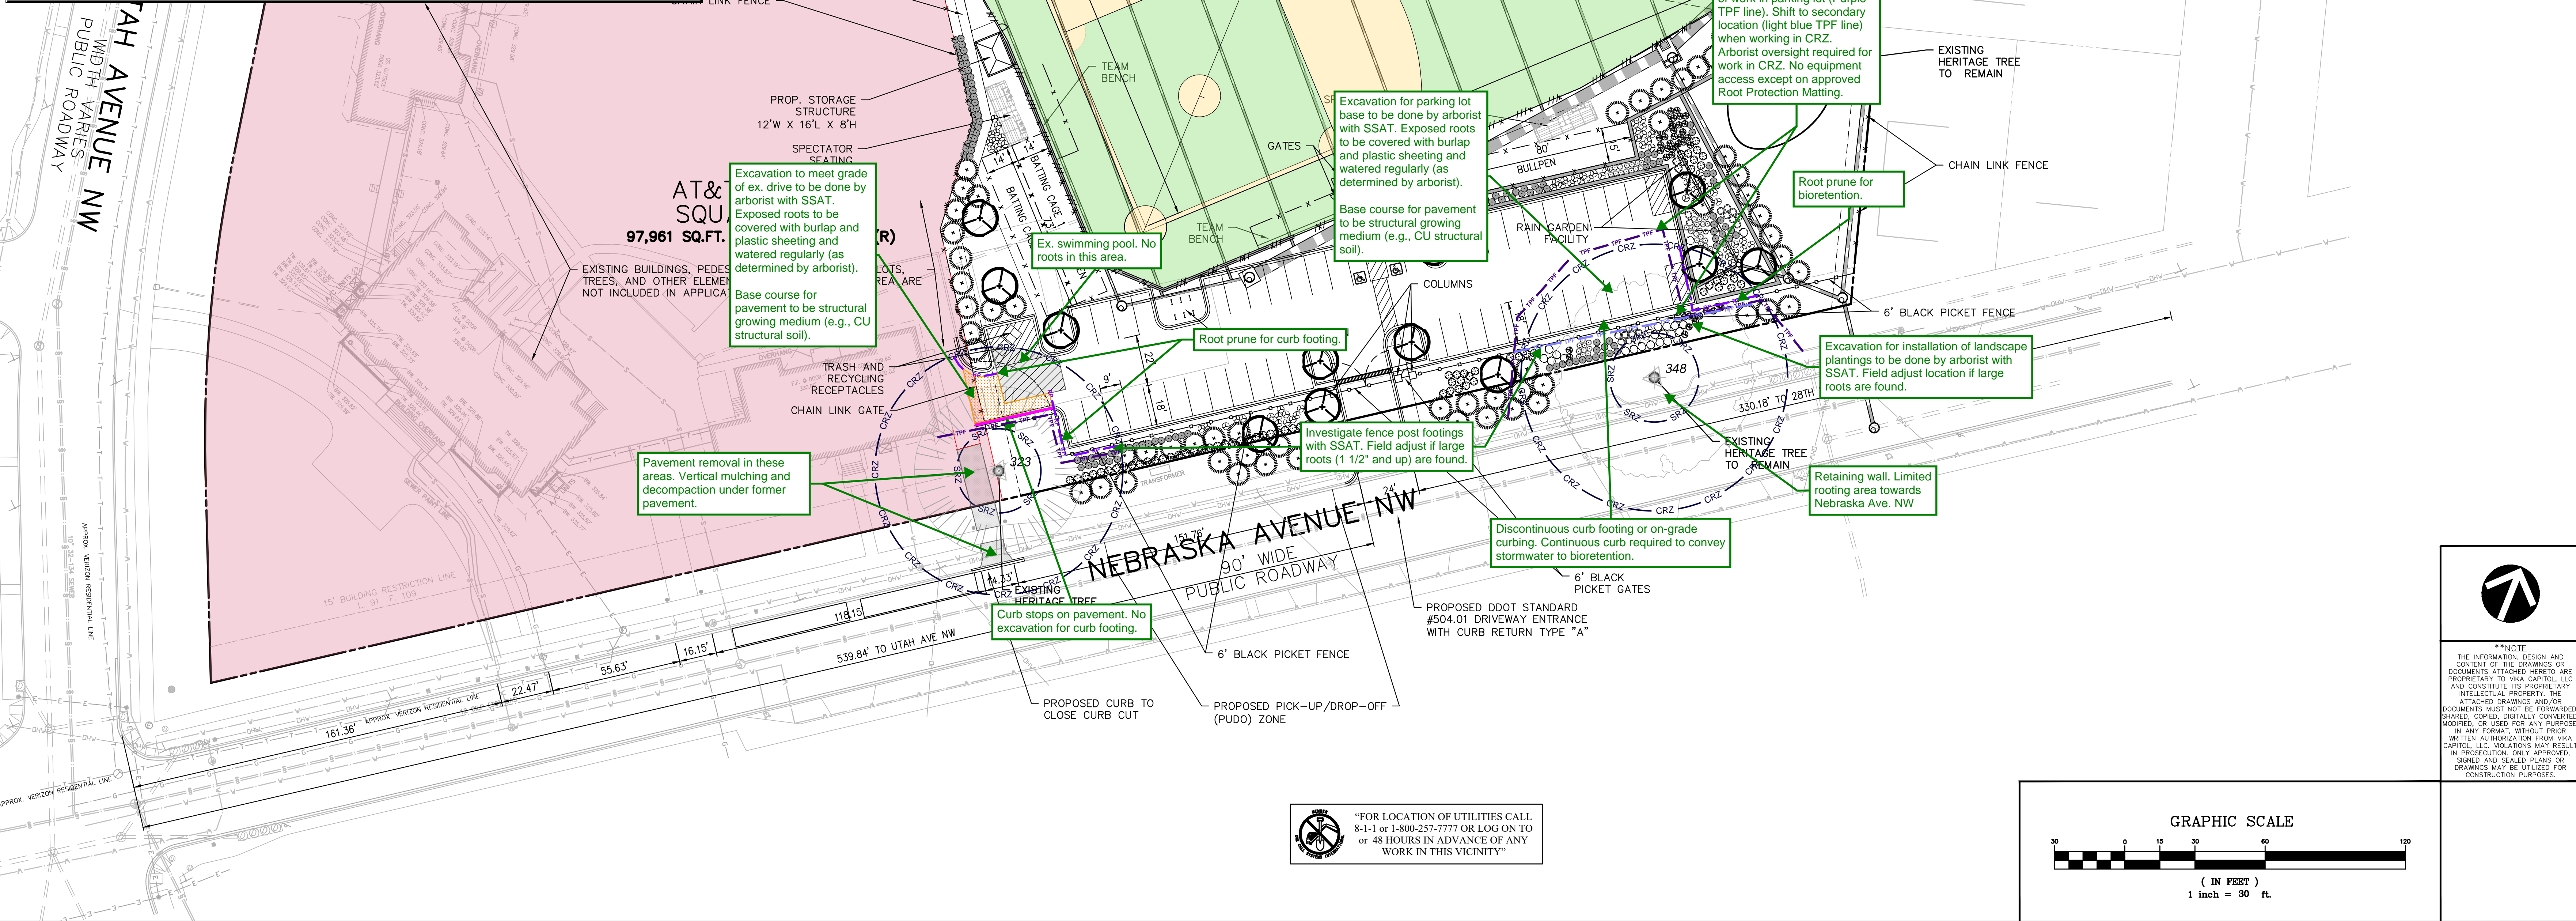
EXHIBIT A

Tree 323 is an Eastern white pine (*Pinus strobus*) measuring 35 inches Diameter at Breast Height (DBH). It was assessed as being in Good condition with only minor damage. This assessment was performed using the assessment methodology described in the *Guide for Plant Appraisal, 10th Ed., Second Printing* by the Council of Tree and Landscape Appraisers, in which separate scores are given for a tree's health, structure, and form; the lowest of the three is the tree's overall rating. Tree 323 was rated 80% for both health and structure and 85% for form. It is currently growing adjacent to a service drive used by ECC — the trunk is about 2.5 ft from the pavement edge. Other built infrastructure within its Critical Root Zone (CRZ) includes a swimming pool to the north, a building to the northwest, and the sidewalk and roadway to the south.

Tree 348 is a red maple (*Acer rubrum*) measuring 38 inches DBH. It was assessed as being in Fair condition, with its component scores being 60% for health and form and 50% for structure. It has

codominant branching, though without a bark inclusion. The large limb on the west side has fungal fruiting bodies consistent with a soft rot fungus. However, no dieback or decline was noted in the branch in the summer of 2021, which suggests that damage to the vascular tissue, if any, is not affecting the tree's health at this time. Mower damage to surface roots was noted on the south side. Girdling roots are not visible, but the lack of trunk flare suggests either a grade change — possibly during installation of a retaining wall — or the presence of belowground girdling roots. Probing the area with a steel surveyor's chaining pin was inconclusive. Three locations on the tree were selected for resistograph drilling — the base of the branch with fungal bodies and two locations near the base. Minor basal decay was detected in one basal location at 14 inches into the trunk. The other locations showed no internal decay. There is a retaining wall approximately 7.5 ft to the south of the trunk, which limits rootable area. While roots may exist below the sidewalk and under the roadway, they are not likely to be significant. Rooting is unconstrained elsewhere.

Due to the close proximity of the work to the existing Heritage Trees, close coordination between the design team, contractor, and the contractor's retained arborist is required for successful execution. A summary of recommended tree preservation measures is described as follows, with extents and locations illustrated on [Exhibit A](#).

- CRZs must be protected by temporary Tree Protection Fence (TPF) as shown on Exhibit A. Appropriate bilingual signage must be installed designating the area as a Tree Protection Area and restricting entry.

- TPF is to be installed in two phases as shown on Exhibit A. Prior to any work within the CRZ, the CRZ must be fenced to the maximum extent to prevent inadvertent damage during staging and site preparation. At the start of work within the CRZ, TPF will be moved to its final location. All work within the CRZ must be overseen by an ISA Certified Arborist provided by the retained arborist.
